R808 Rev 2

September 2016

City of Wanneroo

**Two Rocks Beach Access Stairs
Inspection Report**

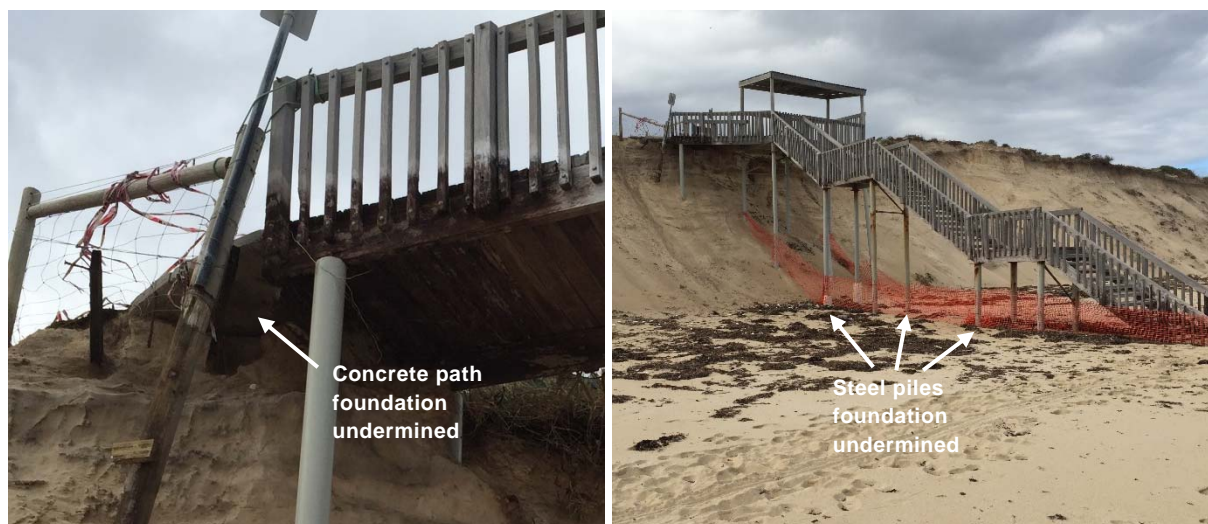
Figure 2.1 Undermined Concrete Footpath & Pile Foundations

- The foundation of the concrete path leading to the beach access stairs has been undermined as a result of the dune erosion (refer Figure 2.1). The end section of this path is currently partially supported and therefore there is a risk of collapse if repair or removal works are not undertaken immediately.

- The pile foundations of the stairs have been exposed, and the design pile embedment has been reduced (refer Figure 2.1). Therefore the structure has a high risk of collapse if it is not repaired or removed immediately.

- The foundation of the end section of concrete path leading to the stairs has been undermined. This section of concrete path should be removed immediately.

- The structural elements of the stairs are at the end of their design life, and the pile foundations of the stairs have been undermined and showed sign of instability.

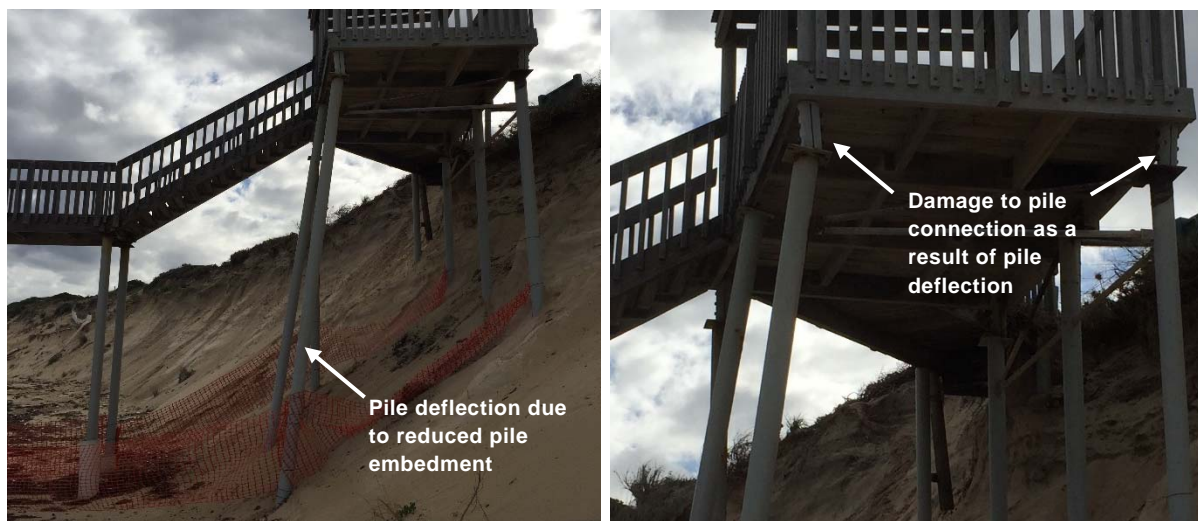
Figure 2.2 Pile Deflection & Damage to Pile Connections

- Two piles under the platform have experienced significant deflection (refer Figure 2.2), likely due to reduced pile embedment as a result of the beach and dune erosion. It is expected that further pile deflection is likely to result in collapse of the stairs. Immediate repair or removal will be required.

- A number of connections from the platform to the steel piles have experienced damage as a result of the pile deflection (refer Figure 2.2). Immediate repair or removal will be required to prevent further damage.

It is considered that the stairs are currently a hazard to public safety and should be removed or repaired immediately. Further storm damage may result in collapse of parts of the structure. While repair of the stairs is an option, due to the age of the structure, cost and functionality issues, it is not recommended. Should the stairs be repaired in their current location, they would be unlikely to be functional due to ongoing erosion and shoreline recession.

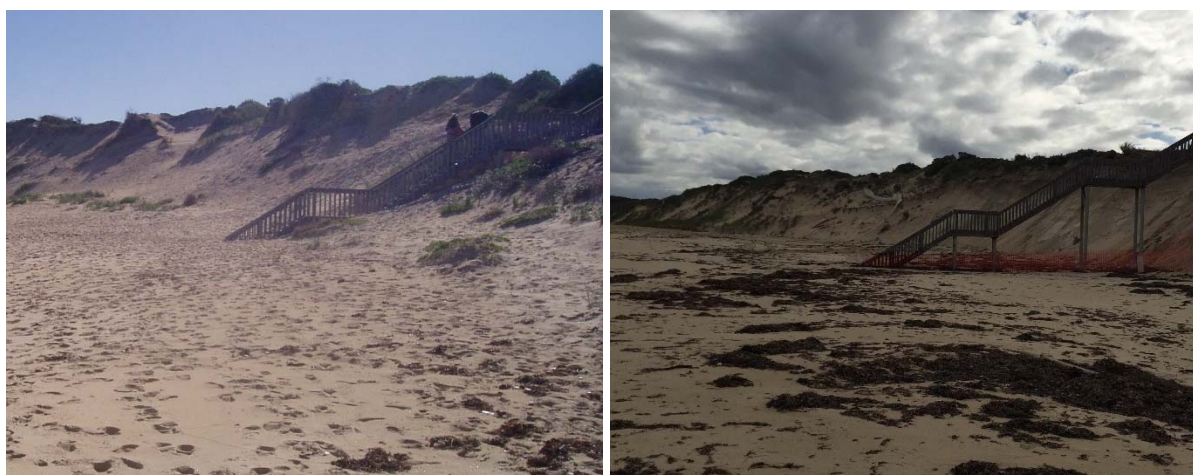
Figure 2.3 Photograph of Stairs in July 2004 (Left) & June 2016 (Right)

It is anticipated that the current location of the stairs is vulnerable to ongoing coastal erosion, as is evident in the following photographs showing the change in beach profile between 2004 and 2016 at the site.

It is expected that this erosion trend will continue to an extent into the future.

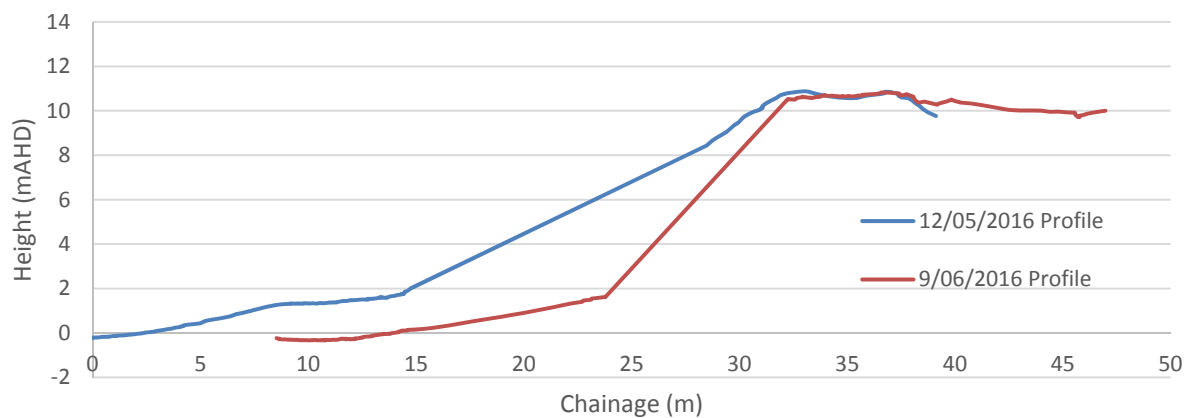
Figure 2.5 Beach Profile at Transect 23

From the survey data, it is evident that the storms generally resulted in a beach/dune recession in the order of 5 m. It is anticipated that similar erosion may occur in the future should similar storm conditions be experienced. In addition, the ongoing trend in shoreline erosion experienced over a number of years at the site is likely to continue into the future.

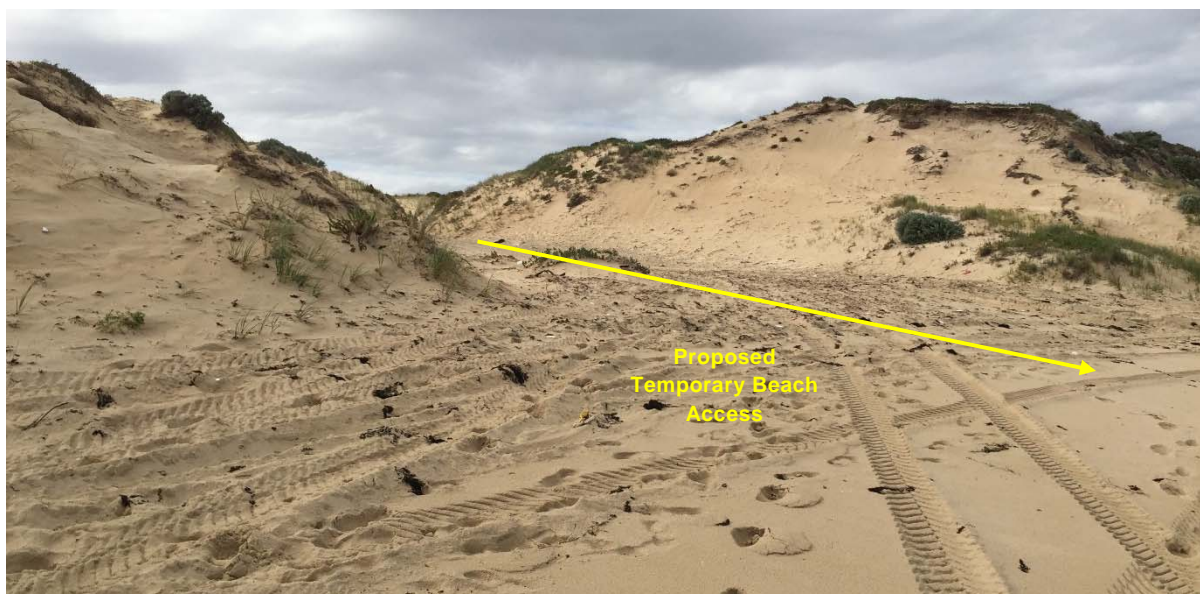
Figure 4.2 Proposed Temporary Access through Sand Blowout

Due to the existing grades in this area, minimal clearing and earthworks would be required. In addition, any further erosion in this area is likely to have less impact on access in this location due to the current low lying elevation of the dunes.

To provide alternative short-term beach access, it is recommended the informal access track north of the existing stairs is upgraded for temporary access. The upgrade should include minor earthworks to improve the grade of access and provision of wind break fence to formalise the track. This location is believed to be appropriate as minimum earthworks are required to provide a suitable grade for beach access. The location and photograph of the proposed temporary beach access is shown in Figures 4.1 and 4.2 respectively.

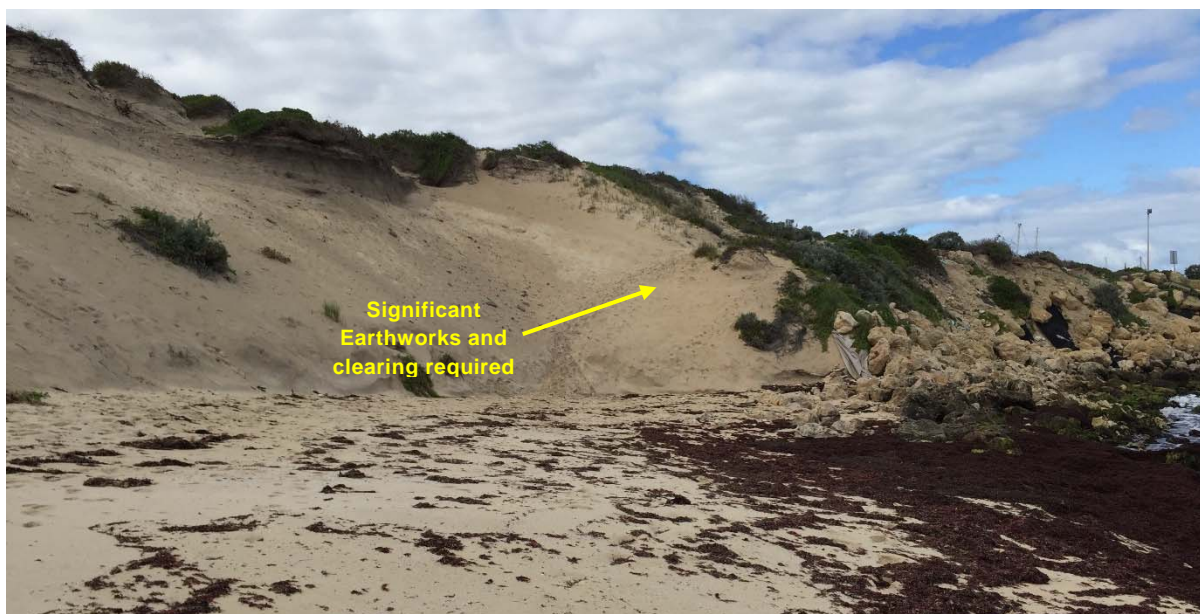
Figure 4.3 Informal Access Immediately North of Two Rocks Marina

Alternative access immediate north of the Two Rocks Marina was considered and investigated during the site inspection. This location is considered unfeasible for short term access due to existing steep grades of dune, which would require significant level of clearing and large scale earthworks to provide an appropriate grade for access. The shoreline at this location is also likely to experience instability due to storm erosion.
