PRE/POST* CONSTRUCTION STREET & VERGE INSPECTION REPORT

PRE/POST CONSTRUCTION ROAD RESERVE DAMAGE REPORT

DATE INSPECTED: 24 DEC 2016	<input checked="" type="checkbox"/> PRE-CONSTRUCTION	<input type="checkbox"/> POST-CONSTRUCTION
-----------------------------	--	--

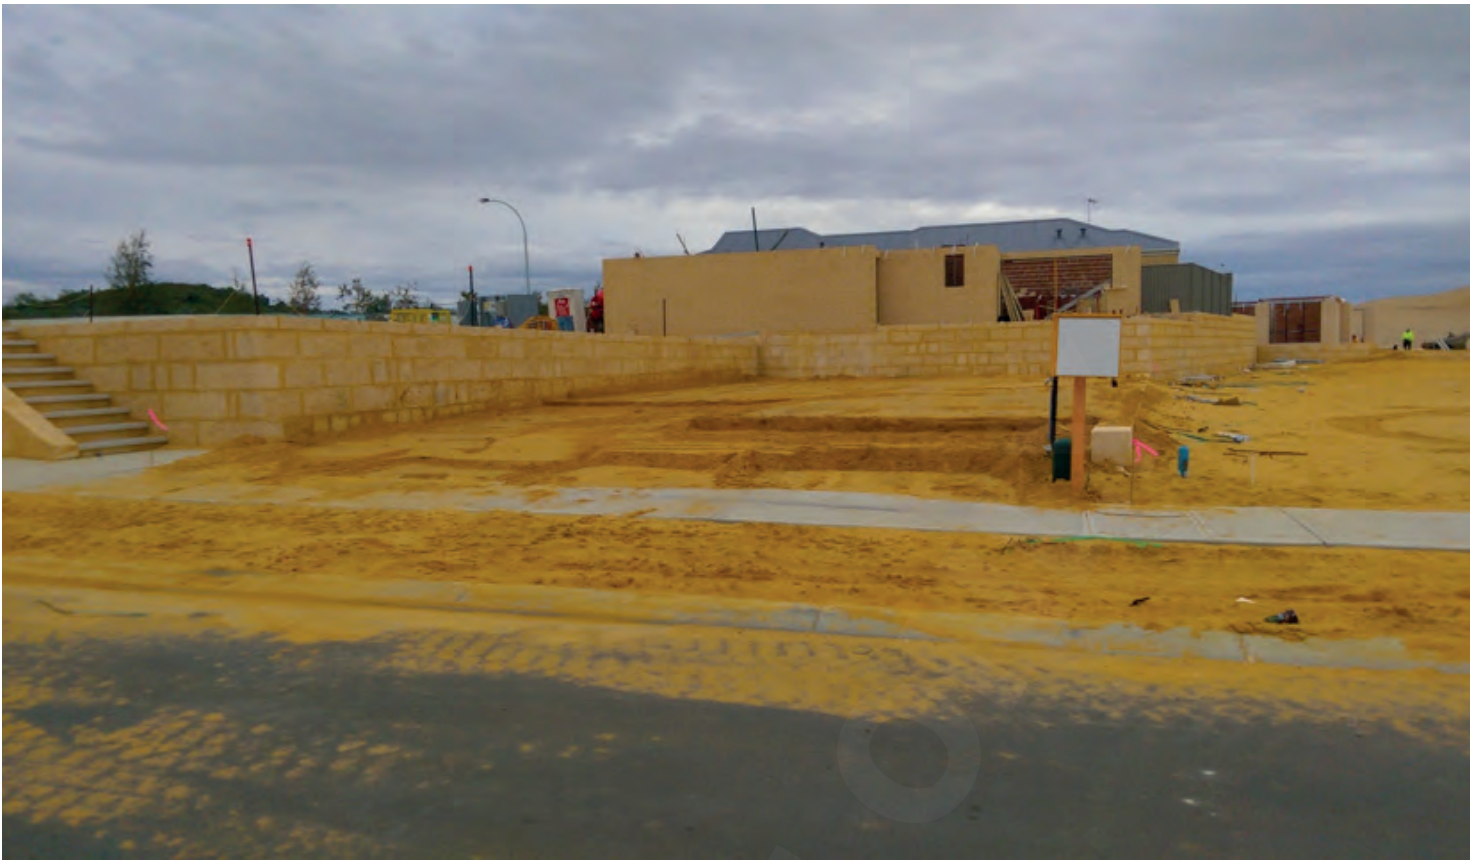
COMMENTS: Block inspected.

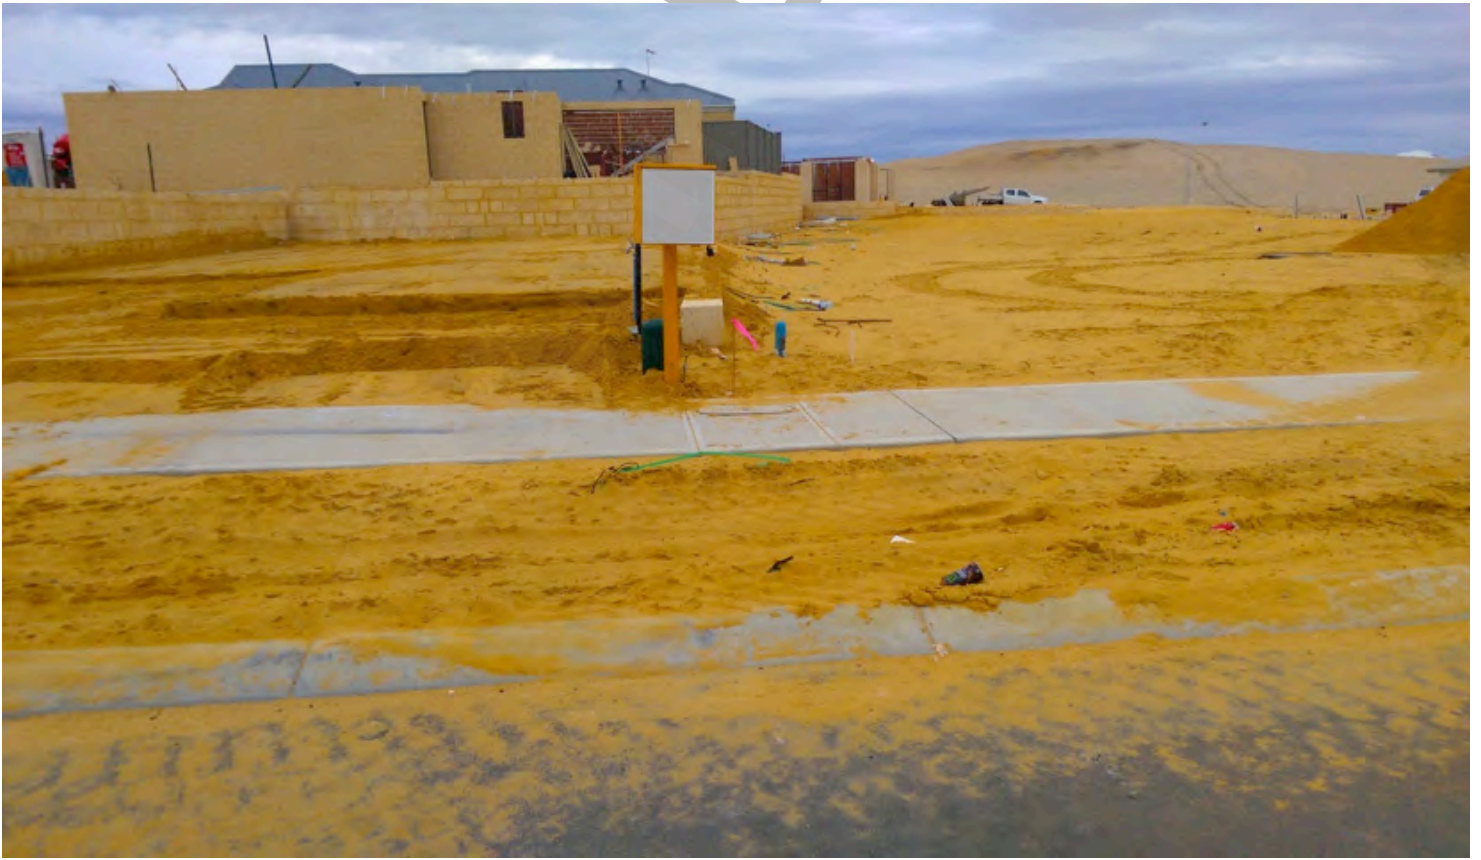
COMMENTS: north extents of block

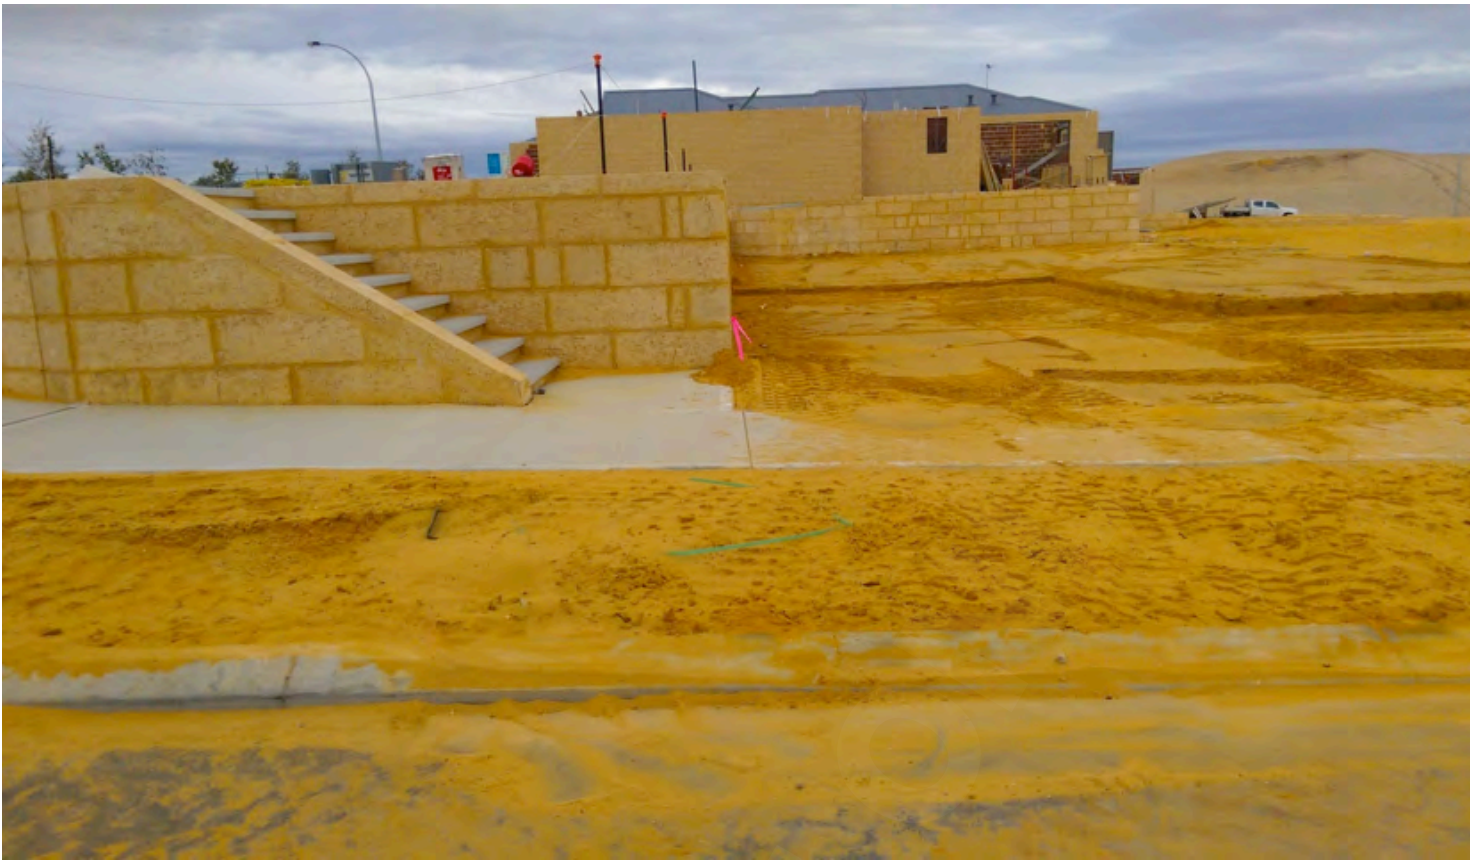
COMMENTS: south extents of block

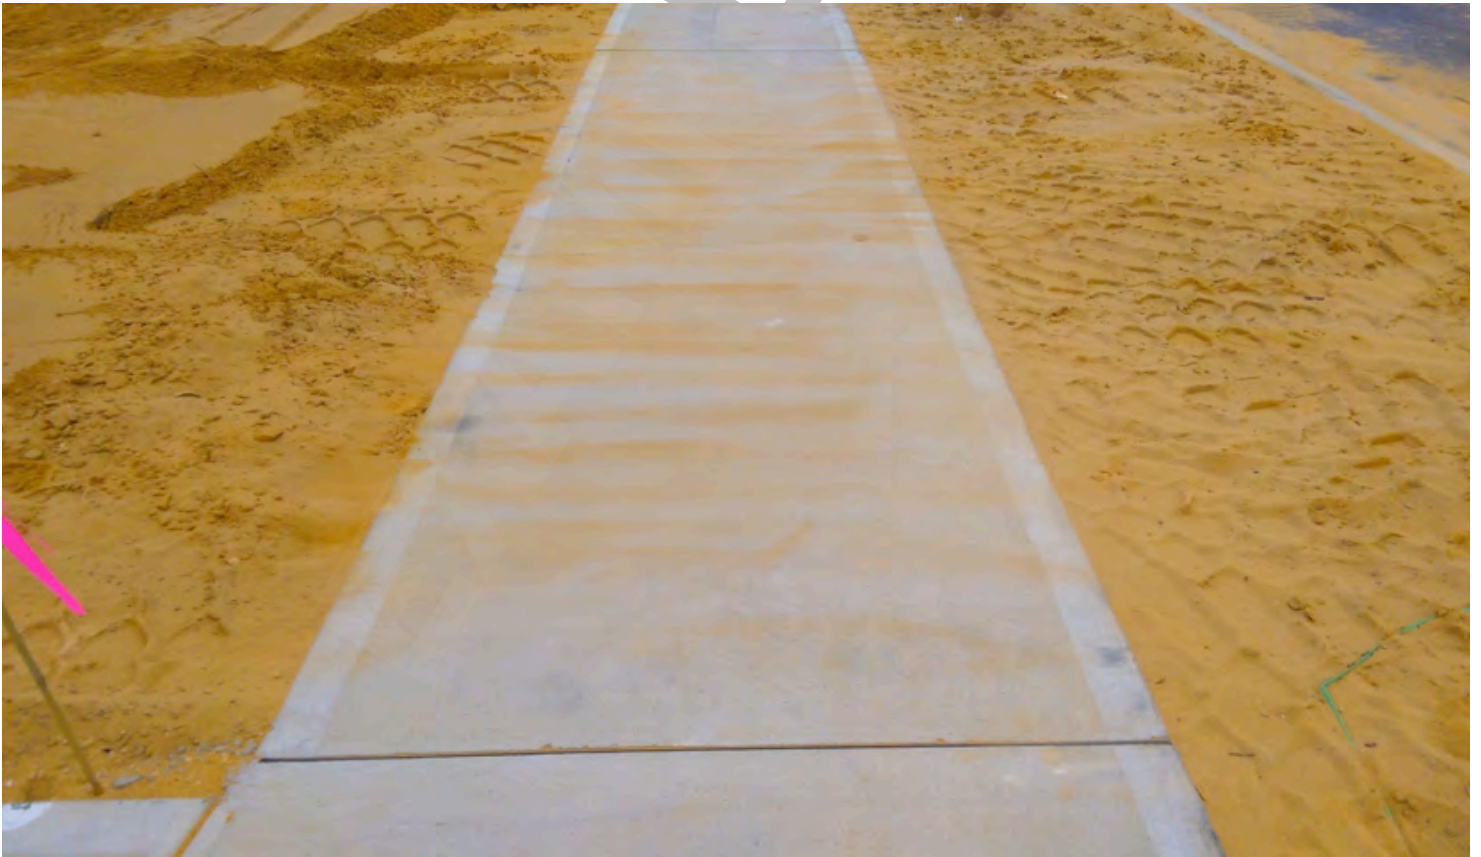
P1 COMMENTS: Full width cracking to panel

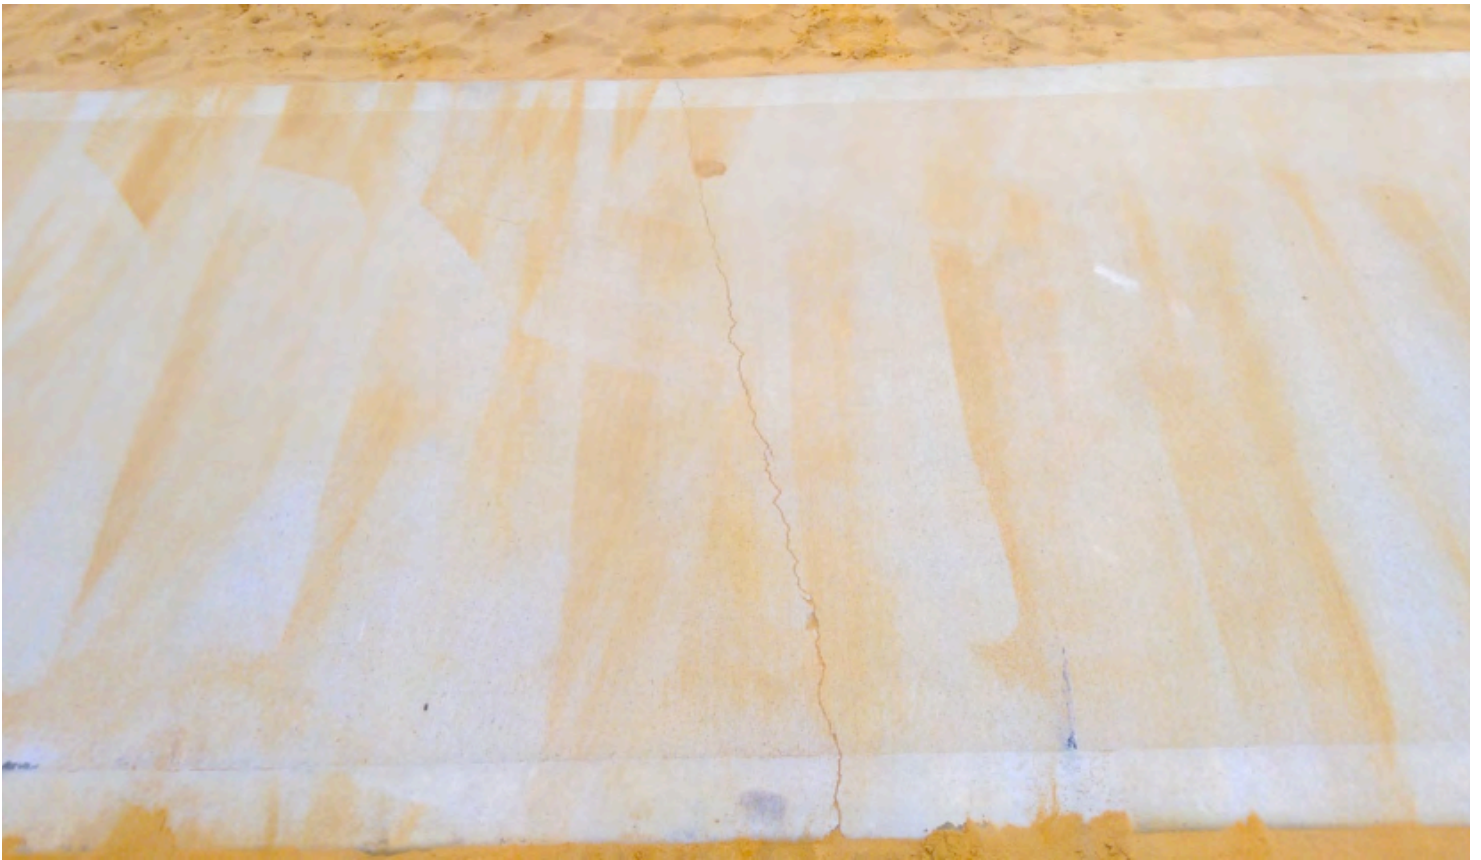
P1 COMMENTS: Close-up of P1 damage

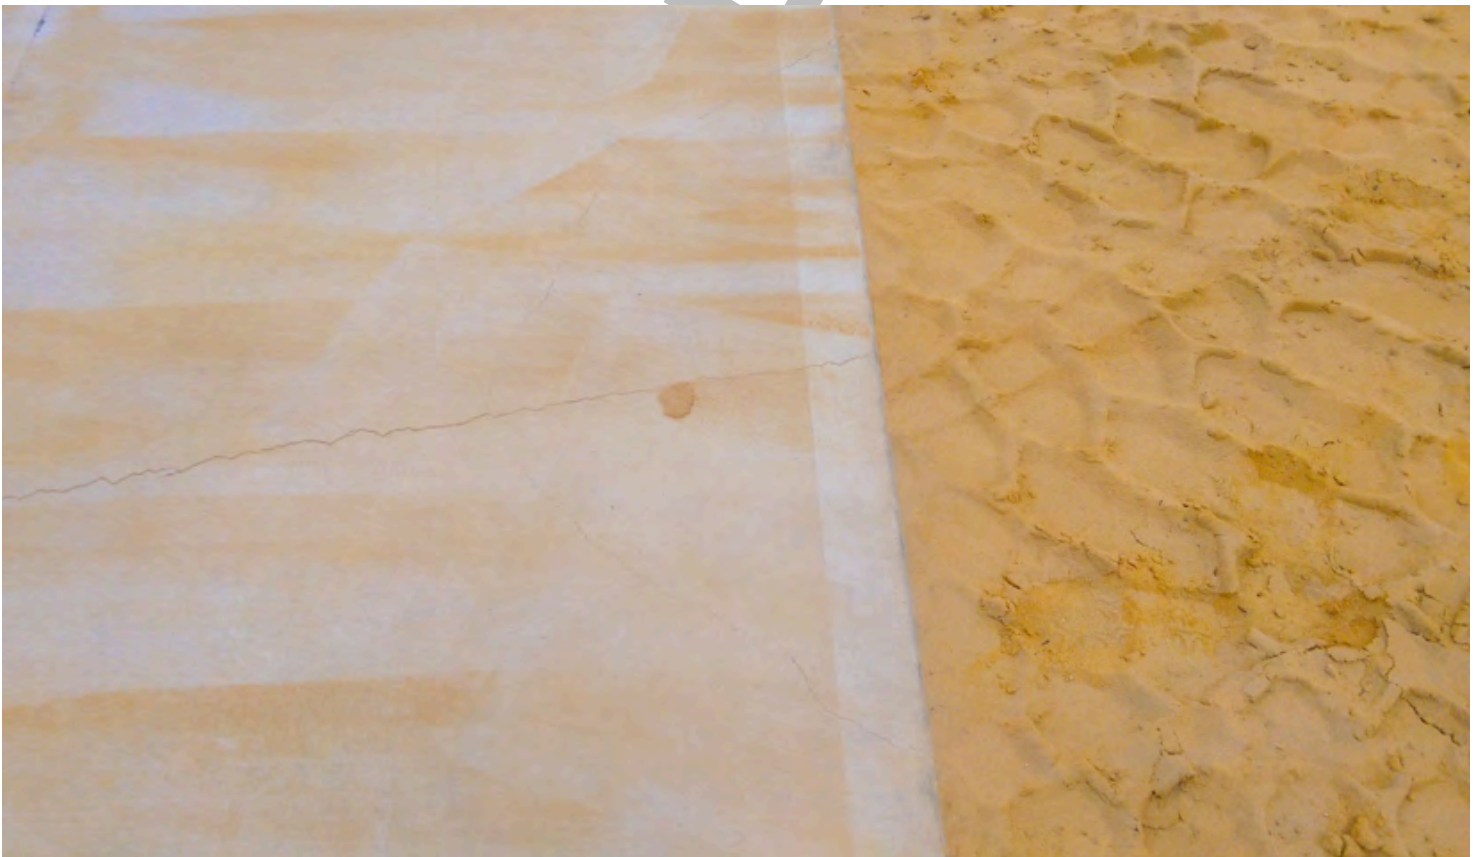
P1 COMMENTS: Close-up of P1 damage

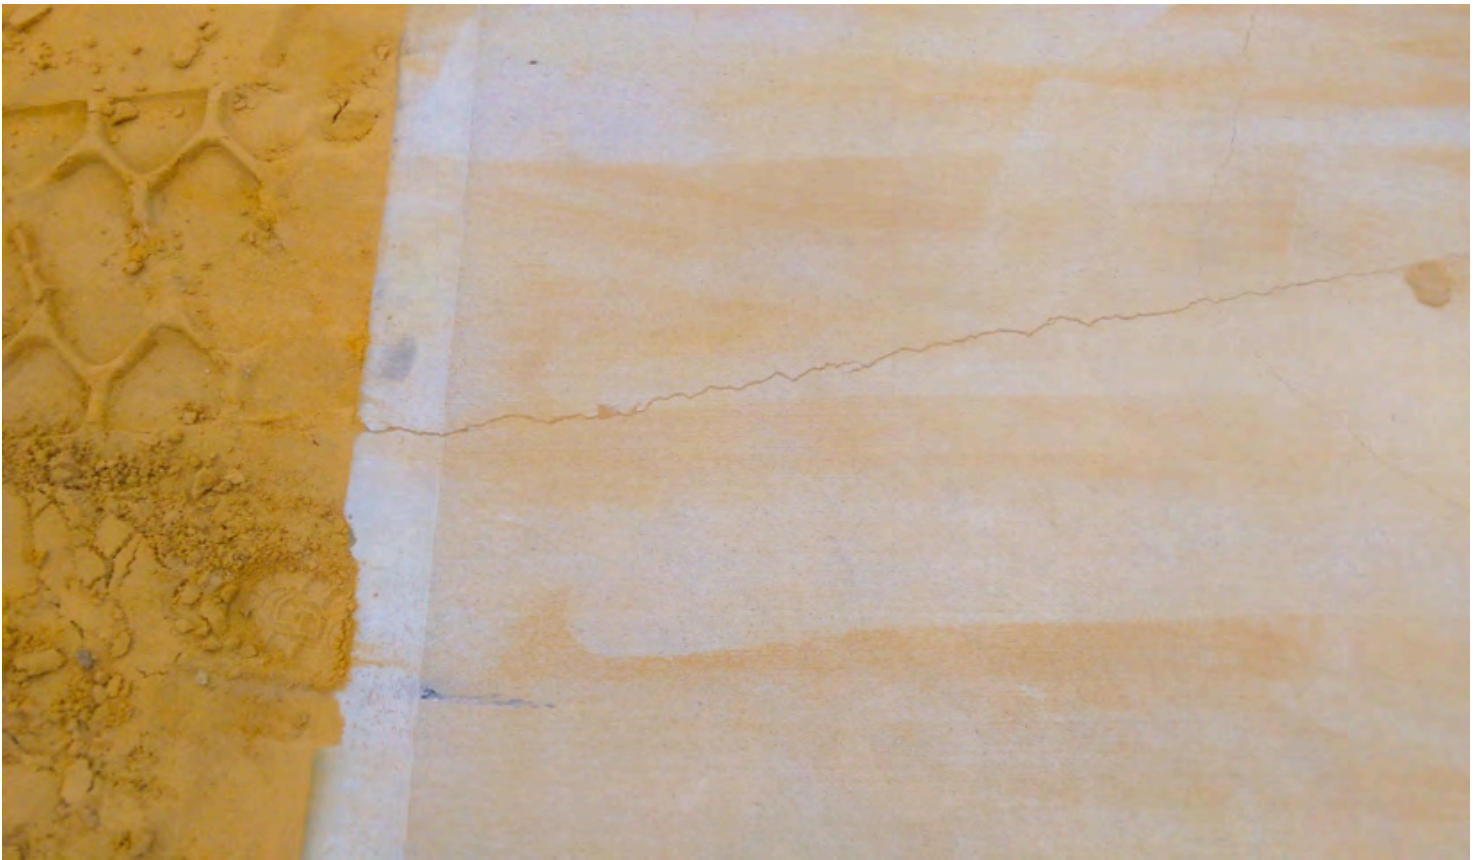
P1 COMMENTS: Close-up of P1 damage

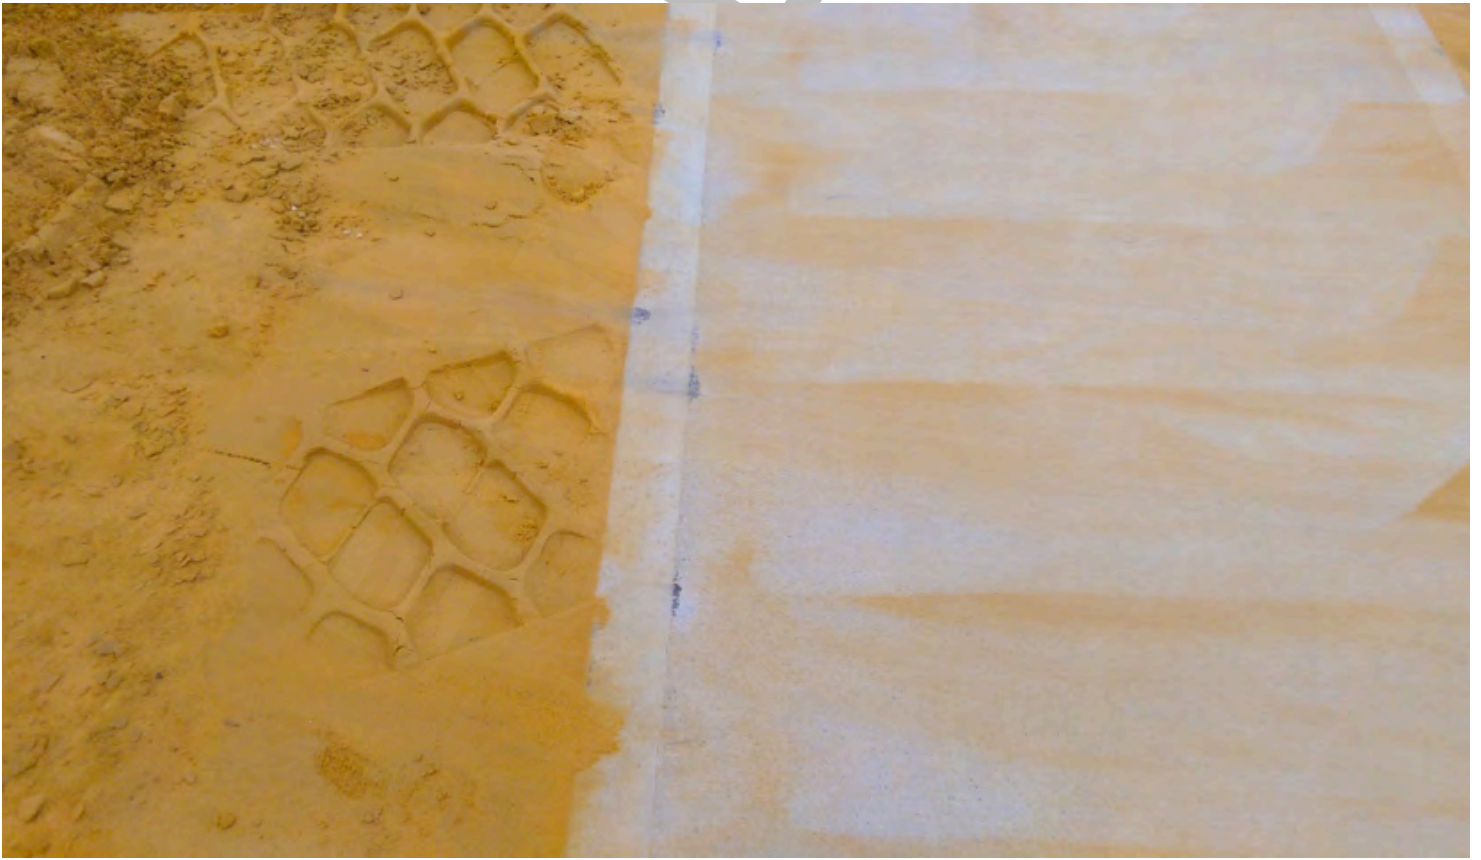
P1 COMMENTS: Close-up of P1 damage

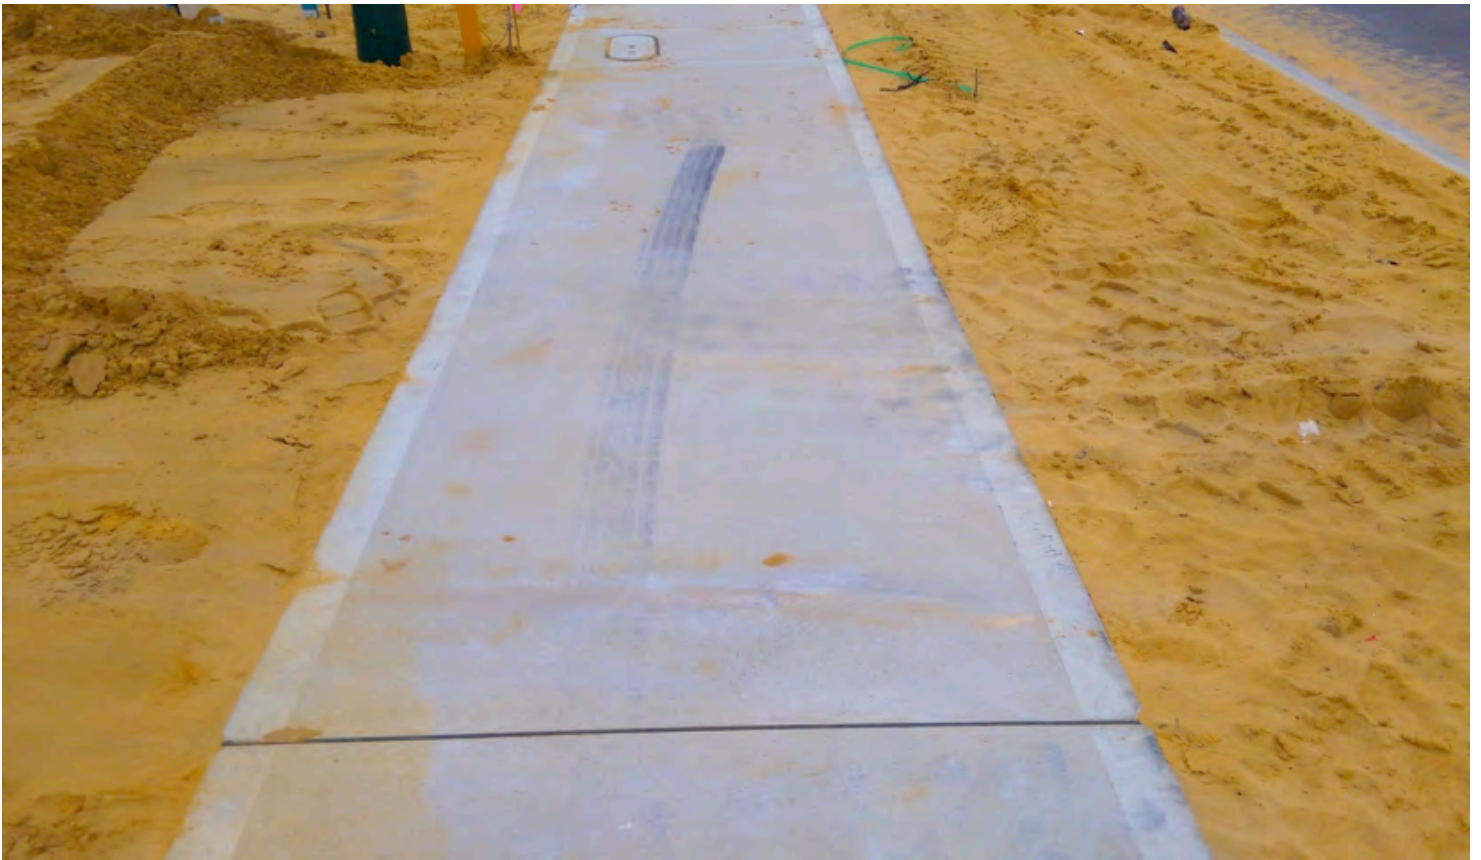
P2 COMMENTS: Minor chipping and tyre damage/staining to panel

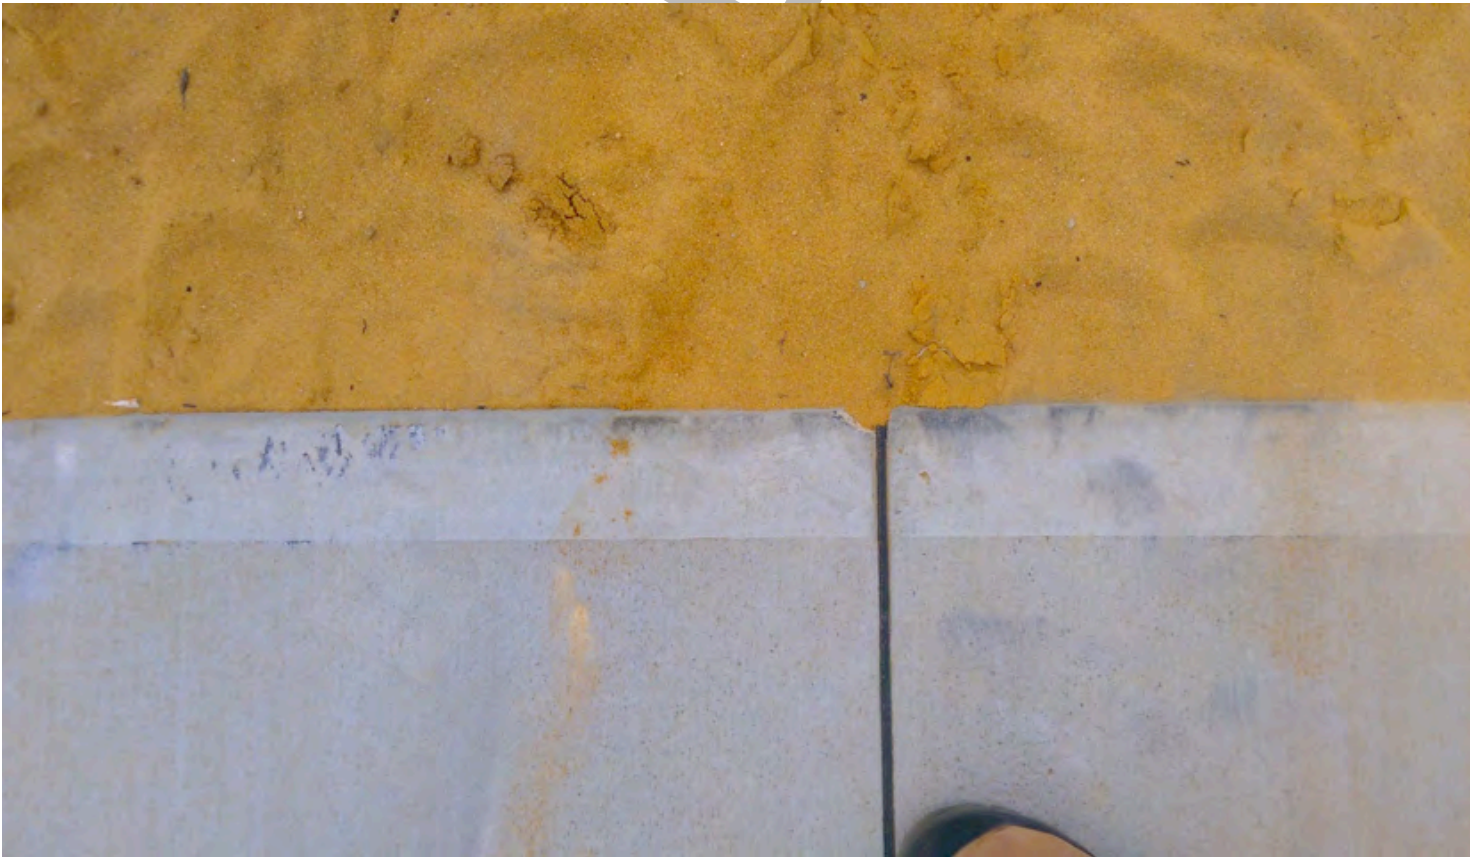
COMMENTS: Close-up of P2 damage

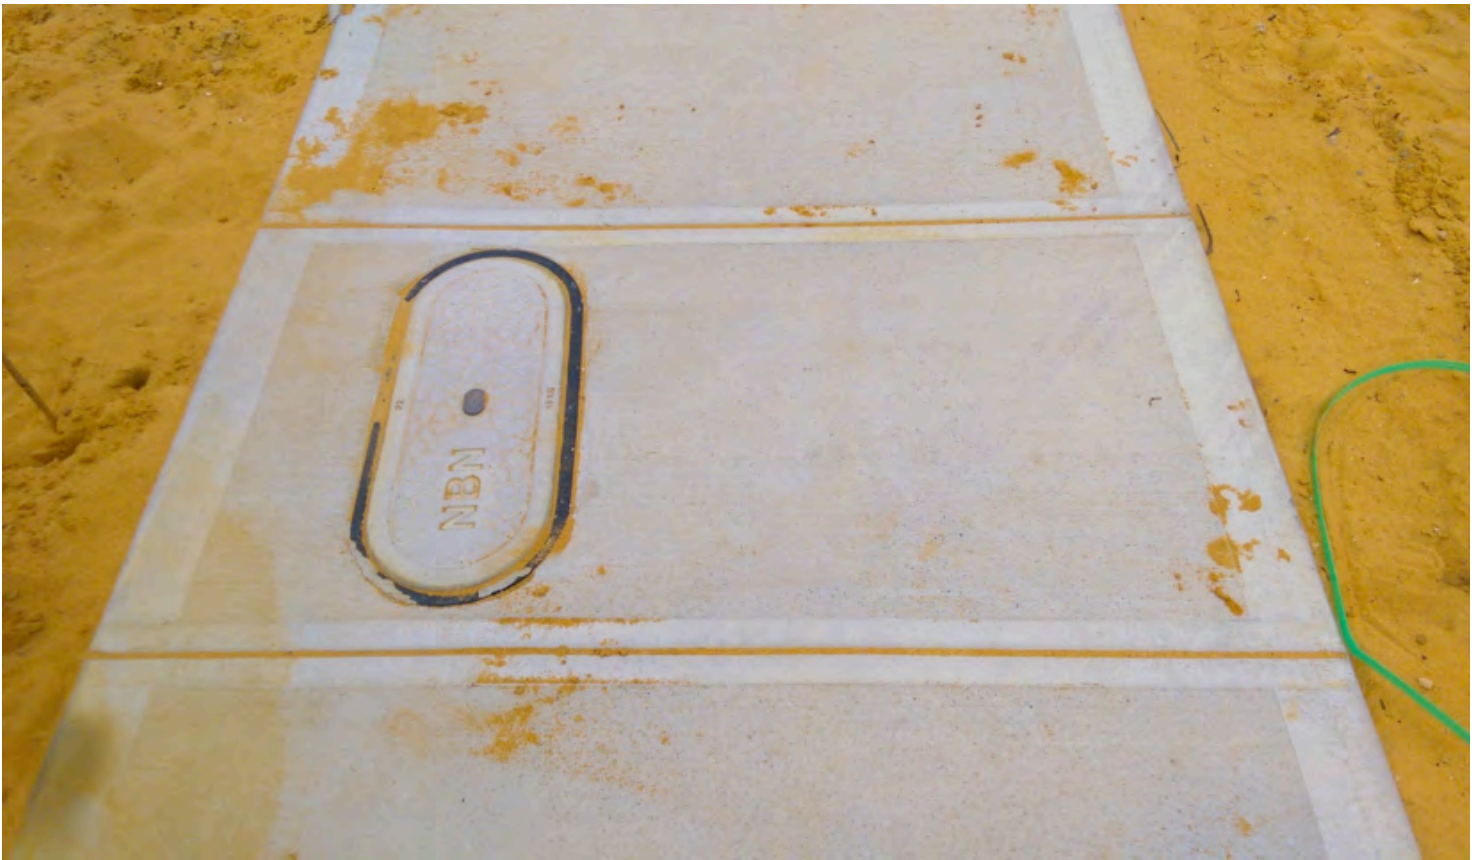
COMMON PANEL P1 COMMENTS: No damage to panel identified

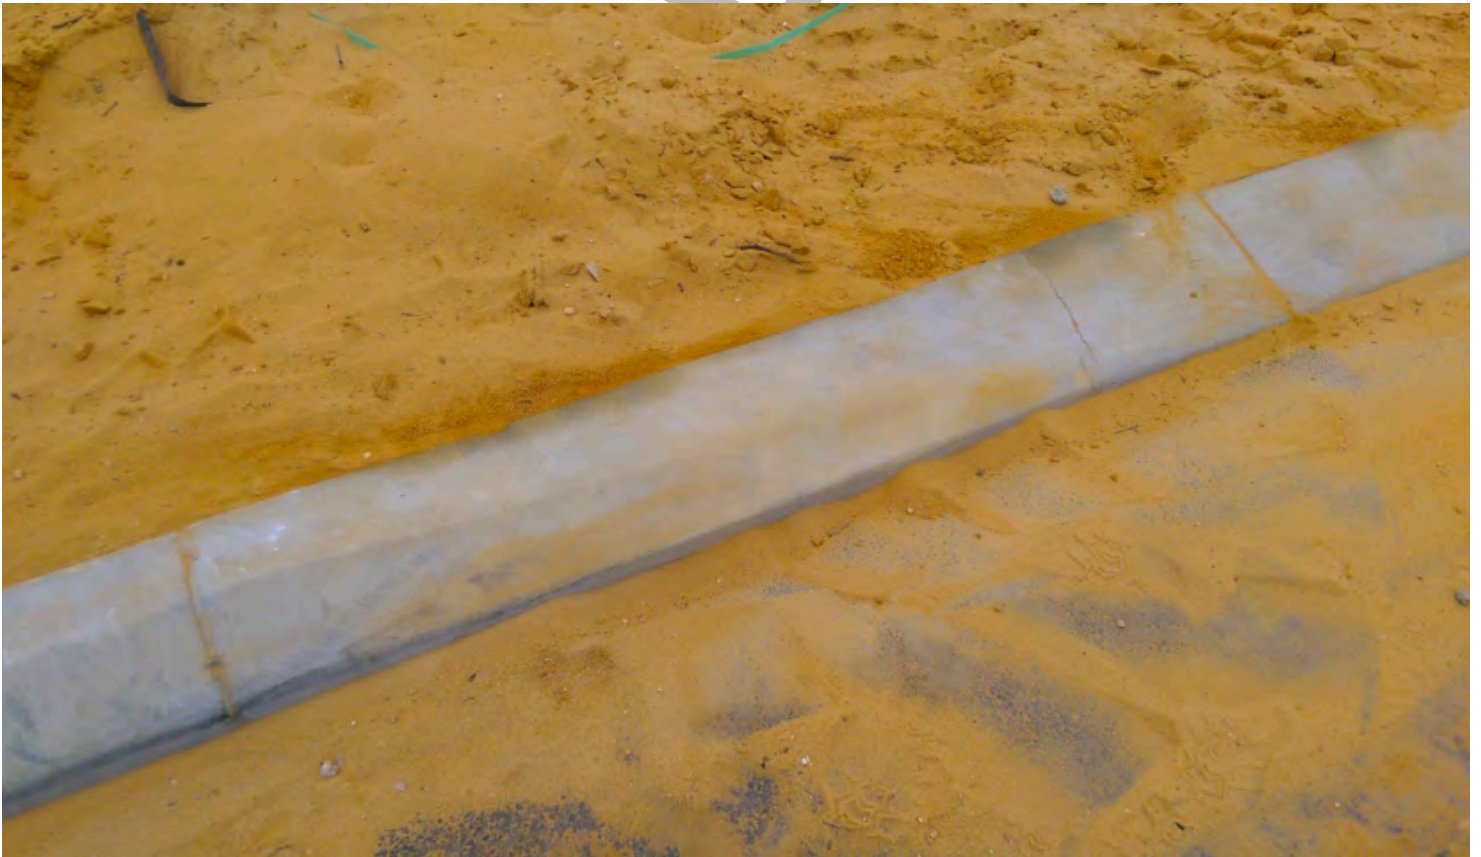
COMMON KERB 1 COMMENTS: Cracking damage to transitional kerb

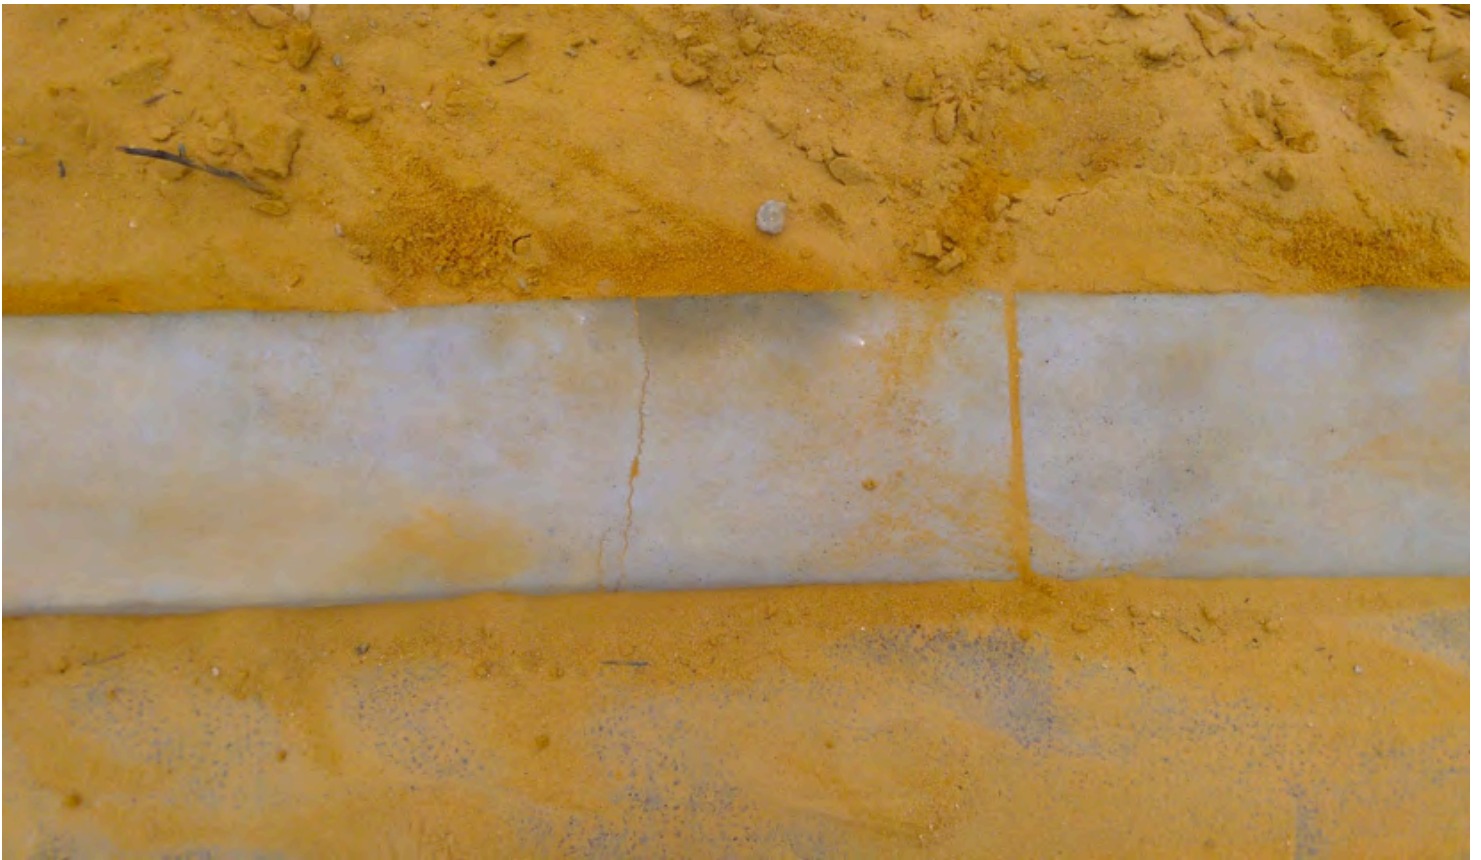
K1 COMMENTS: Close-up of common kerb 1 damage

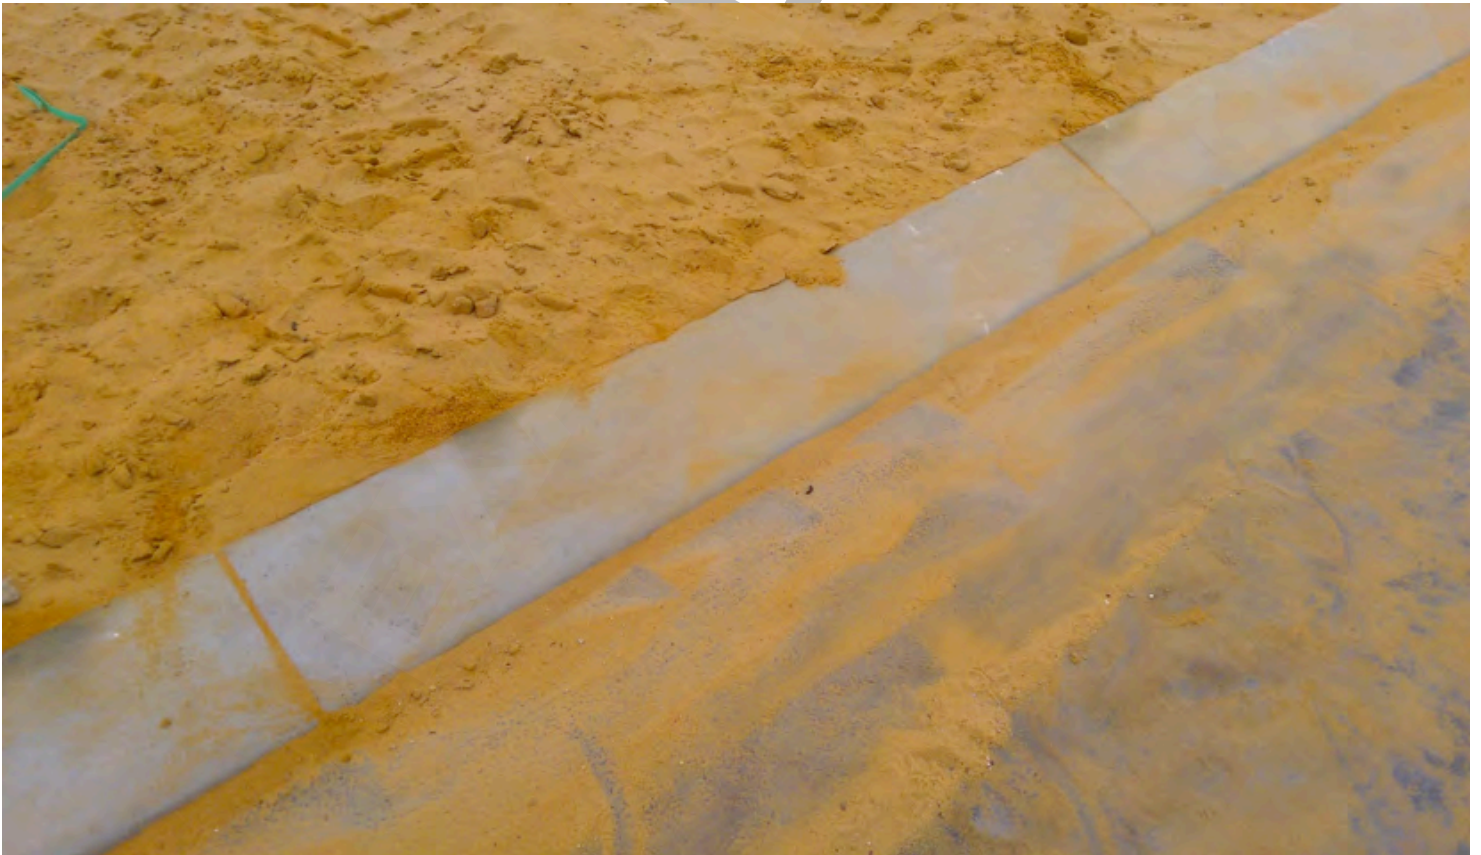
K1 COMMENTS: Shrinkage cracking to kerb

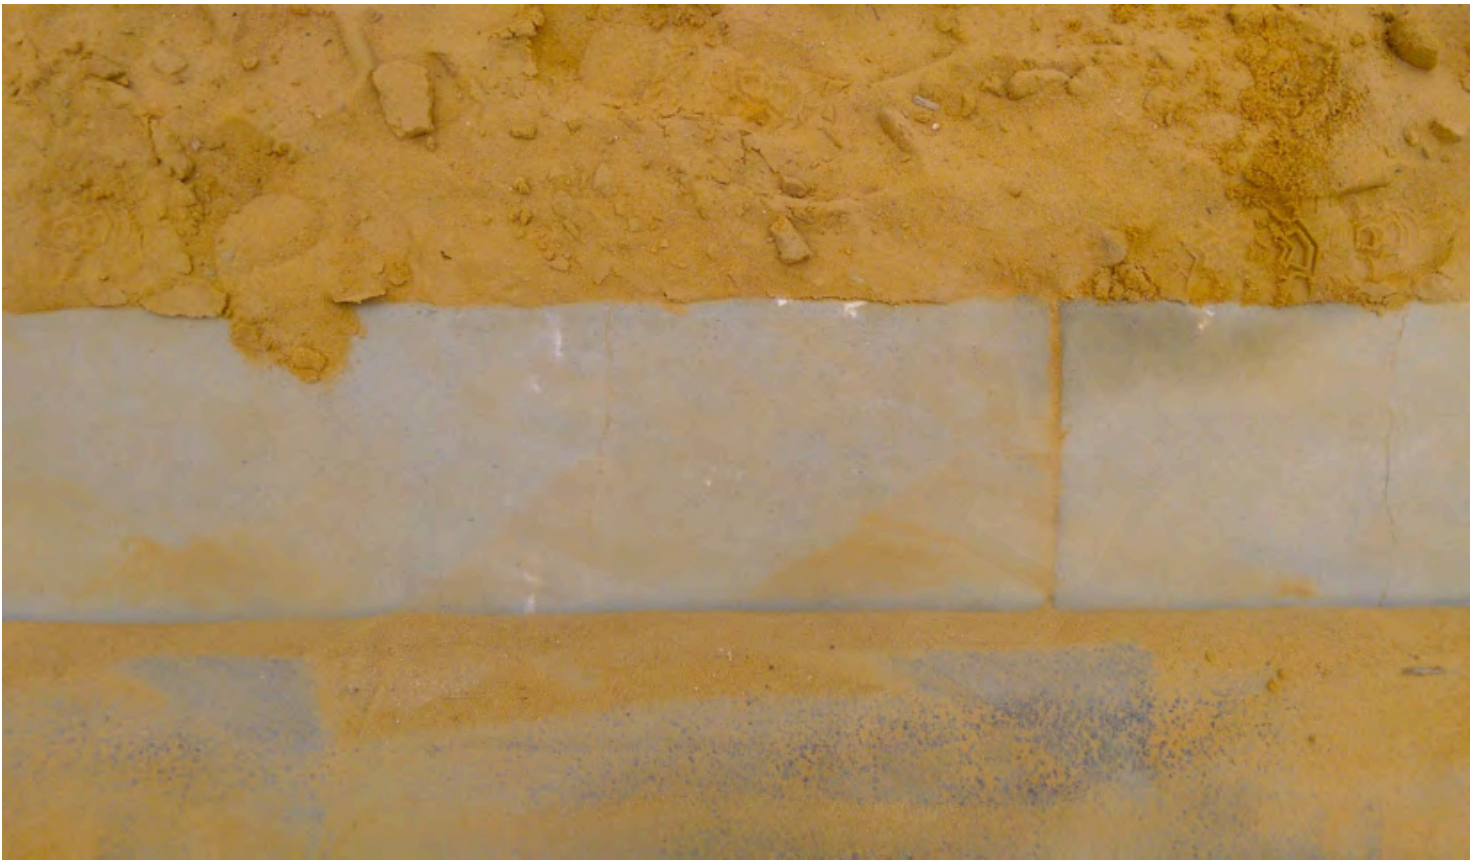
K1 COMMENTS: Close-up of K1 damage

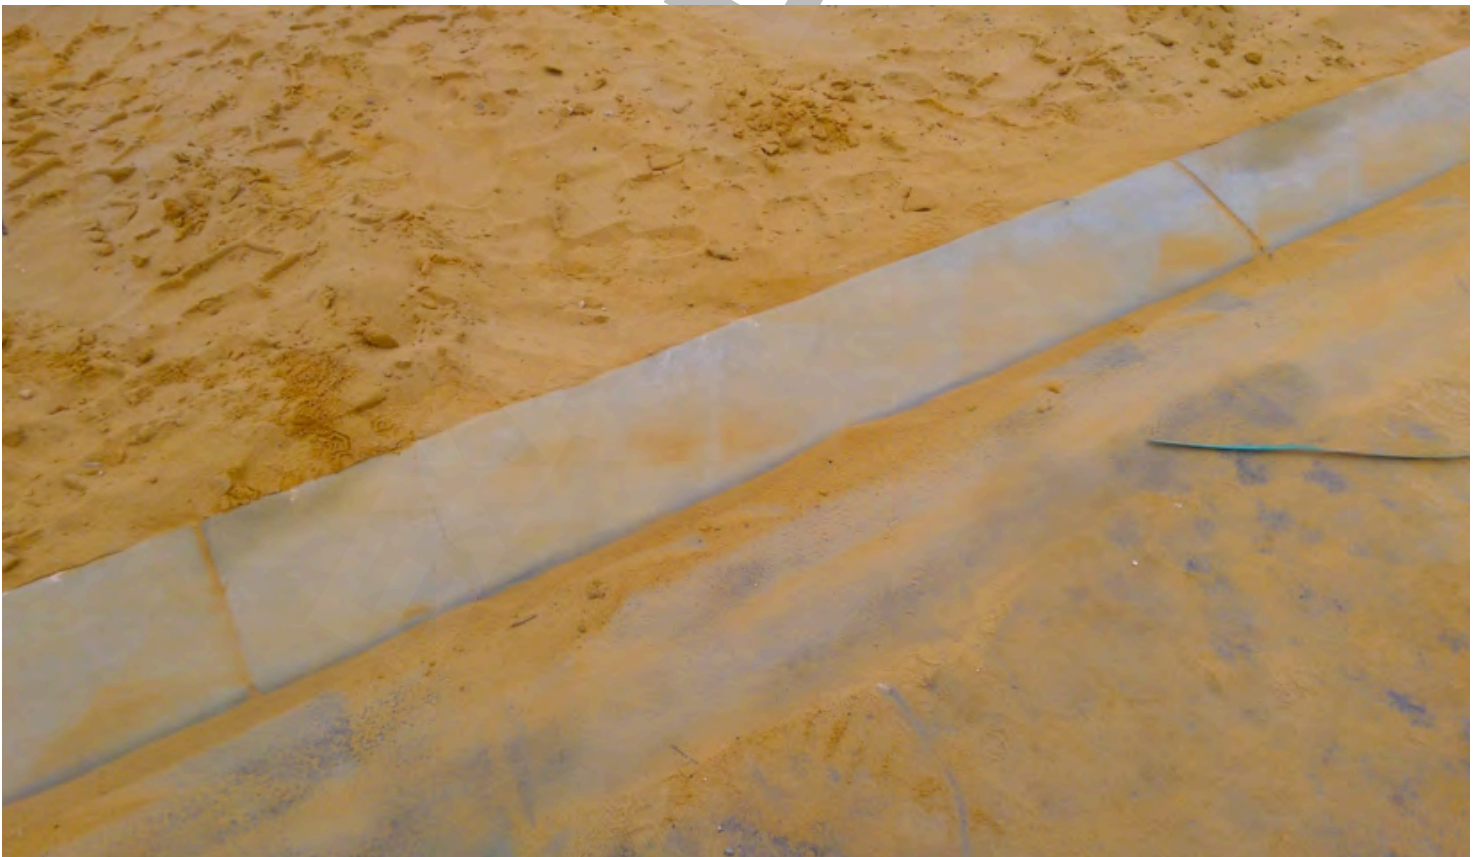
K2 COMMENTS: Cracking damage to kerb

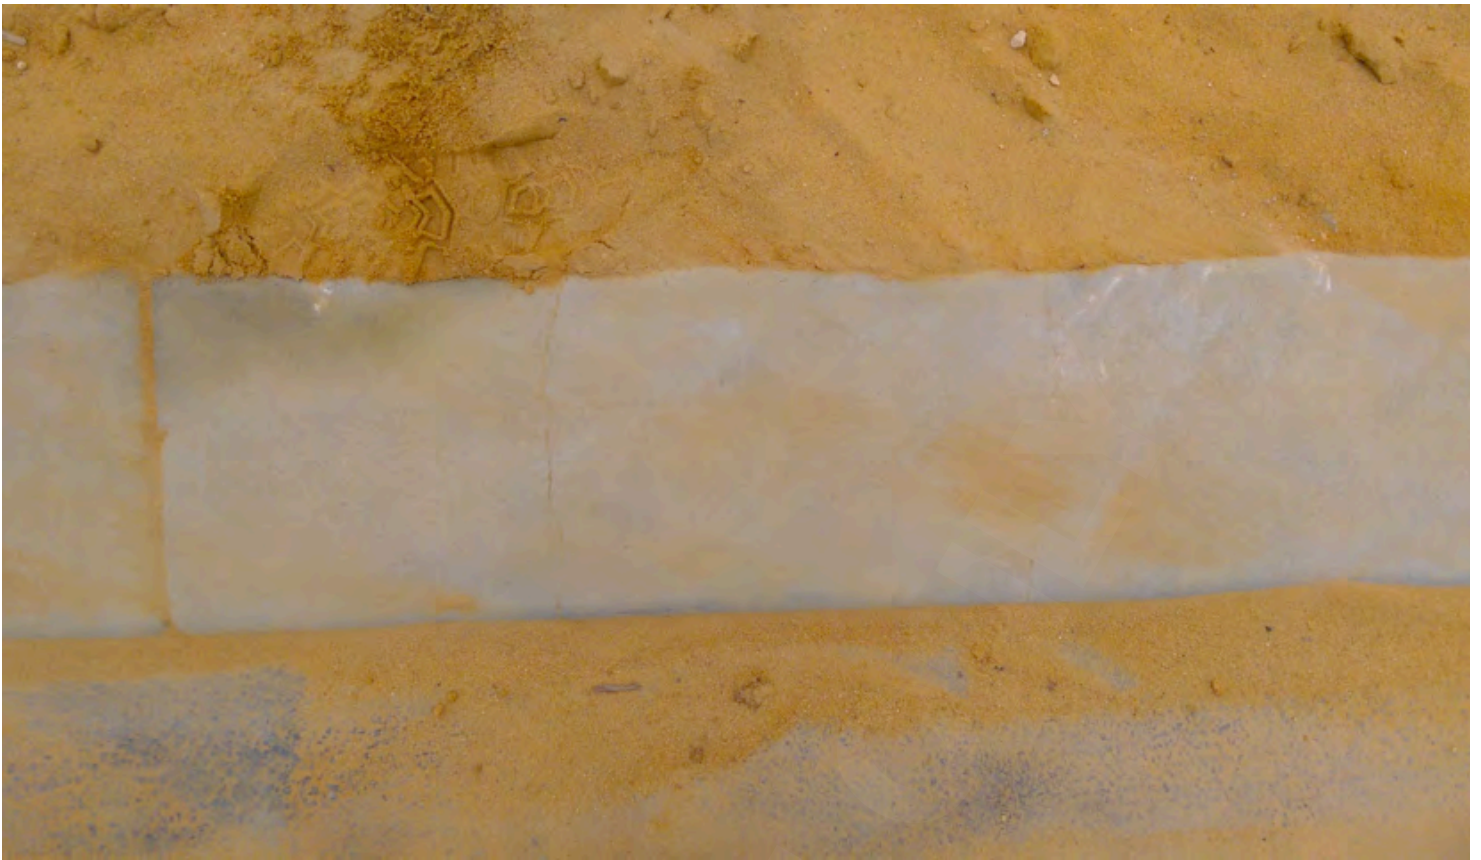
K2 COMMENTS: Close-up of K2 damage

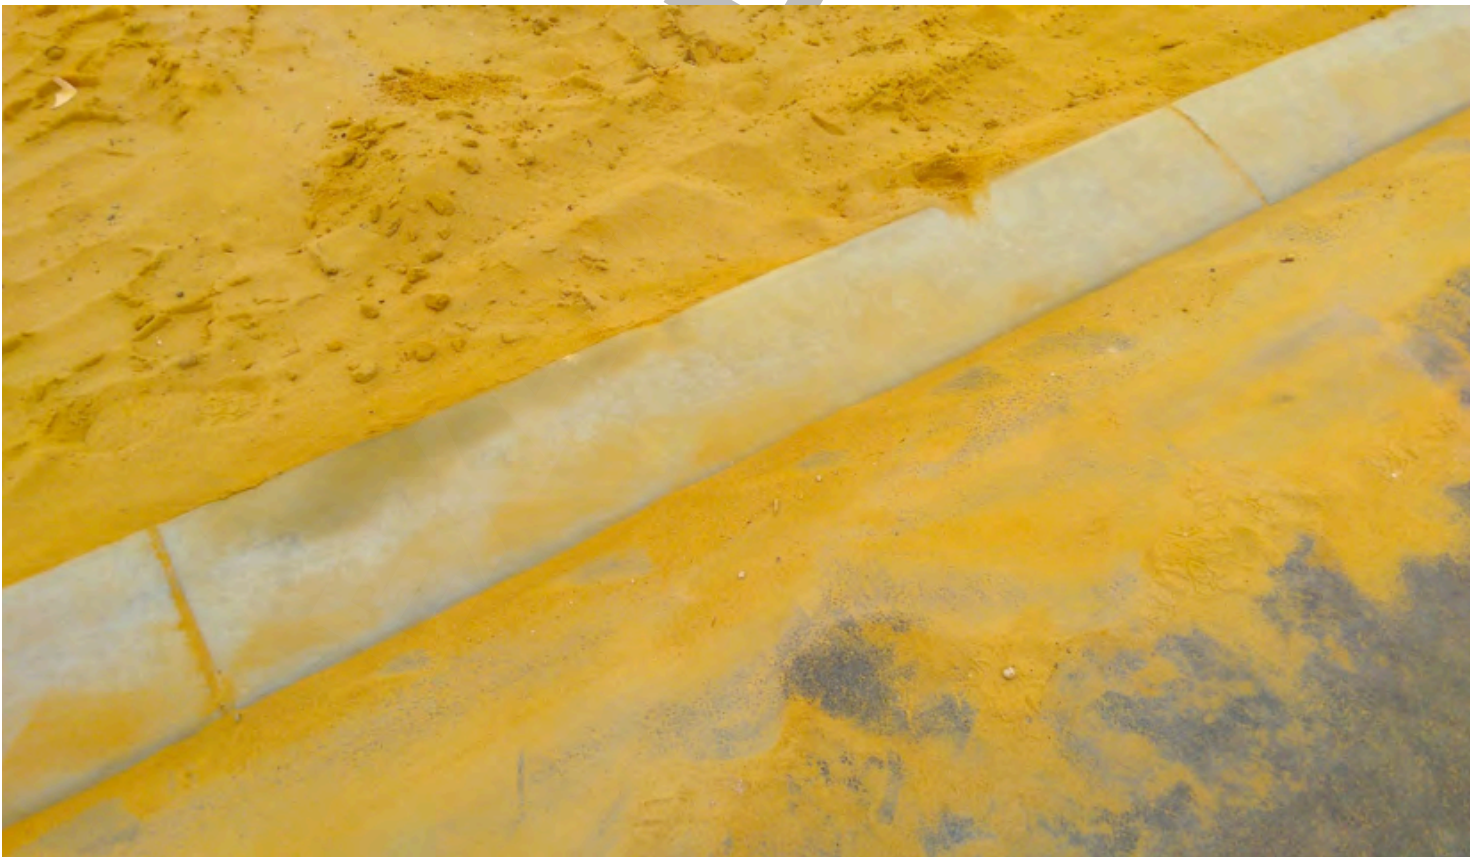
K3 COMMENTS: No damage identified
