PRE/POST* CONSTRUCTION STREET & VERGE INSPECTION REPORT

PRE/POST CONSTRUCTION ROAD RESERVE DAMAGE REPORT

DATE INSPECTED: 24 DEC 2016	<input checked="" type="checkbox"/> PRE-CONSTRUCTION	<input type="checkbox"/> POST-CONSTRUCTION
-----------------------------	--	--

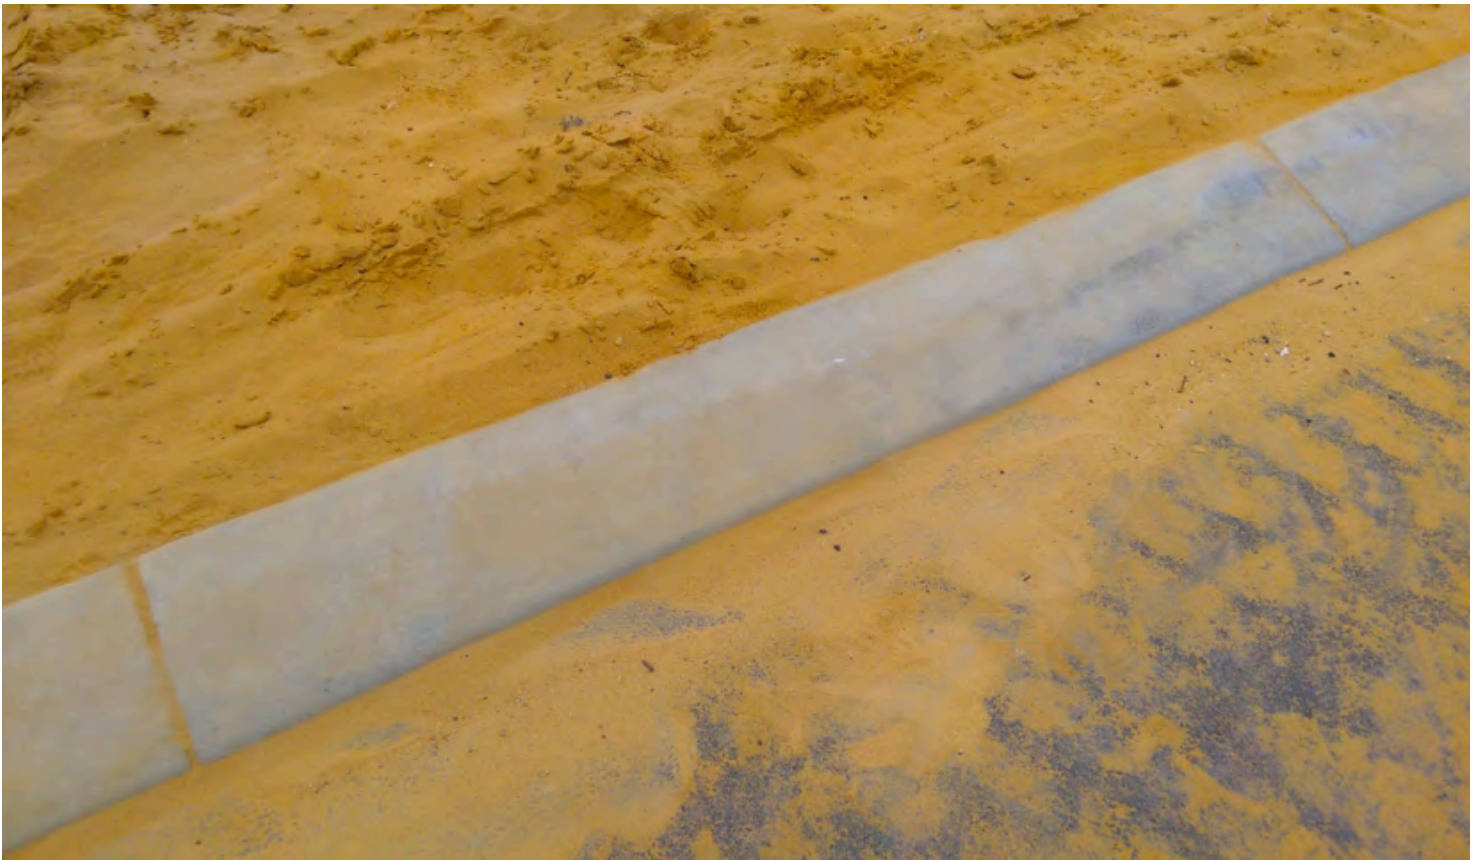
K4 COMMENTS: No damage identified

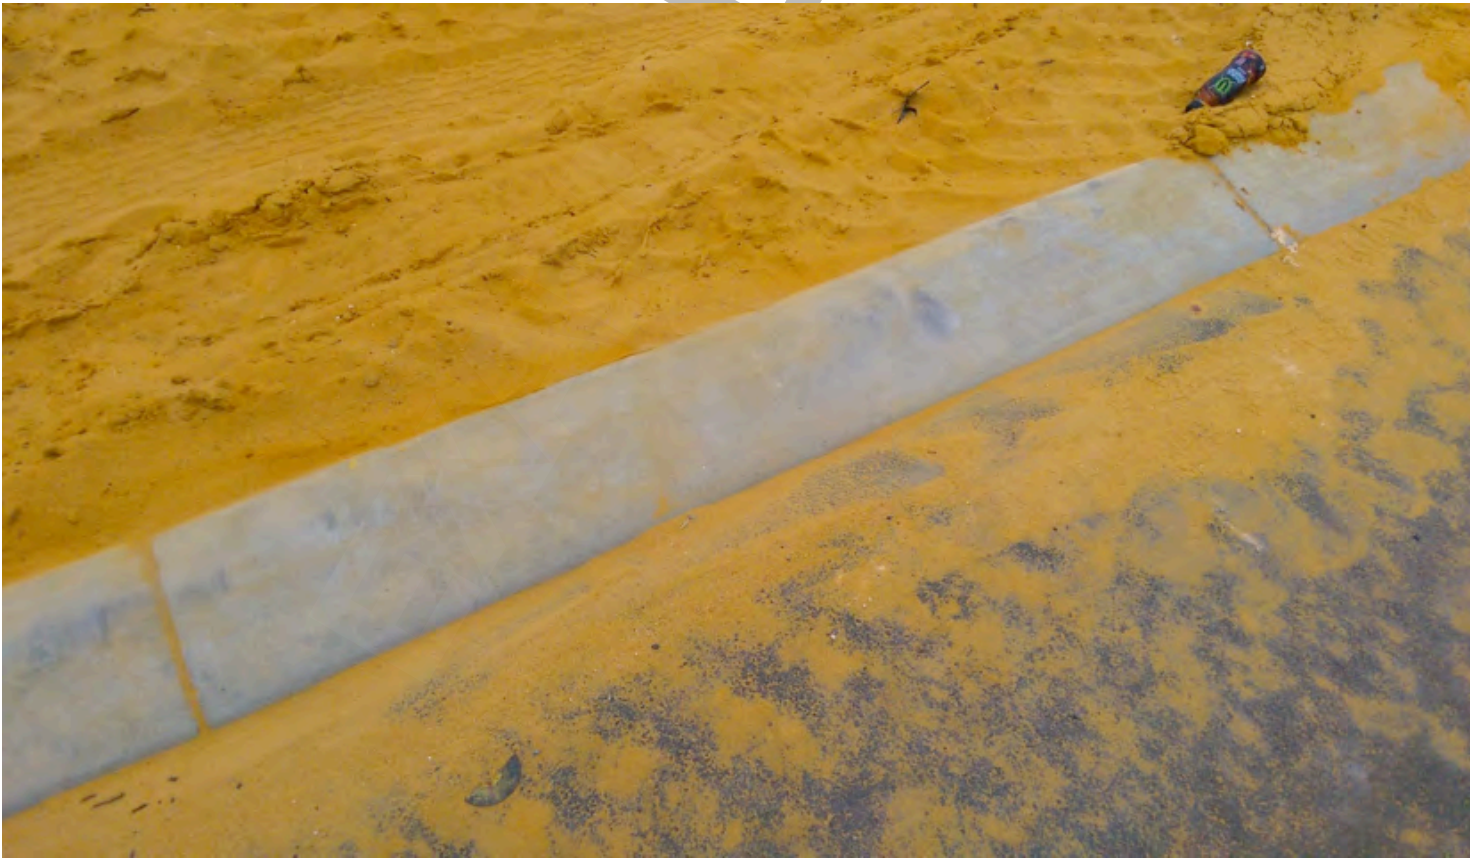
K5 COMMENTS: No damage identified

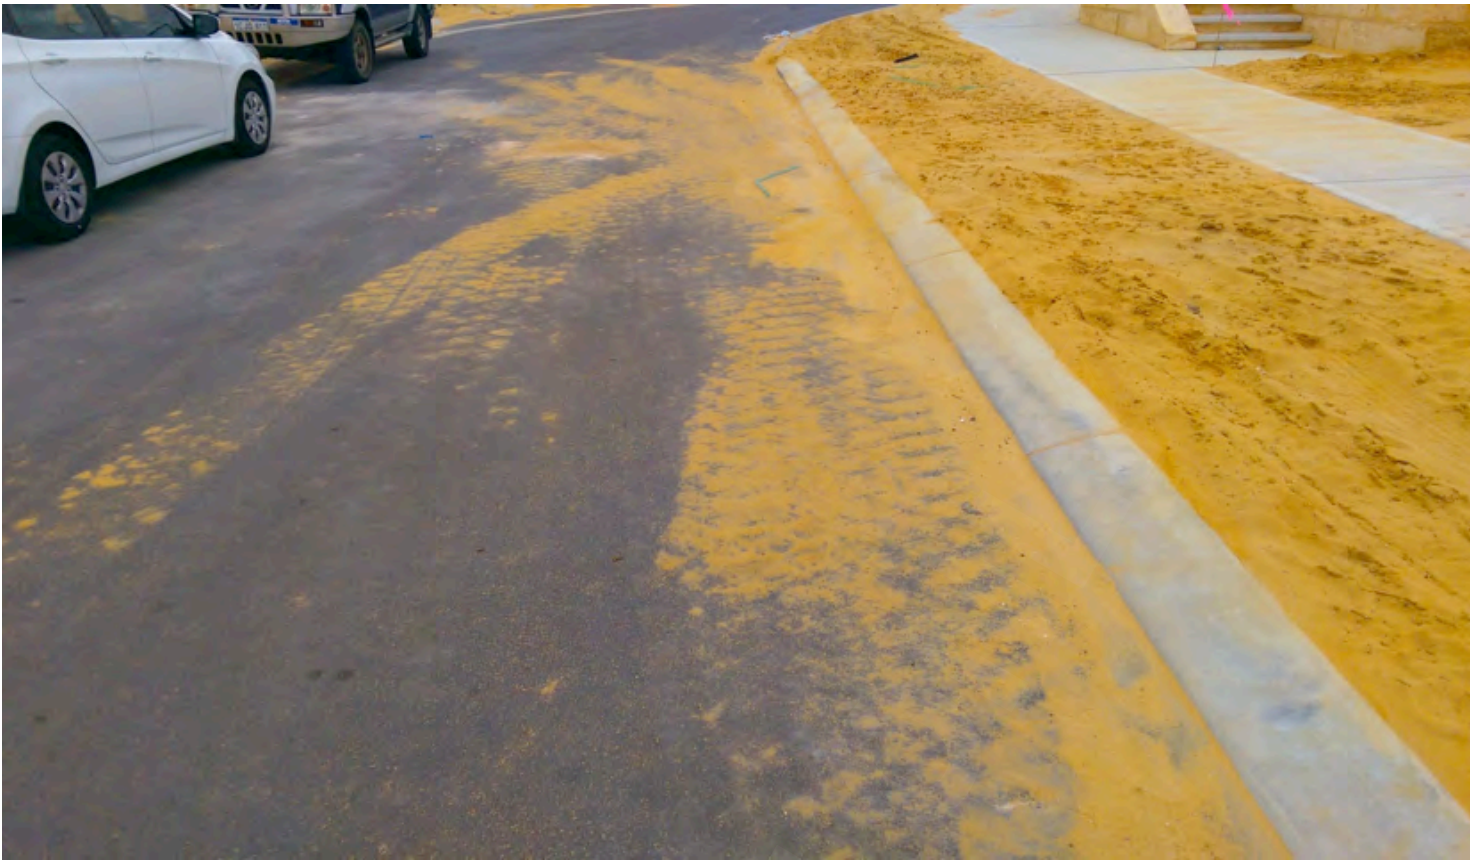
COMMENTS: Surfacing in good condition with no scarring or depressions identified
