CLIENT TIM MARSHALL

LANDSCAPE ARCHITECT

A1 DRAWING NO. LC-01

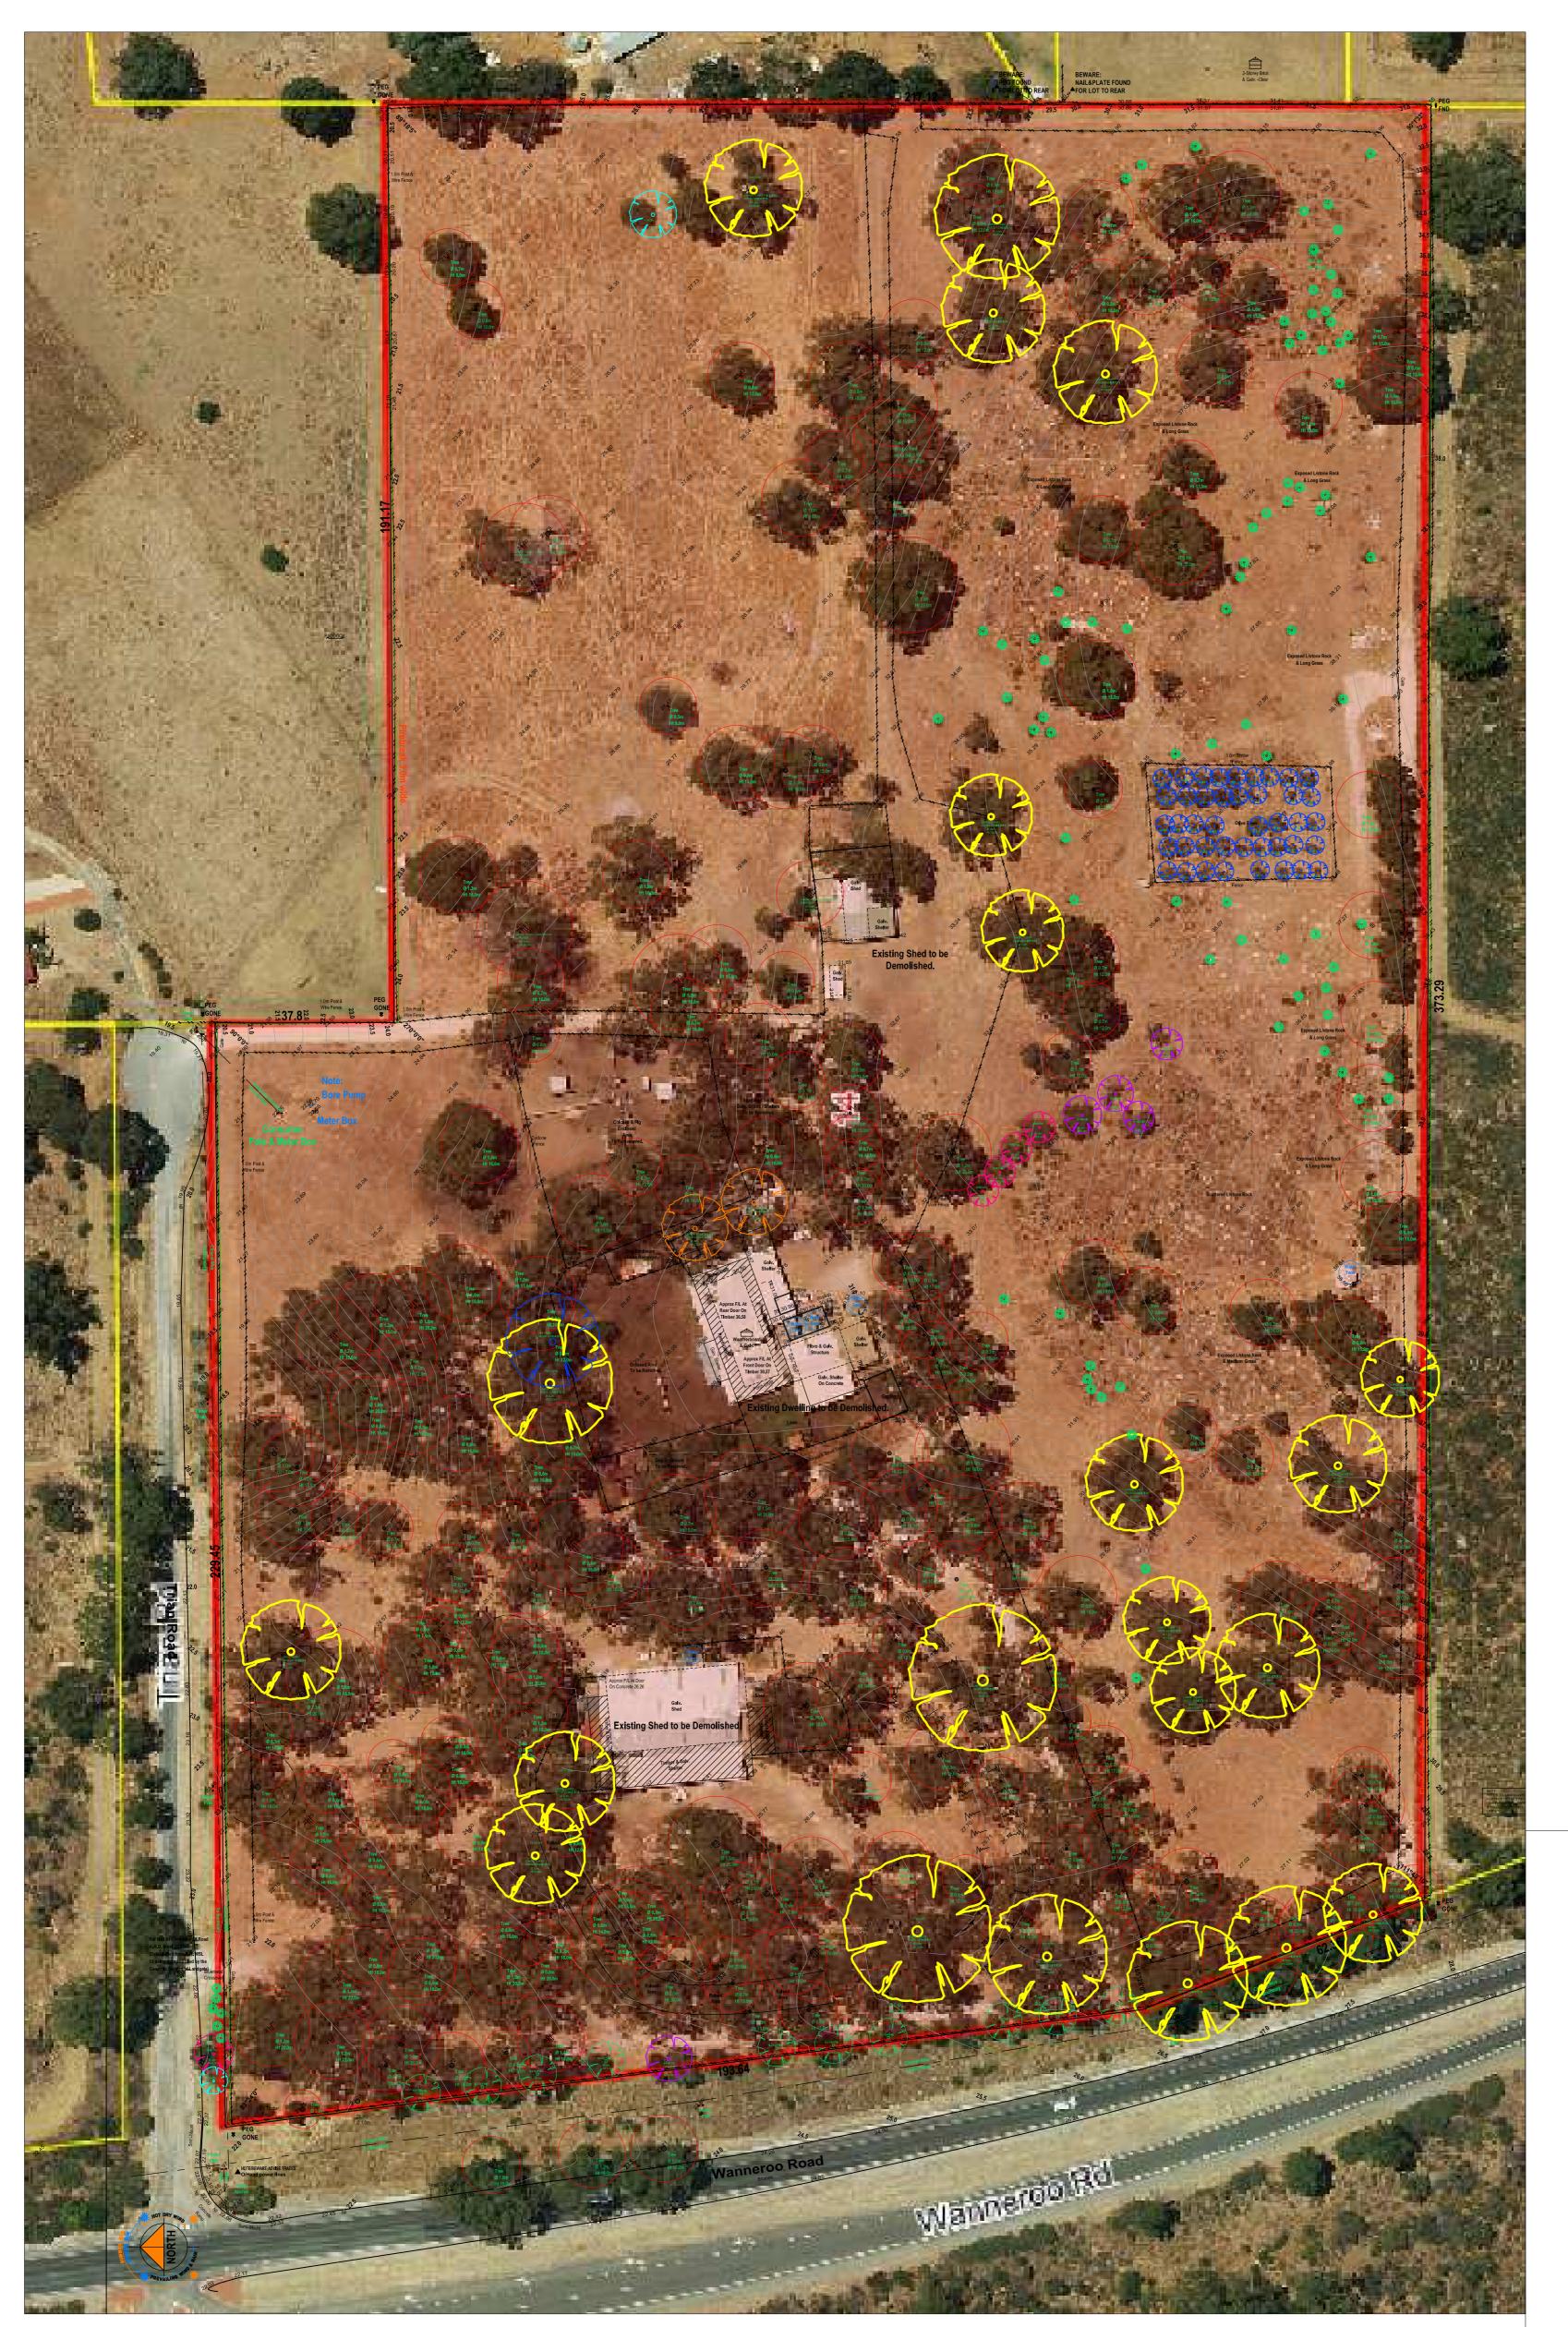
Generally good condition, requiring clean
up and crown lift if required.

Generally good condition, some marked poor or dead have evidence of die buck present, limit access below, 8 x large sentinel trees (habital specimens, x Marked Feature tuart), and usulable for shade tree adjacent playspaces.
