SK1637-01C

SK1637-02C

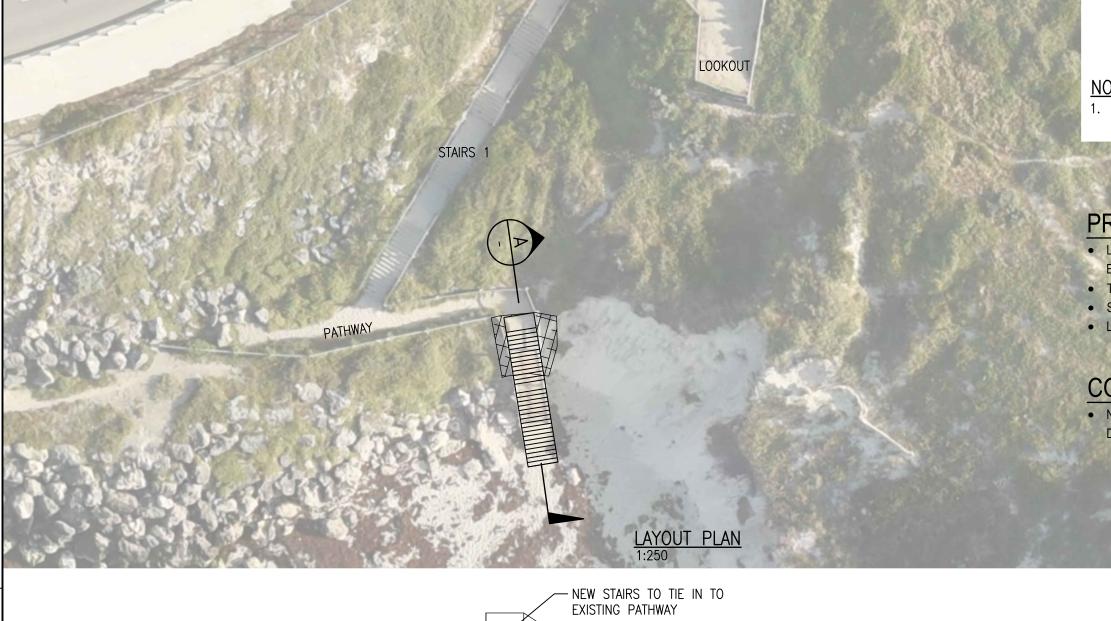
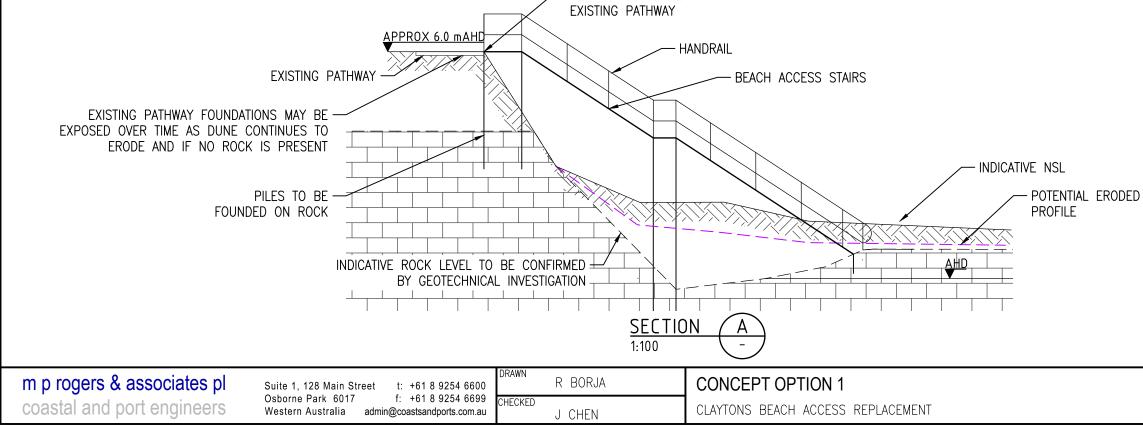
PROS

LIMITED EXTENT OF VEGETATION CLEARING & EARTHWORKS REQUIRED. • TIE IN WELL WITH EXISTING PATHWAY. SIMPLEST TO CONSTRUCT. • LOWEST COST.

CONS

NO ADDITIONAL BUFFER AGAINST CONTINUED BEACH AND DUNE EROSION.
