COMMUNITY INFORMATION SESSION

Two Rocks Beach Access

Options & Multi Criteria Assessment

m p rogers & associates p l

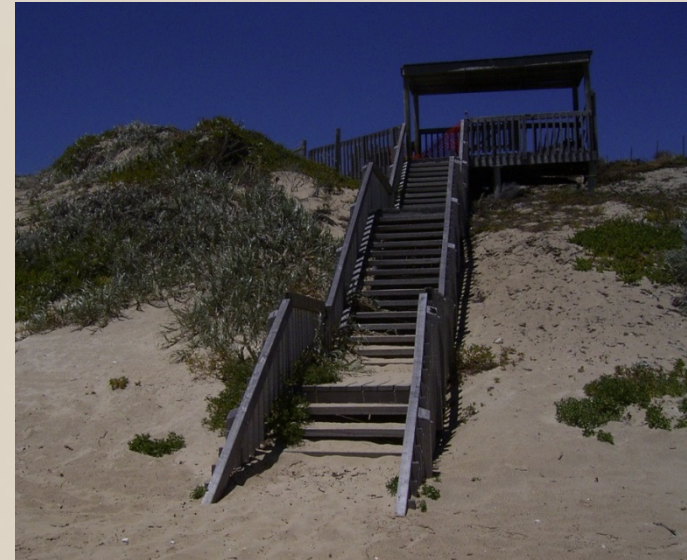
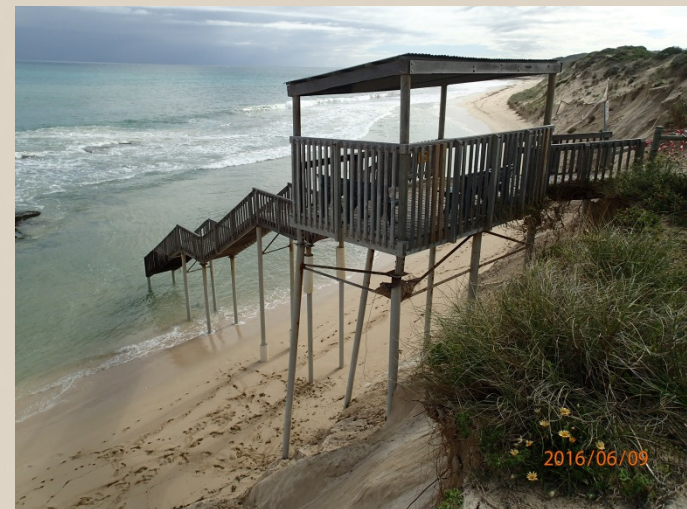
- Previous Staircase was constructed in 2002 with a 15 year design life
- Recent storms in winter 2016 caused 9m beach erosion and 3m dune erosion at the staircase
- Coastal/Structural Engineering Assessment by M P Rogers
- Beach Safety Assessment by Surf Life Saving

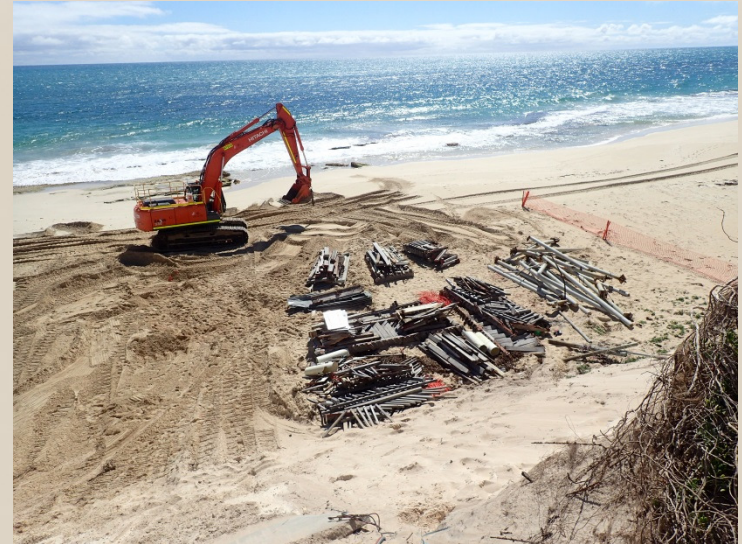
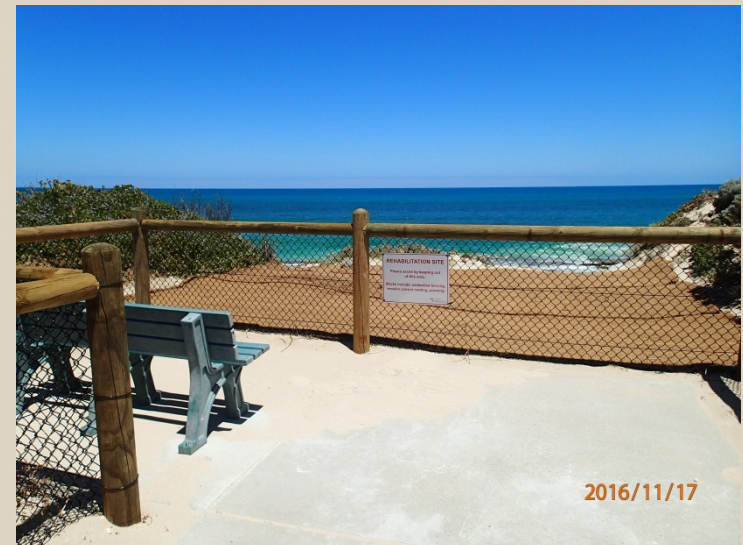
- Community Consultation
 - Community Meeting on 21 September 2016
 - Community Feedback obtained on both short and long term access.
- Council Meeting on 11 October 2016
 - Staircase removed
 - Temporary observation point installed
 - M P Rogers Beach Access Options Assessment

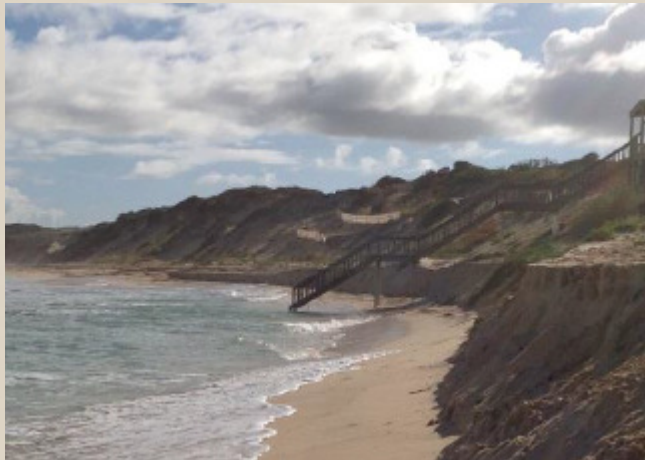
Background – Beach Safety

- SLSWA completed assessment of beach safety
- In summary, whole stretch of coastline is considered unsafe for swimming
- SLSWA rated beaches high risk
- While this is noted, there is a clear community preference for swimming near the location of the existing access point

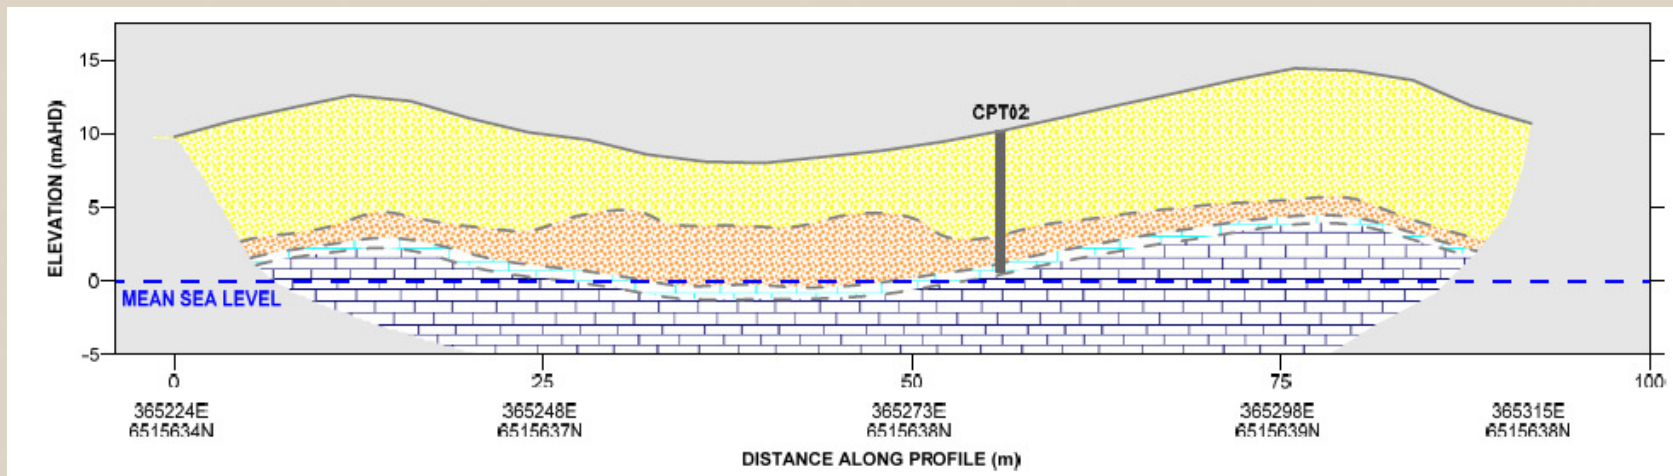
Background – Geotechnical Condns

- DoT has completed a series of geotechnical investigations
- MRA has reviewed these and estimated rock locations
- Some rock present in the foreshore but variable
- Considered in the assessment

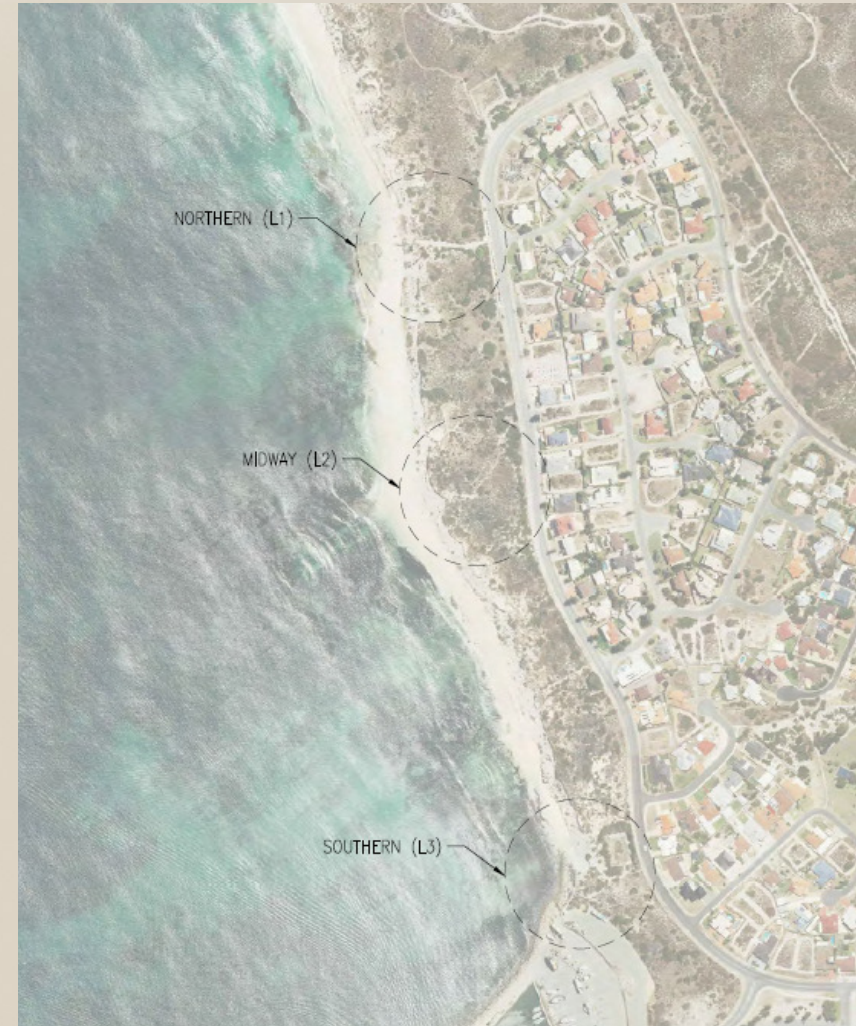
Location Assessment

- Generally determined from the community feedback
- Northern location at existing path
- Southern location at the boat harbour
- Midway location determined based on dune contours, existing tracks and blowout
- Previous short term option discounted

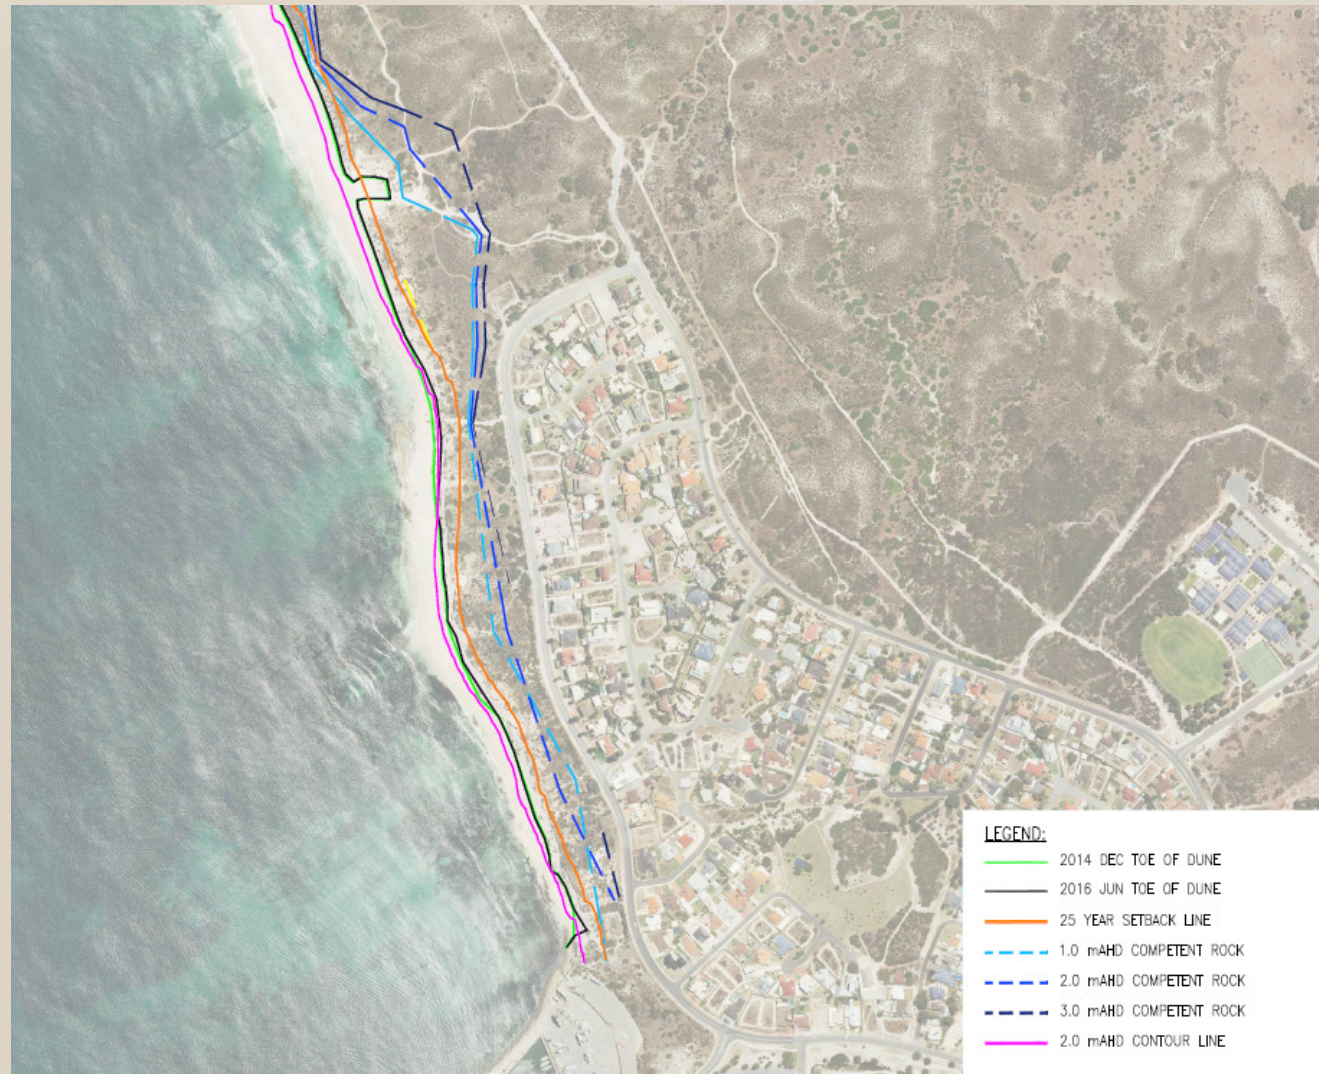
Determination of Landing Point

- City confirmed design life minimum of 15 years
- Aiming for 25 years in design – standard marine structure
- Approach of design is:
 - Design to accommodate fluctuation in shoreline position
 - Cater for 5 years of shoreline movement and SLR
 - Cater for single run of SCPP storm
 - At end of 25 year period structure to stand
- Balance required between allowing for shoreline movement and reducing earthworks

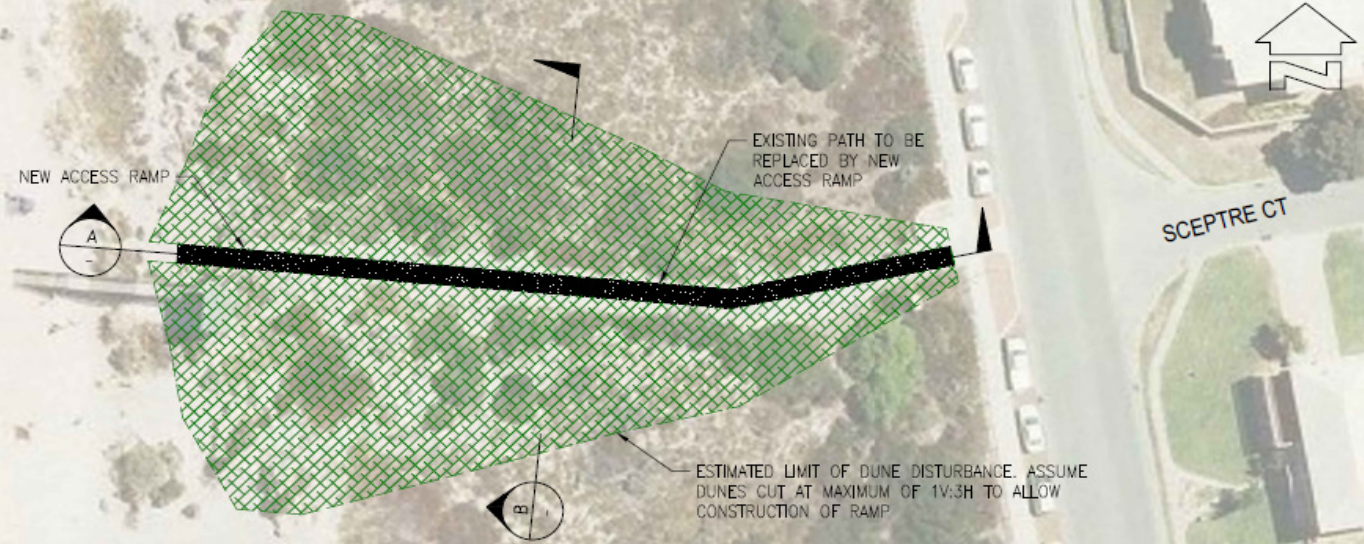
RAMP LAYOUT
1:500

Concept Options – Northern Ramp

- SIGNIFICANT LEVEL OF EARTHWORK & VEGETATION CLEARING REQUIRED.
- RAMP DOES NOT PROVIDE UNIVERSAL ACCESS.
- DOES NOT MAKE USE OF EXISTING INFRASTRUCTURE.
- TREND OF RECENT EROSION.

Access Option	Feasibility & Practicality	Environmental Impacts	Social Impacts / Community Values	Beach Access & Swimming Safety	Design, Capital & Ongoing Costs	Long Term Effectiveness	Response to Climate Change	Reversible / Adaptable in the Future
Northern Location - Ramp	<ul style="list-style-type: none"> Substantial dune clearing and earthworks required for construction Significant level of dune clearing reduces buffer against continue future erosion 	<ul style="list-style-type: none"> Significant level of dune clearing and earthworks required 	<ul style="list-style-type: none"> Community preferred location Provides assisted access for disabled people Use of existing parking 	<ul style="list-style-type: none"> Provides safe beach access at the end of design life Community preferred swimming location 	<ul style="list-style-type: none"> Additional cost of demolition of the existing access path Total capital costs in the order of \$300,000 Moderate level of maintenance cost (e.g. clean sand build up on path) 	<ul style="list-style-type: none"> Functional at the end of design life after continued erosion, but would require maintenance to provide continued beach access 	<ul style="list-style-type: none"> Option accounts for the effects of climate change or sea level rise 	<ul style="list-style-type: none"> Reversible through reasonable level of capital expenditure Adaptable, but at considerable cost / effort Slightly less adaptable than stairs

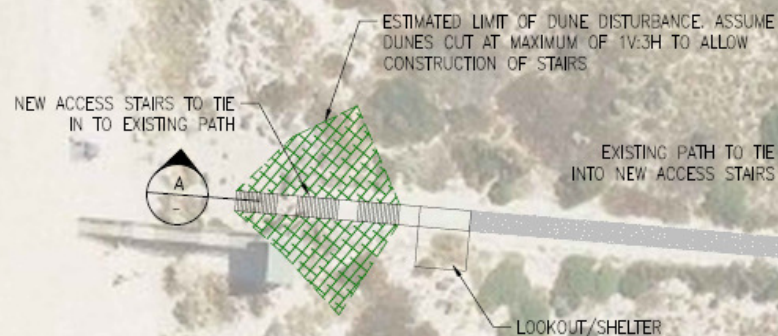
STAIR LAYOUT
1:500

Concept Options – Northern Stairs

- DUNE PROFILE UNDER ACCESS STAIRS SUBJECTED TO CONTINUE LONG TERM RECESSION.
- ACCESS STAIRS MAY BE SIGNIFICANTLY EXPOSED AT THE END OF ITS DESIGN LIFE.
- DOES NOT PROVIDE UNIVERSAL ACCESS.
- TREND OF RECENT EROSION.

Northern Location – Stairs Option 1	<ul style="list-style-type: none"> Majority of the existing beach access path can be used to tie in to the new stairs Accounts for long term erosion and shoreline recession over the design life At the end of the design life, access infrastructure will require mitigation to provide continue access 	<ul style="list-style-type: none"> Low level of dune clearing and earthworks required 	<ul style="list-style-type: none"> Community preferred location Community preferred form of access Use of existing parking 	<ul style="list-style-type: none"> Provides safe beach access at the end of design life Community preferred swimming location 	<ul style="list-style-type: none"> Allow the use of part of the existing access path Total capital costs in the order of \$210,000 Low maintenance cost 	<ul style="list-style-type: none"> Functional at the end of design life after continued erosion, but would require maintenance to provide continued beach access 	<ul style="list-style-type: none"> Structure will be designed for expected increases in sea level rise and future shoreline recession 	<ul style="list-style-type: none"> Reversible through reasonable level of capital expenditure Adaptable, but at considerable cost / effort

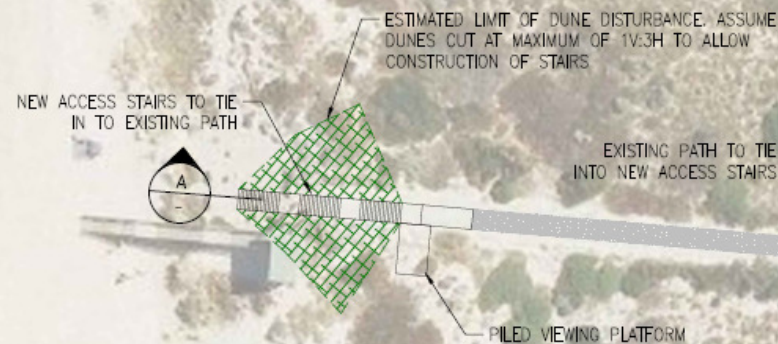
STAIR LAYOUT
1:500

Concept Options – Northern Stairs With Piled Viewing Platform

- DUNE PROFILE UNDER ACCESS STAIRS SUBJECTED TO CONTINUE LONG TERM RECESSION.
- ACCESS STAIRS MAY BE SIGNIFICANTLY EXPOSED AT THE END OF ITS DESIGN LIFE.
- DOES NOT PROVIDE UNIVERSAL ACCESS.
- TREND OF RECENT EROSION.

Northern Location - Stairs Option 2 (Piled Viewing Platform)	<ul style="list-style-type: none"> Majority of the existing beach access path can be used to tie in to the new stairs Accounts for long term erosion and shoreline recession over the design life At the end of the design life, access infrastructure will require mitigation to provide continue access 	<ul style="list-style-type: none"> Low level of dune clearing and earthworks required 	<ul style="list-style-type: none"> Community preferred location Community preferred form of access Use of existing parking 	<ul style="list-style-type: none"> Provides safe beach access at the end of design life Community preferred swimming location 	<ul style="list-style-type: none"> Allow the use of part of the existing access path Total capital costs in the order of \$250,000 Low maintenance cost 	<ul style="list-style-type: none"> Functional at the end of design life after continued erosion, but would require maintenance to provide continued beach access 	<ul style="list-style-type: none"> Structure will be designed for expected increases in sea level rise and future shoreline recession 	<ul style="list-style-type: none"> Reversible through reasonable level of capital expenditure Adaptable, but at considerable cost / effort

- Replacement stairs in the existing location are recommended
- Largely preferred over other options due to costs, reduced environmental impacts and community responses
- Piled lookout structure recommended off stairs
- Will achieve views of coast, similar to previous structure at time of construction
- Recommended Northern Stairs with Piled Viewing Platform

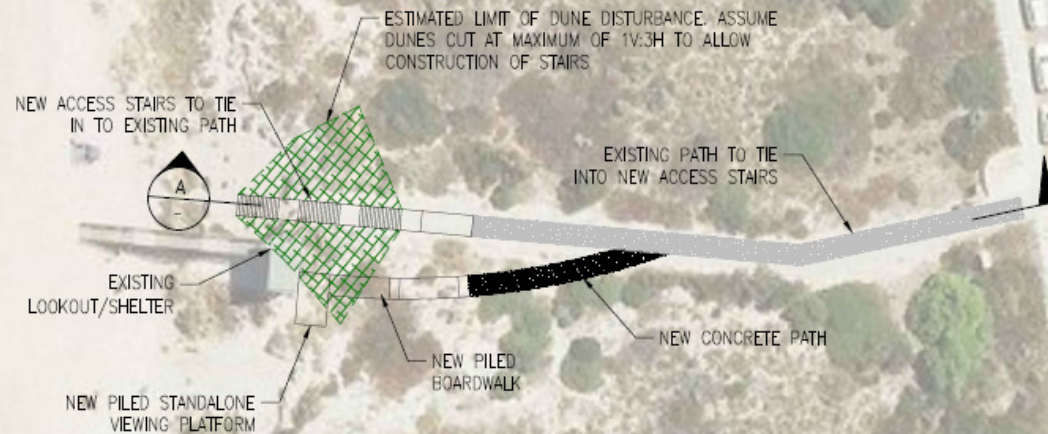
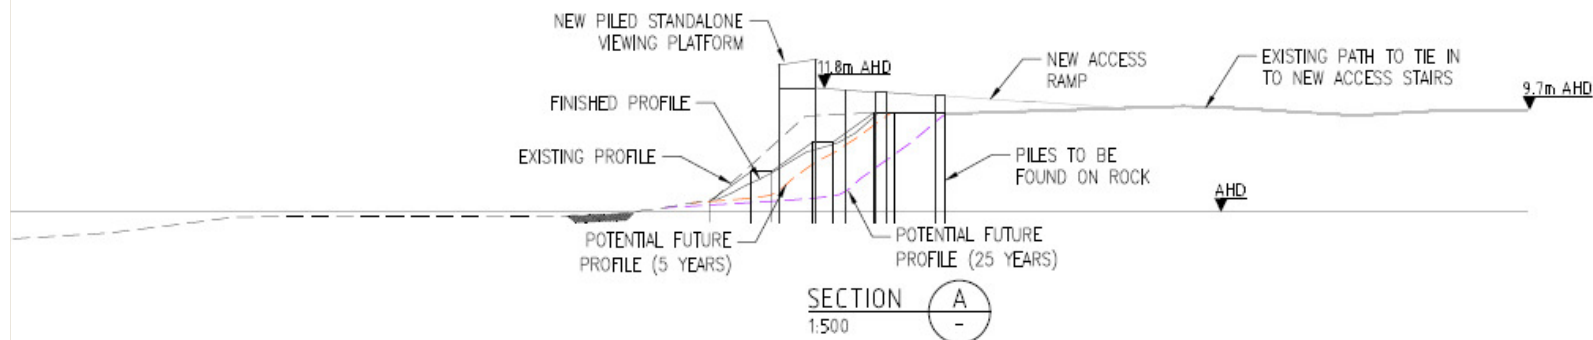
STAIR LAYOUT
1:500

Concept Options – Northern Stairs With Piled Standalone Viewing Platform

- DUNE PROFILE UNDER ACCESS STAIRS SUBJECTED TO CONTINUE LONG TERM RECESSION.
- ACCESS STAIRS MAY BE SIGNIFICANTLY EXPOSED AT THE END OF ITS DESIGN LIFE.
- DOES NOT PROVIDE UNIVERSAL ACCESS.
- TREND OF RECENT EROSION.
- HIGHER COST FOR A STANDALONE VIEWING PLATFORM

Northern Location – Stairs Option 3 (Piled Standalone Viewing Platform)	<ul style="list-style-type: none"> Majority of the existing beach access path can be used to tie in to the new stairs Accounts for long term erosion and shoreline recession over the design life At the end of the design life, access infrastructure will require mitigation to provide continue access 	<ul style="list-style-type: none"> Low level of dune clearing and earthworks required 	<ul style="list-style-type: none"> Community preferred viewing option, with comparable viewing to previous structure. Community preferred location Community preferred form of access Use of existing parking 	<ul style="list-style-type: none"> Provides safe beach access at the end of design life Community preferred swimming location 	<ul style="list-style-type: none"> Allow the use of part of the existing access path Total capital costs in the order of \$450,000 Low maintenance cost 	<ul style="list-style-type: none"> Functional at the end of design life after continued erosion, but would require maintenance to provide continued beach access 	<ul style="list-style-type: none"> Structure will be designed for expected increases in sea level rise and future shoreline recession 	<ul style="list-style-type: none"> Reversible through reasonable level of capital expenditure Adaptable, but at considerable cost / effort

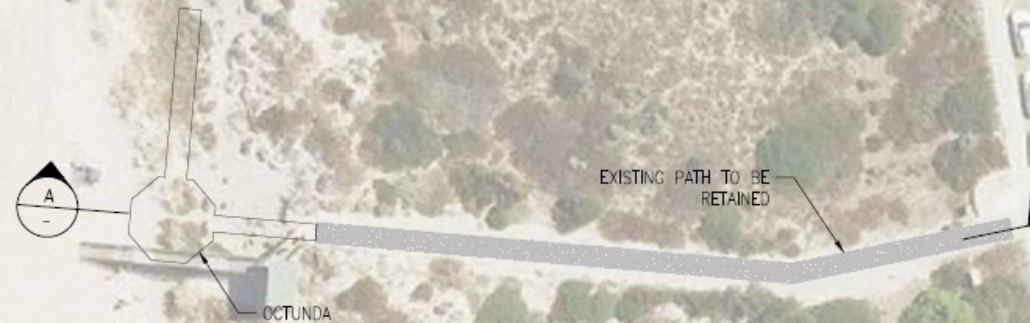
OCTUNDA LAYOUT
1:500

Concept Options – Northern Octunda

- ACCESS PATH LEADING TO THE OCTUNDA MAY BE UNDERCUT DUE TO CONTINUE DUNE EROSION.
- ACCESS POINT IN THE WATER.
- ACCESS STRUCTURE IS EXPOSED TO WAVE ACTION.
- DOES NOT PROVIDE UNIVERSAL ACCESS.
- TREND OF RECENT EROSION.

Northern Location - Octunda	<ul style="list-style-type: none"> Allow the use of the existing access path Some minor armouring of the toe of the dune via precast concrete panel, unlikely to be sufficient for coastal protection Structure subjected to wave loading due to its exposure 	<ul style="list-style-type: none"> Dune clearing not required 	<ul style="list-style-type: none"> Community preferred location Some community support for this form of access Use of existing parking Aesthetically appealing structure 	<ul style="list-style-type: none"> Beach access point in the water. Unsafe beach access even at the current state Community preferred swimming location 	<ul style="list-style-type: none"> Total capital costs in the order of \$600,000 Significant maintenance cost required to maintain access. 	<ul style="list-style-type: none"> Ineffective in the long term as beach access point in the water 	<ul style="list-style-type: none"> Inadequate consideration for future beach recession and storm erosion Beach access path leading to the Octunda may be undercut in 5 years due to future shoreline recession 	<ul style="list-style-type: none"> Reversible through high level of capital expenditure Adaptable, but at considerable cost / effort

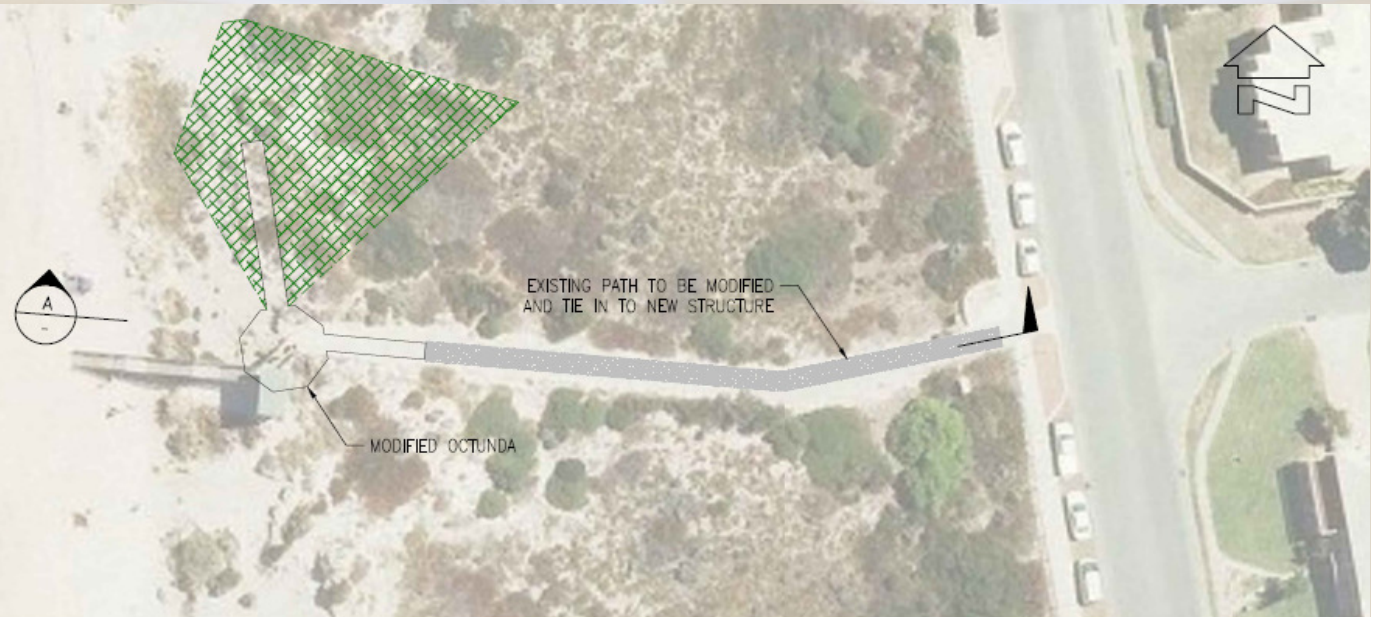
MODIFIED OCTUNDA LAYOUT
1:500

Concept Options – Modified Octunda

- SIGNIFICANT CLEARING OF THE FRONT DUNES
- DOES NOT PROVIDE UNIVERSAL ACCESS.
- TREND OF RECENT EROSION.

Access Option	Feasibility & Practicality	Environmental Impacts	Social Impacts / Community Values	Beach Access & Swimming Safety	Design, Capital & Ongoing Costs	Long Term Effectiveness	Response to Climate Change	Reversible / Adaptable in the Future
Northern Location – Modified Octunda Option	<ul style="list-style-type: none"> Allow the use of the existing access path Some minor armouring of the toe of the dune via precast concrete panel, unlikely to be sufficient for coastal protection 	<ul style="list-style-type: none"> Significant level of dune clearing and earthworks required 	<ul style="list-style-type: none"> Community preferred location Some community support for this form of access Use of existing parking Aesthetically appealing structure 	<ul style="list-style-type: none"> Community preferred swimming location 	<ul style="list-style-type: none"> Total capital costs in the order of \$600,000 Low maintenance cost 	<ul style="list-style-type: none"> Functional at the end of design life after continued erosion, but would require maintenance to provide continued beach access 	<ul style="list-style-type: none"> Inadequate consideration for future beach recession and storm erosion Beach access path leading to the Octunda may be undercut in 5 years due to future shoreline recession 	<ul style="list-style-type: none"> Reversible through high level of capital expenditure Adaptable, but at considerable cost / effort

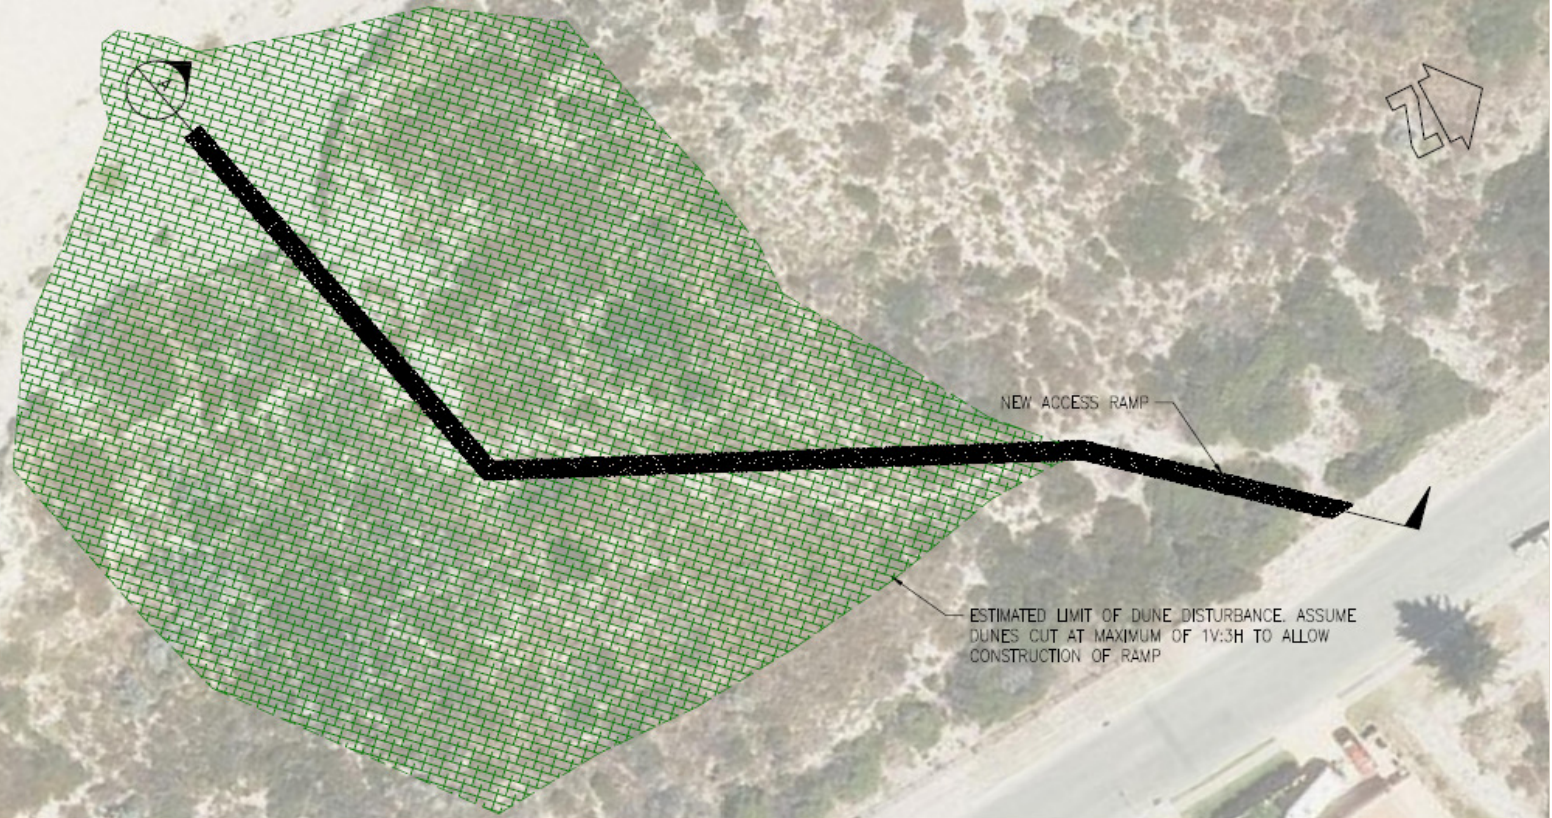
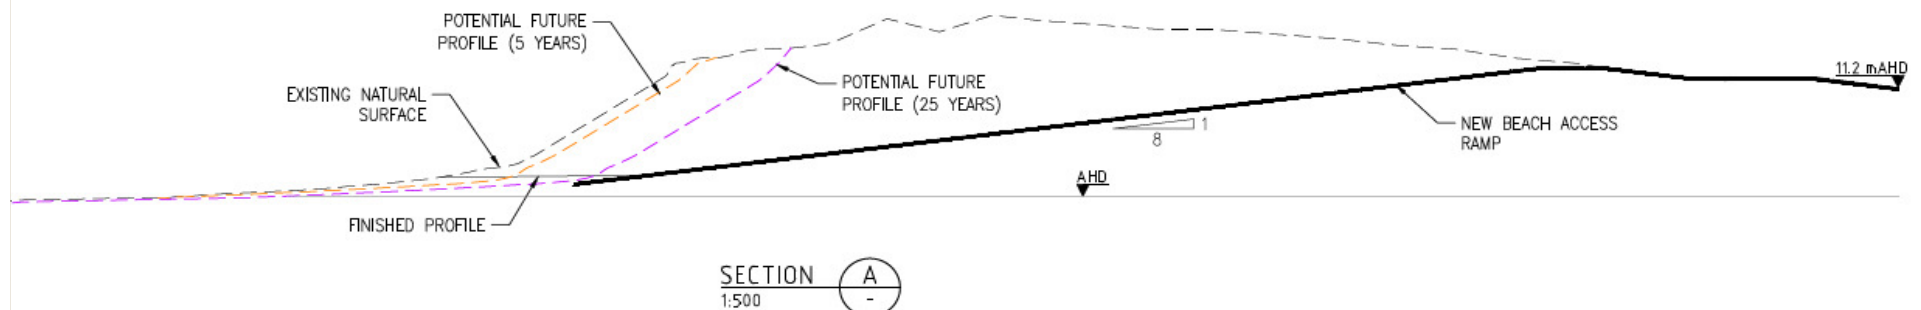
RAMP LAYOUT
1:500

Concept Options – Midway Ramp

- LIMITED COMMUNITY SUPPORT.
- SIGNIFICANT LEVEL OF EARTHWORK & VEGETATION CLEARING REQUIRED.
- RAMP DOES NOT PROVIDE UNIVERSAL ACCESS.
- SIGNIFICANT CONSTRUCTION COST.
- LIMITED PARKING.

Midway Location - Ramp	<ul style="list-style-type: none"> Substantial dune clearing and earthworks required for construction Significant level of dune clearing reduces buffer against continue future erosion 	<ul style="list-style-type: none"> Significant level of dune clearing and earthworks required 	<ul style="list-style-type: none"> Low level of community support at this location Provides assisted access for disabled people Long walking distance to the beach Limited parking 	<ul style="list-style-type: none"> Provides safe beach access at the end of design life Unsafe swimming location 	<ul style="list-style-type: none"> Total capital costs in the order of \$800,000 Moderate level of maintenance cost (e.g. clean sand build up on path) 	<ul style="list-style-type: none"> Functional at the end of design life after continued erosion, but would require maintenance to provide continued beach access 	<ul style="list-style-type: none"> Option accounts for the effects of climate change or sea level rise 	<ul style="list-style-type: none"> Only reversible through high capital expenditure Adaptable, but at considerable cost / effort Slightly less adaptable than stairs

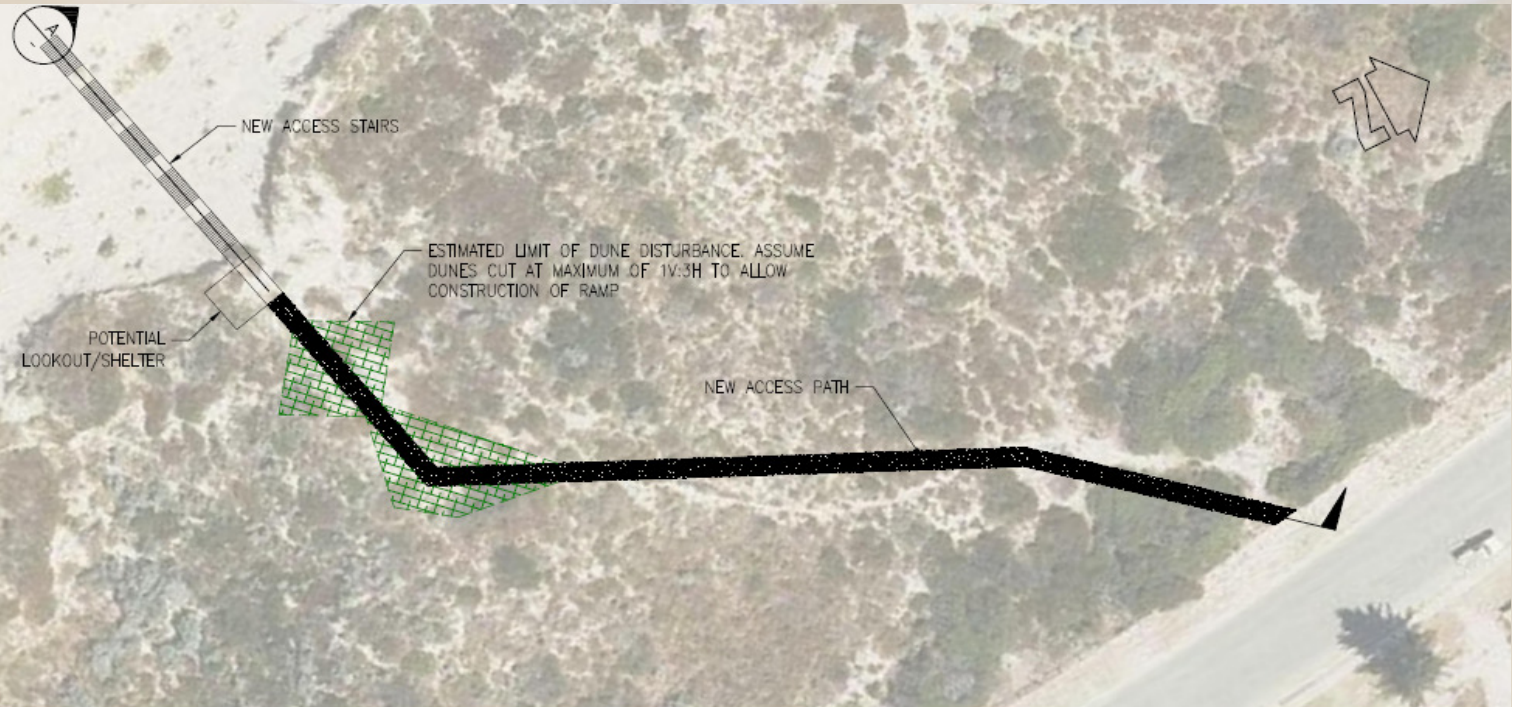
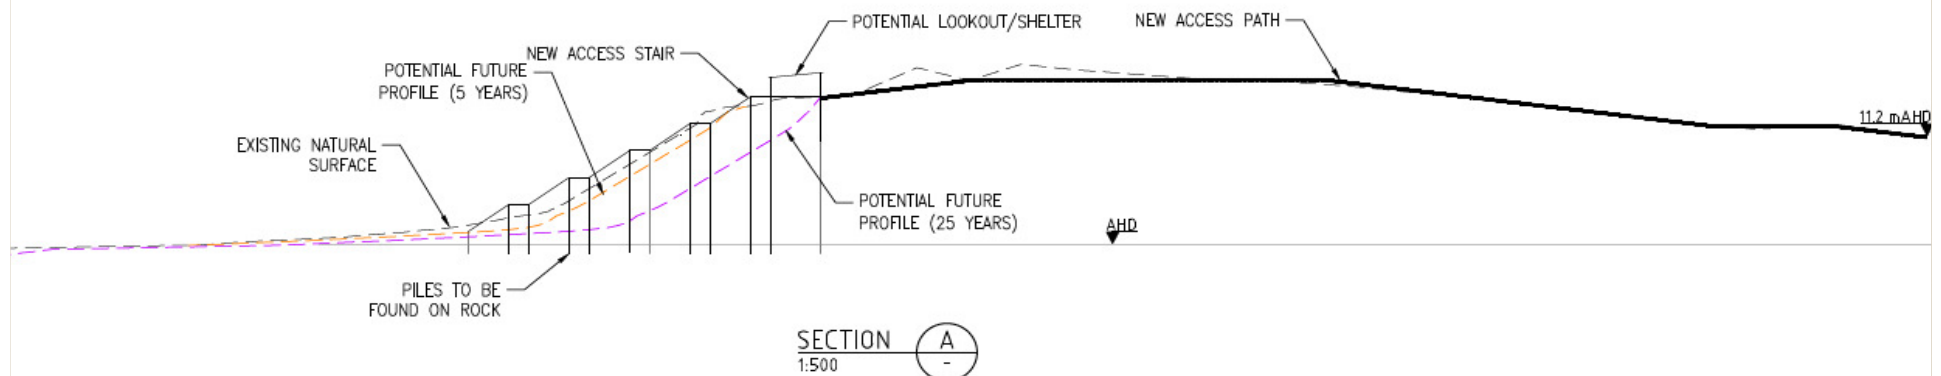
STAIR LAYOUT

Concept Options – Midway Stairs

- LIMITED COMMUNITY SUPPORT.
- LONGER WALKING DISTANCE.
- NEW ACCESS PATH LEADING TO STAIRS REQUIRED.
- ACCESS STAIRS SUBJECTED TO CONTINUE LONG TERM RECESSION.
- ACCESS STAIRS MAY BE SIGNIFICANTLY EXPOSED AT THE END OF ITS DESIGN LIFE.
- DOES NOT PROVIDE UNIVERSAL ACCESS.
- LIMITED PARKING.

Midway Location - Stairs	<ul style="list-style-type: none"> Require a new access path leading to the new stairs to be constructed Longer stairs required to accommodate the dune profile 	<ul style="list-style-type: none"> Low level of dune clearing and earthworks required 	<ul style="list-style-type: none"> Low level of community support at this location Long walking distance to the beach Limited parking 	<ul style="list-style-type: none"> Provides safe beach access at the end of design life Unsafe swimming location 	<ul style="list-style-type: none"> Additional cost for provision of new access path to tie into the new stairs Total capital costs in the order of \$350,000 Low maintenance cost 	<ul style="list-style-type: none"> Functional at the end of design life after continued erosion, but would require maintenance to provide continued beach access 	<ul style="list-style-type: none"> Structure will be designed for expected increases in sea level rise and future shoreline recession 	<ul style="list-style-type: none"> Reversible through reasonable level of capital expenditure Adaptable, but at considerable cost / effort

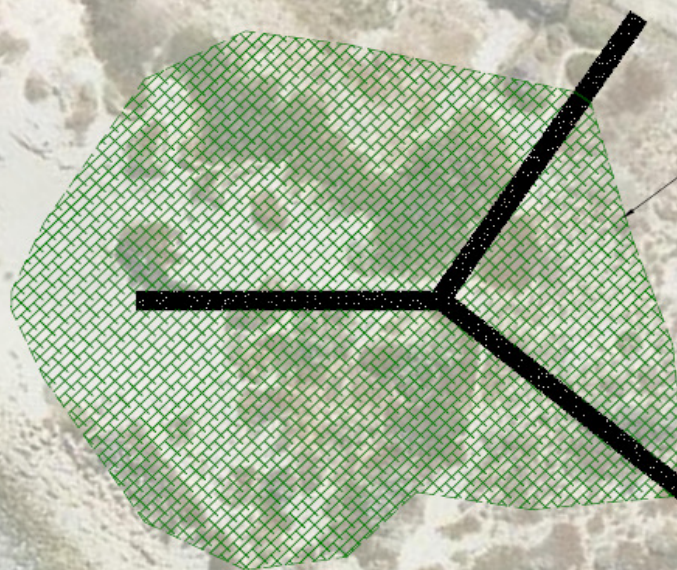
RAMP LAYOUT
1:500

Concept Options – Southern Ramp

ESTIMATED LIMIT OF DUNE DISTURBANCE, ASSUME DUNES CUT AT MAXIMUM OF 1V:3H TO ALLOW CONSTRUCTION OF STAIRS

NEW ACCESS RAMP

Southern Location - Ramp	<ul style="list-style-type: none"> Use of the existing carpark north of the Two Rocks boat harbour Substantial dune clearing and earthworks required for construction 	<ul style="list-style-type: none"> Significant level of dune clearing and earthworks required 	<ul style="list-style-type: none"> Low level of community support at this location Long walk distance to the swimming beach Use of existing parking at Boat Harbour 	<ul style="list-style-type: none"> Provides safe beach access at the end of design life Not suitable location for swimming 	<ul style="list-style-type: none"> Total capital costs in the order of \$400,000 Moderate level of maintenance cost (e.g. clean sand build up on path) 	<ul style="list-style-type: none"> Functional at the end of design life after continued erosion, but would require maintenance to provide continued beach access 	<ul style="list-style-type: none"> Option accounts for the effects of climate change or sea level rise 	<ul style="list-style-type: none"> Reversible through reasonable level of capital expenditure Adaptable, but at considerable cost / effort Slightly less adaptable than stairs

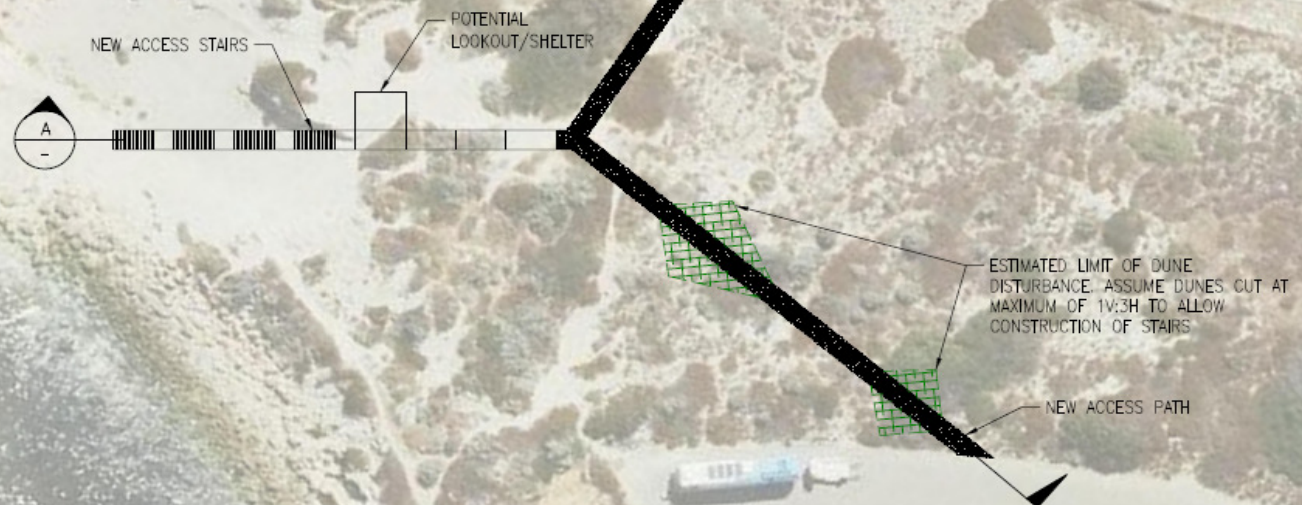
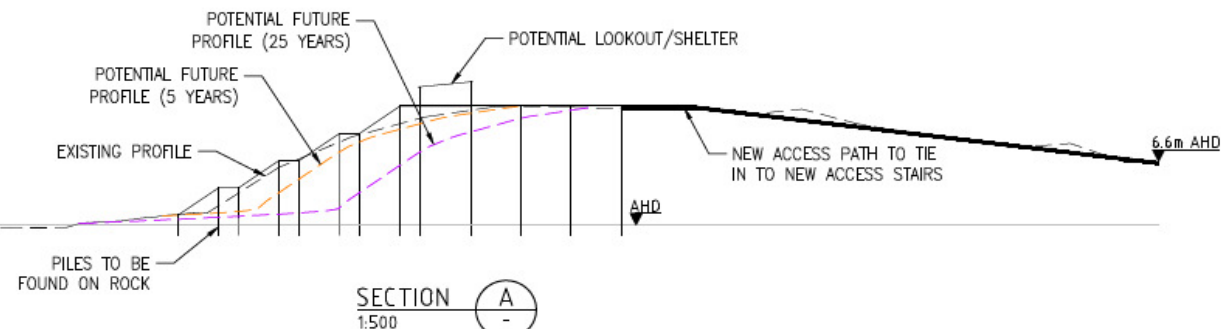
STAIR LAYOUT

Concept Options – Southern Stairs

- LIMITED COMMUNITY SUPPORT.
- LONG WALK TO PREFERRED SWIMMING BEACH.
- DUNE PROFILE UNDER ACCESS STAIRS SUBJECTED TO CONTINUE LONG TERM RECESSION.
- ACCESS STAIRS MAY BE SIGNIFICANTLY EXPOSED AT THE END OF ITS DESIGN LIFE.
- DOES NOT PROVIDE UNIVERSAL ACCESS.
- NOT PERPENDICULAR TO THE BEACH.
- UNSAFE LOCATION FOR SWIMMING.

Southern Location - Stairs	<ul style="list-style-type: none"> Use of the existing carpark north of the Two Rocks boat harbour Longer stairs required to ensure continue access in the long term 	<ul style="list-style-type: none"> Low level of dune clearing and earthworks required 	<ul style="list-style-type: none"> Low level of community support at this location Long walking distance to the swimming beach Use of existing parking at Boat Harbour 	<ul style="list-style-type: none"> Provides safe beach access at the end of design life Not suitable location for swimming 	<ul style="list-style-type: none"> Additional cost for provision of new access path to the new stairs Total capital costs in the order of \$380,000 Low maintenance cost 	<ul style="list-style-type: none"> Functional at the end of design life after continued erosion, but would require maintenance to provide continued beach access 	<ul style="list-style-type: none"> Structure will be designed for expected increases in sea level rise and future shoreline recession 	<ul style="list-style-type: none"> Reversible through reasonable level of capital expenditure Adaptable, but at considerable cost / effort
