Appendix 5
Engineering & Servicing Report
(Cossill & Webley)

DISTRICT STRUCTURE
PLAN AMENDMENT
REPORT
LOT 6 TARONGA PLACE,
EGLINTON

LOT 6 TARONGA PLACE, EGLINTON, WA
GEOTECHNICAL INVESTIGATION REPORT

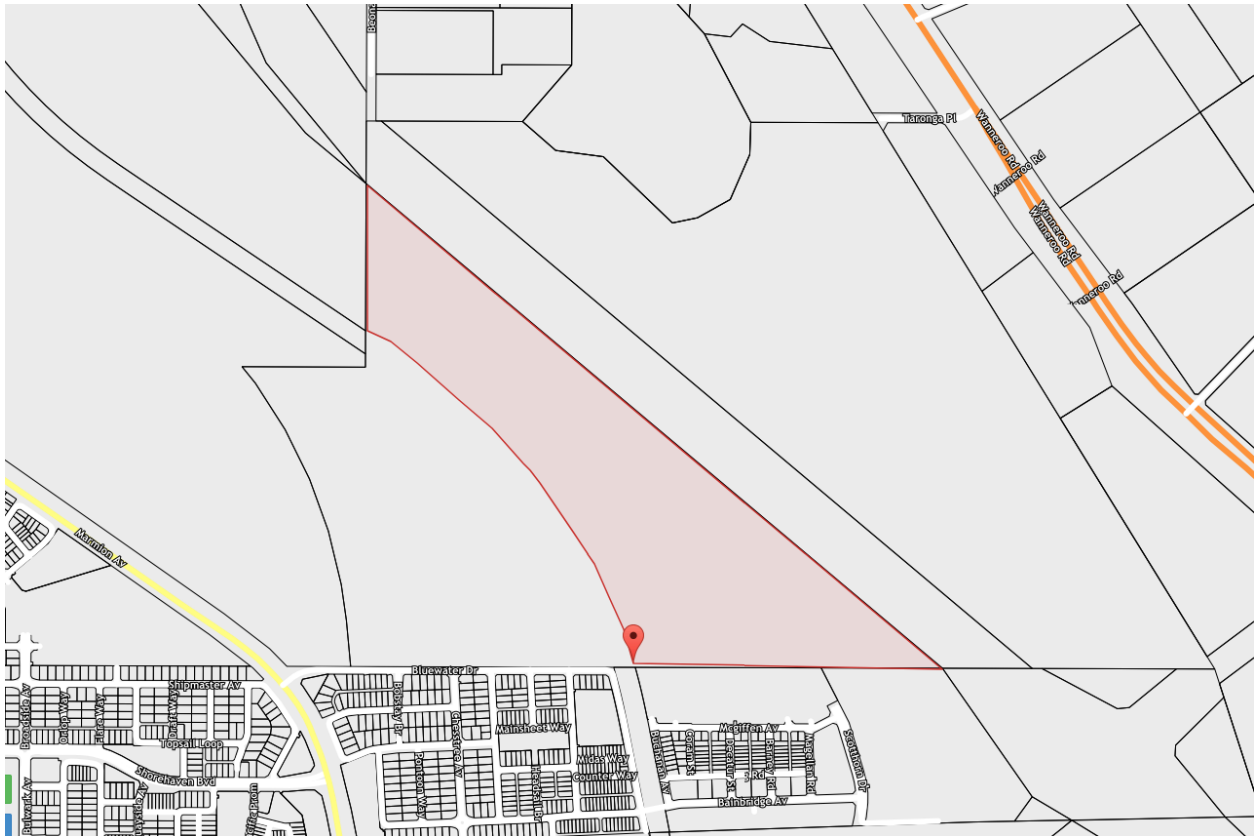
Figure 1 - Site Plan (MNG Maps 2018)

The area proposed to be amended in the DSP is identified by the red boundary presented below in

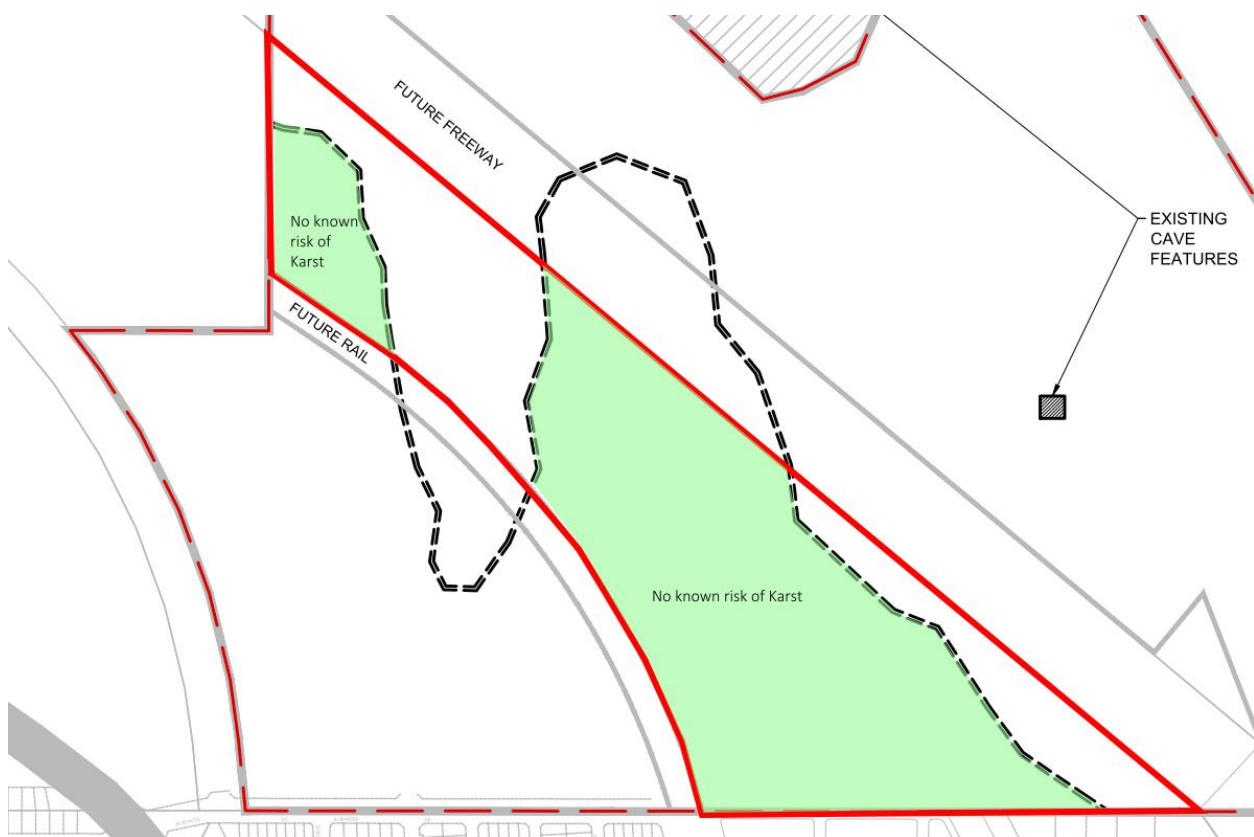
Figure 5: Inferred Potential Karst Risk Zone (CMW Geosciences)

Subsequently, CMW Geosciences were engaged to review the likely impact of karst formations on future development, and confirmed the eastern portion is likely to be within a recognised zone of potential karst features. *Figure 5* below presents the likely inferred western edge of a potential karst risk zone within the DSP amendment area. CMW Geosciences has previously prepared a Preliminary Karst Landform Management Methodology report which describes the manner in which any karst identified within the Site can be treated, which is presented in Appendix B for information, and is discussed further in Section 4.2 below.

CMW has also recently undertaken a more detailed geotechnical investigation within the potential Karst risk zone in the DSP area. This investigation did not encounter any specific Karst formations within the identified Karst risk zone in the DSP area, however maintained the recommendations of the previous report for dealing with the potential risk of Karst through managed engineering outcomes. This investigation is included in Appendix C of this report.

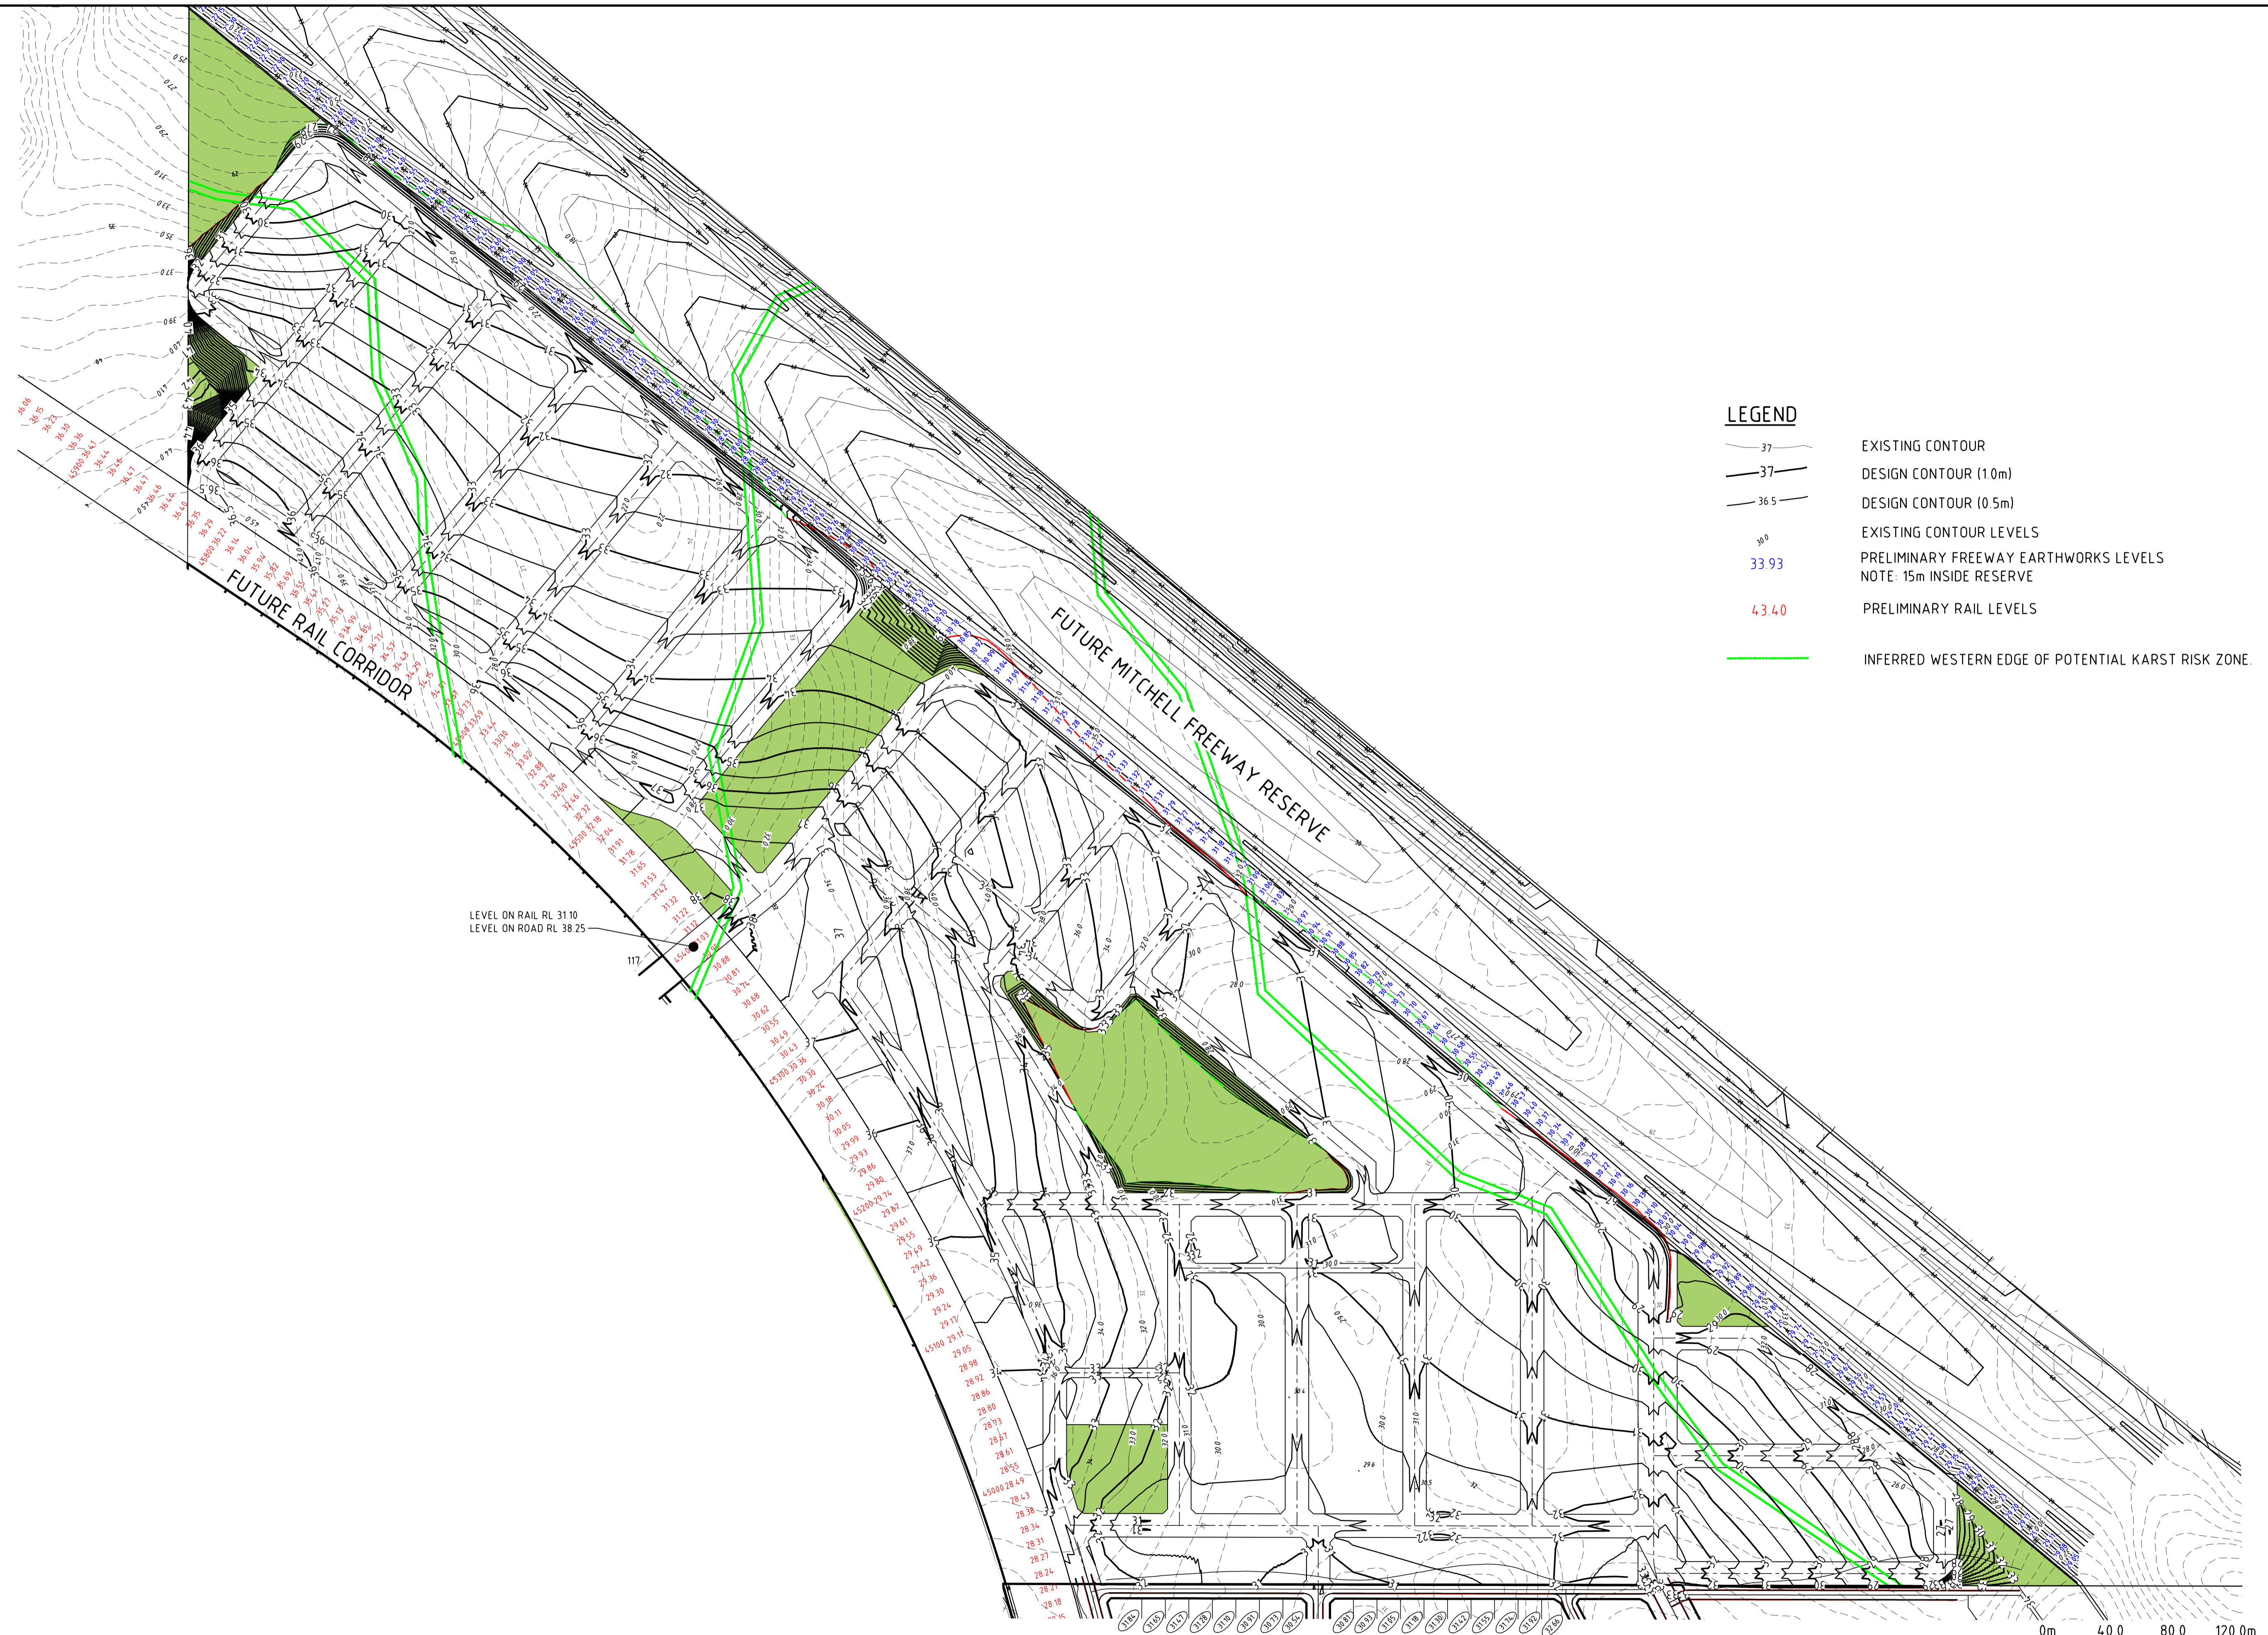
- 37 — EXISTING CONTOUR
- 37 — DESIGN CONTOUR (1.0m)
- 36.5 — DESIGN CONTOUR (0.5m)
- 30.0 EXISTING CONTOUR LEVELS
- 33.93 PRELIMINARY FREEWAY EARTHWORKS LEVELS
NOTE: 15m INSIDE RESERVE
- 43.40 PRELIMINARY RAIL LEVELS
- INFERRED WESTERN EDGE OF POTENTIAL KARST RISK ZONE.
