EAST WANNEROO CELL 6 AGREED
STRUCTURE PLAN (ASP8): PROPOSED
AMENDMENT NO. 43
LOT 2 (NO. 26) DRIVER ROAD, DARCH

8997_20Jan06R_bs

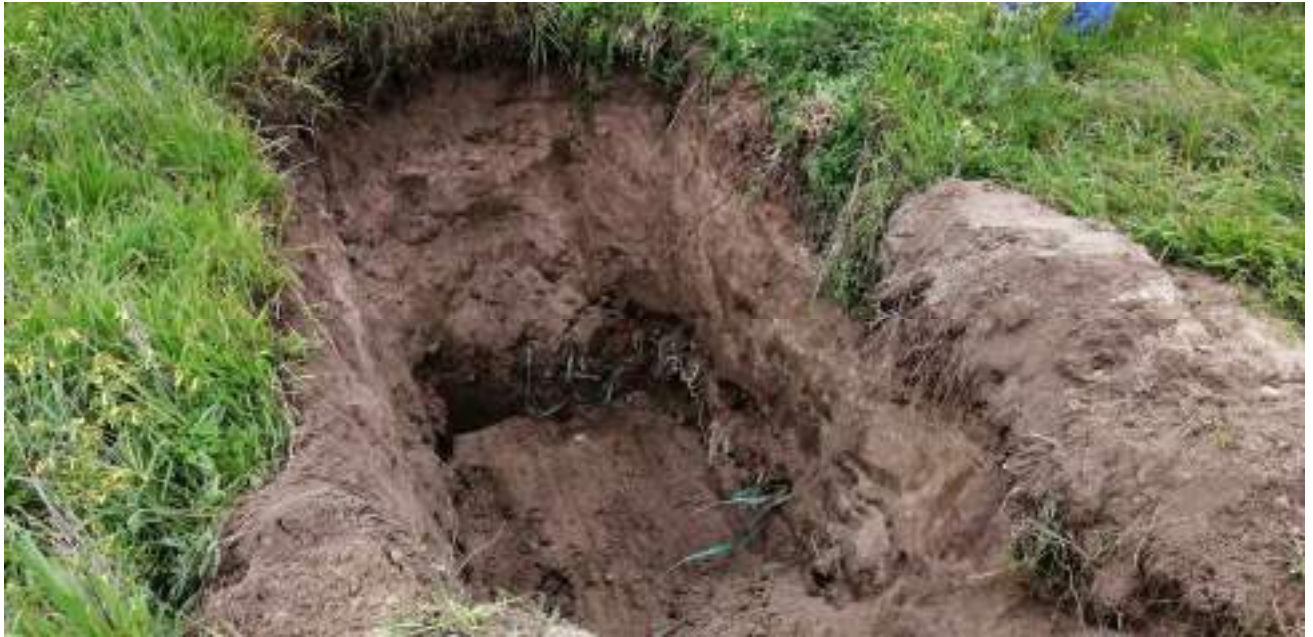
Photograph 11: Example test pit for infiltration testing in Unit 1B (Uncontrolled FILL) material – prior to water addition

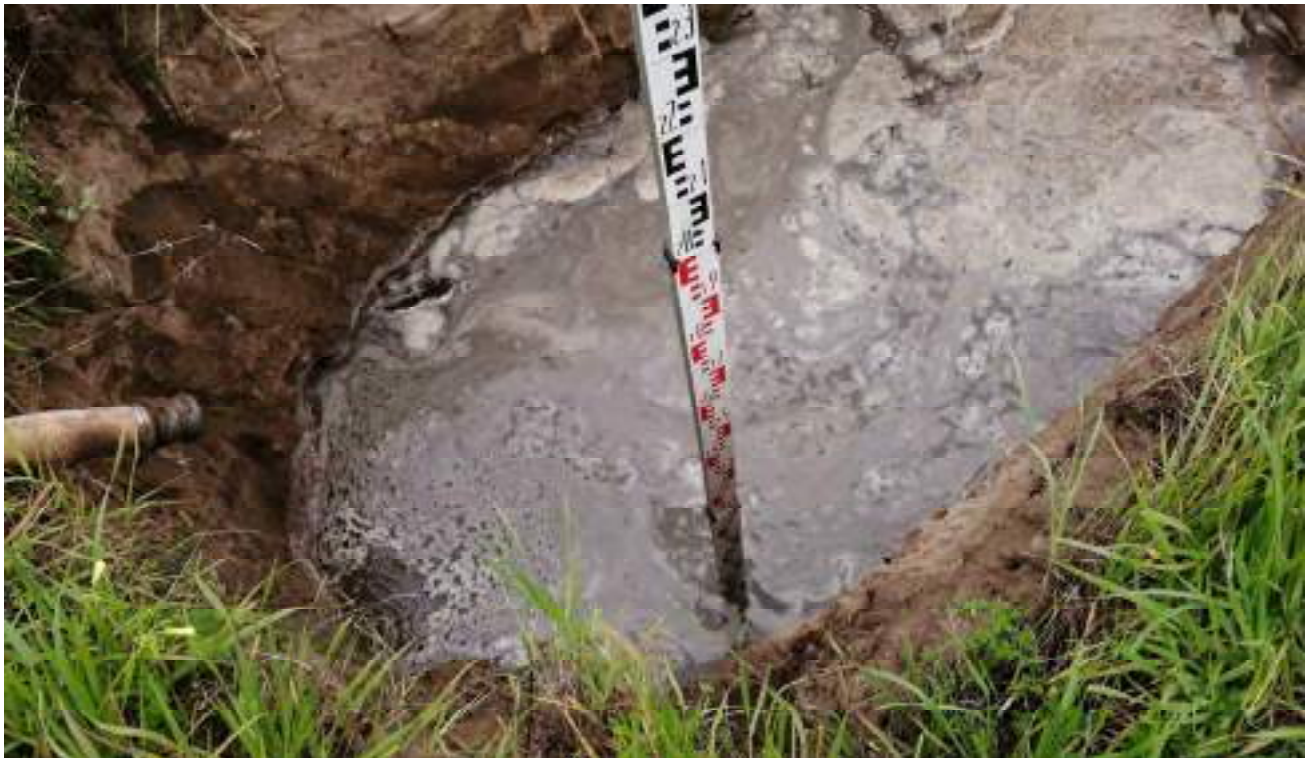
Photograph 12: Testing in progress in Unit 1B (uncontrolled FILL) material

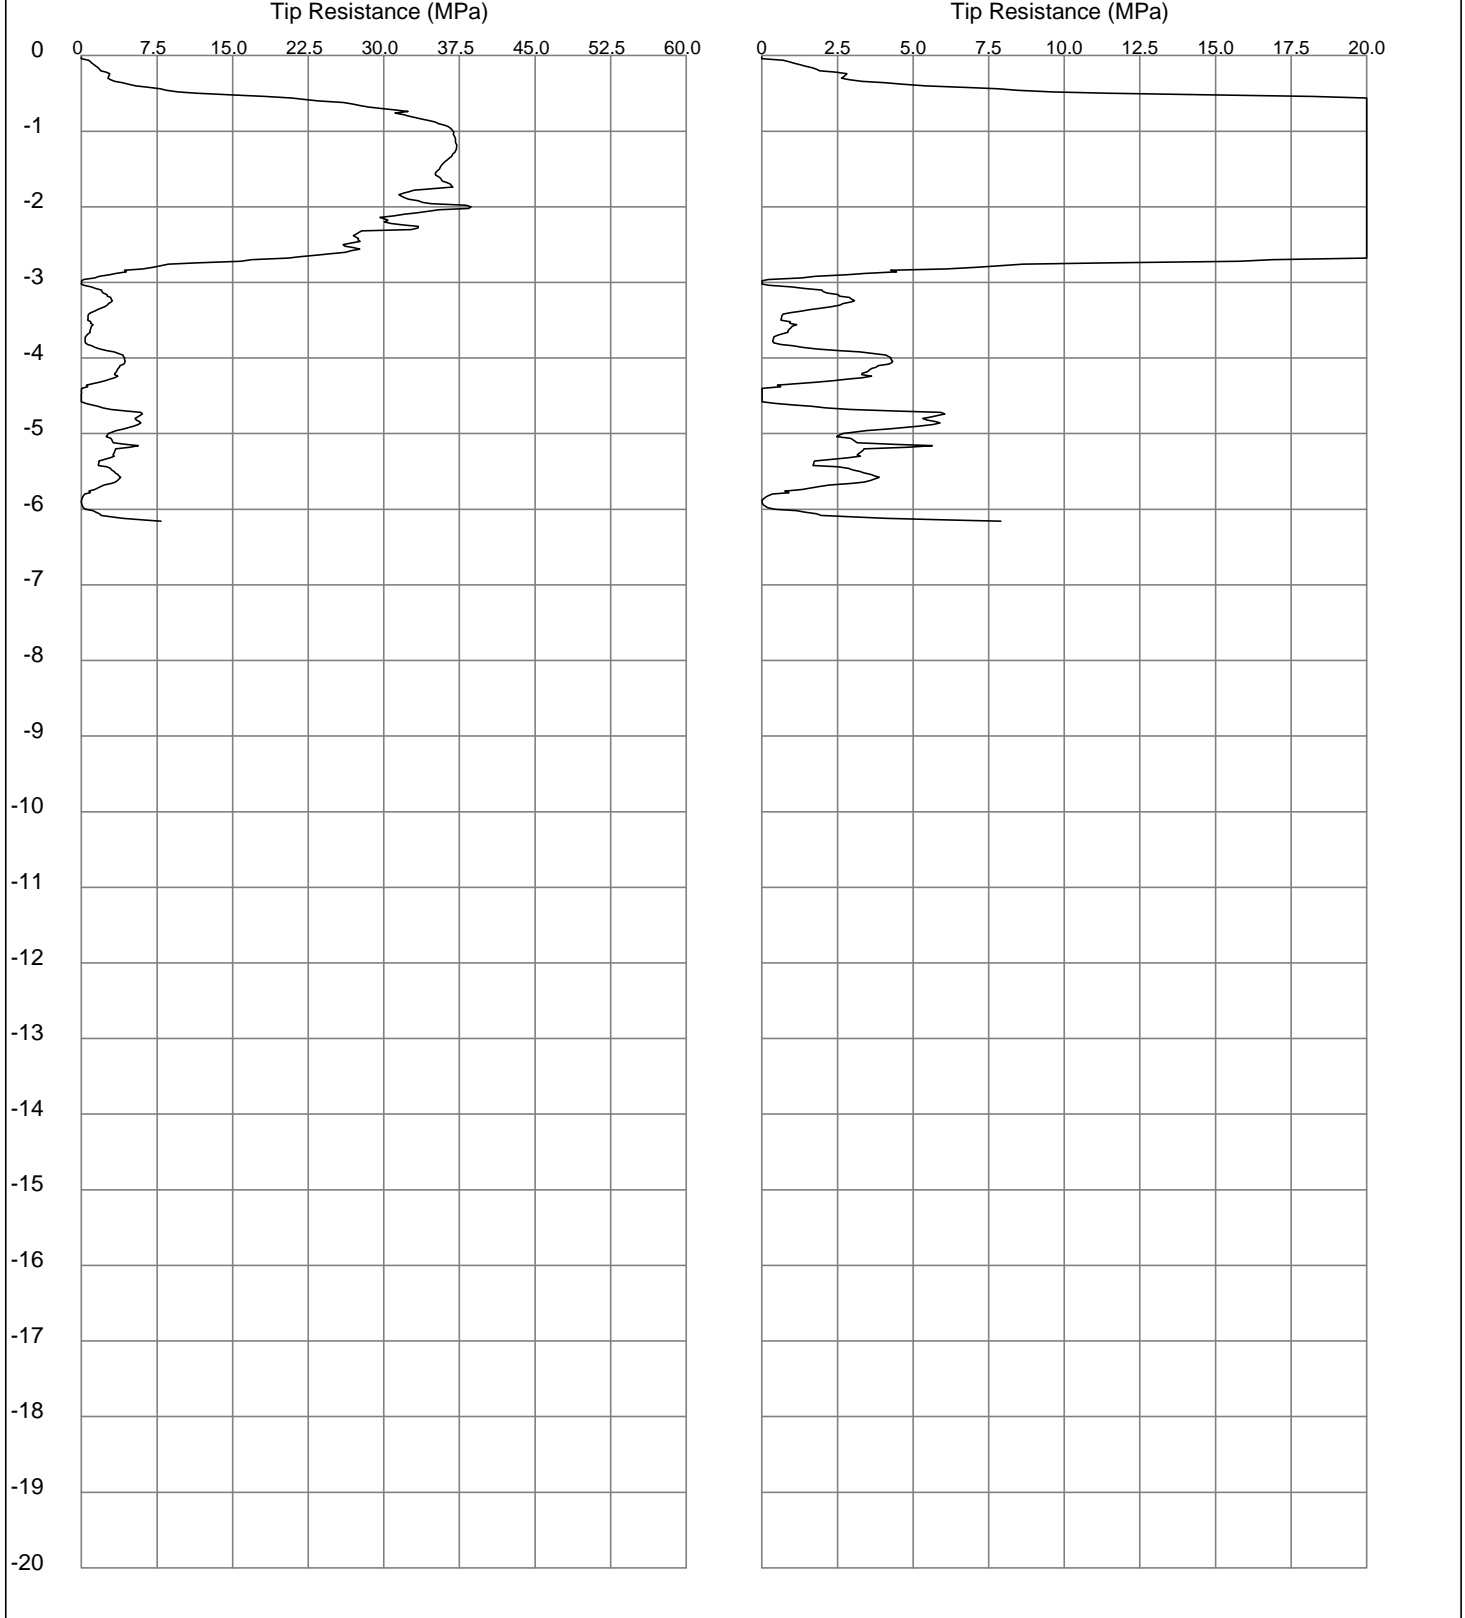
Project no. 3925	Remarks Refusal criteria; Damage to cone	Sounding No. CPT 02	
R/L = 58.56m AHD	Hole open to depth (m) -	Total depth (m) 6.16	Operator Brad
Co ordinate: X= 391549.35 Y= 6480187.70	Groundwater Level (m) -	Cone No. 100709M	File 2
Co-ordinates in MGA94 Z50	Pre Drilled depth (m) -	Probe Rig PR001	Date Completed 28-8-2017

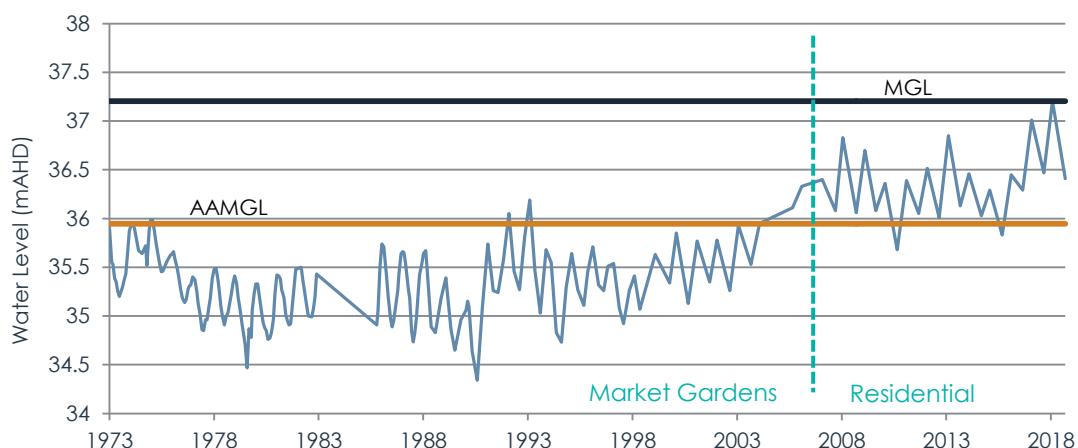
There is a clear step up in groundwater levels from approximately 2008 onwards. This is associated with a change in land use, particularly in the Madeley and Darch areas, from irrigated market gardens to residential development. A review of aerial photography in 2003 and 2012 indicates that residential areas (inclusive of Public Open Space) in these two suburbs (outside of the Study Area) increased from 28% to 97%. From 2012 to 2018 there has been minimal increase in residential areas in these suburbs and therefore further significant increases in groundwater are considered unlikely. Development of the Study Area will have limited impact on regional groundwater levels as all rainfall on the site is currently infiltrated, with minimal irrigation, unlike previous surrounding market garden uses.

Figure 7: Groundwater levels in DWER Bore MM14

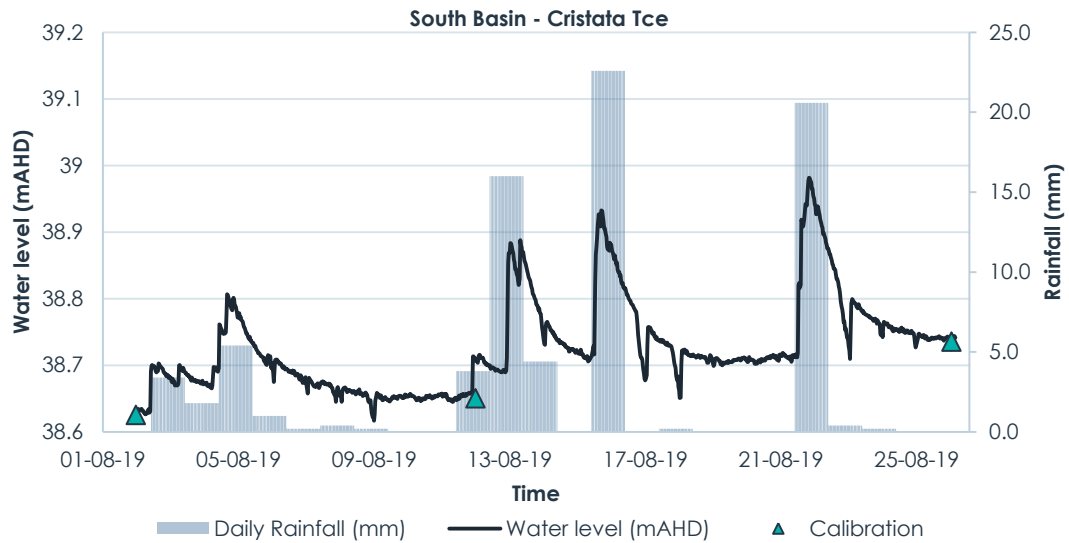
Figure 10: Cristata Terrace Sump Observed Water Levels (August 2019)

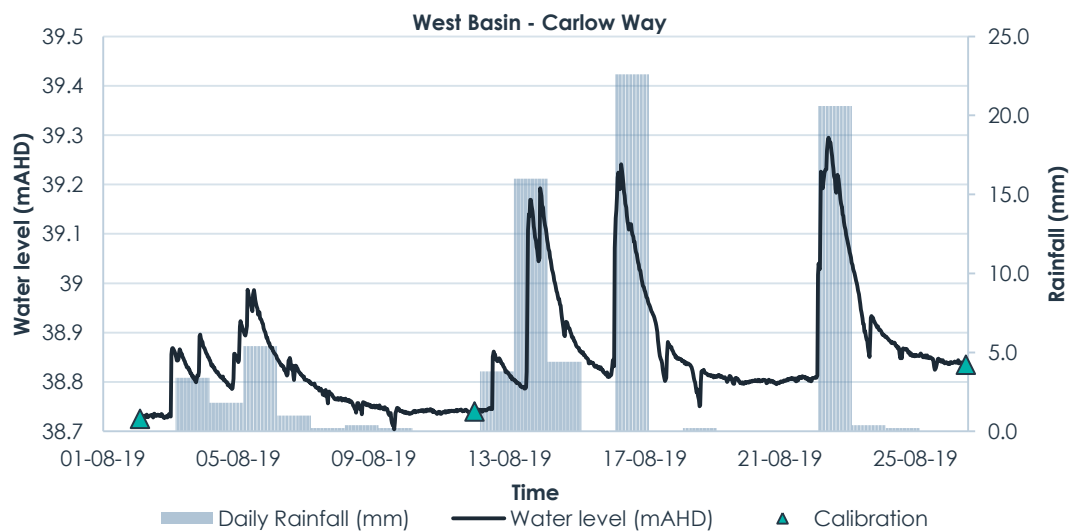
Figure 11: Carlow Way Sump Observed Water Levels (August 2019)

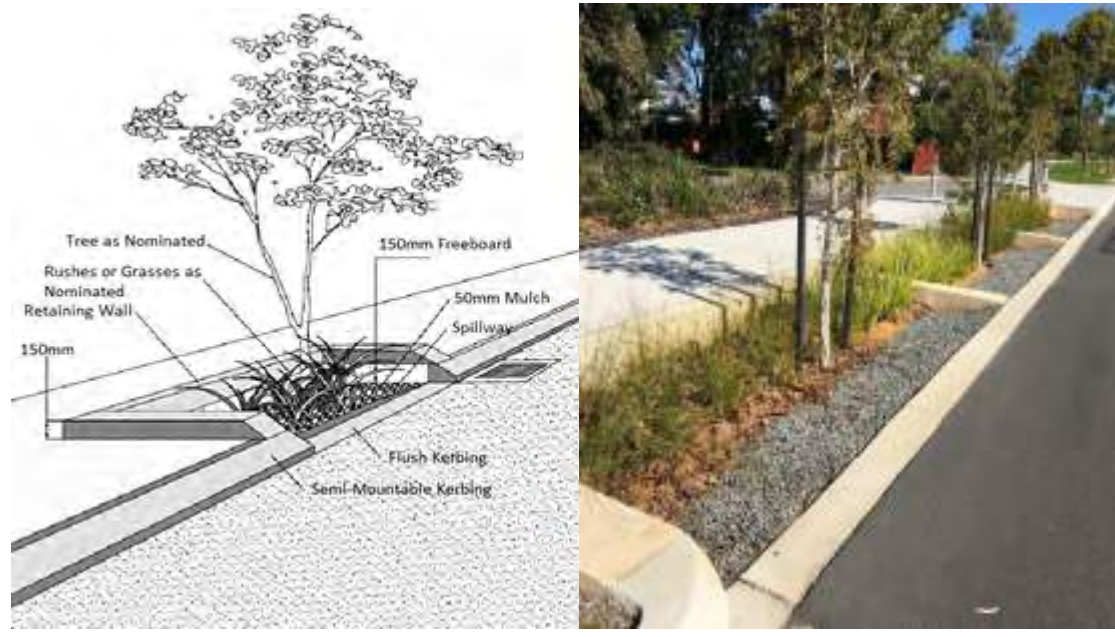
Figure 13: Typical roadside tree pit or raingarden

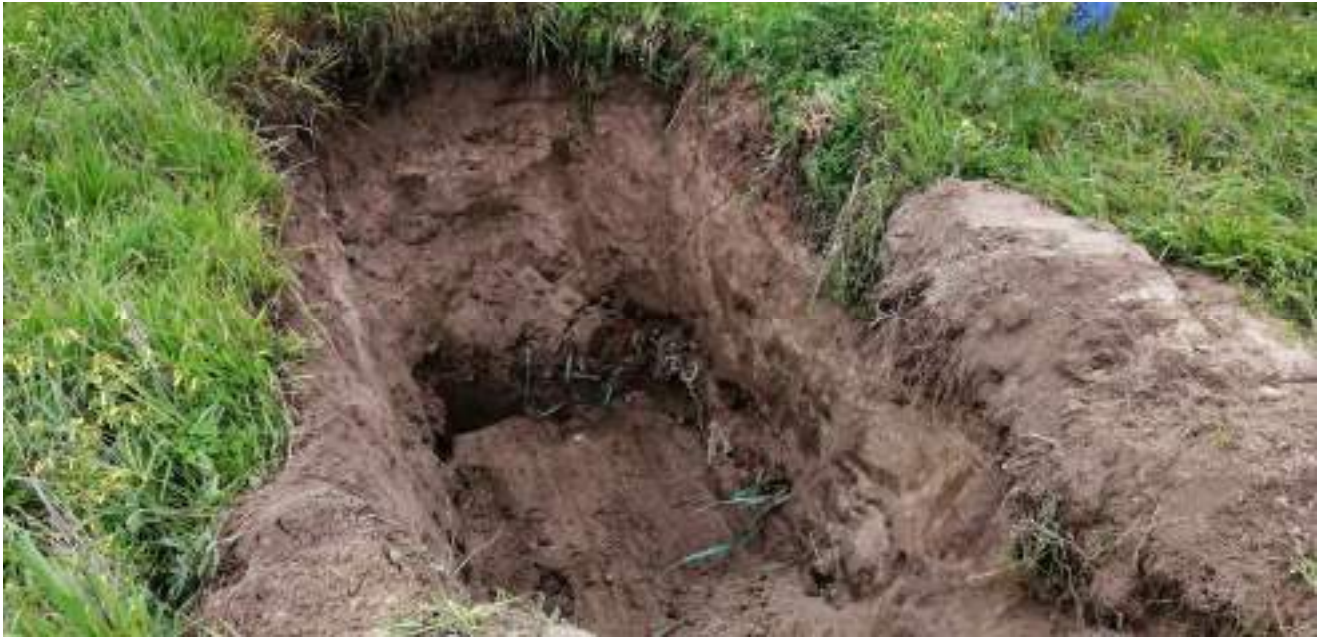
Photograph 5: Example test pit for infiltration testing in Unit 1B (Uncontrolled FILL) material – prior to water addition

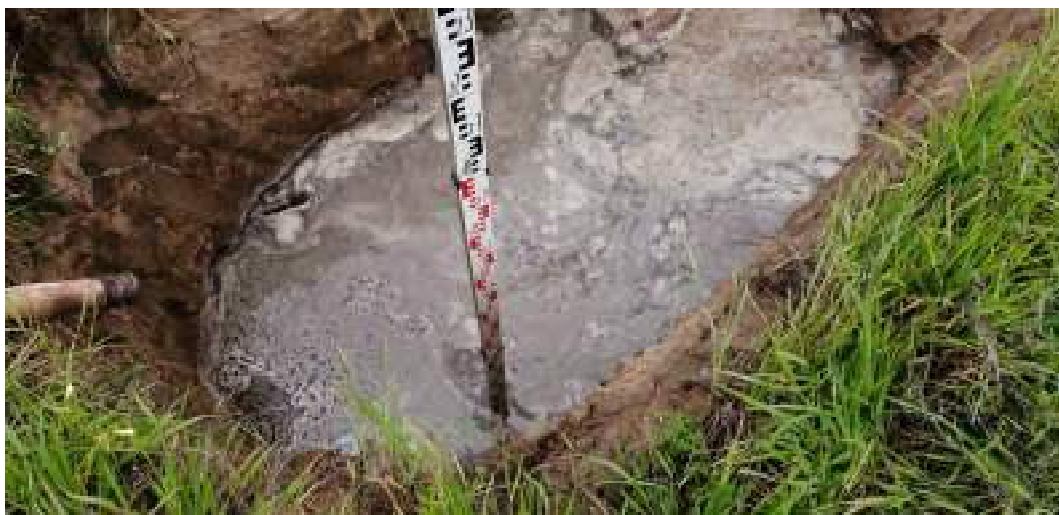
Photograph 6: Testing in progress in Unit 1B (uncontrolled FILL) material

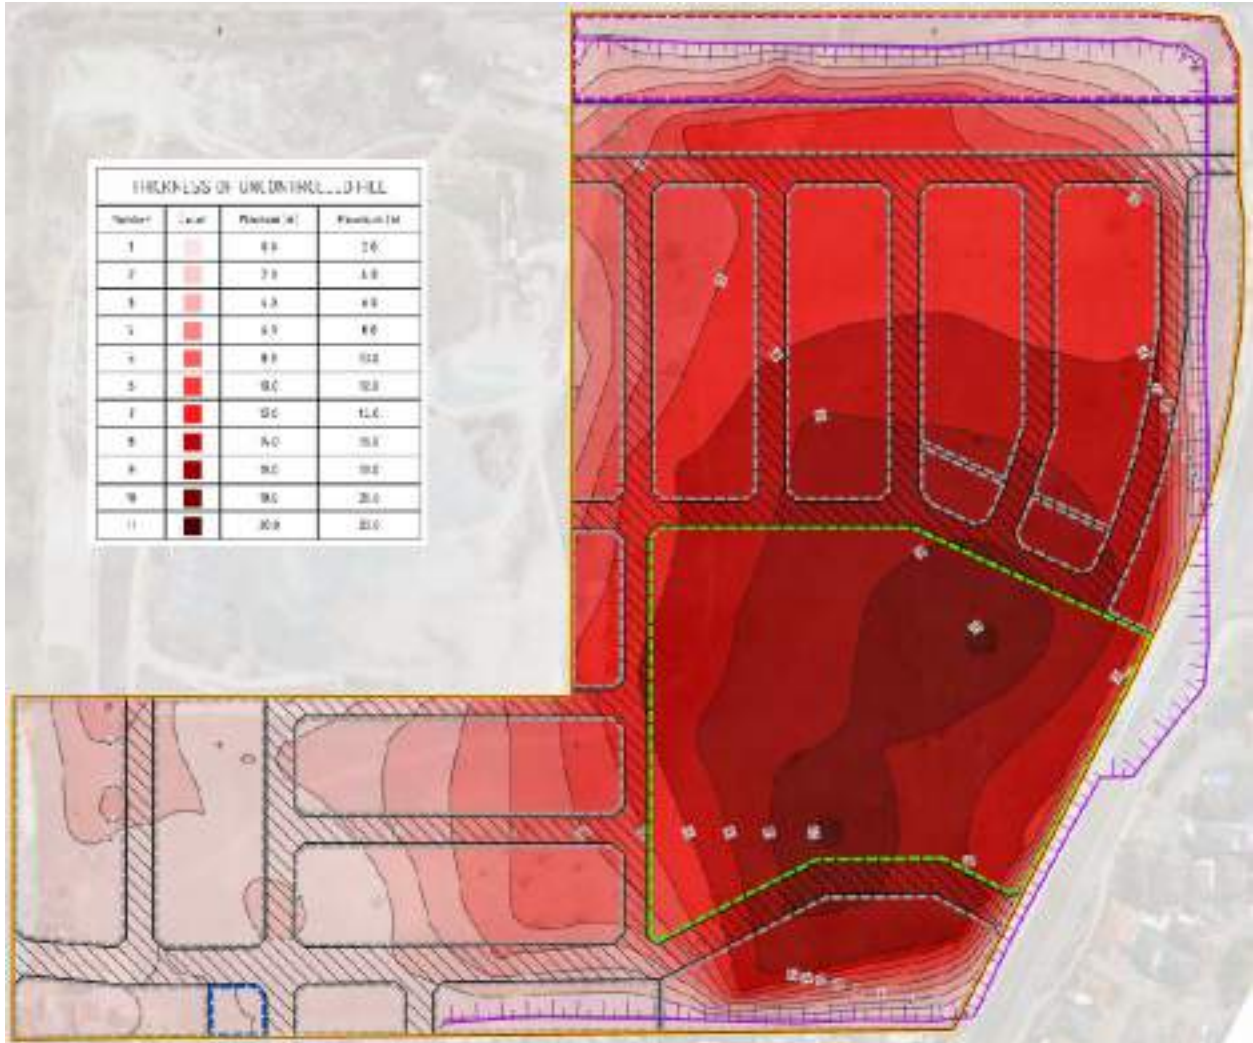
Figure 6 – Uncontrolled Fill Thickness (Galt Geotechnics, 2019)

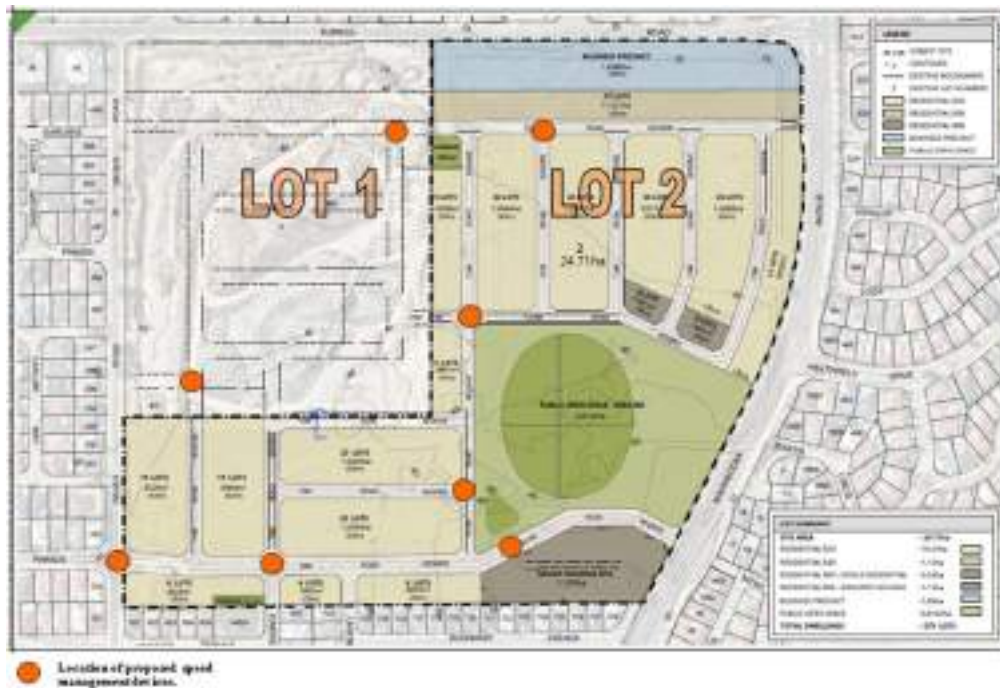
Figure 3.4: Location of proposed speed management devices

Liveable Neighbourhoods provides guidance on the street leg length and target operating speeds on local roads (see Element 2, Table 6: Street leg length and target operating speed). Based on this, additional speed management devices are recommended for Lot 2 as shown indicatively in **Figure 3.4**. It is recommended that roundabouts, mini-roundabouts, raised plateaux or other similar traffic calming measures are installed to ensure a safe traffic operating environment. The location of devices for Lot 1 will depend on the final road layout adopted.
