Lot 1665 Wanneroo Road Sinagra

Local Water Management Strategy

Prepared for Stockland by Strategen

September 2019

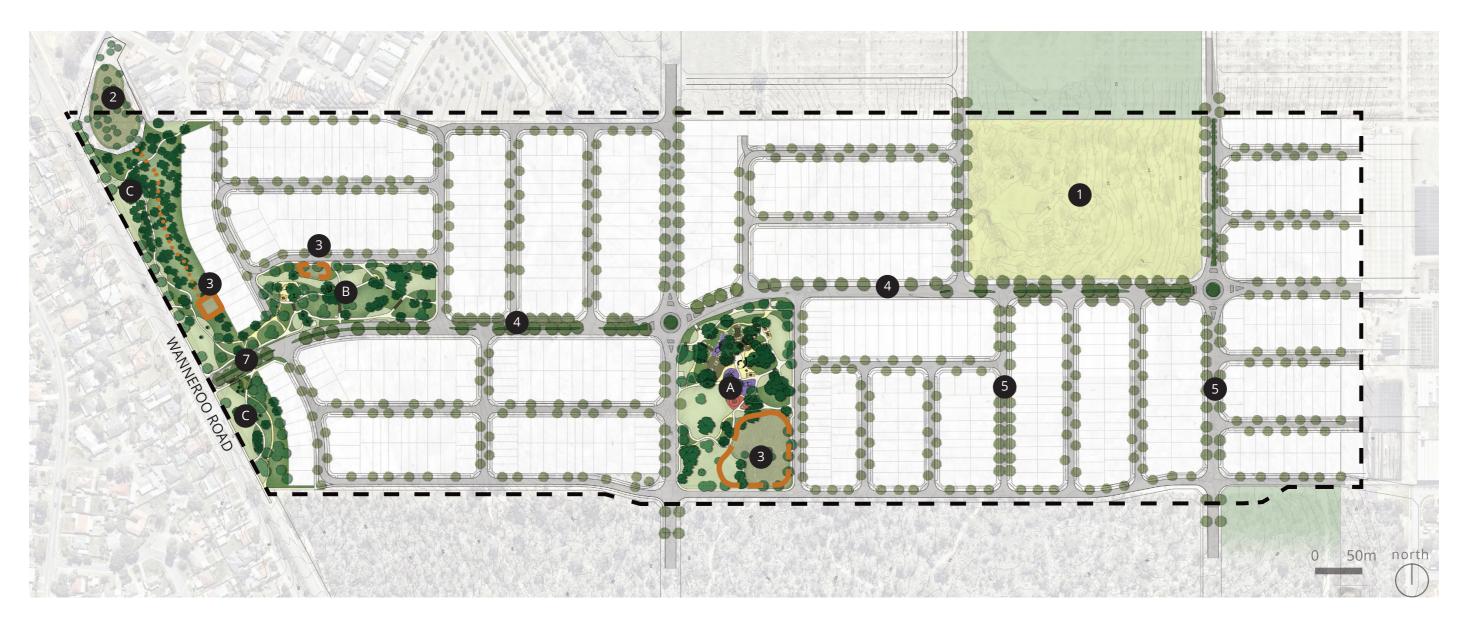
LANDSCAPE MASTER PLAN

CONCEPT DESIGN

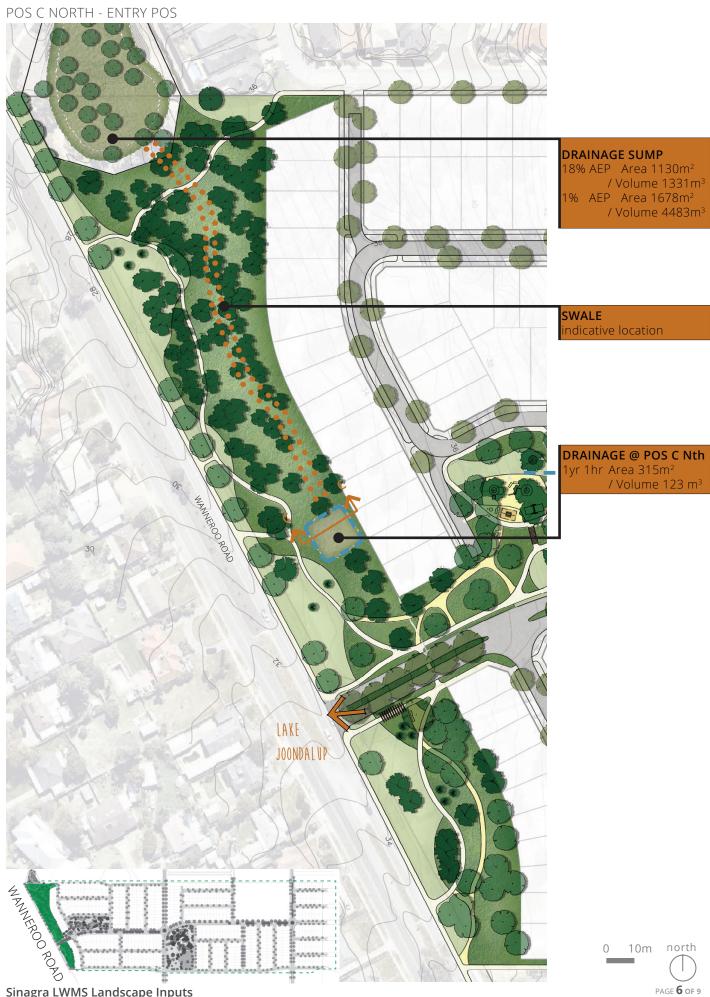
POS DRAINAGE SECTIONS

CATCHEMENT B, C, E

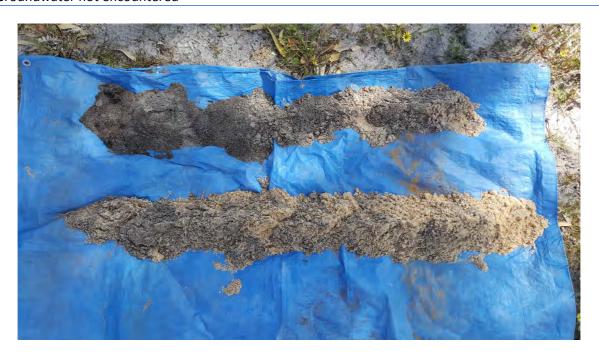
HA01 spoil

End of borehole at 2.0 m Target depth Groundwater not encountered

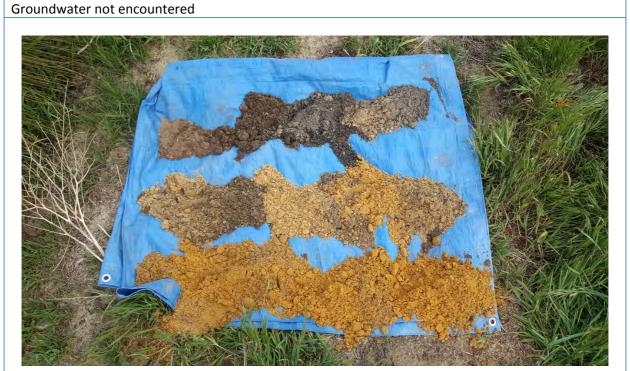
HA02 spoil

End of borehole at 2.0 m Target depth

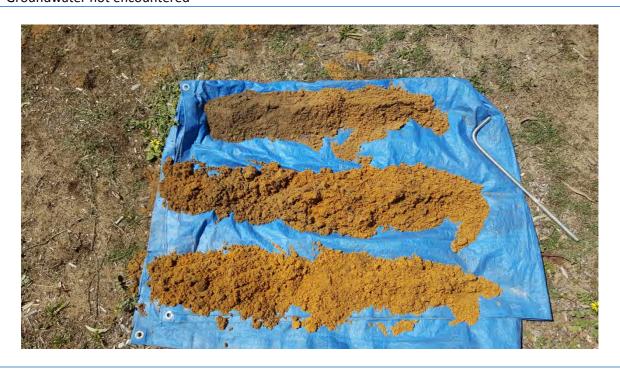
HA03 spoil

End of borehole at 2.0 m Target depth Groundwater not encountered

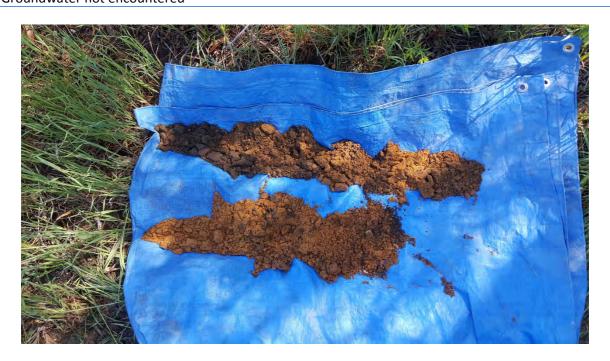
HA04 spoil

End of borehole at 0.70 m Refusal due to Limestone Groundwater not encountered

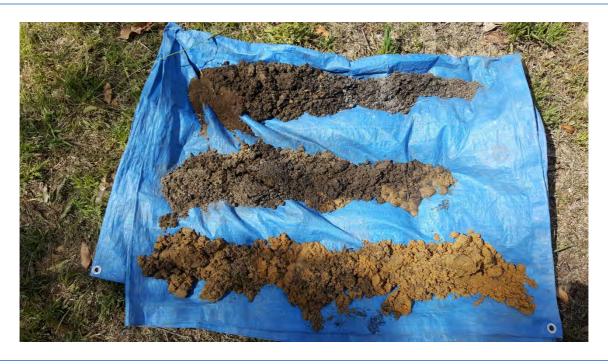
HA05 spoil

End of borehole at 2.0 m Target Depth Groundwater not encountered

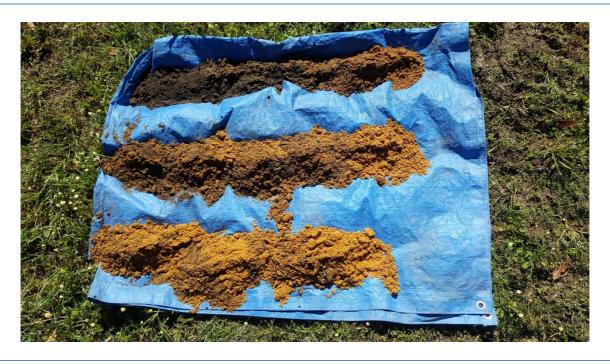
HA06 spoil

End of borehole at 2.0 m Target Depth Groundwater not encountered

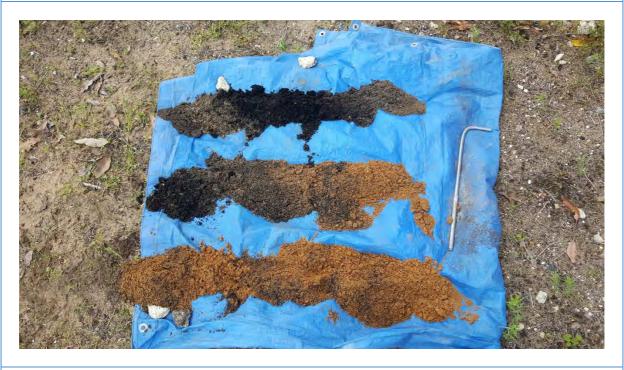
HA08 spoil

Loose to Medium Dense

Groundwater not encountered
