**SITE SURVEY**  
**LOT 1 ON D.49531**  
**37 DANBURY CRESCENT**  
**GIRRAWHEEN**

**SORENSEN SHORT & ASSOCIATES**

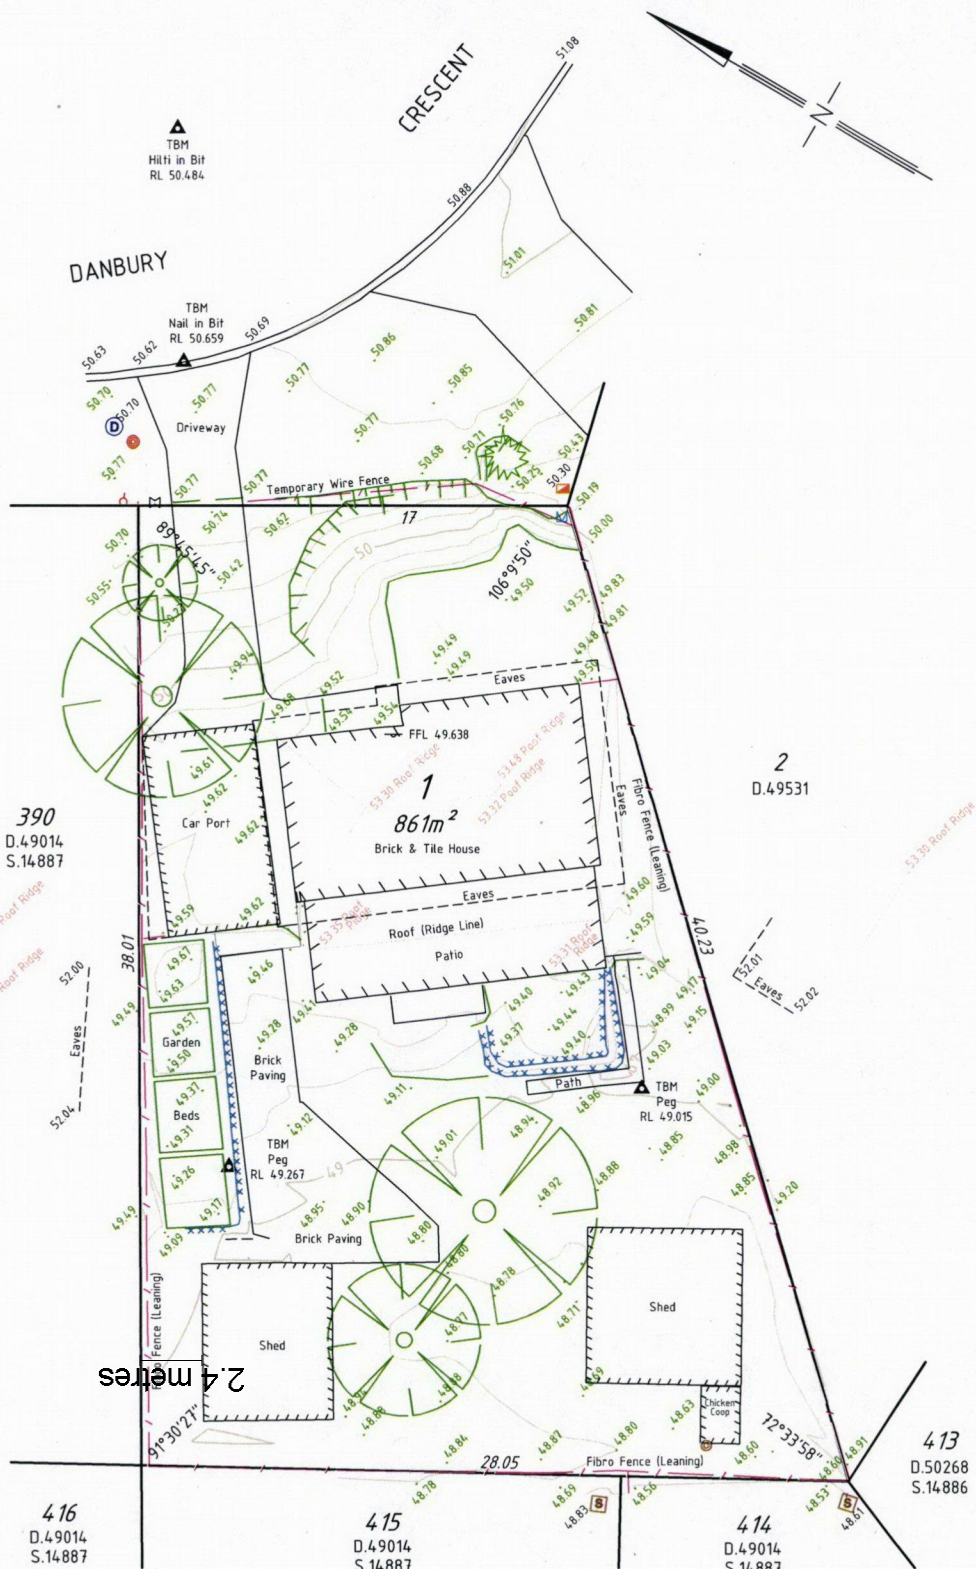
\* LEVEL DATUM IS AHD (APPROX.)  
ORIGIN OF LEVELS IS SEWER MANHOLE (LID) M6455  
RL 48.83m

SITE SURVEY only. The information shown on this drawing is current at the date of survey. Boundary information, Easements etc. to be verified from the Certificate of Title, Plan/Diagram or a boundary repeg. Boundary position approximate only. Location of boundary pegs or fences in relation to the boundary lines are not guaranteed. Sewer, Drainage may vary from schematic presentation, clearances to be checked on site. Service information to be confirmed with relevant authorities. For underground services ring 'DIAL BEFORE YOU DIG' for confirmation.

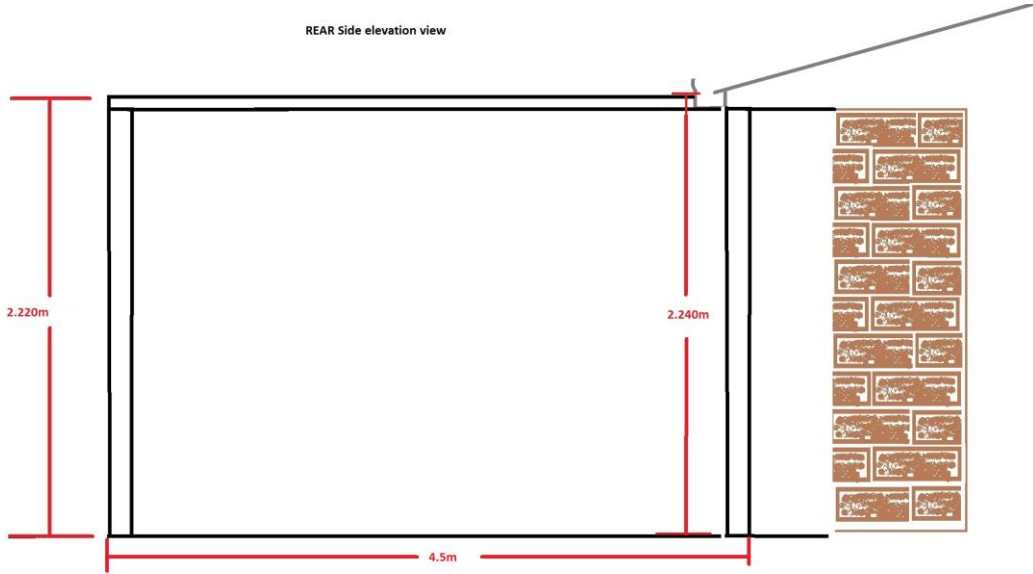
REAR Side elevation view

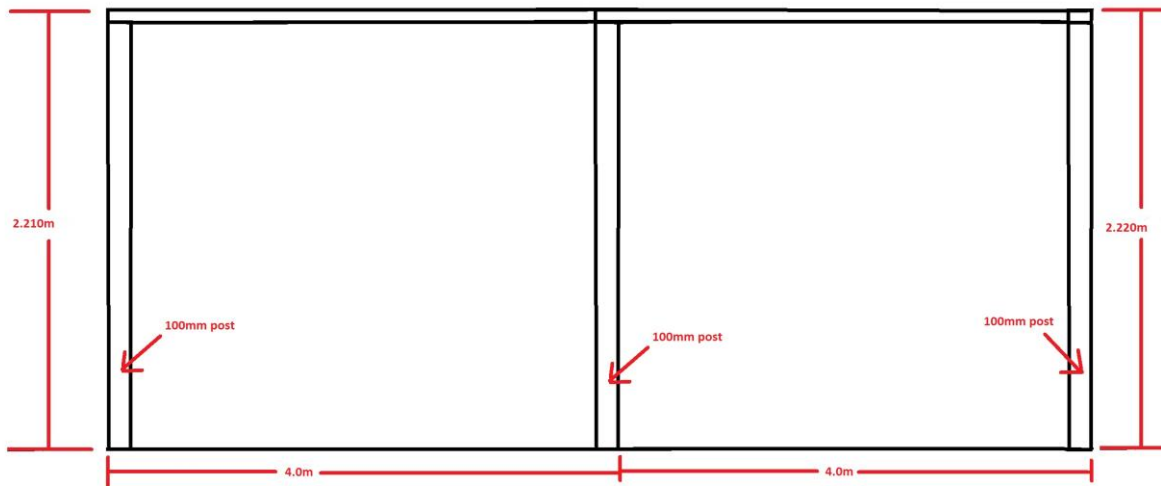
Carport Northern Side Elevation Boundary Side

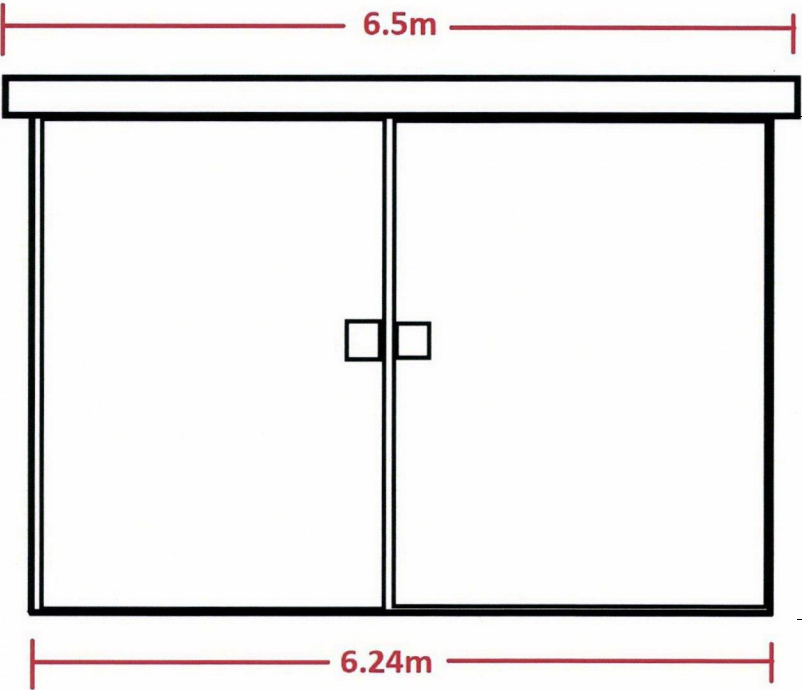
# SHED ELEVATION

Front

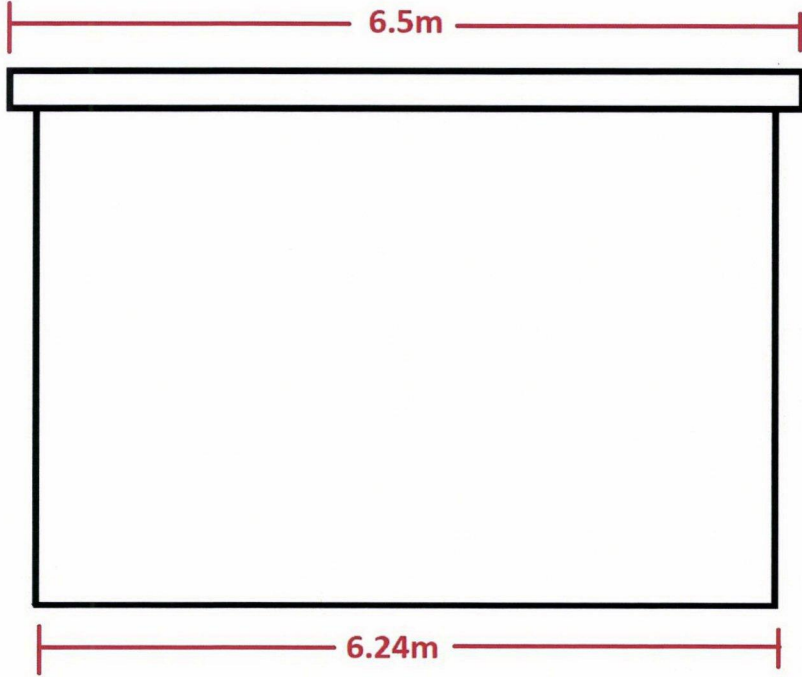
Sides and Rear
