# Appendix 8

Engineering Report (Cossil & Webley)

LOCAL STRUCTURE PLAN  
ENGINEERING REPORT  
LOT 9004 TARONGA  
PLACE, EGLINTON  
August 2021

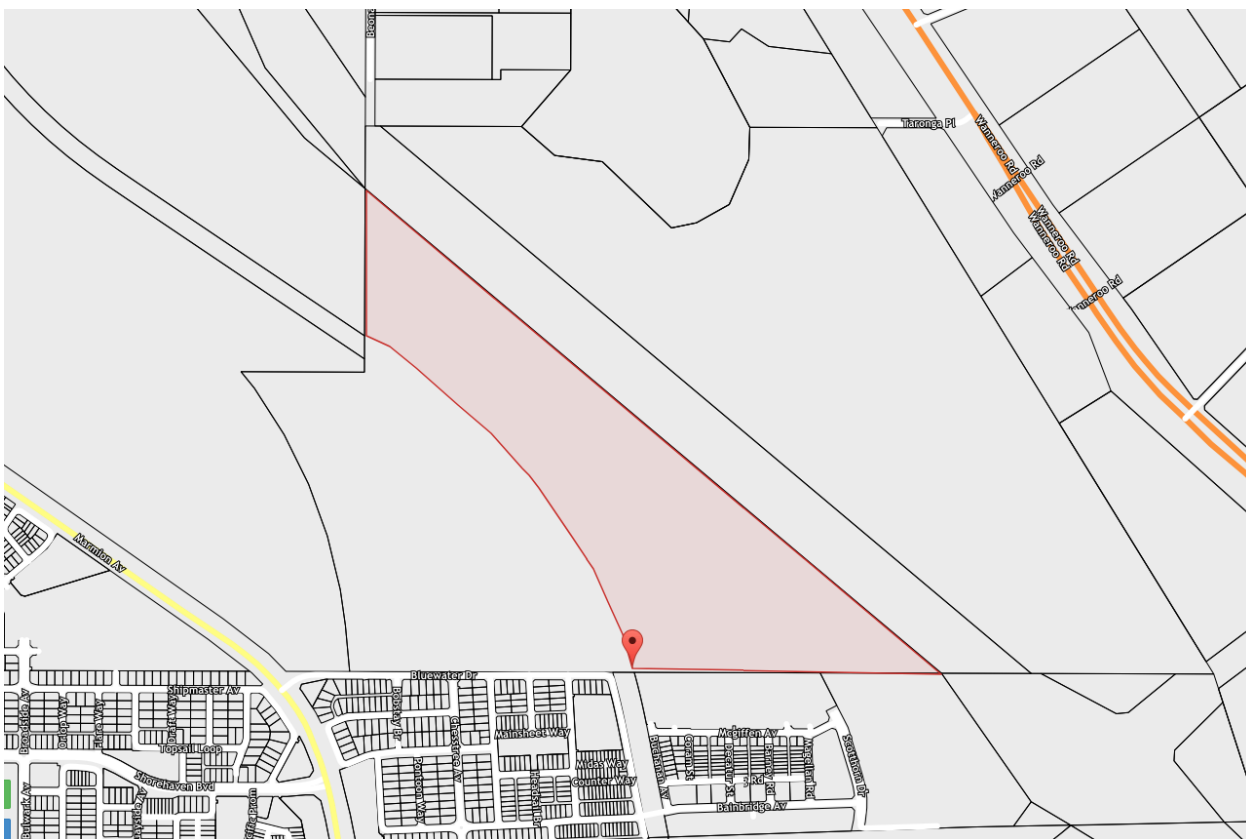
The Lot 9004 LSP area is identified by the red boundary presented below in Figure 1

Figure 1 - Site Plan (MNG Maps 2021)

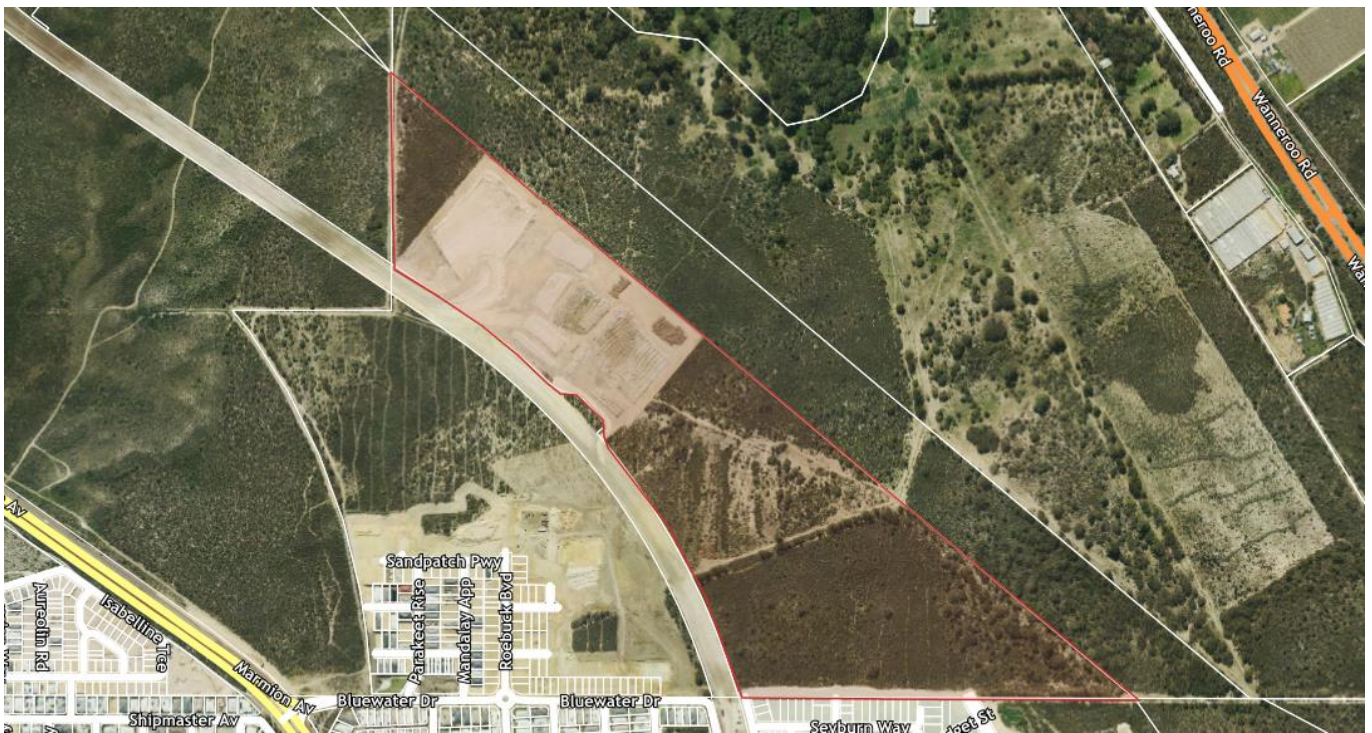
The Lot 9004 LSP is situated within the City of Wanneroo, approximately 45 kilometres north of the Perth city centre. The Site is bound by the existing Shorehaven Development to the south, the future Mitchell Freeway road reserve to the north & east, and Rail Reserve and future & existing residential development to the west. Approximately 60% of the Site is covered with vegetation, which mostly consisting of shrubs and low lying bushes. The balance of the land is cleared of large vegetation, which was completed in 2008 under a clearing permit, and more recently by the PTA for the stockpiling of material generated from the Yanchep Rail Extension Project. *Figure 2* below refers.

*Figure 2 – Aerial Photography (MNG Maps 2021)*

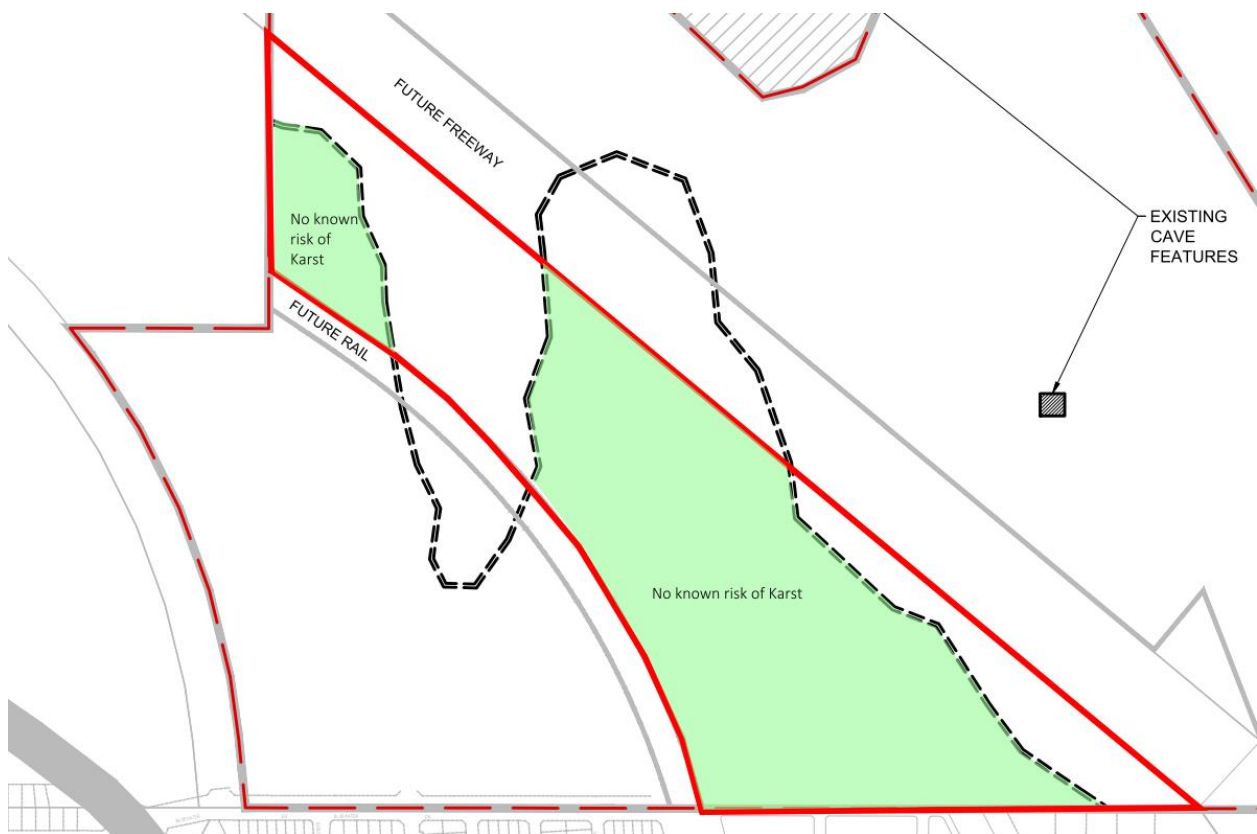
Subsequently, CMW Geosciences were engaged to review the likely impact of karst formations on future development, and confirmed the eastern portion is likely to be within a recognised zone of potential karst features. *Figure 5* below presents the likely inferred western edge of a potential karst risk zone within the DSP amendment area. CMW Geosciences has previously prepared a Preliminary Karst Landform Management Methodology report which describes the manner in which any karst identified within the Site can be treated, which is presented in Appendix B for information, and is discussed further in Section 4.2 below.

*Figure 5: Inferred Potential Karst Risk Zone (CMW Geosciences)*

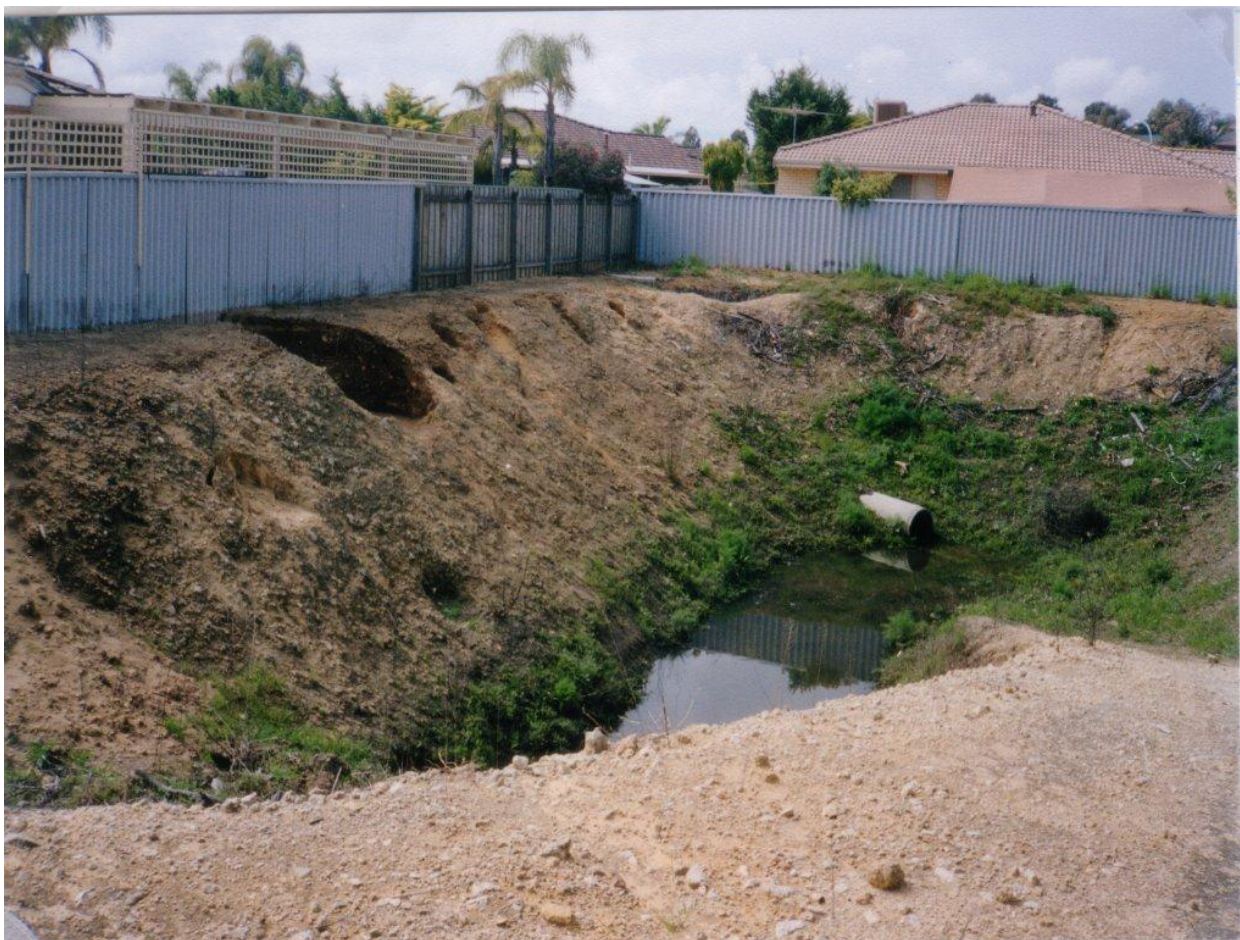
Several sinkhole collapse features occurred within a road drainage basin following a significant rainfall event (Figure 1). The road basin is located within an urban residential development characterised by sand overlying pinnacled limestone at shallow depth. The collapses occurred in the mid 1990's and were investigated by Ray Gordon (2003) who has presented a schematic cross section of the site. No damage to the adjacent houses was reported. Remediation work included replacement of some sections of the boundary fences and precautionary underpinning of the foundations on one of the neighbouring residences.

Figure 1 – Road drainage basin at Regatta Drive, Edgewater showing sinkholes on left and at rear.

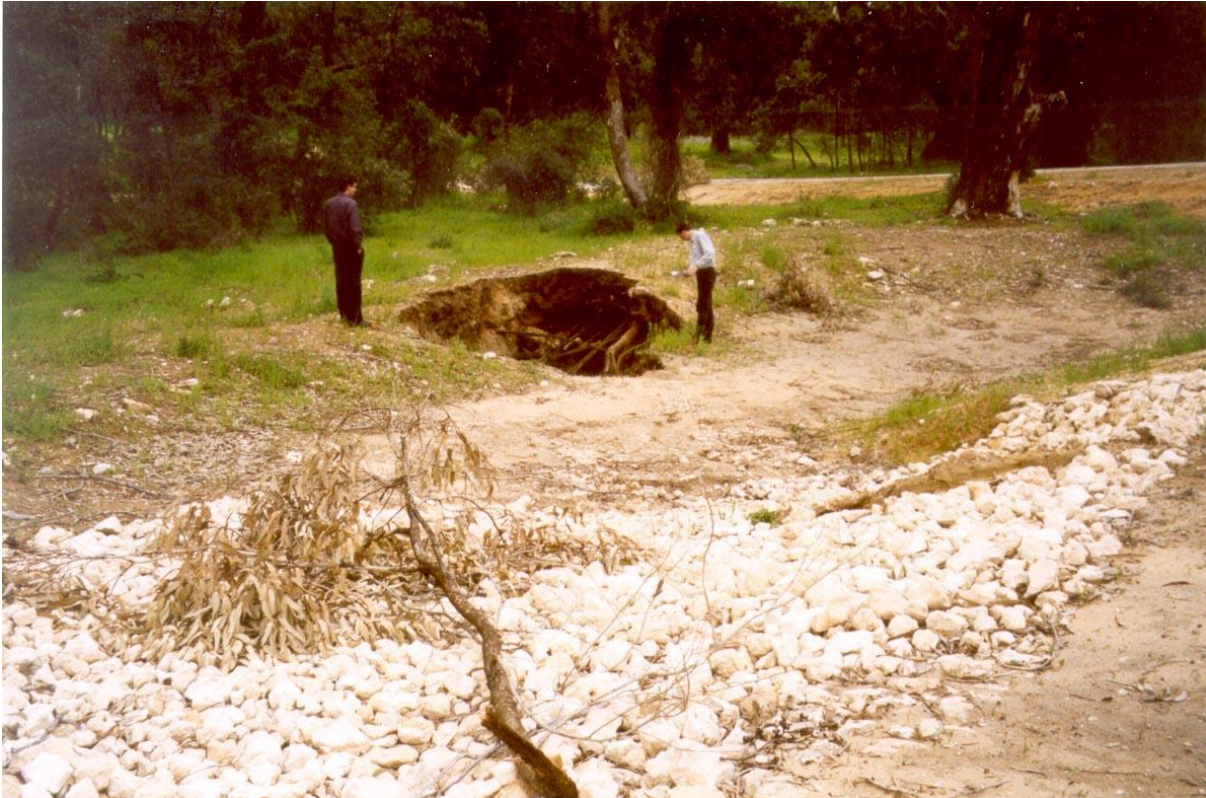
Sinkhole collapse occurred within a road runoff discharge area following winter rainfall soon after construction for a Special Rural subdivision (Figure 2). The collapse occurred in the early 2000's within an area of sand overlying shallow limestone between areas of scattered limestone outcrop. There was no damage reported, however, this example further highlights the potential risks associated with large volumes of concentrated runoff from road drainage basins triggering collapse events.

Figure 2 - Sinkhole within road drainage discharge area, Emerald Drive, Carabooda.

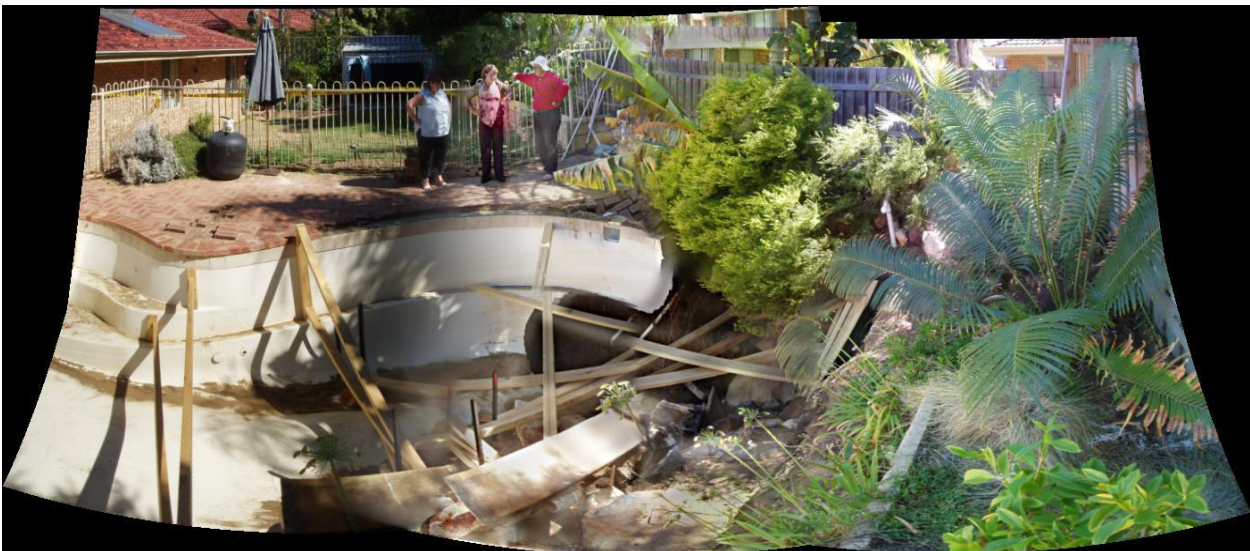
Undermining of a swimming pool due to sinkhole collapse occurred in March 2007 (Figure 3). The contribution of uncontrolled water discharge from a range of possible sources adjacent to the pool was suspected of contributing to progressive development of the sinkhole over many years which finally resulted in sudden collapse of the pool. Limited investigation at the site indicated a ground profile comprising sand overlying limestone at a depth of approximately 6 m.

Figure 3 - Woodvale swimming pool with bracing following collapse

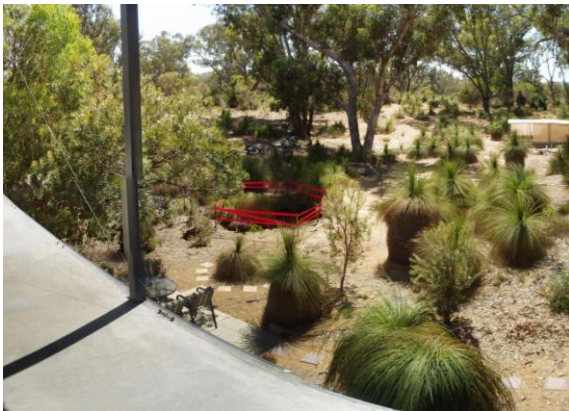
Sinkhole collapse about 4 m wide and 3 m to 4 m deep occurred in December 2007 located approximately 12 m from the edge of a residence within a Special Rural subdivision (Figures 4a and 4b). The site is underlain by a 3 m to 6 m thick surface sand layer overlying limestone. A combination of CPT and air core borehole investigation identified loose

Figure 4a – Breakwater Drive, Two Rocks. View of sinkhole from balcony of residence

This arrangement had been in place for over a year prior to the collapse occurring. On the day of the collapse the owner had turned on the bore pump and then been distracted at the front of the property for between half to one hour with the pump running and pools overflowing. On his return to collect water from the pools they had “disappeared” down the sinkhole. One pool was completely gone and the corner of the second pool was visible at the base of the sinkhole.

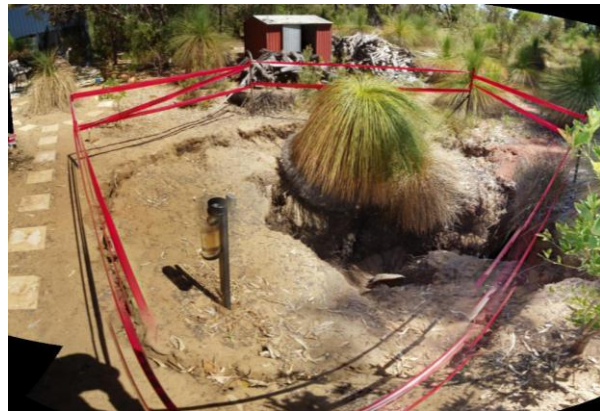
Figure 4b - Breakwater Drive, Two Rocks. Close up view of sinkhole. Note tension crack around edge of failure zone
