LOCAL WATER MANAGEMENT STRATEGY

Mariginiup - Precinct 15

Document Number: STOMAR_01 Date: 22/08/2023

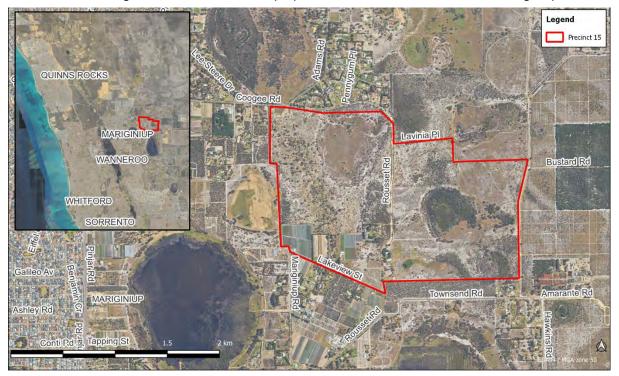
Figure 1: Site plan and location

This LWMS has been prepared on behalf of Stockland to support the Mariginiup – Precinct 15 Local Structure Plan (LSP) of the Mariginiup landholding within the City of Wanneroo (the City) (Figure 1). LSP approval is being sought for the site which comprises approximately 315.3 ha of passive rural land and a tenant running a small bobcat and site preparation business in the suburb of Mariginiup.

The LSP covers approximately 315.3 ha and will be developed to provide housing, a town centre, regional sporting fields, primary and high schools and public open space (POS). The LSP is shown in Figure 1.

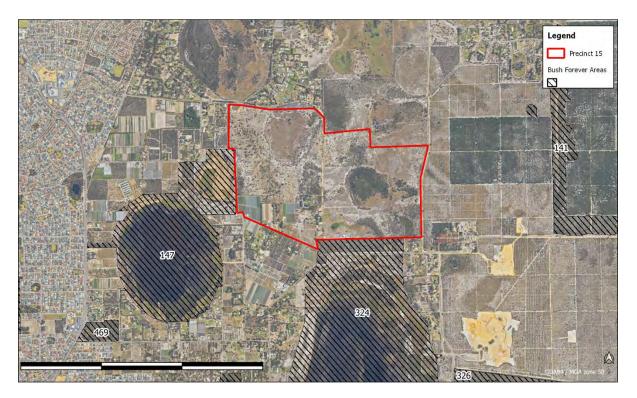
Figure 6: Bush Forever sites

A search of the Western Australian Local Government Association Administrative Planning Categories mapping tool (WALGA 2018) did not identify any Bush Forever sites within the site. The nearest Bush Forever sites are site no. 147 (West of the site) and 324 (South of the site), as shown in Figure 6.

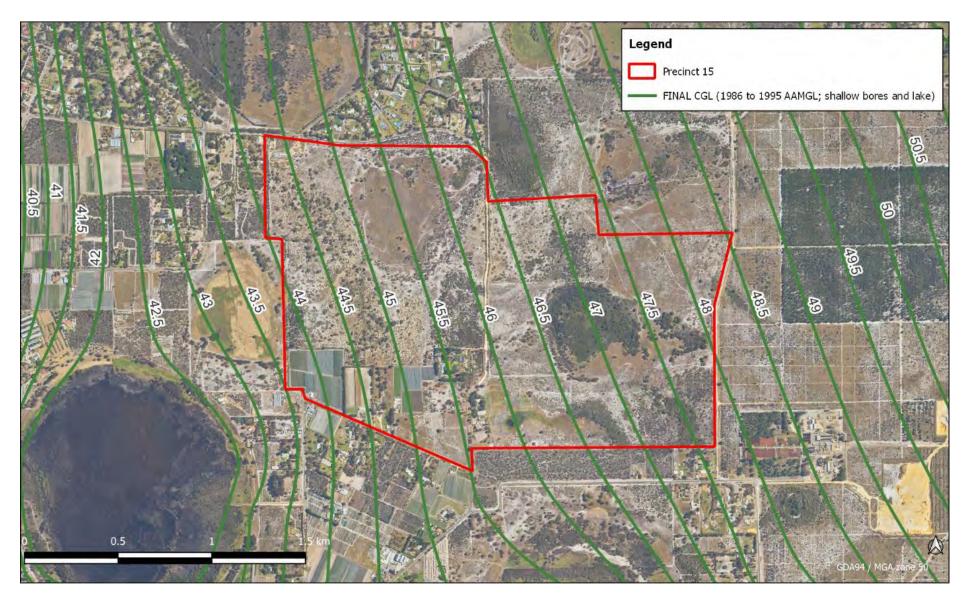
Figure 10: AAMGL/adopted CGL (1986 to 1995)

Maximum groundwater levels recorded on site in 2022 and 2023 (as discussed in Section 2.11.3) were slightly higher than the AAMGL across the site. It is noted that total rainfall recorded for the month of August in 2022 at the closest BoM weather station (Wanneroo, BoM 9105) was significantly higher (by approximately 100 mm) than both the baseline rainfall (1961 to 1990) and average rainfall (1990 to 2017) as outlined in Section 2.2.1. As the maximum groundwater levels were recorded in the months following this historically high month of rainfall, and without more recent long-term site-specific groundwater data, it is still recommended that the 1986 to 1990 AAMGL is adopted for the site.

The proposed CGL for the East Wanneroo DSP area is the 1986 to 1995 average annual maximum groundwater level (AAMGL), which is considered appropriate for Precinct 15 without adjustment. Several surface water infiltration basins have been identified across the site, as shown in Figure 15. The DWMS specifies that subsoil drainage is to be at the CGL, and the subsoil drainage pipework will underlie the surface water infiltration basins. A clearance of at least 0.5 m from the basin invert to the CGL will therefore be required to allow for the subsoil drainage pipework to have an invert level at CGL and to allow for infiltration from the surface water basins.

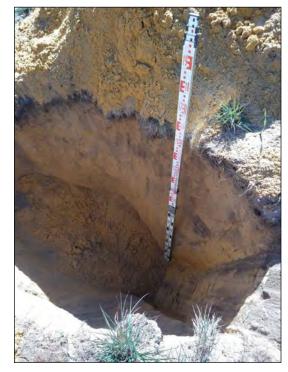
PIT No: 28 PROJECT No: 212040.00 DATE: 6/7/2022 SHEET 1 OF 1

Γ			Description	. <u>c</u>		Sam		& In Situ Testing	_	Dynamic Penetrometer Test			
RL		Depth (m)	of Strata	Graphic Log	Type	Depth	Sample	Results & Comments	Water	(blow	Sper 150	mm)	
-	-	0.15	TOPSOIL/SAND SP: fine to medium grained, grey-brown, \trace silt, trace rootlets, moist, topsoil.	XX.						-			
-	- - -		SAND SP: fine to medium grained, pale yellow, trace silt, moist, loose. Sand derived from Tamala Limestone.										
21	- 1		- becoming yellow-brown and medium dense from 0.9 m depth.							[_] -1[- 1			
20	2	2.1 -								-2			
-	-	2.1	Pit discontinued at 2.1m (Collapsing conditions)										
	-3												
Ŀ	-

WATER OBSERVATIONS: No free groundwater observed.

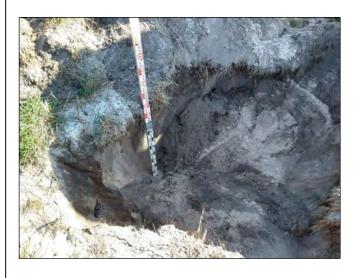
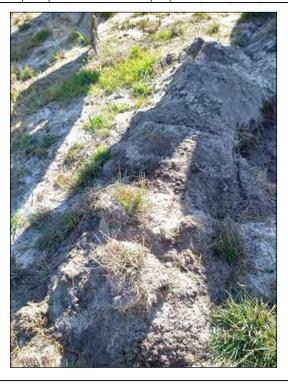
PIT No: 30 PROJECT No: 212040.00 DATE: 6/7/2022 SHEET 1 OF 1

\square		Description	ic		Sam	pling &	& In Situ Testing	_	
R	Depth (m)	of Strata	Graphic Log	Type	Depth	Sample	Results & Comments	Water	Dynamic Penetrometer Test (blows per 150mm) 5 10 15 20
49	0.15	TOPSOIL/SAND SP: fine to medium grained, grey-brown, trace silt, with rootlets, moist, topsoil.	ŶΛ						-
		SAND SP: fine to medium grained, grey, trace silt, moist, loose. Bassendean Sand.							
48	- - 1 - -	- becoming medium dense from 0.9 m depth. - becoming pale grey from 1.0 m depth.							- - - - - - - - - - - - - - - - - - -
-	- 1.5 -	Pit discontinued at 1.5m (Collapsing conditions)	<u></u>						
47	-2								
46	-3

WATER OBSERVATIONS: No free groundwater observed.

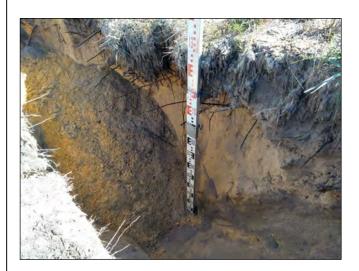
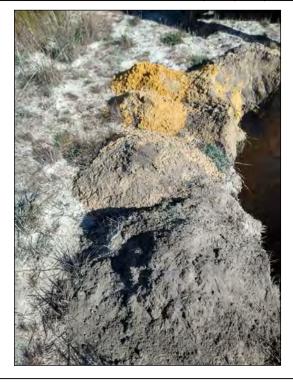
PIT No: 31 PROJECT No: 212040.00 DATE: 6/7/2022 SHEET 1 OF 1

Description	.e		Sam		& In Situ Testing	-		D 1		T (
RL	Depth (m)	of Strata	Graphic Log	Type	Depth	Sample	Results & Comments	Water	Dynamic (blo ⁻ 5	20 1)		
56	- 0.2	TOPSOIL/SAND SP-SM: fine to medium grained, dark grey-brown, with silt, trace roots and rootlets, moist, \medium dense, topsoil.										
	- - -	SAND SP: fine to medium grained, pale yellow, trace silt, moist, medium dense. Sand derived from Tamala Limestone.										
55	- 1 	- becoming yellow-brown from 0.85 m depth.									•	
54	- 1.8	Pit discontinued at 1.8m (Collapsing conditions)	<u> </u>	<u> D </u>	-1.8-							
53	- 3 - - -

WATER OBSERVATIONS: No free groundwater observed.

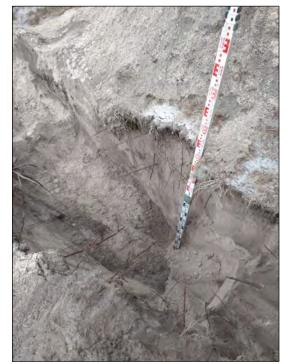
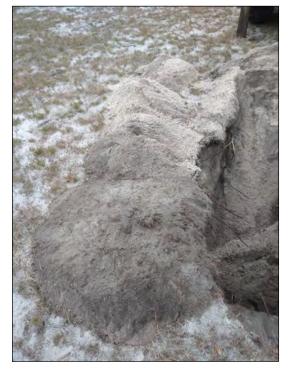
PIT No: 33 PROJECT No: 212040.00 DATE: 5/7/2022 SHEET 1 OF 1

_	Description	lic		Sam		& In Situ Testing	<u> </u>	
R	Depth (m)	of Strata	Graphic Log	Type	Depth	Sample	Results & Comments	Water	Dynamic Penetrometer Test (blows per 150mm) 5 10 15 20
48	0.15	TOPSOIL/SAND SP: fine to medium grained, grey-brown, trace silt, trace rootlets, moist, topsoil.	Υ <u>Λ</u>						
		SAND SP: fine to medium grained, grey, trace silt, moist, loose. Bassendean Sand.							
47	- 1	- becoming pale brown from 0.7 m depth.							-1
		- becoming medium dense from 1.25 m depth.							
	-2	Pit discontinued at 1.9m (Collapsing conditions)	<u></u>						
- 4-									
45	- 3

WATER OBSERVATIONS: No free groundwater observed.

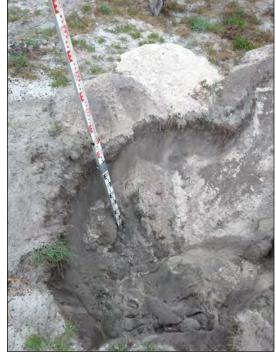
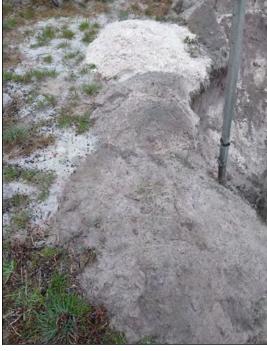
PIT No: 37 PROJECT No: 212040.00 DATE: 5/7/2022 SHEET 1 OF 1

Description	lic		Sam		& In Situ Testing	-	Dumanuia Danataan	
坧	Depth (m)	of	Graphic Log	Type	Depth	Sample	Results & Comments	Water	Dynamic Penetrom (blows per 150	omm)
		Strata	0	É.	ð	Saı	Comments		5 10 15	20
- 22-	- 0.1	\trace silt, trace rootlets, moist, topsoil.							L	
-	- - - -	SAND SP: fine to medium grained, grey-brown, trace silt, moist, loose. Bassendean Sand. - becoming grey from 0.35 m depth.								
ł	-1	- becoming pale grey from 0.9 m depth.							-1	
49	-	- becoming medium dense from 1.05 m depth.								
Ì	- 1.4	Pit discontinued at 1.4m (Collapsing conditions)	<u> </u>							:
ł	_									:
ł	-									
ŀ	-2									:
-92										:
	-									
ŀ	F									:
ł	_									÷
ł	-									
ţ.	-3									÷
Ł	-									
-4	-									
ł	-									÷
							WESS AR			1

WATER OBSERVATIONS: No free groundwater observed.

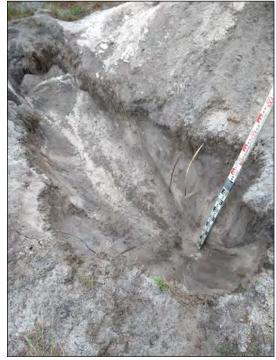
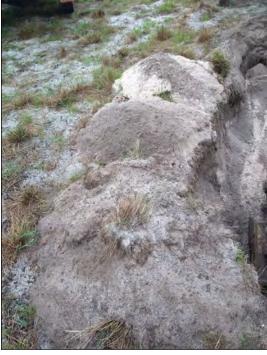
PIT No: 42 PROJECT No: 212040.00 DATE: 5/7/2022 SHEET 1 OF 1

Π		Description	<u>i</u>		Sam	pling &	& In Situ Testing	_	
RL	Depth (m)	of Strata	Graphic Log	Type	Depth	Sample	Results & Comments	Water	Dynamic Penetrometer Test (blows per 150mm) 5 10 15 20
	0.2	TOPSOIL/SAND SP: fine to medium grained, grey-brown, trace silt, with rootlets, moist, loose, topsoil.	<u>D</u>	D	0.1				-1
		SAND SP: fine to medium grained, grey, trace silt, moist, loose. Bassendean Sand.							
2 2 2	-1	- becoming pale grey from 0.65 m depth. - becoming medium dense from 0.75 m depth.							
. 49	1.8	Pit discontinued at 1.8m (Collapsing conditions)							
	-2								
48	-3								
					1		A State	and and

WATER OBSERVATIONS: No free groundwater observed.

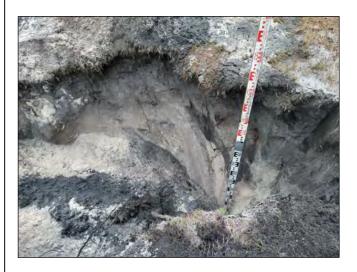
PIT No: 43 PROJECT No: 212040.00 DATE: 5/7/2022 SHEET 1 OF 1

Description	lic		Sam		& In Situ Testing	-	
RL	Depth (m)	of Strata	Graphic Log	Type	Depth	Sample	Results & Comments	Water	Dynamic Penetrometer Test (blows per 150mm) 5 10 15 20
		TOPSOIL/SAND SP-SM: fine to medium grained, dark grey-brown, with silt, trace rootlets, moist, medium dense, topsoil. SAND SP: fine to medium grained, grey, trace silt, moist, medium dense. Bassendean Sand. - becoming pale grey from 0.5 m depth.		D	0.1				
	- 1.8 -2 	Pit discontinued at 1.8m (Collapsing conditions)

WATER OBSERVATIONS: No free groundwater observed.

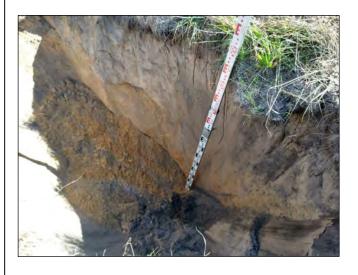
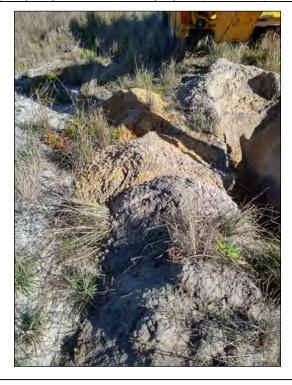
PIT No: 102 PROJECT No: 212040.00 DATE: 6/7/2022 SHEET 1 OF 1

Description	.e		Sam		& In Situ Testing	-	Dumonia D	
RL	Depth (m)	of Strata	Graphic Log	Type	Depth	Sample	Results & Comments	Water		etrometer Test er 150mm) 15 20
52	0.15	TOPSOIL/SAND SP: fine to medium grained, grey-brown, trace silt, trace rootlets, moist, topsoil. SAND SP: fine to medium grained, grey, trace silt, moist, loose. Sand derived from Tamala Limestone. - becoming pale yellow from 0.4 m depth.		D	0.1					
51	- 1 	 becoming years brown non 0.0 m depth. becoming orange-brown and weakly cemented from 1.5 m depth. 								
-	- 2 - 2 	Pit discontinued at 1.7m (Collapsing conditions)								
20	- 3									
	-

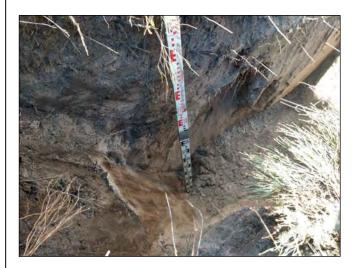
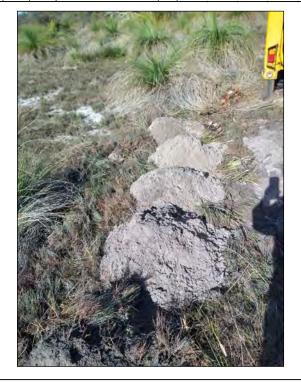
PIT No: 103 PROJECT No: 212040.00 DATE: 6/7/2022 SHEET 1 OF 1

Description	lic		Sam		& In Situ Testing	L.	
Ч		epth m)	of	Graphic Log	Type	Depth	Sample	Results & Comments	Water	Dynamic Penetrometer Test (blows per 150mm)
\vdash			Strata TOPSOIL/SAND SP-SM: fine to medium grained, dark	x		0.1	Se			5 10 15 20
F	F	0.2	grey-brown, with silt, trace rootlets, moist, loose, topsoil.	<u> </u>	D	0.1				
-	-		SAND SP: fine to medium grained, grey, trace silt, moist, loose. Bassendean Sand.							
49	-		- becoming pale grey from 0.65 m depth.							
Ē	-1		- becoming medium dense from 0.9 m depth.							
ł	Ļ									
ł	ļ									
ļ	-									
-8-	ŀ									
F	-2	0.0								-2
Ē	E	2.2	Pit discontinued at 2.2m (Collapsing conditions)							
	ŀ									
47	ļ									
ľ	-3									
ļ	ŀ									
ŀ	-

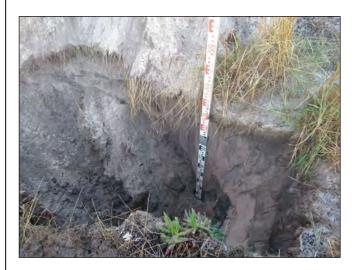
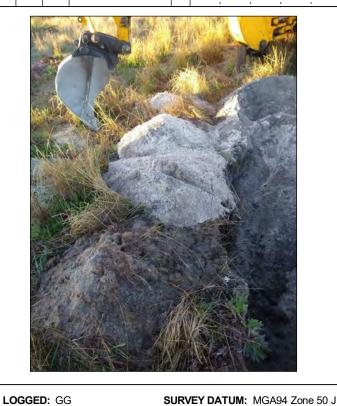
PIT No: 105 PROJECT No: 212040.00 DATE: 7/7/2022 SHEET 1 OF 1

Description	<u>ic</u>		Sam	pling &	& In Situ Testing	_				
⊾	Depth (m)	of	Graphic Log	Type	Depth	Sample	Results & Comments	Water	Dynami (blo	c Penel ows per	tromete 150mm	r Lest 1)
		Strata	0	É.	ð	Saı	Comments		5	10	15	20
	0.15	TOPSOIL/SAND SP: fine to medium grained, grey-brown, trace silt, trace rootlets, moist, topsoil.	XX.							:		:
		SAND SP: fine to medium grained, grey, trace silt, moist, γ medium dense. Bassendean Sand.							ן ר	:		
		^L - becoming pale grey from 0.4 m depth.										:
- 22-										i		
	1								-1			-
												÷
	1.6	Pit discontinued at 1.6m (Collapsing conditions)	[: · · · ·									<u> </u>
-2-												
-	2											
										÷		÷
. [
- 20-												
:	3									:		
												÷
										÷	:	÷

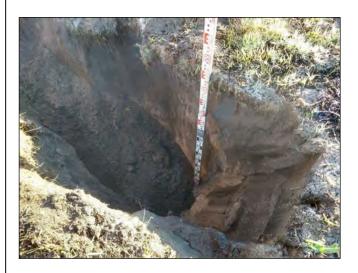
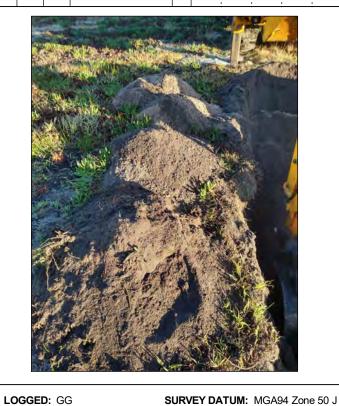
PIT No: 106 PROJECT No: 212040.00 DATE: 7/7/2022 SHEET 1 OF 1

Description	. <u>u</u>		Sam	pling &	& In Situ Testing	_	_			
Ъ	Depth (m)	of	Graphic Log	Type	Depth	Sample	Results & Comments	Water		nic Pene lows per		
	. ,	Strata	G	Τ	De	San	Comments	-	5	10	15	20
	0.15	TOPSOIL/SAND SP-SM: fine to medium grained, dark grey-brown, with silt, trace rootlets, moist, topsoil.	<u> N </u>	D	0.1				• •		•	•
52	- - - 0.5	SAND SP-SM: fine to medium grained, dark grey-brown, with silt, moist, medium dense. Bassendean Sand. - becoming dark grey from 0.35 m depth.		D	0.4			-		•	•	
	-	SAND SP: fine to medium grained, grey, trace silt, moist, medium dense. Bassendean Sand.						-		•		
	-1 - -	- becoming pale brown from 0.4 m depth.						-	-1 	•		
51	-										-	
	- 2 2.1								-2	•		
F	- 2.1	Pit discontinued at 2.1m (Collapsing conditions)										
20	-											
	-											
-	-											
-	-3								•			
ŀ	-											
-64	-								:	;	÷	;

WATER OBSERVATIONS: No free groundwater observed.

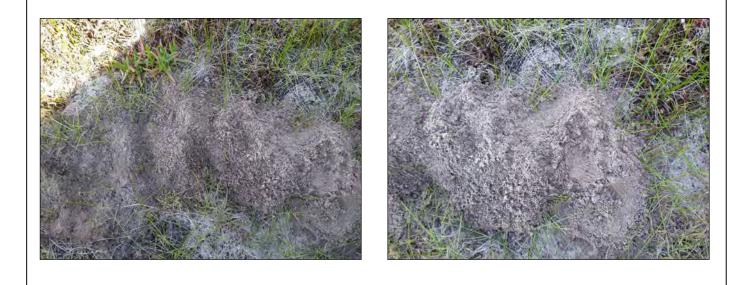
Description	ic _		Sam		& In Situ Testing	~	Dynamic Penetrometer Test		
RL	Depth (m)	of Strata	Graphic Log	Type	Depth	Sample	Results & Comments	Water	bynami (blc	ows per 1	150mm)
		TOPSOIL/SAND SP-SM: fine to medium grained,							L		
00	- 	 \moist, medium dense. SAND SP: fine to medium grained, grey, trace silt, moist, loose. Bassendean Sand. becoming pale brown from 0.6 m depth. becoming medium dense from 0.75 m depth. 			10						
49	-1 1.0 - - - - -	Bore discontinued at 1.0m (Target depth)	1	—D—	—1.0—						
	- -2 -										
48	- - -										
	-3

RIG: 110 mm diameter hand auger DRILLER: GG TYPE OF BORING: Hand auger

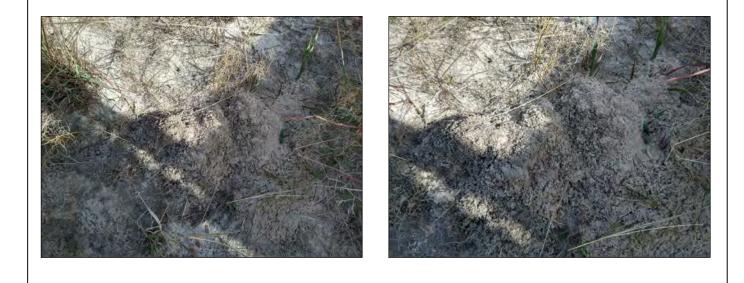
Description	Dic	Sampling & In Situ Testing			& In Situ Testing	5	Dynamic Penetrometer Test			
Ę	Depth (m)	of Strata	Graphic Log	Type	Depth	Sample	Results & Comments	Water	Dynam (bl	ows per	150mr	n) 20
-	0.05	brown, with silt, trace rootlets, moist.							- -		:	
		SAND SP: fine to medium grained, grey, trace silt, moist, loose. Bassendean Sand. - becoming pale grey from 0.3 m depth.										
	-1 1.0	Bore discontinued at 1.0m (Target depth)	· · · · ·	—D—	—1.0—				-1			
									•			
									• • • •		:	:
-	-2								•		:	
-	2											
									•			
-									•			
-											:	
	-3								•			
									:	÷	÷

RIG: 110 mm diameter hand auger DRILLER: GG TYPE OF BORING: Hand auger

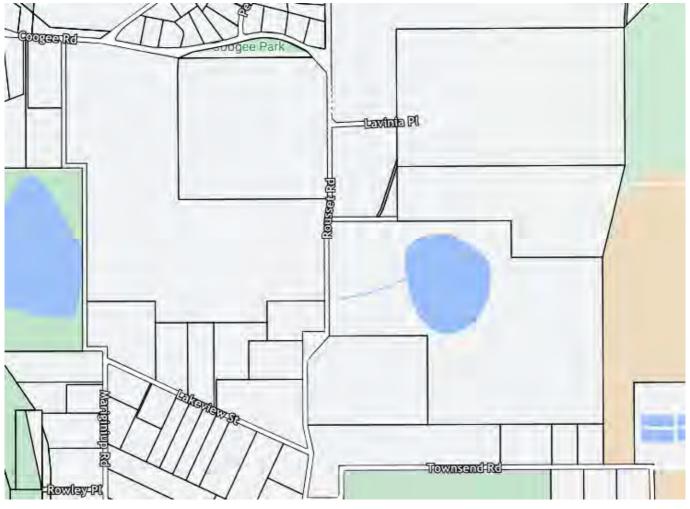
The Precinct 15 LSP area is identified by the red boundary presented below in Figure 1

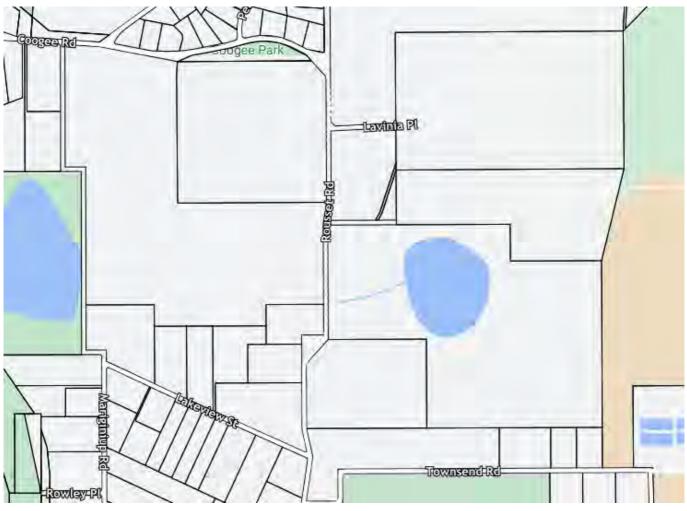
Figure 1 - Site Plan (MNG Maps 2022)

The Precinct 15 LSP is situated within the City of Wanneroo, approximately 45 kilometres north of the Perth city centre. The Site is bound by existing rural and rural-residential properties. The majority of the site has been cleared historically prior to 1965 for grazing purposes. There has been some regrowth across the site since this time. Vegetation types vary from shrubs and low lying bushes through to mature trees of significant height. *Figure 2* below refers.

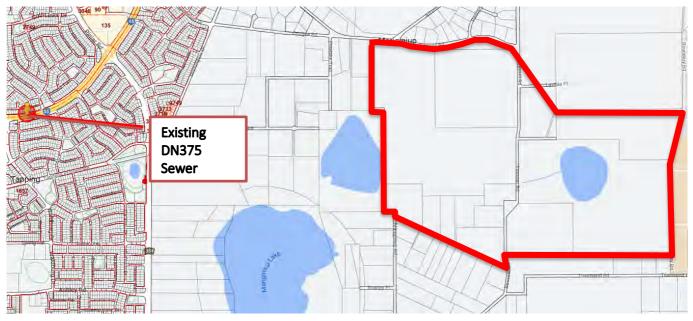
Figure 11 – Existing Sewerage Infrastructure (Water Corporation, 2023)

The Water Corporation has advised the existing wastewater network in proximity to the Site has a limited capacity available at a discharge point into the existing DN375 Neerabup Collector Sewer located on Joondalup Drive. The figure below shows the location of the discharge point relative to the Site.

It is understood that the capacity available in the existing network is in the order of 18L/s, possibly higher. This capacity would allow approximately 1300 lots to connect to the wastewater network.

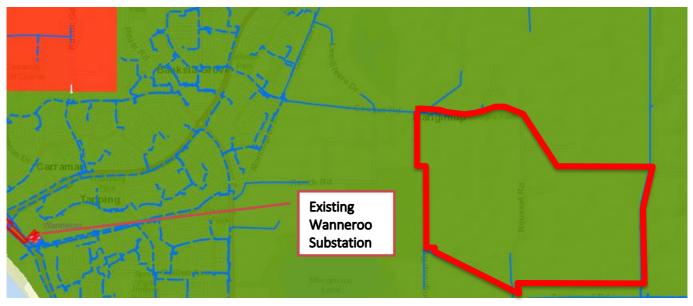
Figure 13 – Network Capacity and Existing Overhead Powerlines (Western Power)

There is an existing high voltage underground power cable in Coogee Road which extends power from the existing "Wanneroo Zone Substation" located at the intersection of Wanneroo Road and Clarkson Ave west of Precinct 15. There is 25 to 30MVA projected to be available from this sub-station, which will be sufficient to service future development of Precinct 15.

It is anticipated that the local network will be incrementally extended from the existing HV feeder located in Coogee Road into Precinct 15. A series of HV feeds, switch stations and transformers will be required throughout Precinct 15 to meet individual site requirements.

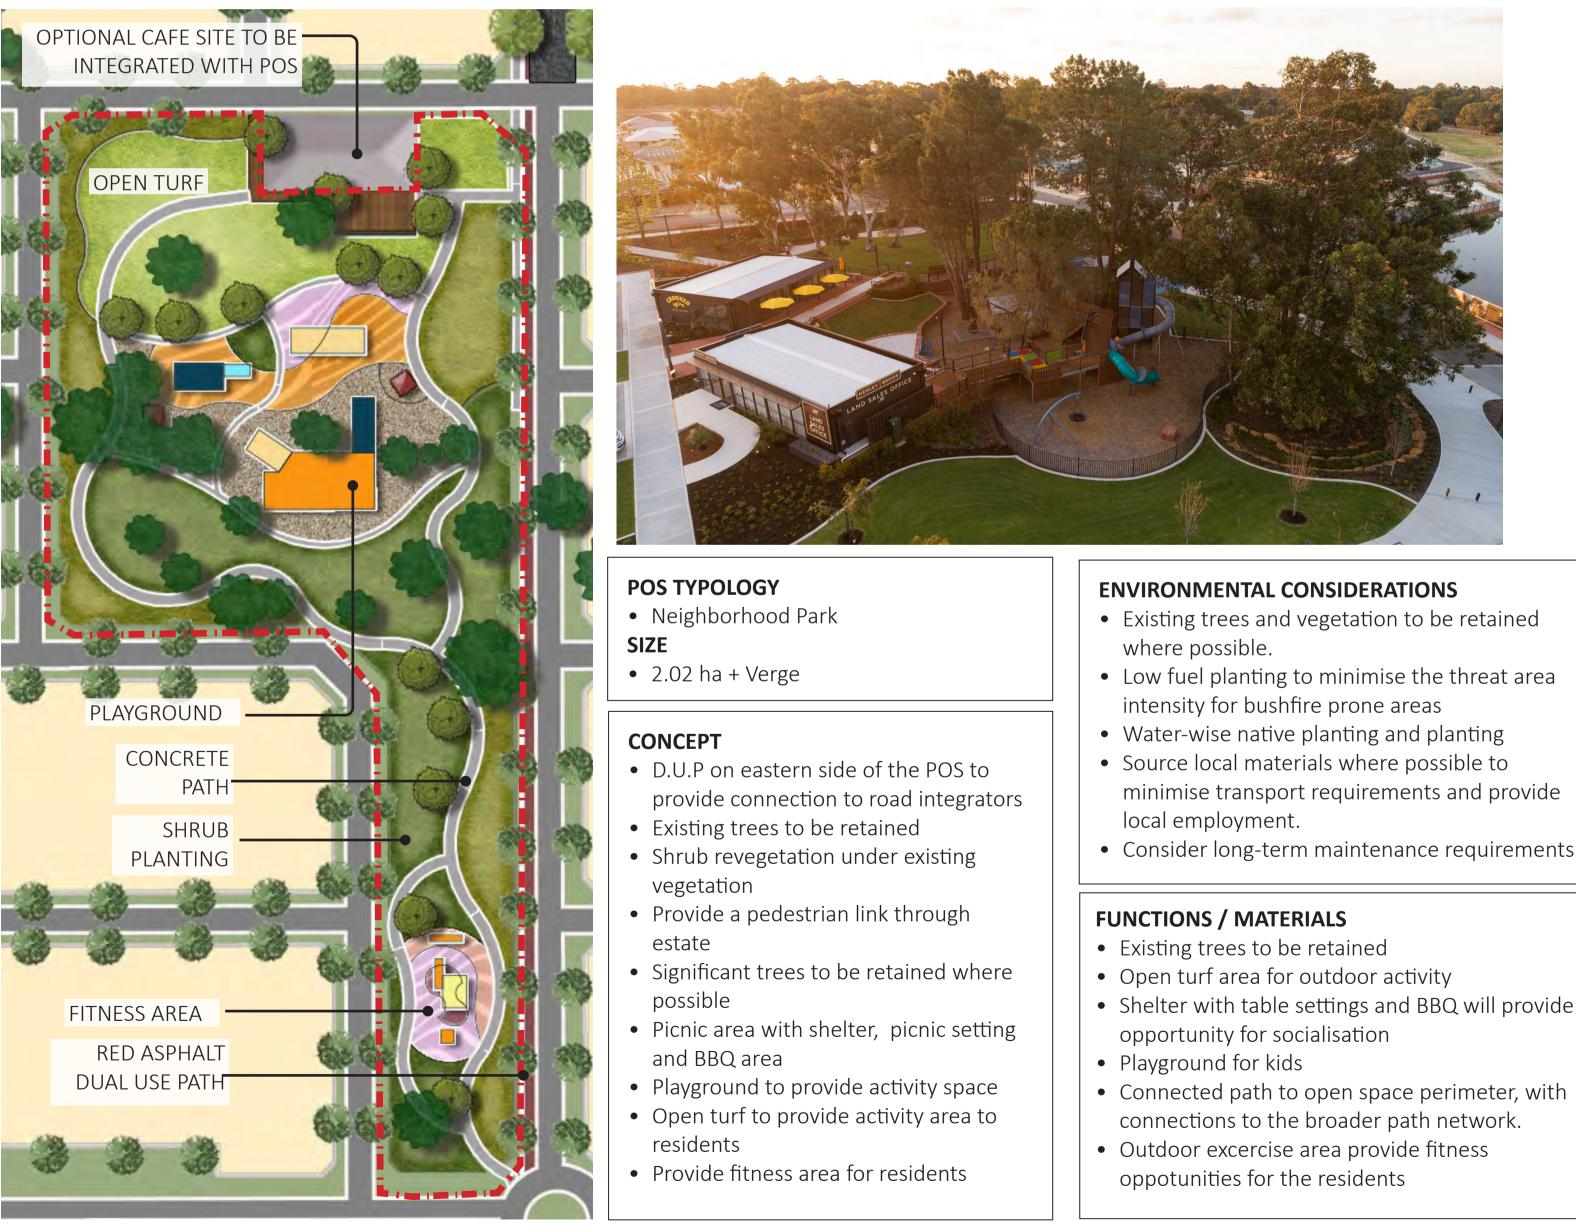
MARIGINIUP- Stockland LANDSCAPE DETAILED PLAN POS 1, 2 AND 3

DRAINAGE LEGEND - CATCHME	NT 1	ENVIRONMENTAL CONSIDERATIONS
FIRST 15mm BRA DETAILS Depth(m): Base Area(m ²) Top Area(mAHD): Slope	0.30 1600 1747 1:3	 Existing trees and vegetation to be retained where possible. Low fuel planting to minimise the threat area intensity for bushfire prone areas Water-wise native planting and planting Source local materials where possible to
 POS TYPOLOGY Neighborhood Park SIZE 1.43 ha + Verge 		 minimise transport requirements and provide local employment. Consider long-term maintenance requirements. Provide a buffer to the adjacent road
 D.U.P on northern side of the POS to provide connection to road integrators Existing trees to be retained Shrub revegetation under existing vegetation Provide a pedestrian link through estate Significant trees to be retained where possible Picnic area with shelter, picnic setting and BBQ area Playground to provide activity space Open turf to provide activity area to residents Provide entry signage 		 FUNCTIONS / MATERIALS Existing trees to be retained Open turf area for outdoor activity Shelter with table settings and BBQ will provide opportunity for socialisation Playground for kids Connected path to open space perimeter, with connections to the broader path network. Entry signage to convey directions and enhance the character of the estate

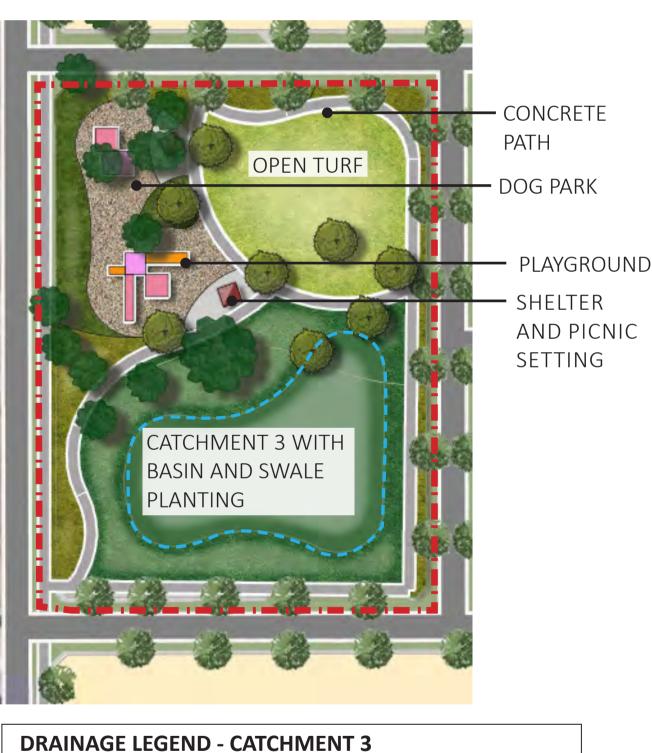
POS 3 CONCEPT

FIRST 15mm BRA DETAILS	
Depth(m):	0.30
Base Area(m ²)	2500
Top Area(mAHD):	2683
Slope	1:3

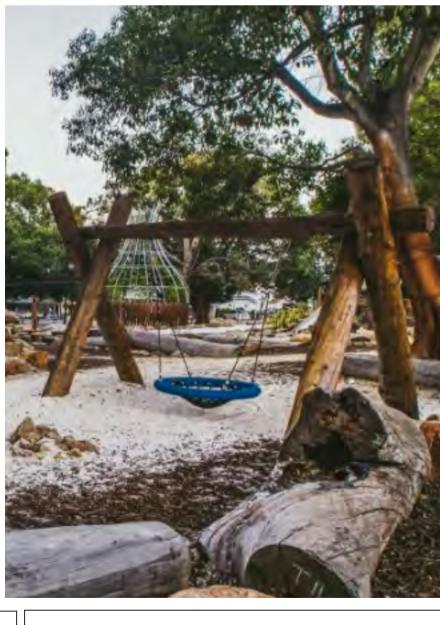
DRAINAGE LEGEND - CATCHMENT 8 FIRST 15mm BRA DETAILS Depth(m): Base Area(m²) Top Area(mAHD): Slope

POS TYPOLOGY Local Park SIZE • .660 ha + Verge

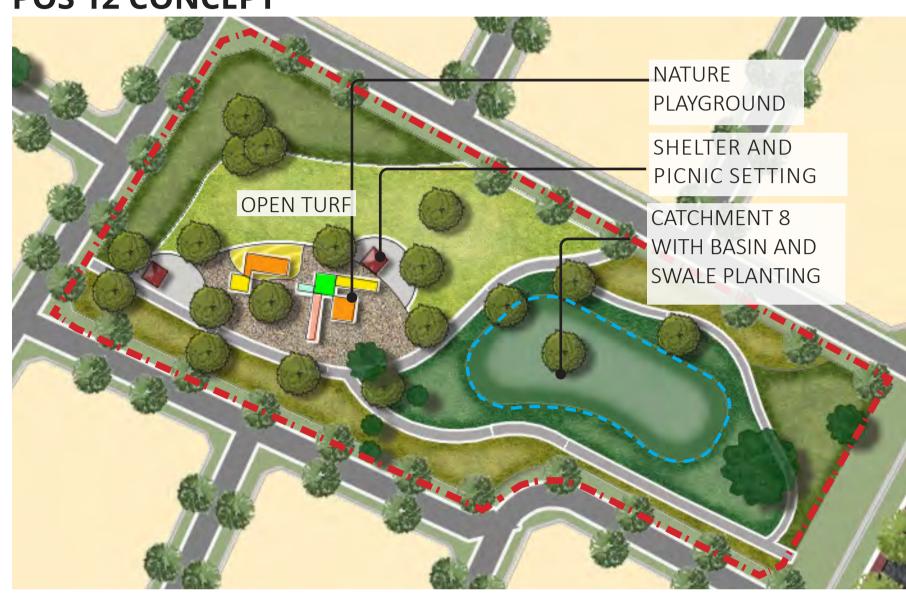
POS 12 CONCEPT

DRAINAGE LEGEND - CATCHMENT 12

FIRST 15mm BRA DETAILS	
Depth(m):	0.30
Base Area(m ²)	1521
Top Area(mAHD):	1665
Slope	1:3

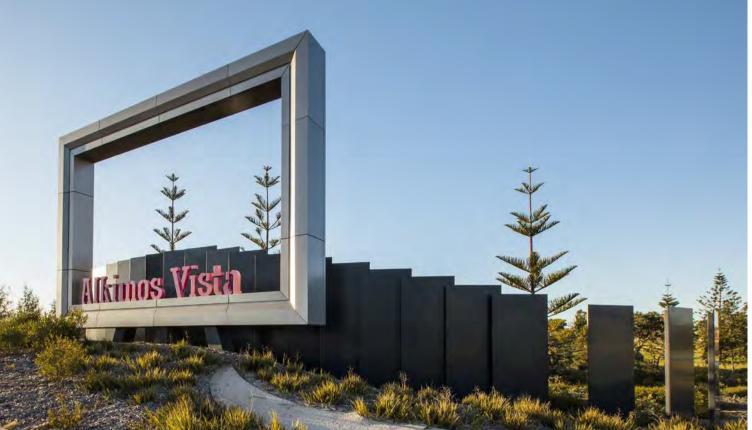
POS 13 CONCEPT

POS TYPOLOGY • Pocket Park SIZE • 1,488 m² + Verge

- Plantings to provide buffer to external road
- Provide a pedestrian link through estate and

• Provide a buffer to the adjacent road

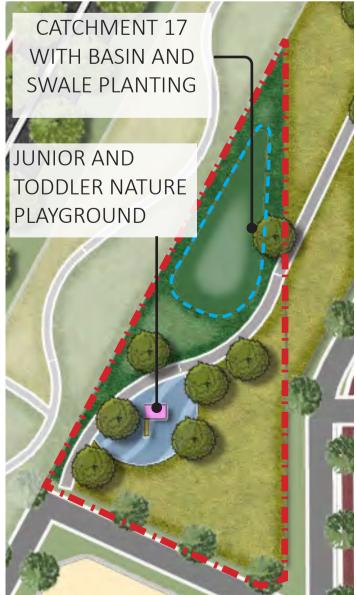
POS 17 CONCEPT

DRAINAGE LEGEND - CATCHMENT 17

FIRST 15mm BRA DETAILS	
Depth(m):	0.30
Base Area(m ²)	576
Top Area(mAHD):	666
Slope	1:3

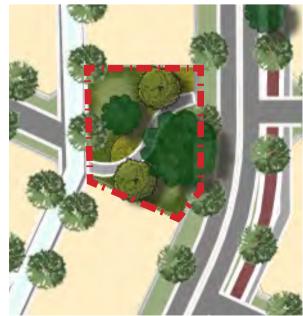
POS 18 CONCEPT

• Neighbourhood Park

- Open turf to provide activity area to residents
- Turf mounding to create a unique landscape topography • Drainage basin as per LWMS

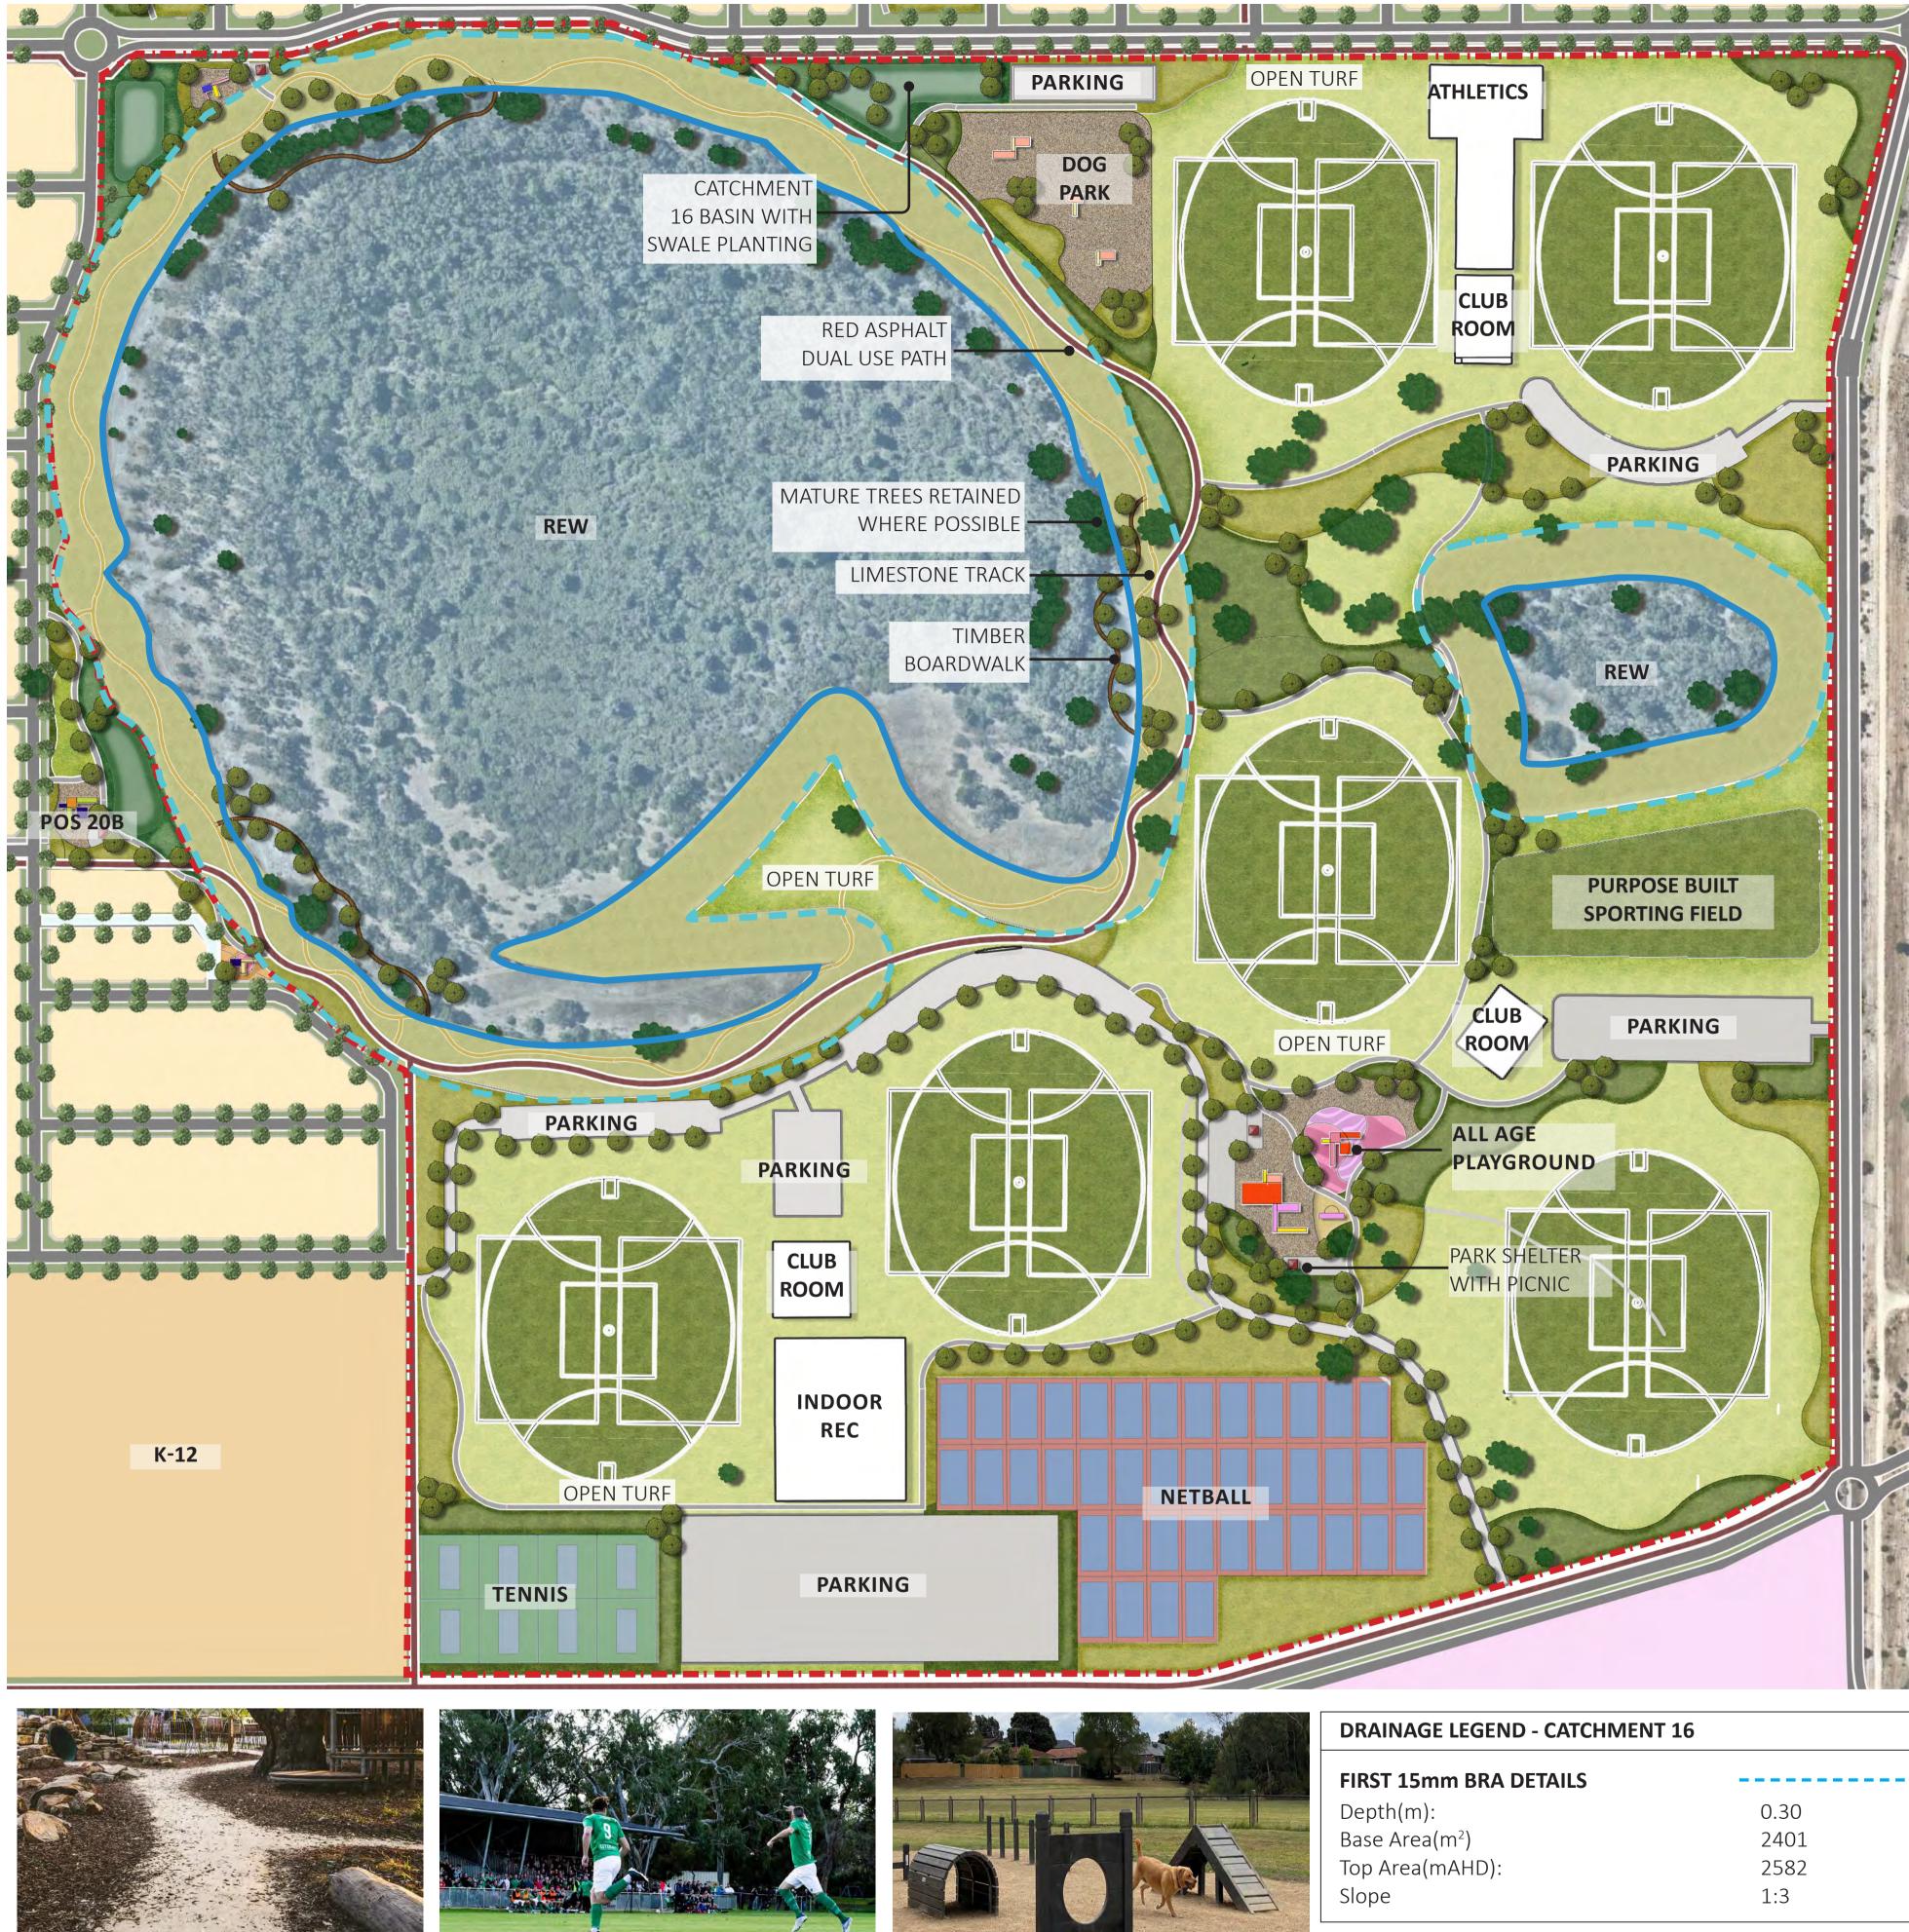
MARIGINIUP- Stockland LANDSCAPE DETAILED PLAN REGIONAL SPORTING COMPLEX

- Large area of existing vegetation to retained and protected for local flo fauna habitat
- Revegetation planting around REW buffers to enhance local flora and habitat. Palette aligns with spring s results
- Significant existing trees to be retain open space where possible
- Water-wise native planting.
- Consider long-term maintenance requirements.
- Source local materials where possi to minimise transport requirement provide local employment.
- Dirt and crushed limestone track/p in existing vegetation area instead

or 6xAFL and etland erimeter, oath		
estate,	LOCATIO	ON PLAN
/ space		LEGEND
pace provide	 FUNCTIONS / MATERIALS Significant existing trees 	
r to	to be retained	TURF
er to	 Playing field including 6x AFL Senior oval 	SHRUB PLANTING (AMENITY)
to	Open turf area for	LOW FUEL PLANTING
ws to	outdoor activityMounded turf to create	BASIN
/ide	good views	
nd	 Shelter with table settings and BBQ will 	LOT
&	provide opportunity for	DUAL USE PATH
d	socialisationAll-age playground for all	FOOTPATH
ded in	people	MULCH ONLY
gn	 Dog park for dog agility play opportunity for 	STREET TREES
	 residents Turf mounding to create 	EXISTING TREES
I S to be	unique landscape	PROPOSED TREES
ora and	topographyBoardwalk to provided	
N	good view above drainage	CRUSHED LIMESTONE PATH
fauna	basinLimestone path in shrub	BOARDWALK
survey	planting	REW
ained in	 Outdoor excercise area provide fitness 	REVEGETATION
	oppotunities for the	••• EXTENT OF WORK
