City of Wanneroo

Quinns Beach - Survey Review & Evaluation of Groyne
Field

Job J678/1, Letter Report 08151 Rev 0
Record of Document Revisions

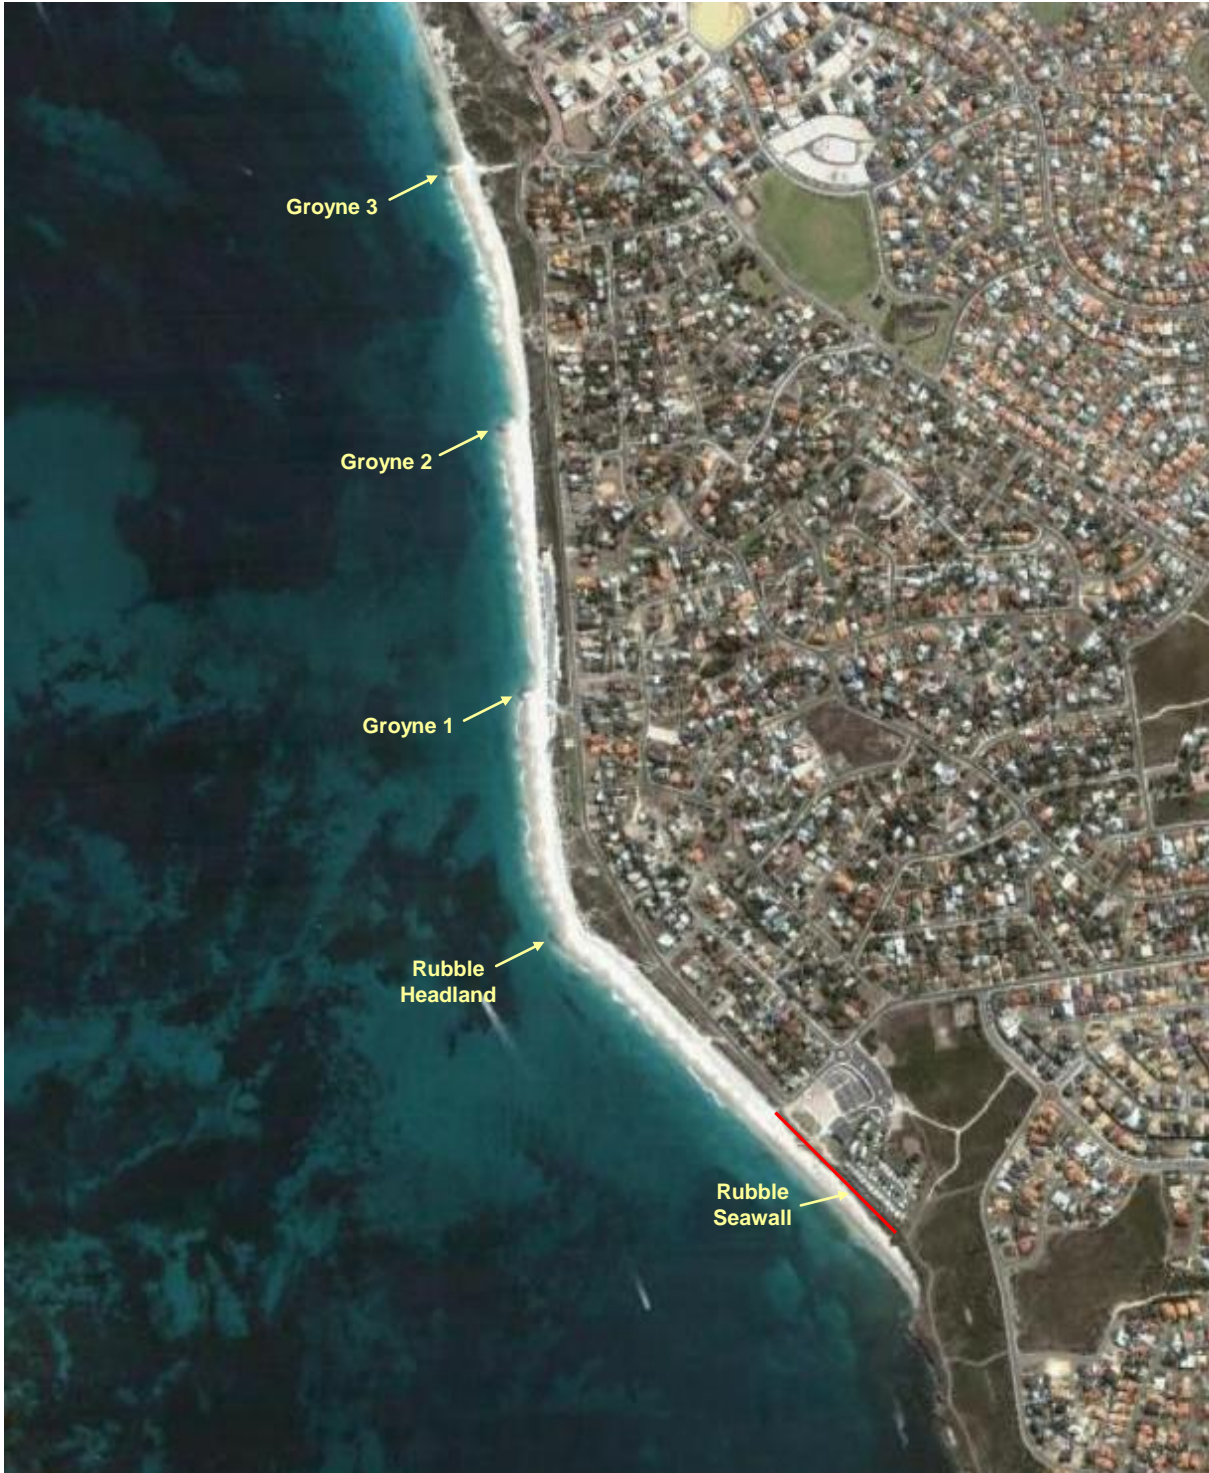
Figure 1.1 - Locations of Coastal Structures on Quinns Beach

More recently, between 1997 and 2002 sand nourishment and removal of public infrastructure in effected areas was used in an attempt to manage the problems associated with the erosion, however after significant erosion was experienced along sections of the beach in 2001 further works were undertaken. Three rubble groynes were constructed with extensive sand nourishment also completed in stages between 2002 and 2006. The location of these structures is shown in Figure 1.1.

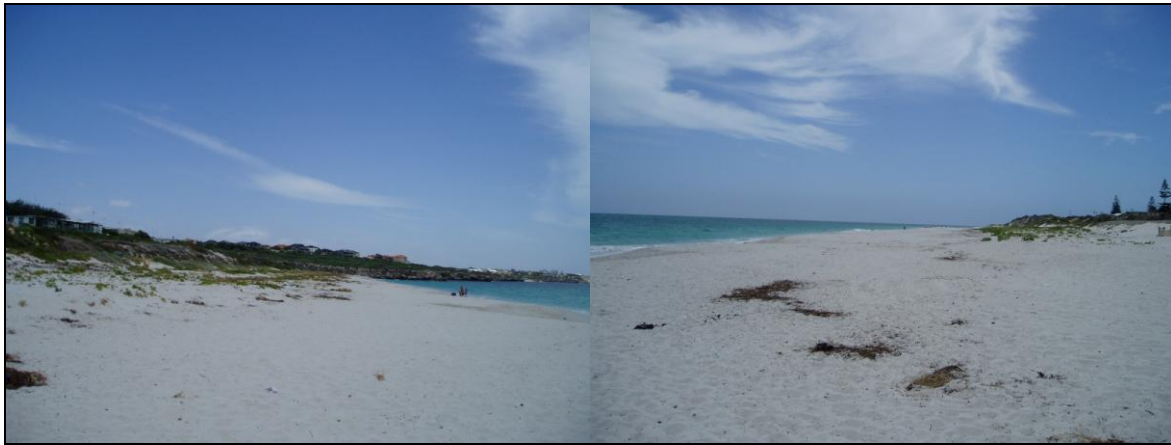
Figure 3.1 - Southern Beach

- The beach to the south of the headland appears to have experienced significant accretion. This is considered a good result as the relocation of the surf club to this beach along with the development of district beach facilities is likely to increase the demand for beach space in this area. The wider beach would help to accommodate this.

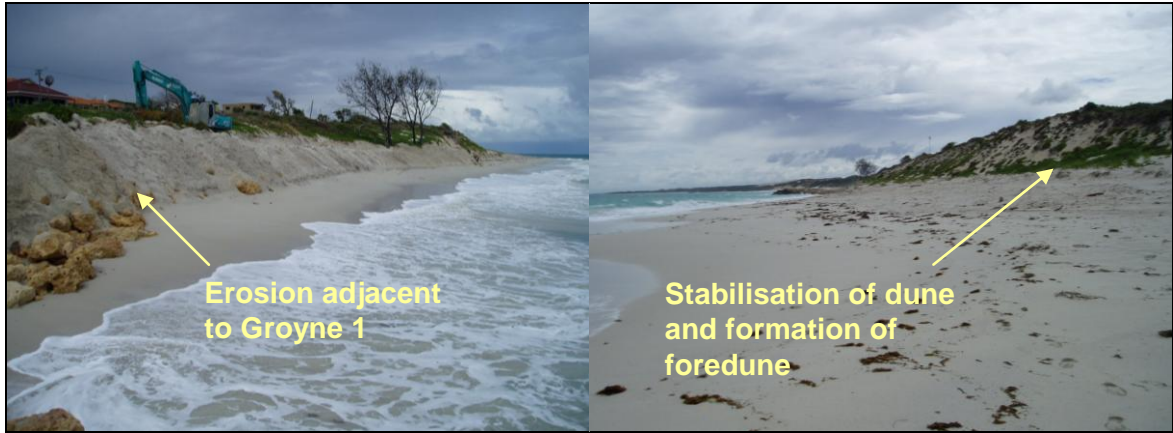
Figure 3.2 - Headland to Groyne 1

- The southern compartment (between the existing headland and groyne 1) appears to have experienced accretion in the longer term, particularly at the south of the compartment where a fore dune has established. However, the north of the compartment adjacent to groyne 1 did experience erosion during the 2007 winter period. This is believed to have been a result of the increased number of winter storms, which grossly increased the amount of southerly sand transport and therefore resulted in erosion on the southern side of groyne 1 since insufficient sand was bypassing from the north of the groyne. Furthermore, it should be noted that the occurrence of several higher water level events during 2007 lead to erosion higher up on the beach profile which has more of an impact visually.

Given that the only area that has not achieved the desired outcome as a result of this implementation of the scheme is immediately adjacent to groyne 1, it follows that a solution that deals with this area only would be ideal. One way to assist in solving this problem would be to retreat locally in this location. This could involve removing the car parking bays on one side of the car park. As car bays are typically in the order of 5 m in length, removing the car bays from one side of the car parking area would provide an additional 5 m buffer at relatively low cost. This increased buffer may allow space

for the formation of a small fore dune that would provide a greater buffer against the seasonal variations that occur.

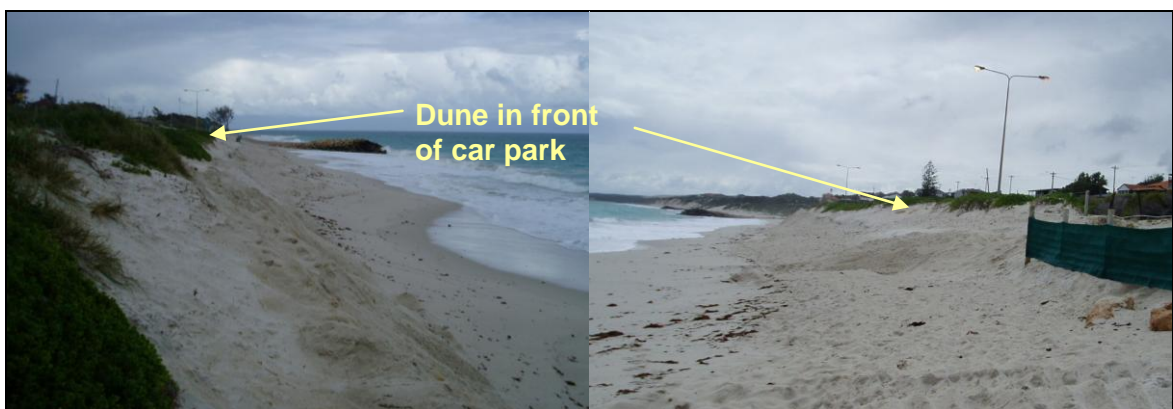
Figure 3.3 - Groyne 1 to Groyne 2

- The central compartment (between groynes 1 and 2) has not experienced the same recent accretion as the northern compartment as there is no fore dune present. However, over time a dune has formed along this compartment and now provides a buffer to help protect the car park. This buffer is believed to generally be in the order of around 5 m and is shown in the photographs below. Nevertheless, in the summer of 2007/2008 erosion was experienced immediately to the north of groyne 1. This is believed to have occurred as a result of the switch from the winter regime (where sand is transported to the south) to the summer regime (where sand is transported to the north). Given the abnormally high number of storms during the winter of 2007 that resulted in erosion to the south of Groyne 1, when the season switched back to the summer regime there was insufficient sand on the southern side of the groyne to feed around to the north. Consequently, the erosion occurred to the north of groyne 1 until such time as the sediment built up on the southern side of the groyne to such an extent that it began to bypass the head of the groyne.

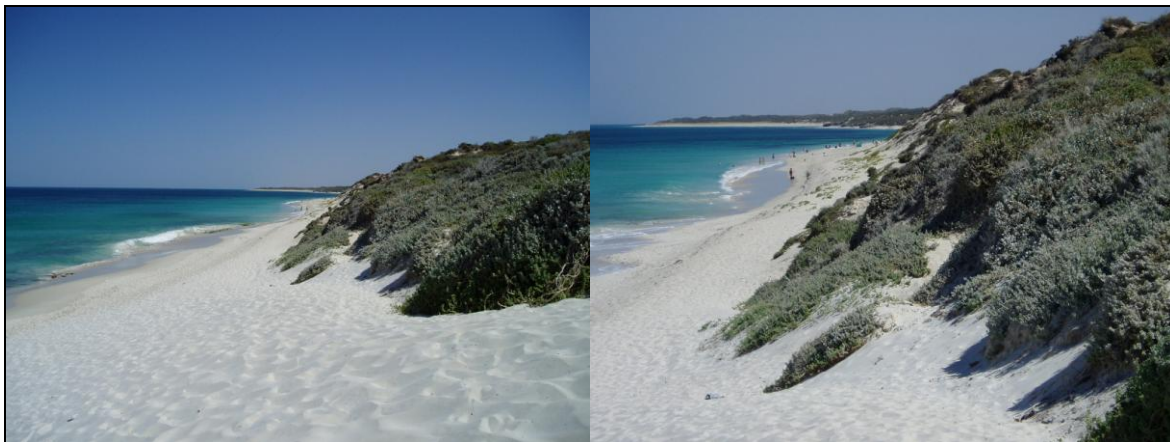
Figure 3.5 - North of Groyne 3

- The beach to the north of groyne 3 appears to have stabilised as there does not appear to be any recent signs of erosion of the dune face which is better than the predicted outcome. This beach was predicted to erode at about 1 m/year. The better than anticipated performance may have resulted from the magnitude of southerly sediment transport in recent years.
