Coastal Aquatic Risk Assessment

Two Rocks Review

September 2016

**Prepared For:
City of Wanneroo**

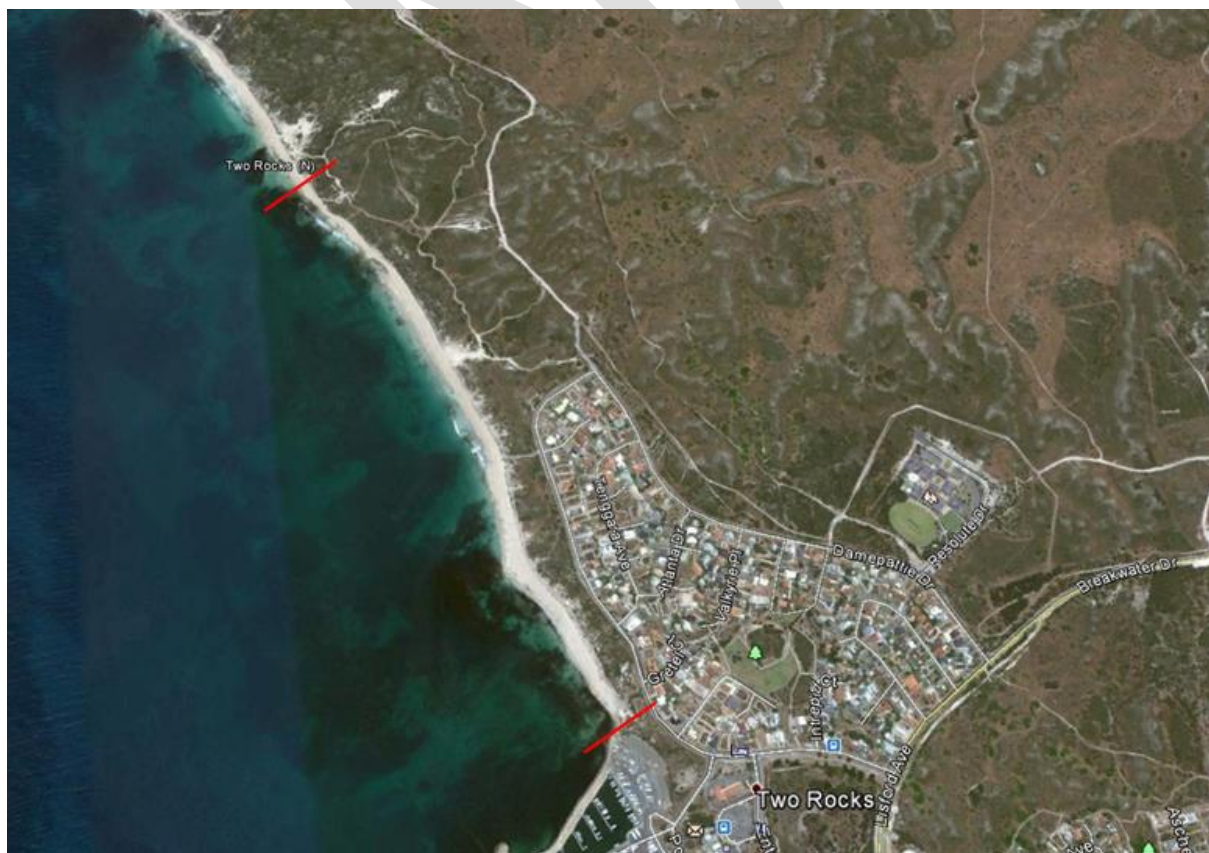
A 1.5km stretch of beach was assessed from the northern side of the breakwater north to a rocky outcrop (Figure 1). The southern corner of the beach has experienced erosion and is partly backed by a makeshift seawall to protect the backing dunes. The beach receives waves averaging just over 1m, which maintains a low tide terrace and at times, a transverse bar and rip system, with rips occurring along the length of the beach. Along the length of the beach there is a rock platform which extends from the beach out into the wave zone. The beach is backed 4-10m high foredunes with several small blowouts, then vegetated transgressive dunes that extend up to 5km inland. Several 4WD tracks reach the back of the beach.

Figure 1: Overview of study area with north and south limits marked in red. (Google Earth)

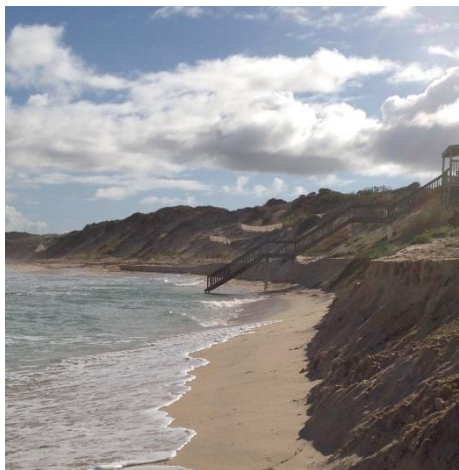
Stair access from Sovereign Drive in May 2014.

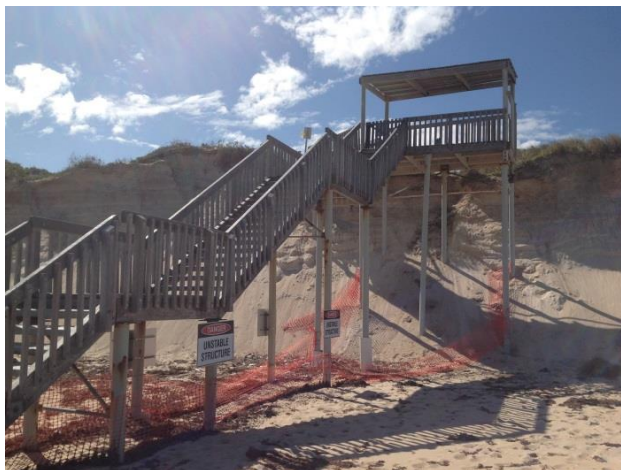
Stair access from Sovereign Drive in September 2016.

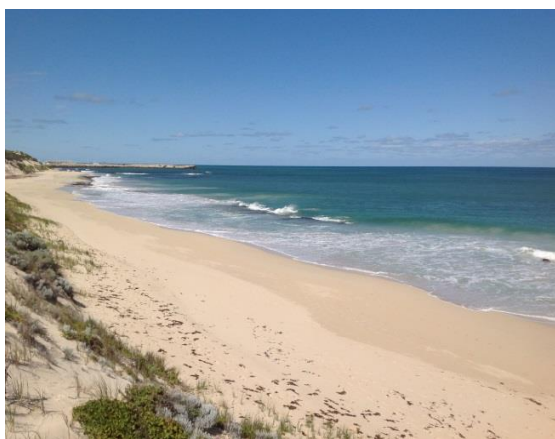
The 1.5km section of beach extending north from the Two Rocks Marina, inclusive of both the beach in front of the existing staircase and the beach in front of the proposed short term access track, is not ideal for swimming activities due to the presence of submerged rocks and reef platforms which occur consistently along the beach extending from the beach into the wave zone. These rock platforms can be exposed or submerged depending on tide, waves and weather conditions. They pose a hazard to recreation in the water with risk of head injuries and other minor injuries from slipping or being dumped on the rocks by waves. The beaches to the south of Two Rocks Marina (Wreck Point through to The Spot) are more suitable for swimming and other recreational activities. The section of beach north of the Marina is suitable for other recreational activities including beach walking/jogging, fishing and other beach based activities.

View south from the proposed new access showing consistent reef platforms along the beach.

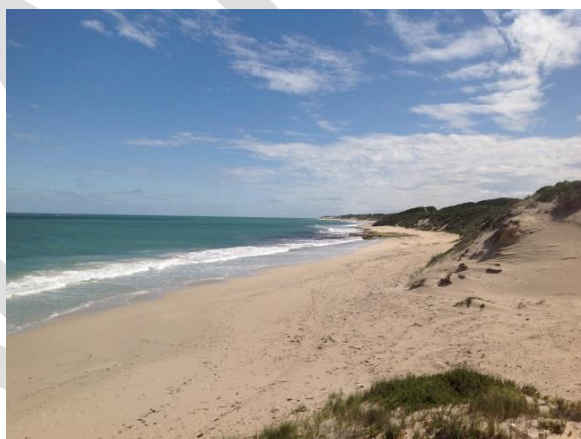
View north from the proposed new access showing reef platforms. Note that some rock platforms are submerged in the surf zone.

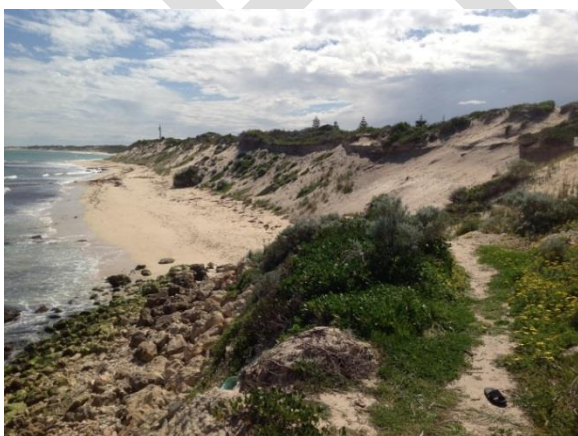
Informal beach access from the north side of Two Rocks Marina.

The City of Wanneroo should consider closing all informal access to the beach.

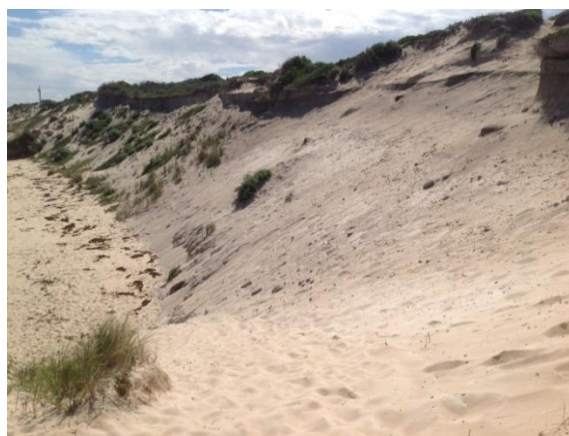
Steep beach access via dunes on the north side of Two Rocks Marina.

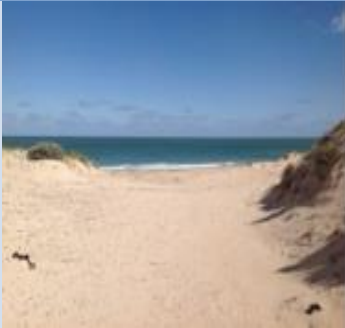
Proposed new access	-31.484561, 115.580231	Gated access	Install Open Access Sign Formalise Access (fences)	Informal Access	Uneven surfaces snakes
2 (8351)

The City of Wanneroo should formalise the access track at the northern end of Sovereign Drive and install appropriate signage at either end of the track.

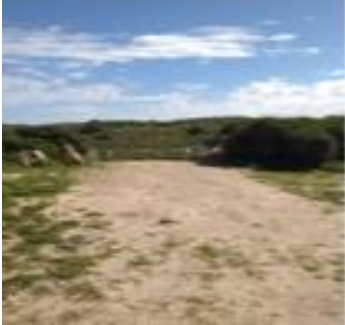
Proposed new access	-31.485899, 115.581988	Gated access	Install Open Access Sign Formalise Access (fences)	Gated access	Uneven surfaces Snakes
3 (8349)

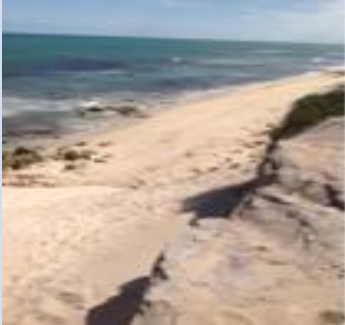
Informal access	-31.492616, 115.582975	Defined Access Sign	Fence off access	Informal Access	Dune erosion Steep access Uneven surfaces Snakes Drop off

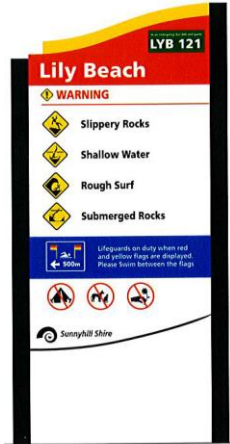
Table H6

</div>	<div>Location Identification:</div> <table><tr><td>Beach Name:</td><td>North Two Rocks</td></tr><tr><td>Site Reference:</td><td>Sovereign Drive. In case of emergency dial '000'</td></tr><tr><td>Sign Type:</td><td>Level 3 - Open Access Sign</td></tr><tr><td>GPS Location:</td><td>31°29'9.90"S 115°34'55.76"E</td></tr><tr><td>Location Description and Siting:</td><td>Install sign on the right hand side of the access track from the northern end of Sovereign Drive.</td></tr></table>	Beach Name:	North Two Rocks	Site Reference:	Sovereign Drive. In case of emergency dial '000'	Sign Type:	Level 3 - Open Access Sign	GPS Location:	31°29'9.90"S 115°34'55.76"E	Location Description and Siting:	Install sign on the right hand side of the access track from the northern end of Sovereign Drive.								
Beach Name:	North Two Rocks																		
Site Reference:	Sovereign Drive. In case of emergency dial '000'

Sign Type:	Level 3 - Open Access Sign																		
GPS Location:	31°29'9.90"S 115°34'55.76"E																		
Location Description and Siting:	Install sign on the right hand side of the access track from the northern end of Sovereign Drive.																		
<div>Hazards and Warnings:</div> <table><tr><td> </td><td> </td><td> </td><td> </td><td> </td><td> </td></tr><tr><td>No Lifesaving Service</td><td>Dangerous Current</td><td>Submerged Rocks</td><td>Dumping Waves</td><td>Snakes</td><td>Uneven Ground</td></tr><tr><td>NARSSM WS,15</td><td>NARSSM WS,29</td><td>NARSSM WS,35</td><td>NARSSM WS,41</td><td>NARSSM WS,10</td><td>NARSSM WS,7</td></tr></table>		 	 	 	 	 	 	No Lifesaving Service	Dangerous Current	Submerged Rocks	Dumping Waves	Snakes	Uneven Ground	NARSSM WS,15	NARSSM WS,29	NARSSM WS,35	NARSSM WS,41	NARSSM WS,10	NARSSM WS,7

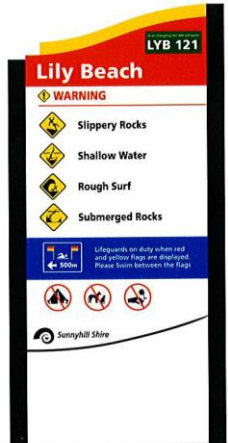
Table H7

Location Identification:	
	Beach Name:	North Two Rocks
	Site Reference:	Sovereign Drive. In case of emergency dial '000'
	Sign Type:	Level 3 - Open Access Sign
	GPS Location:	31°29'4.76"S 115°34'48.96"E
	Location Description and Siting:	Install sign at the bottom of the access track on the left hand side where it can be easily seen.
