Appendix 1
Subdivision approval (WAPC 155520)

CLIENT	ACUMEN DEVELOPMENT SOLUTIONS		
PROJECT	KARST RISK DESK STUDY		
LOCATION	CAPRICORN FORESHORE, YANCHEP		
TITLE	SITE & LOCATION PLAN		
Job No	J1601249	Fig No	FIGURE 1
Rev	A

Appendix 7
Coastal Risk Assessment and
Recommendations: Capricorn Yanciep
Development

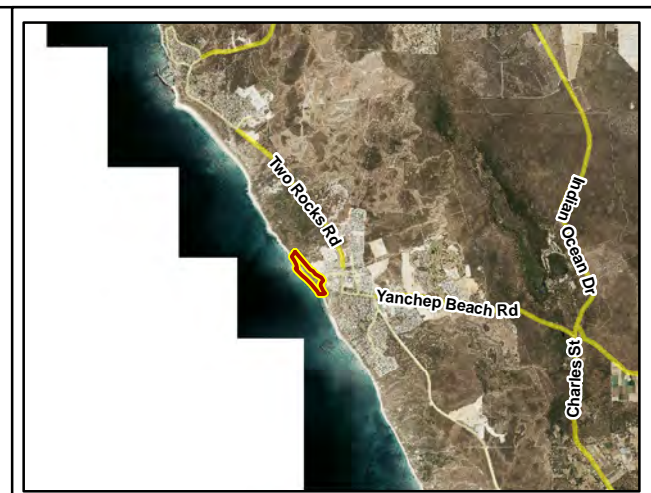
CLIENT	ACUMEN DEVELOPMENT SOLUTIONS		
PROJECT	KARST RISK DESK STUDY		
LOCATION	CAPRICORN FORESHORE, YANCHEP		
TITLE	KARST RISK		
Job No	J1601249	Fig No	FIGURE 3
		Rev	A

The City of Wanneroo Karstic Features Risk Zones map (Local Planning Policy 4.13: Caves and Karstic Features) shows the site to be in a “low karst risk” area. This is presented in Figure 3, Karst Risk Map.

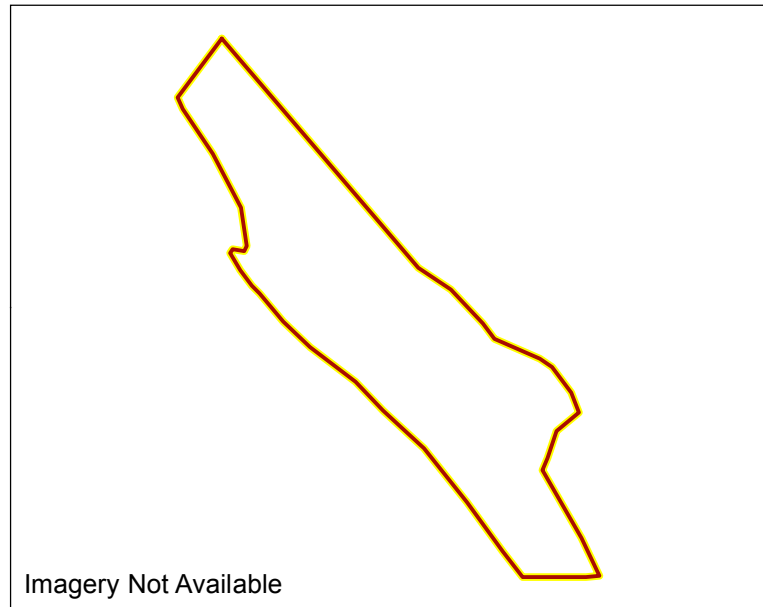
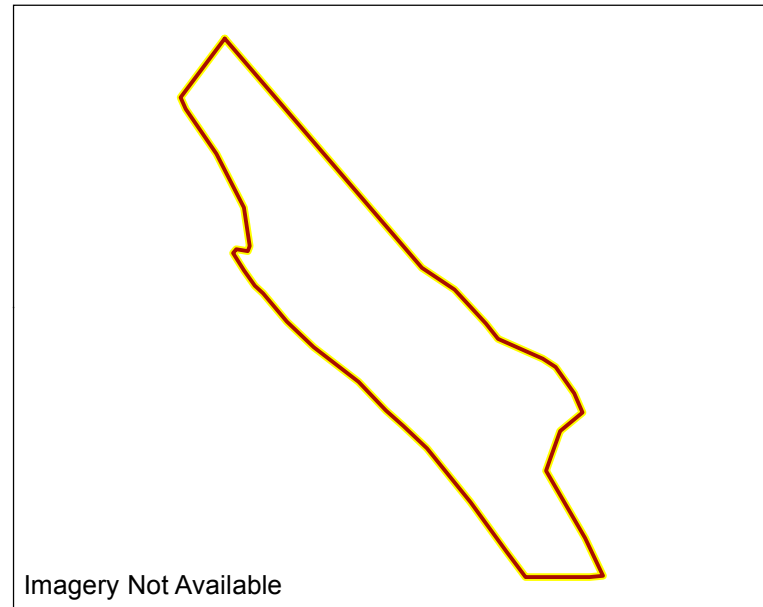
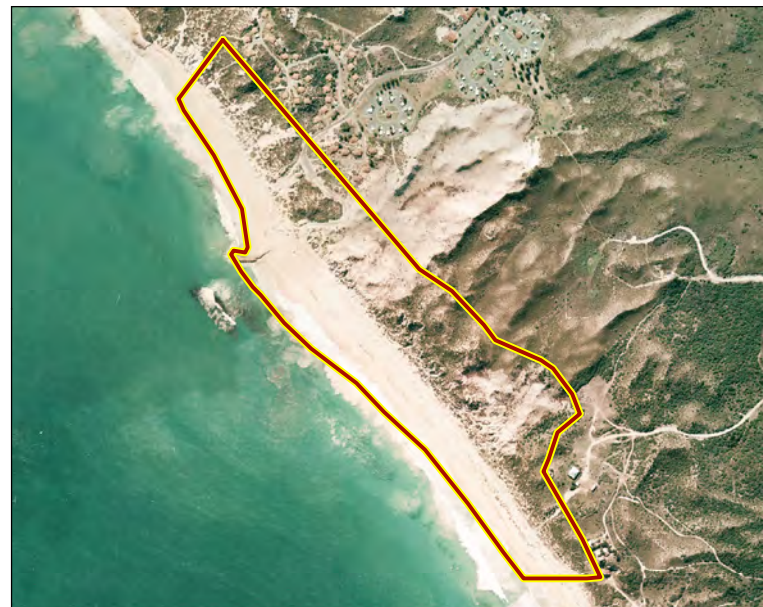
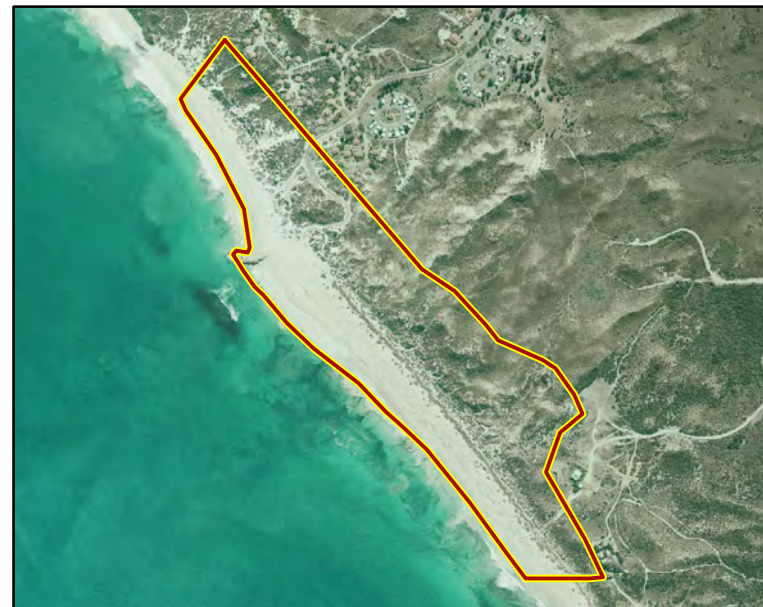
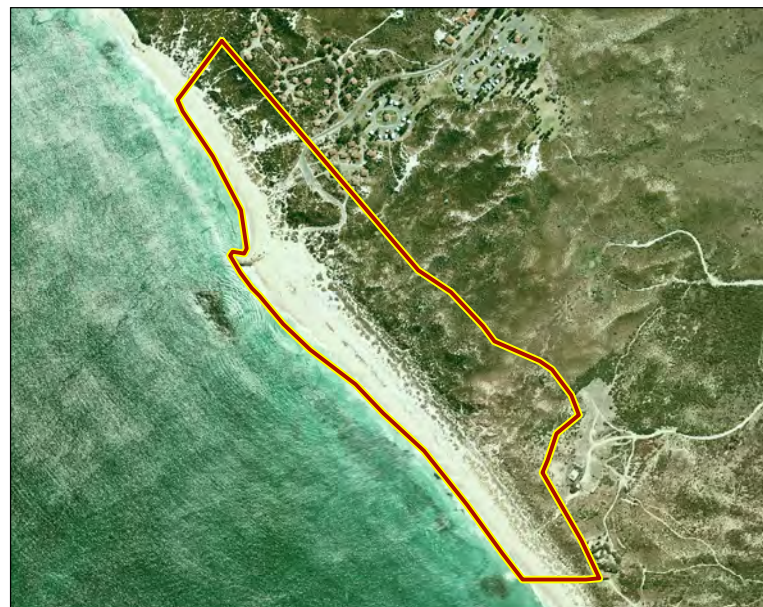
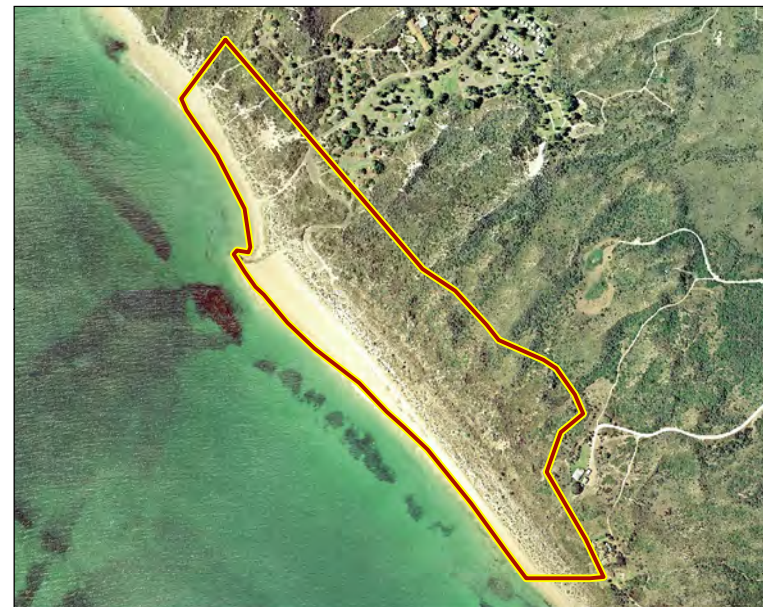
CLIENT	ACUMEN DEVELOPMENT SOLUTIONS		
PROJECT	KARST RISK DESK STUDY		
LOCATION	CAPRICORN FORESHORE, YANCHEP		
TITLE	HISTORICAL AERIAL IMAGERY (1953 - 2000)		
Job No	J1601249	Fig No	FIGURE 4A
Rev	A

Historical aerial photographs show that the site has remained relatively unchanged since at least 1963. Minor erosion and accretion of the shoreline is noted however, no development of the site appears to have occurred in this time. Historical aerial photographs are shown on Figures 4A-4D.

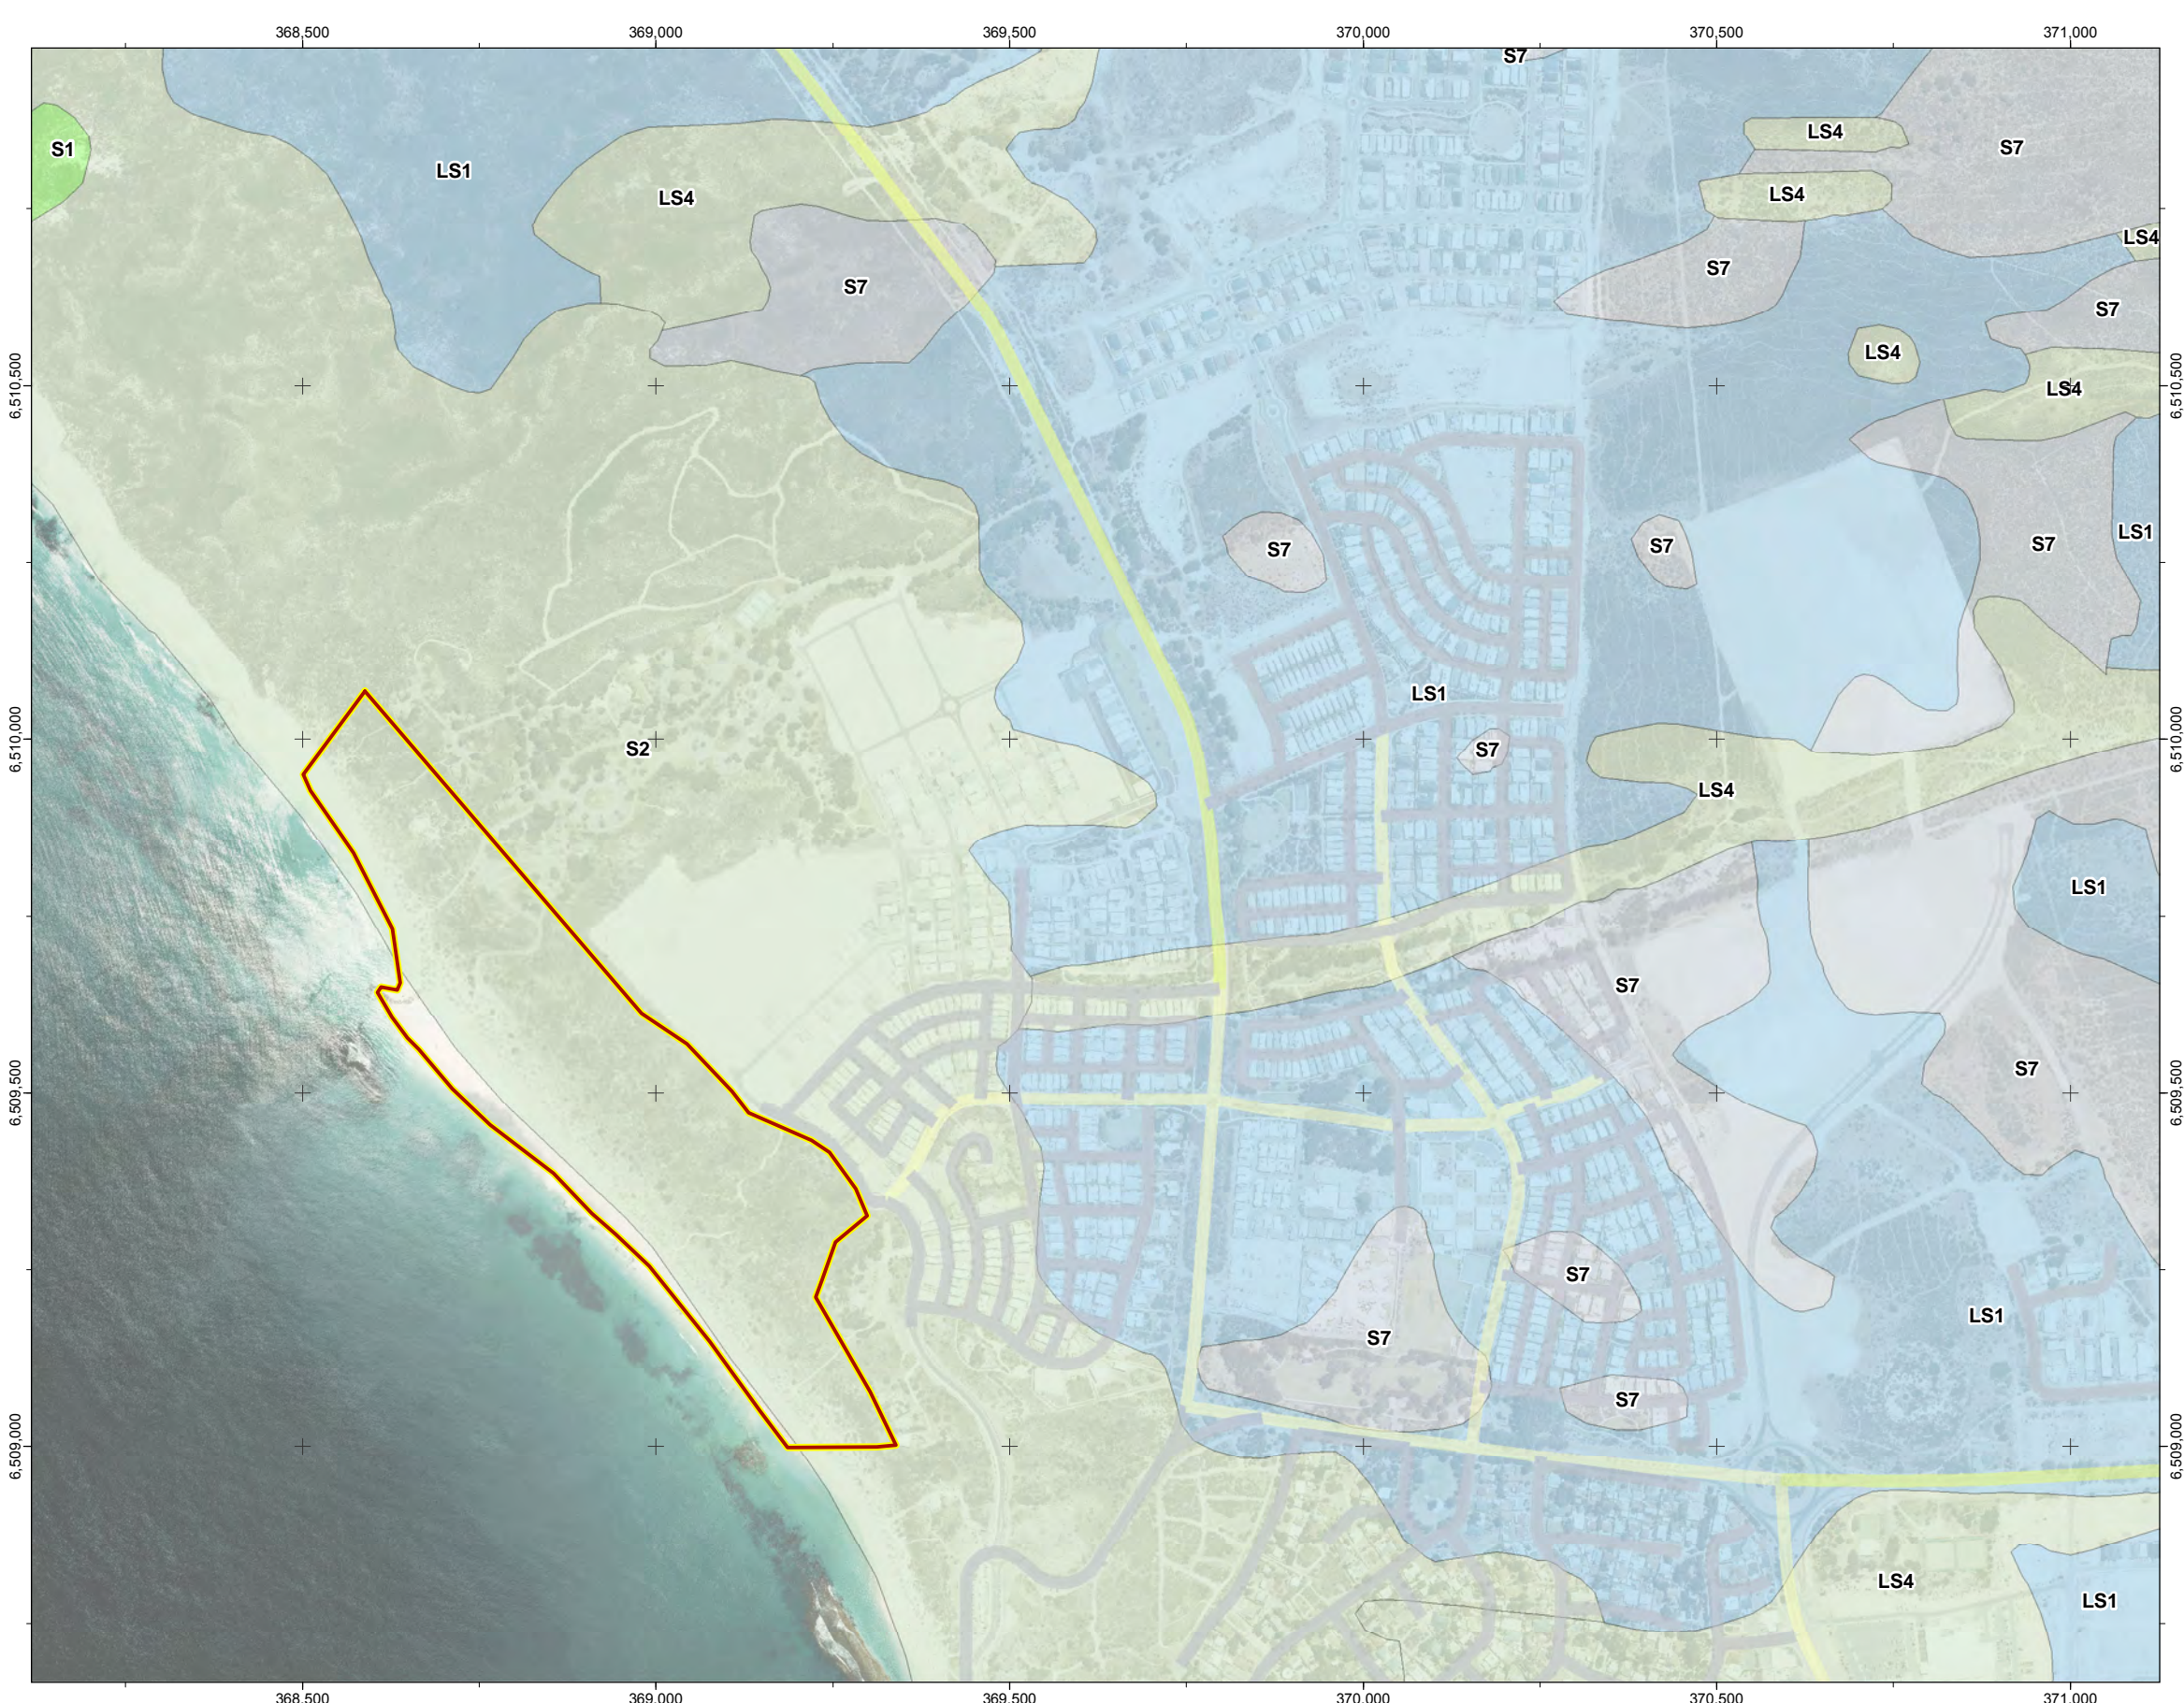
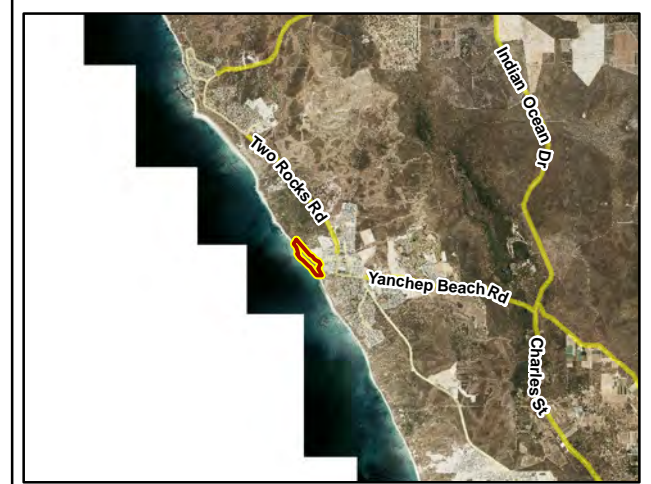
CLIENT	ACUMEN DEVELOPMENT SOLUTIONS		
PROJECT	KARST RISK DESK STUDY		
LOCATION	CAPRICORN FORESHORE, YANCHEP		
TITLE	INDICATIVE GEOTECHNICAL ASPECTS		
Job No	J1601249	Fig No	FIGURE 5
		Rev	A

- LS1 ; LIMESTONE - light yellowish brown, fine to coarse-grained, sub-angular to well rounded, quartz, trace of feldspar, shell debris, variably lithified, surface kankar, of eolian
- LS4 ; LIMESTONE - pale yellowish brown weakly cemented, friable, medium-grained, sub-rounded, quartz and shell debris, of eolian
- S1 ; CALCAREOUS SAND - white, fine to medium-grained, sub-rounded quartz and shell debris, of eolian origin
- S2 ; CALCAREOUS SAND - white, fine to medium-grained, sub-rounded quartz and shell debris, of eolian origin
- S7 ; SAND - pale and olive yellow, medium to coarse-grained, sub-angular quartz with a trace of feldspar, moderately sorted, of residual

8. GEOTECHNICAL DESK STUDY (FIGURE 5)

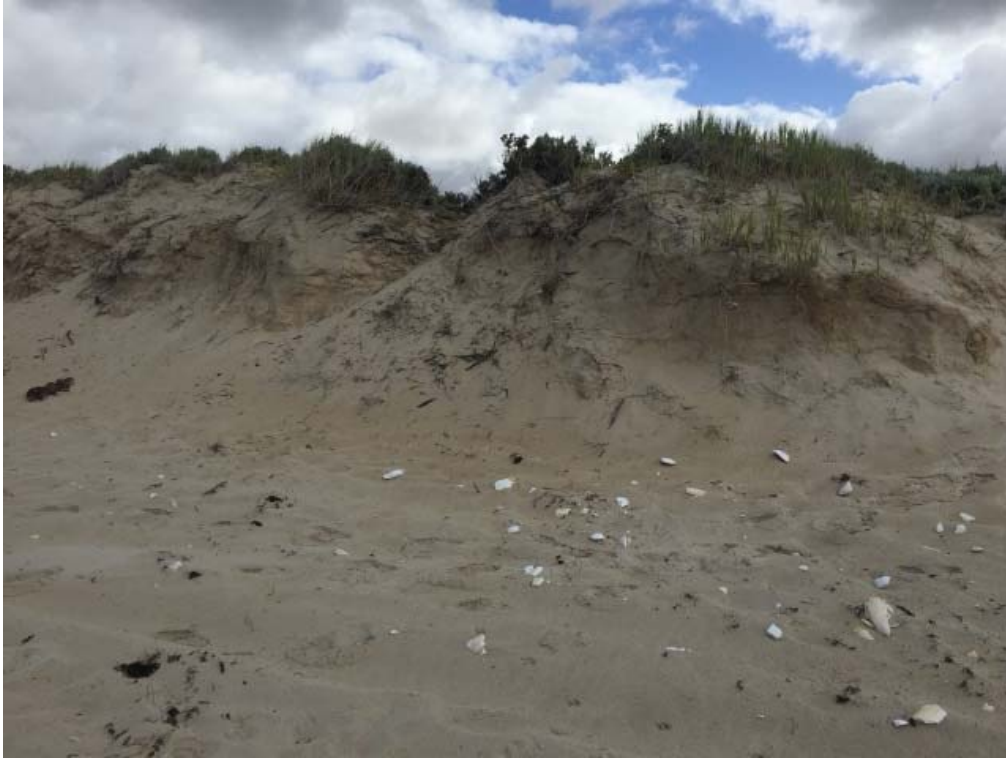
Photograph 11: Erosion at the southern part of the foreshore site

Erosion of the shoreline was noted during the site visit, particularly at the southern end of the foreshore site.

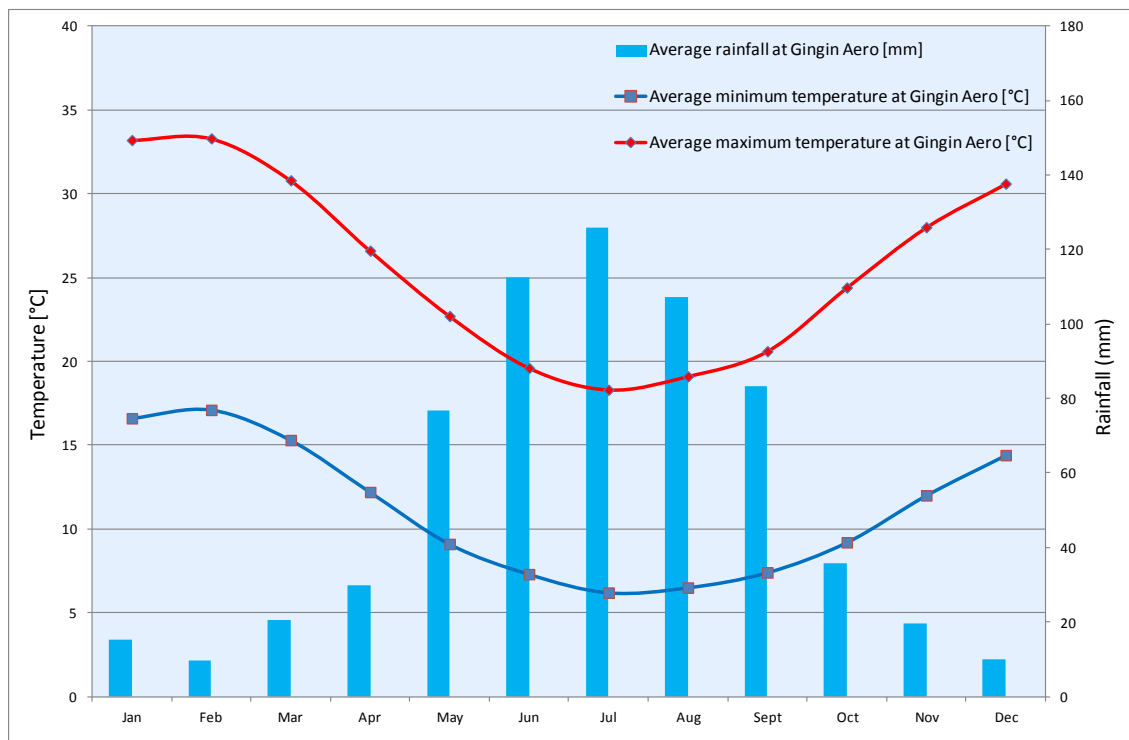
Figure 2: Mean monthly climatic data (temperature and rainfall) for Gingin Aero

The Yanchep locality experiences a Mediterranean climate characterised by mild, wet winters and warm to hot, dry summers. The nearest Bureau of Meteorology (BoM) weather station at Gingin Aero (Station No. 009178) provides average monthly climate statistics for the Yanchep locality (Figure 2). Average annual rainfall recorded at Gingin Aero since 1996 is 620.2 mm (BoM 2017). Rainfall may occur at any time of year; however, most occurs in winter in association with cold fronts from the southwest. Highest temperatures occur between December and February, with average monthly maximums ranging from 30.6°C in December to 33.3°C in February (BoM 2017). Lowest temperatures occur between June and September, with average monthly minimums ranging from 6.2°C in July to 7.4°C in September (BoM 2017).

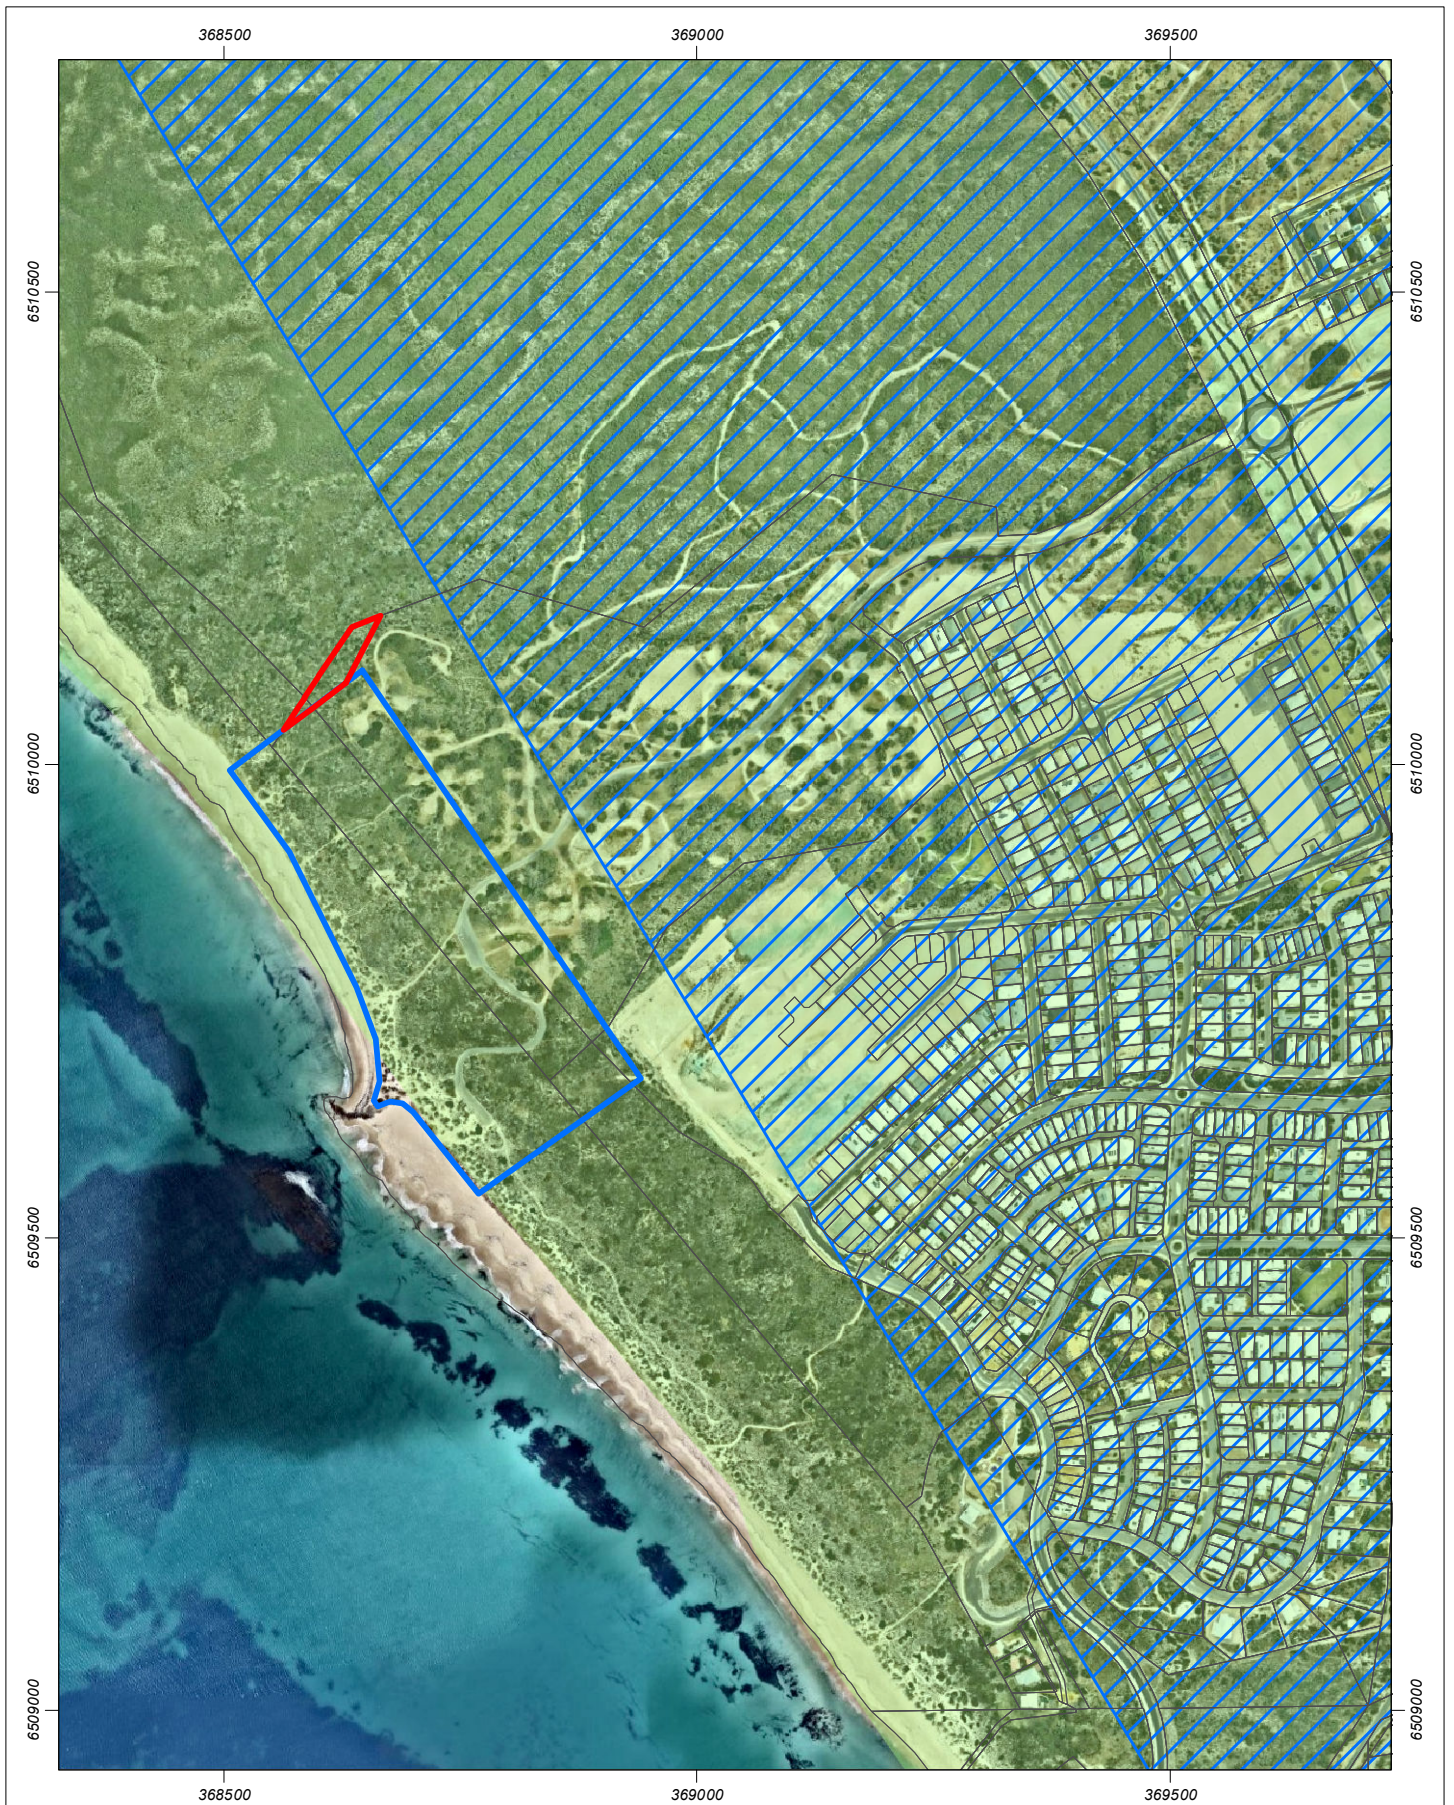
Scale 1:8,000 at A4

System 6 mapping refers to vegetation mapping undertaken at a Vegetation Complex scale by Heddle *et al.* (1980). This is the primary source of information used to calculate potential impacts of proposals to clear native vegetation on the Swan Coastal Plain. The survey area occurs within the Quindalup Complex (Figure 3) which is described as:

Figure 3: Regional vegetation mapping

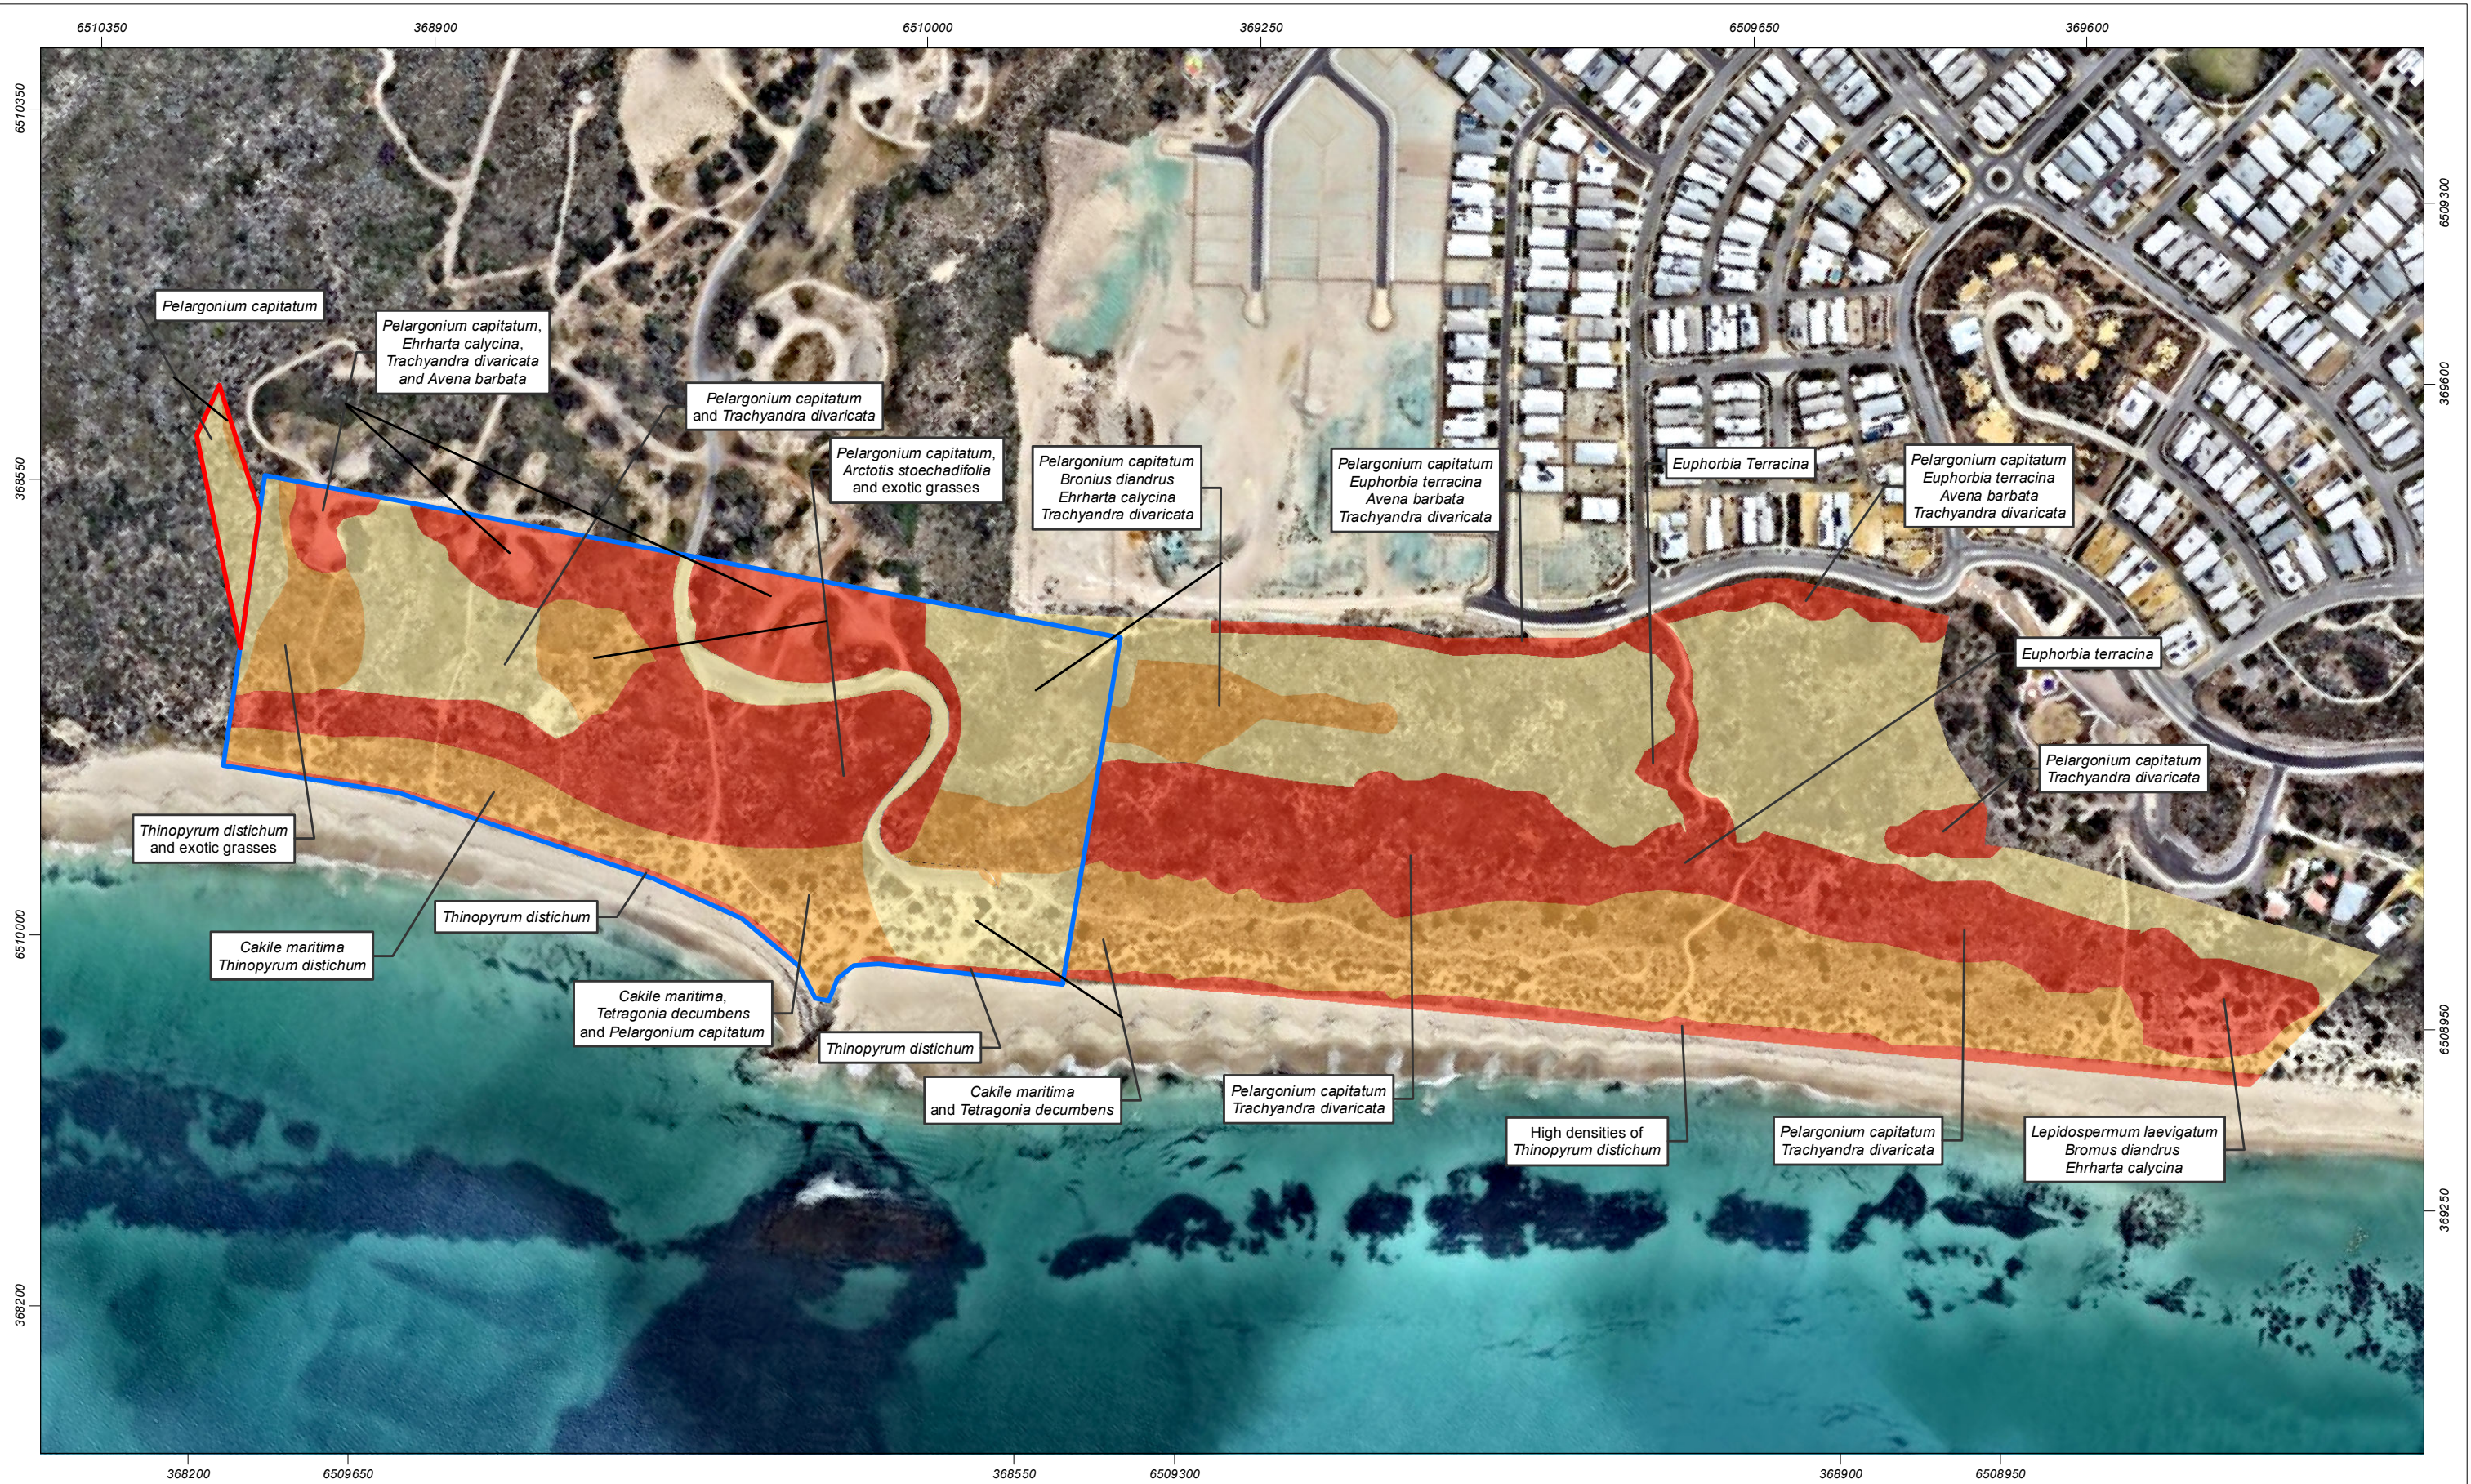
Figure 5: High level weed mapping

Weed density within the survey area was mapped and is presented in Figure 5.

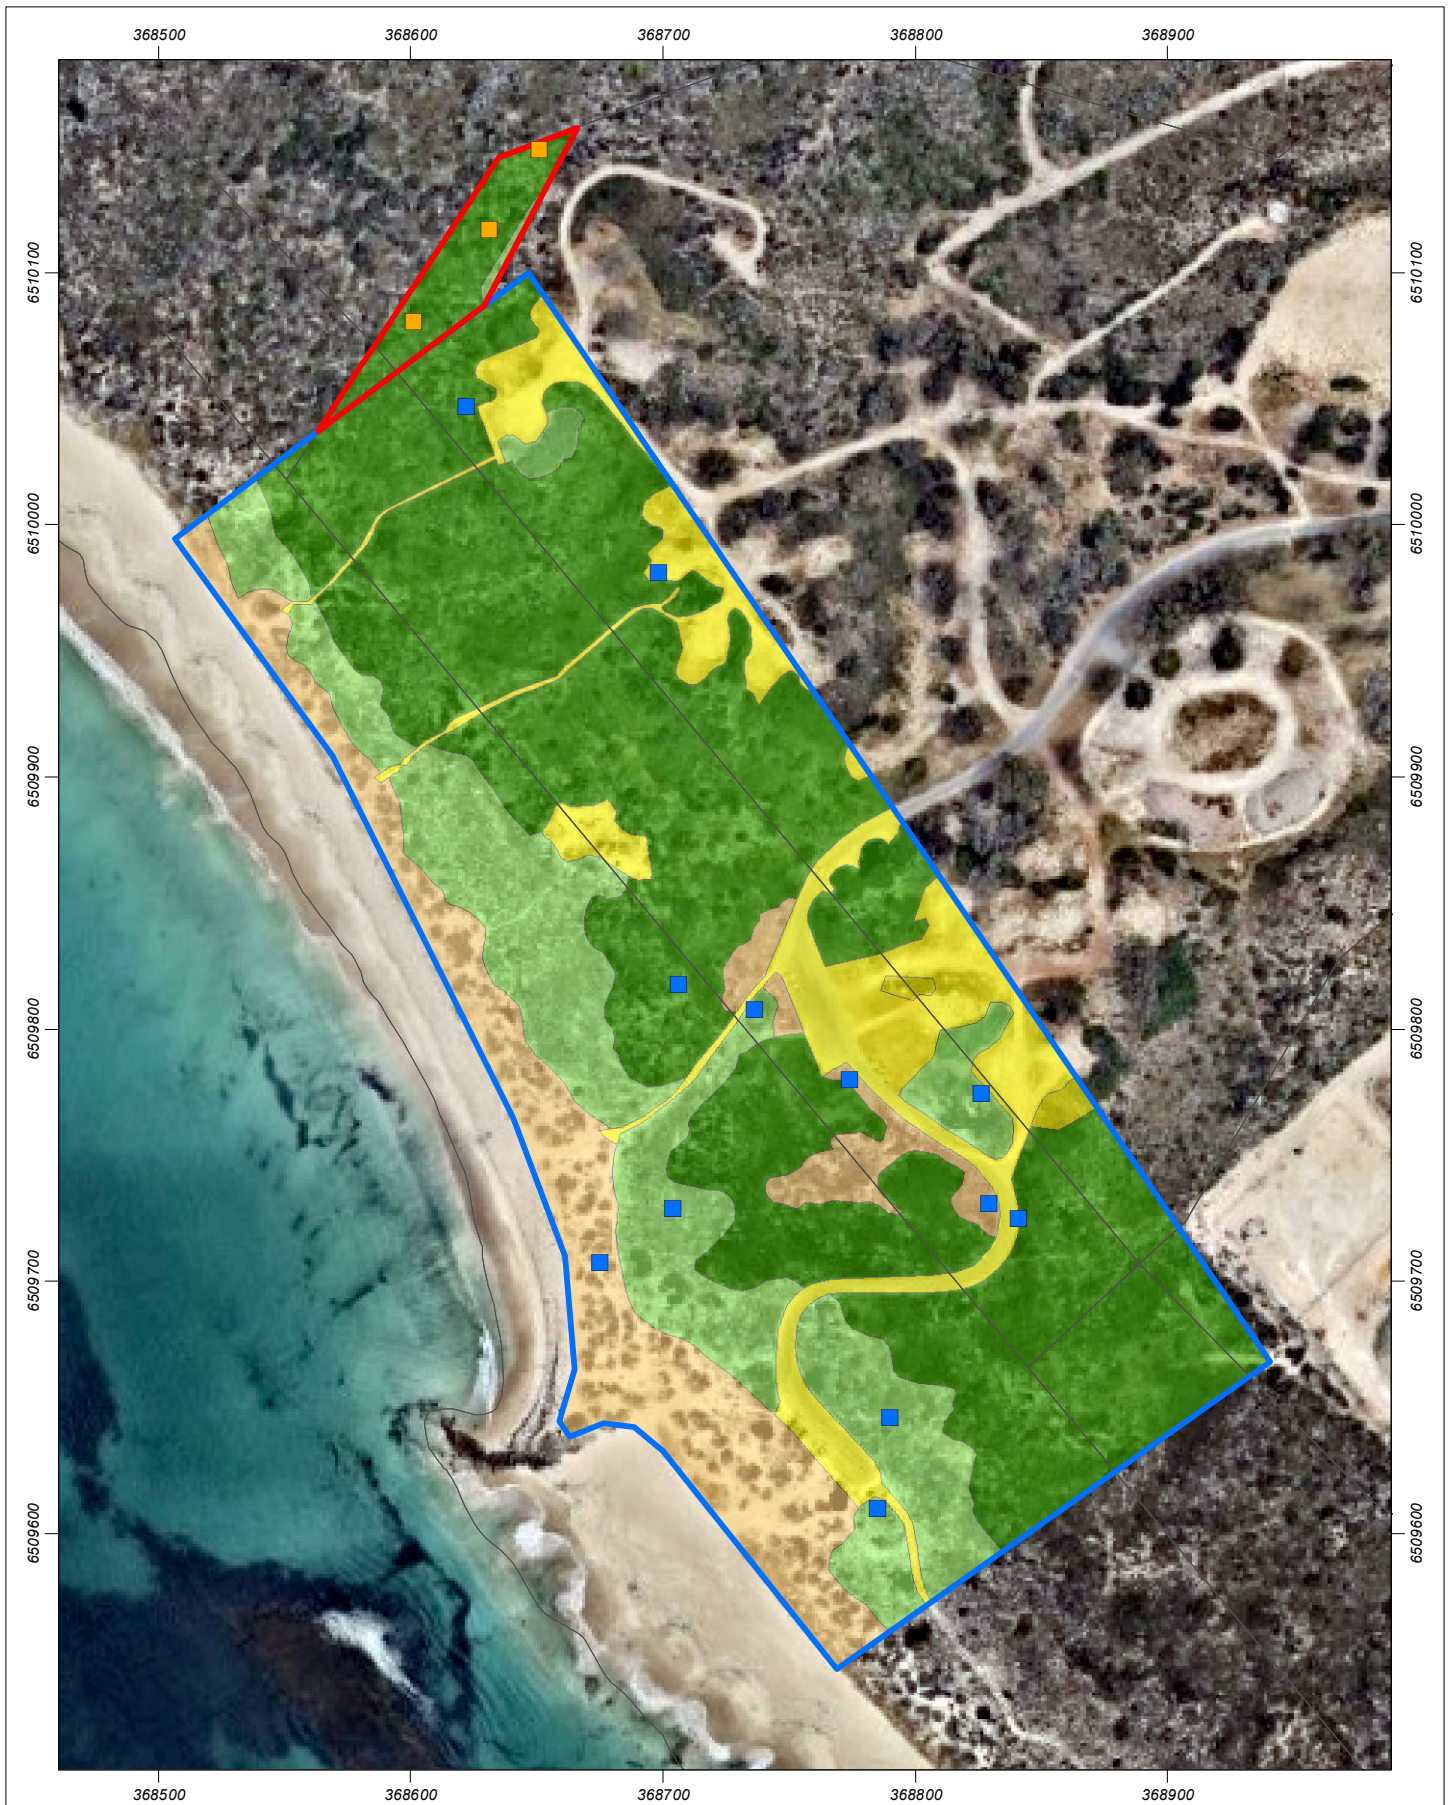
Figure 7: Vegetation condition

Vegetation Condition	Area (ha)	Percentage of the Survey area
Very Good	5.53	51.62
Good to Very Good	2.05	19.51
Good	1.56	14.84
Completely degraded	1.36	12.94
Total	10.51	100

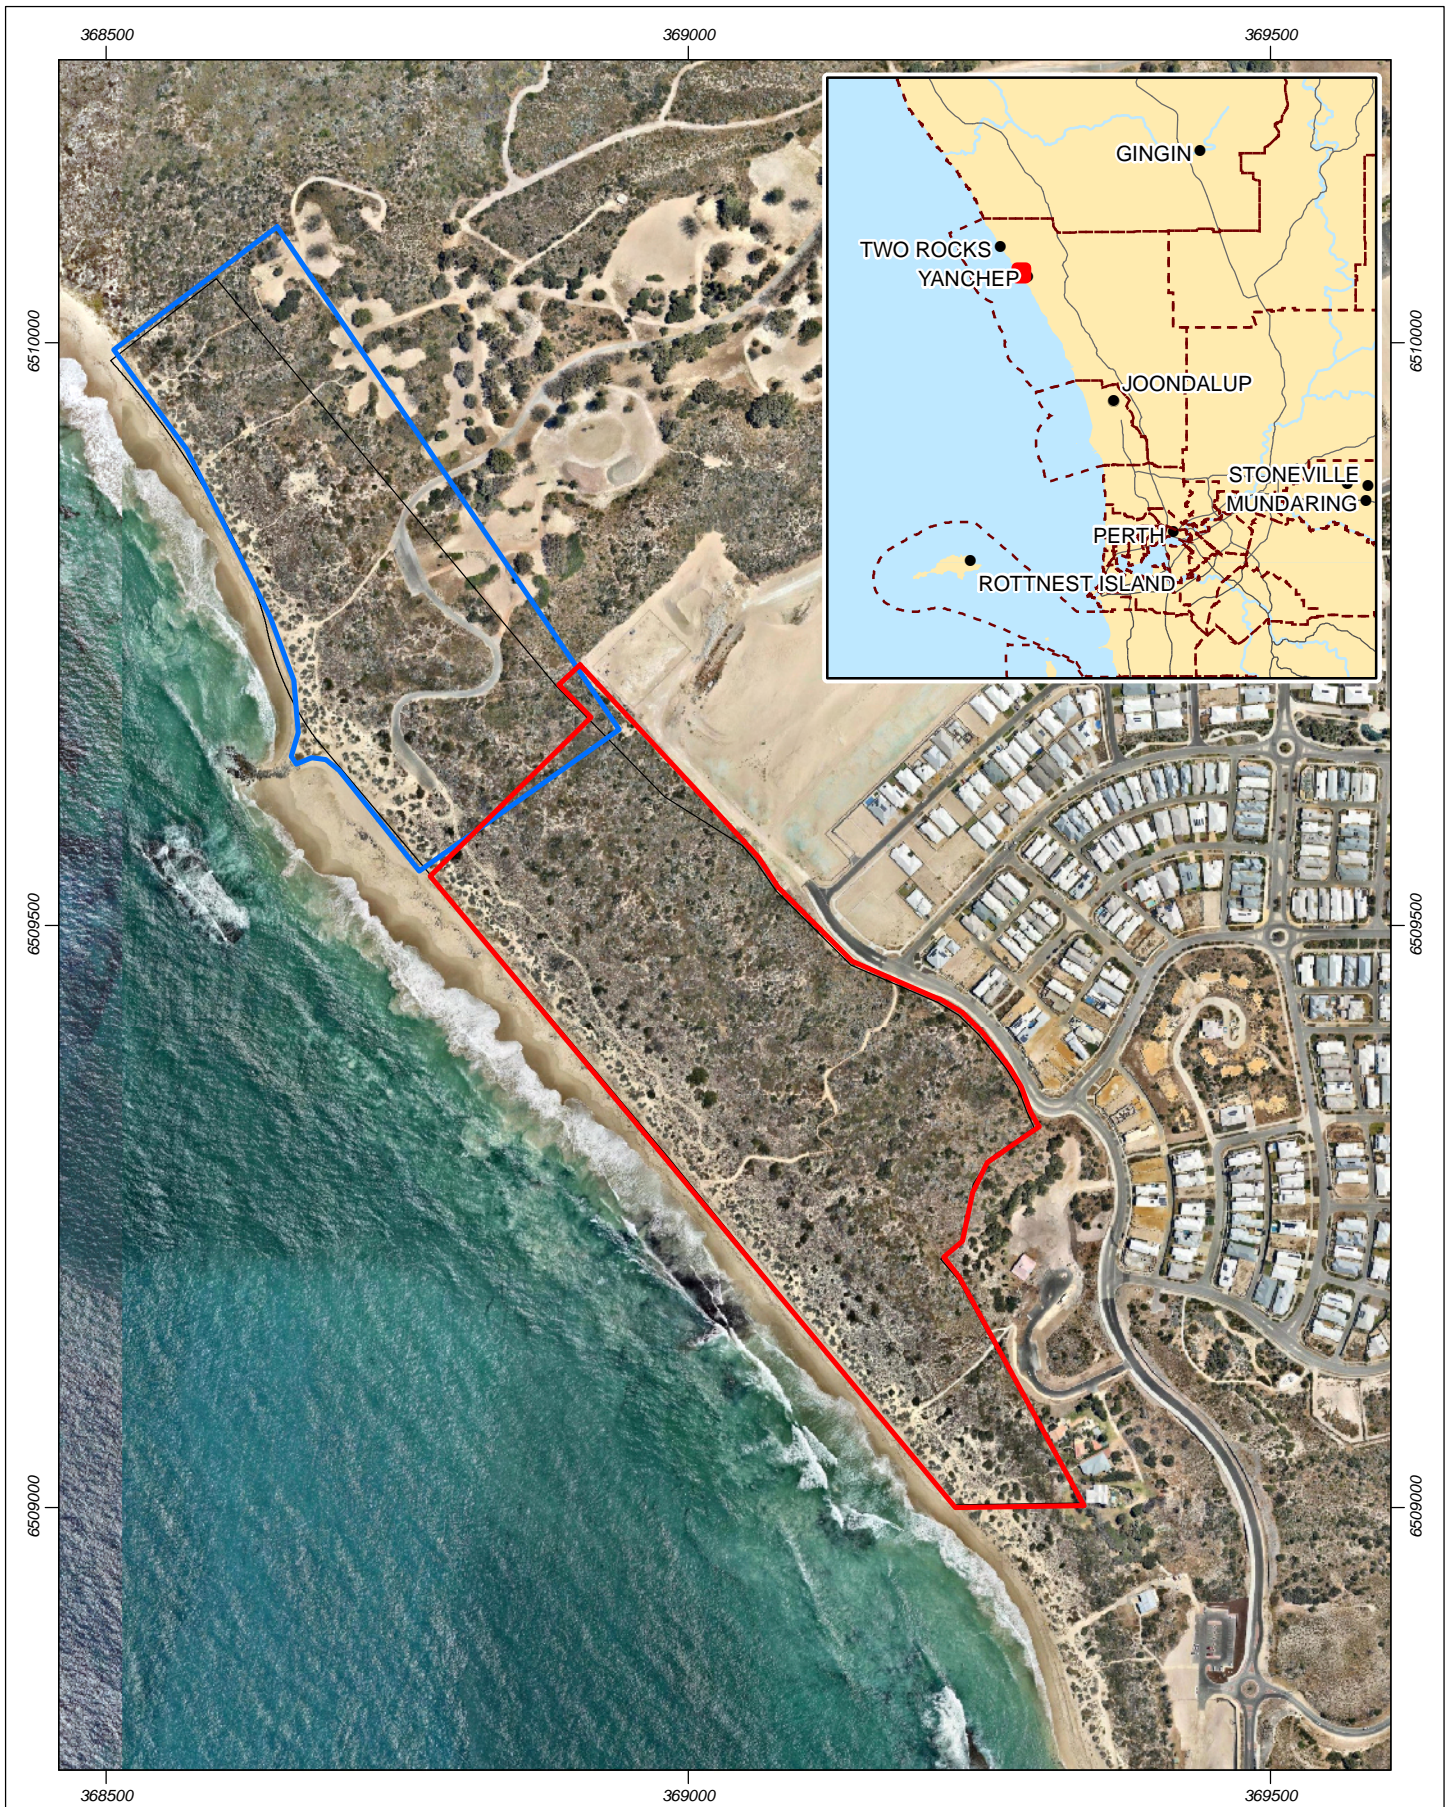
Scale 1:6,500 at A4

This memo presents the findings of a flora and vegetation survey to be supplemented to a Level 2 flora and vegetation survey conducted within the Project area on 25 November 2016. The supplementary survey was undertaken within the southern portion of the foreshore reserve; to the south of the 2016 survey area, including detailed quadrat analysis to support the proposed development of the Capricorn foreshore reserve that forms part of the Coastal Village and Coastal Node, Yanchep (the survey area; Figure 1).

Figure 1: The survey area
