Appendix 1
Subdivision approval (WAPC 155520)

CLIENT	ACUMEN DEVELOPMENT SOLUTIONS		
PROJECT	KARST RISK DESK STUDY		
LOCATION	CAPRICORN FORESHORE, YANCHEP		
TITLE	SITE & LOCATION PLAN		
Job No	J1601249	Fig No	FIGURE 1
Rev	A

Appendix 7
Coastal Risk Assessment and
Recommendations: Capricorn Yanciep
Development

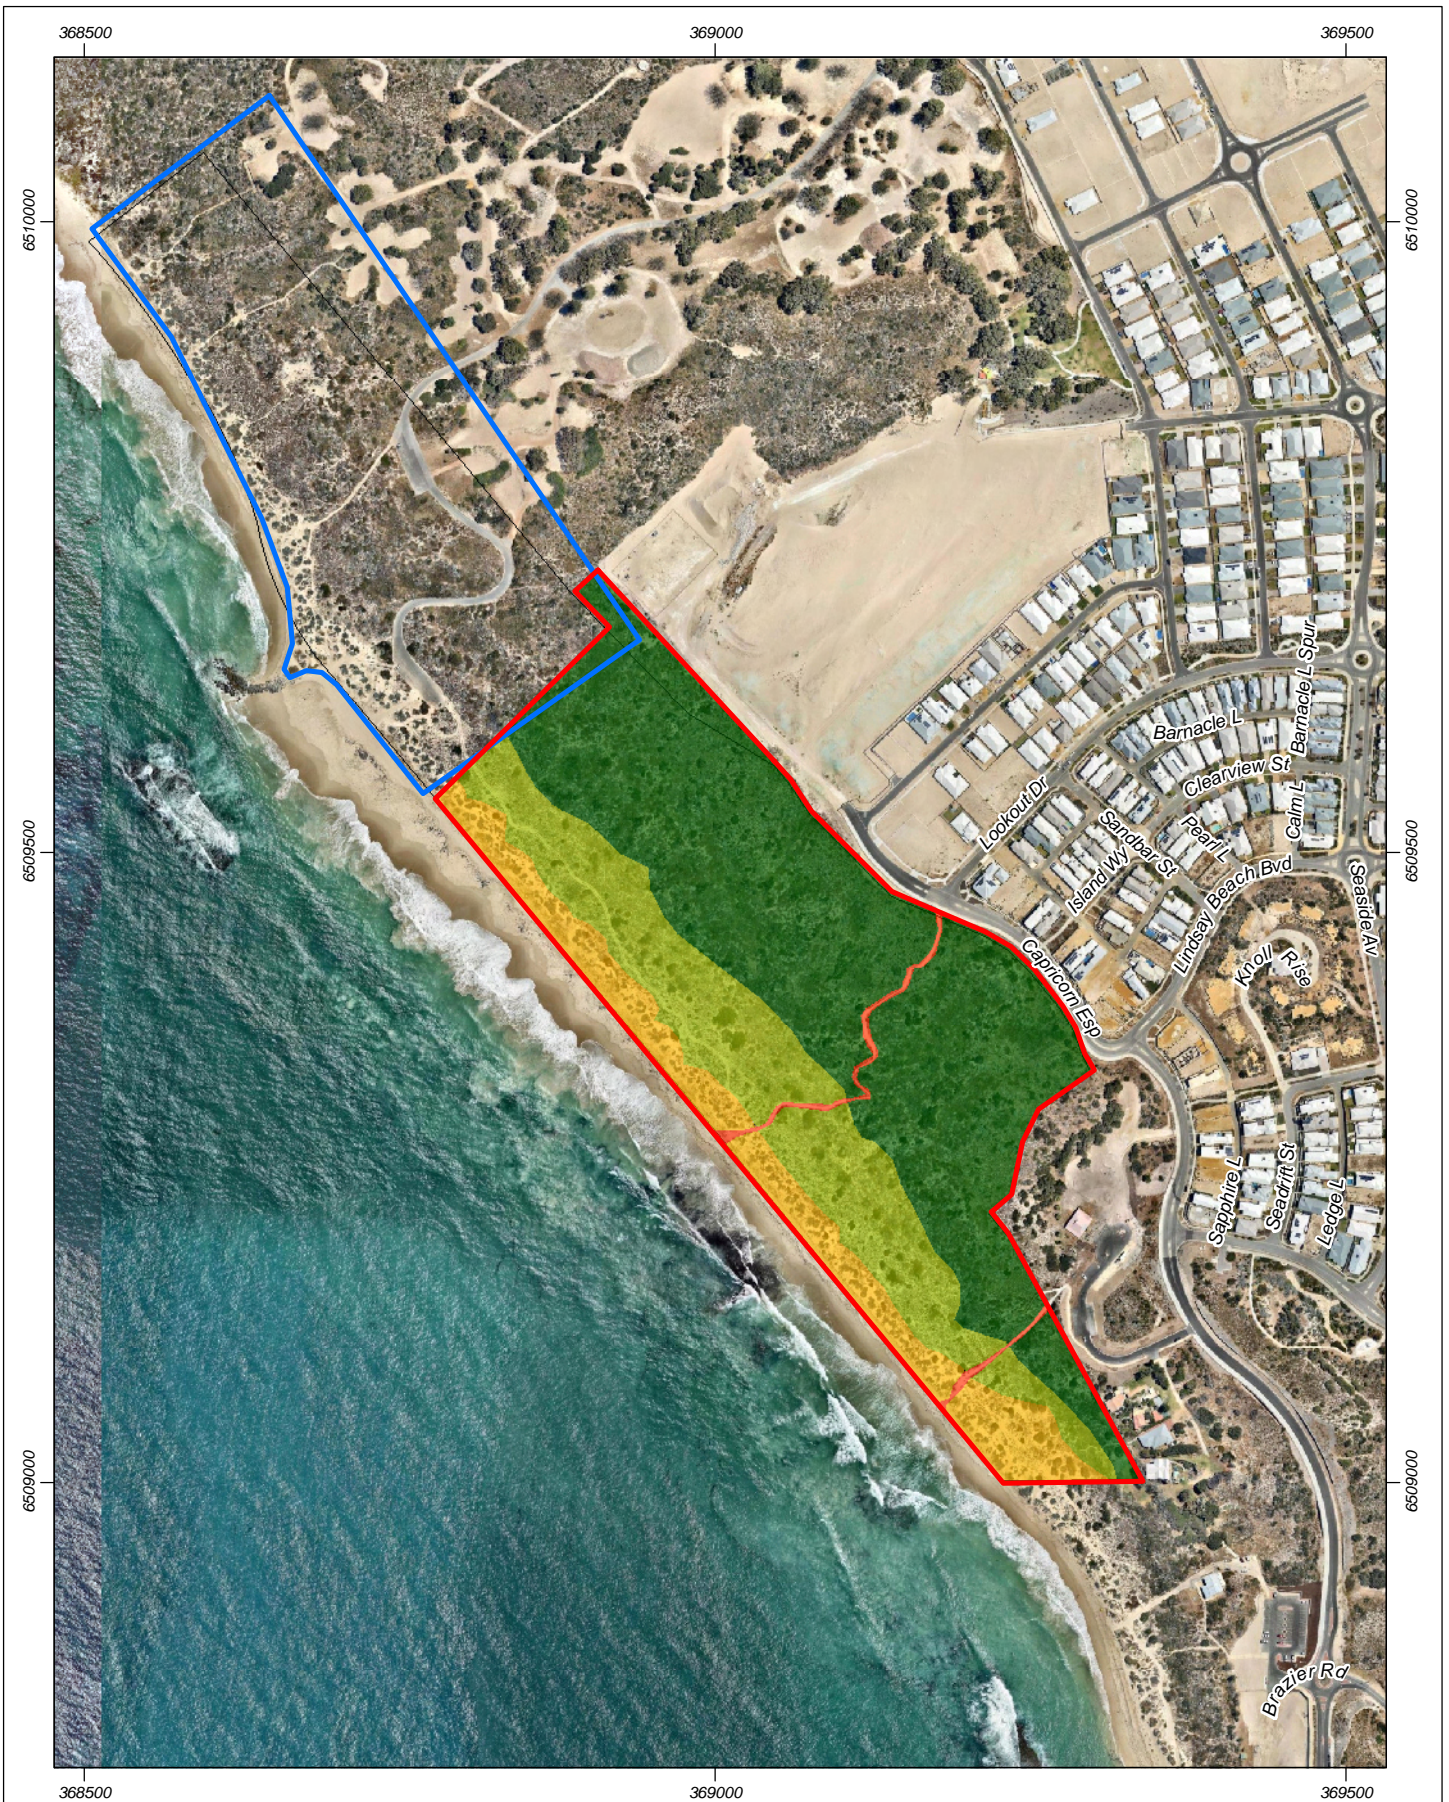
Scale 1:6,000 at A4

Figure 4: Vegetation condition mapped within the survey area

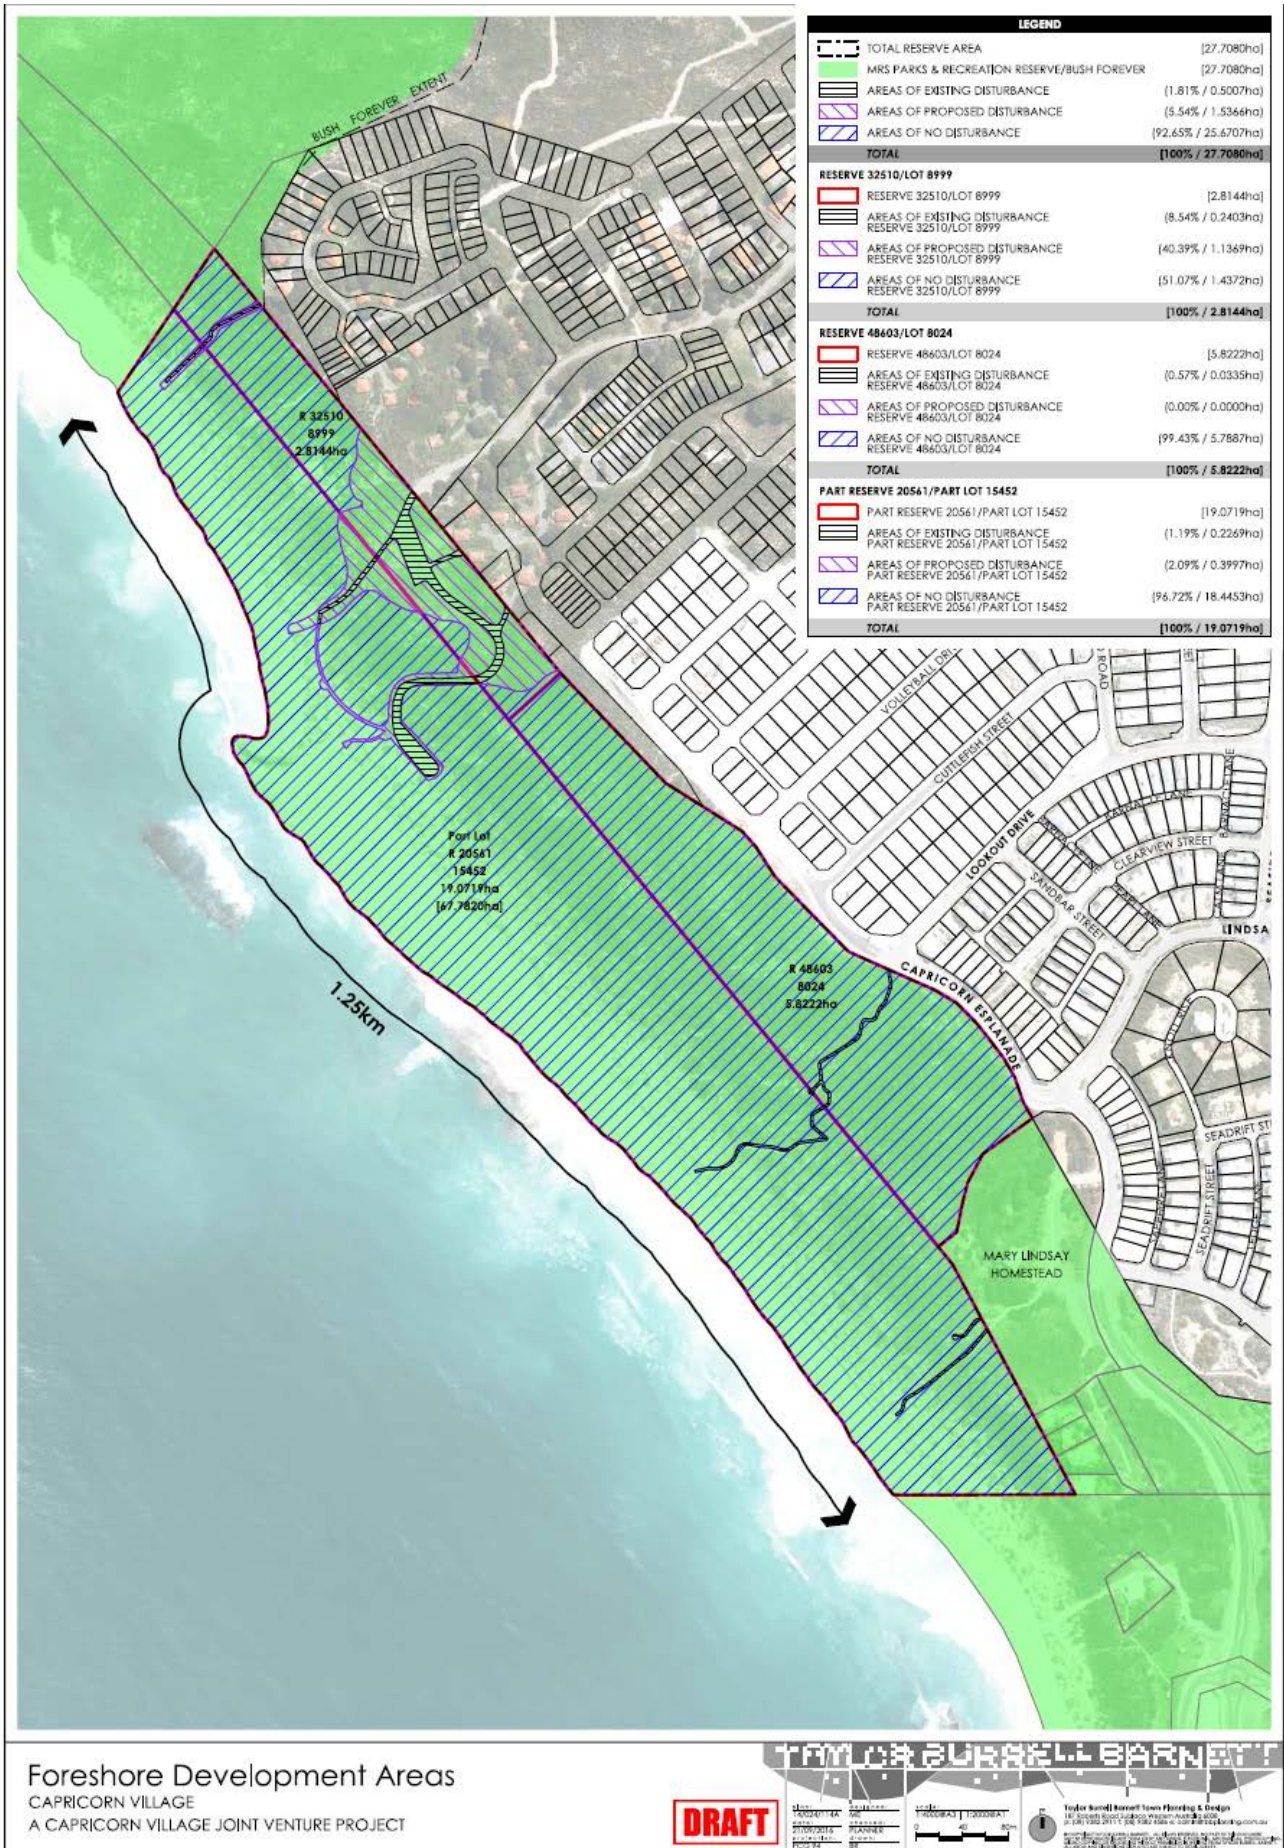
The foreshore reserve is long and narrow; about 1.25km north-south and up to 250m wide from the coast to the inland boundary (Figure 1). It consists of Quindalup dune systems which are steeply undulating with soils of pale calcareous sands over limestone. The vegetation is coastal heath with areas of sedgeland (Coastal Sword-Sedge *Lepidosperma gladiatum*) in some valleys (Plate 1). The Bush

Figure 1. Location of survey area.

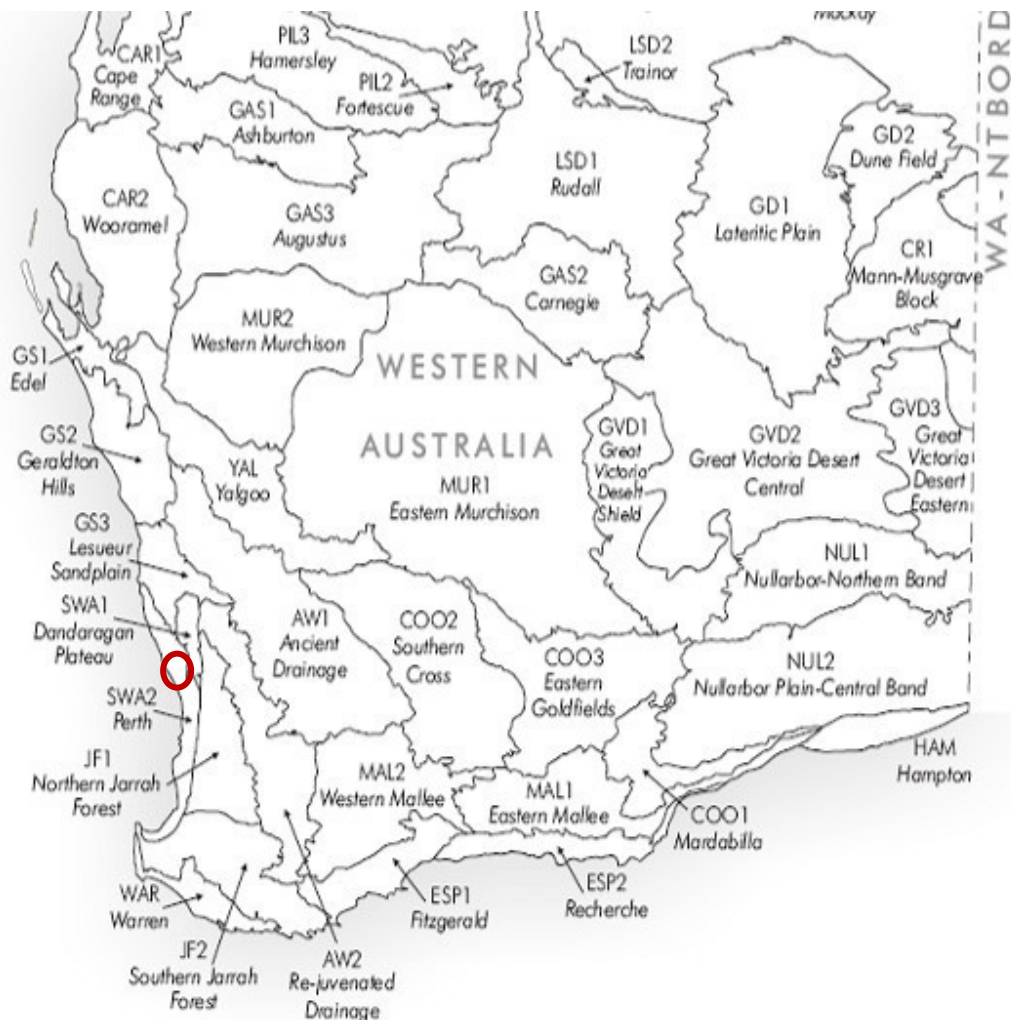
The Interim Biogeographic Regionalisation of Australia (IBRA) (Environment Australia 2000) has identified 26 bioregions in Western Australia that are further divided into subregions (Figure 2). Bioregions are classified on the basis of climate, geology, landforms, vegetation and fauna (Thackway and Cresswell 1995). IBRA Bioregions are affected by a range of different threatening processes and have varying levels of sensitivity to impact (EPA 2004). The survey area lies in the Swan Coastal Plain Bioregion (DSEWPaC 2012) and in the Swan Coastal Plain subregion (SWA2) as shown in Figure 2.

Figure 2. IBRA Subregions in Western Australia. Note the survey area (indicated by red circle) lies in the SWA2 Perth IBRA subregion.

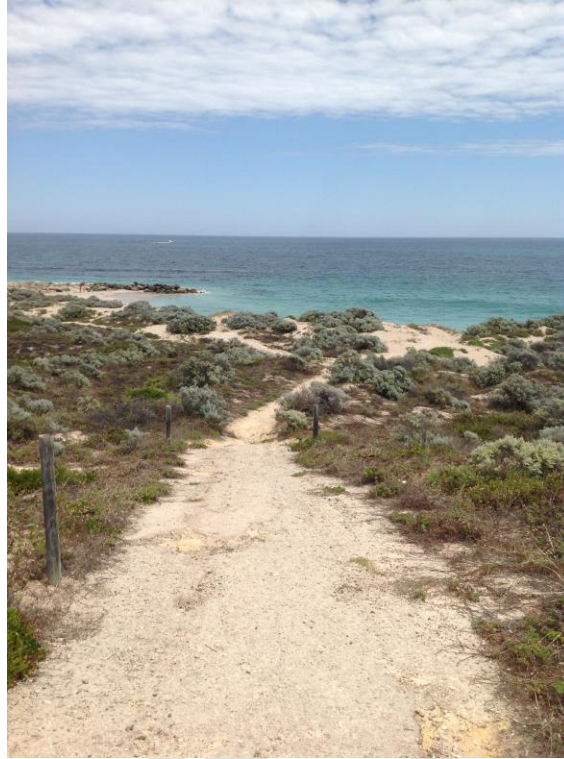
Figure 3: Example of a formal track to Capricorn Beach which branches out in to multiple informal tracks through the dunes.

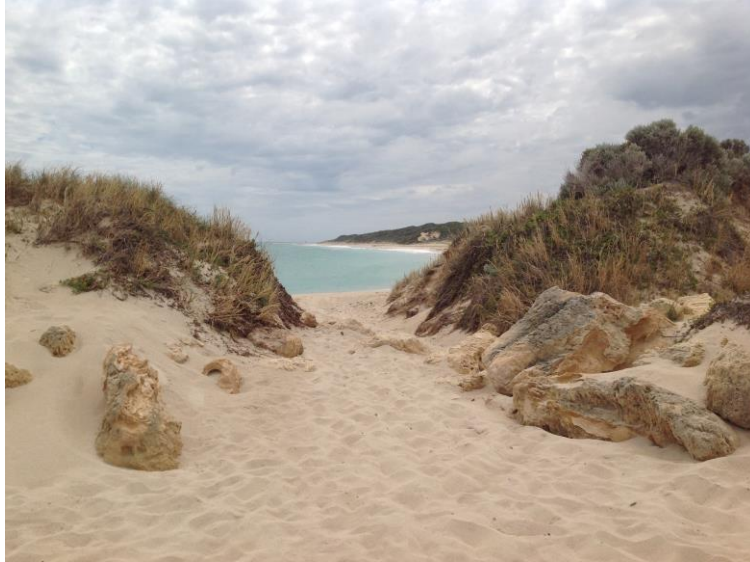
Figure 4: State of the current pedestrian access track between Yanchep Beach and Capricorn Beach.

To allow for potential roving patrols from Yanchep Beach SLSWA recommend the land manager consider the development of a sufficient vehicle access track between Yanchep Beach and Capricorn Beach, ideally behind the groyne (Figure 4). With the likely increase in usage of Capricorn Beach following development it would be beneficial to provide vehicle access to this section of beach allowing lifesaving services to conduct roving patrols of the area and respond to incidents as required. Provision of direct access between the two beaches in this location behind the groyne will help reduce response times in the event of an emergency.

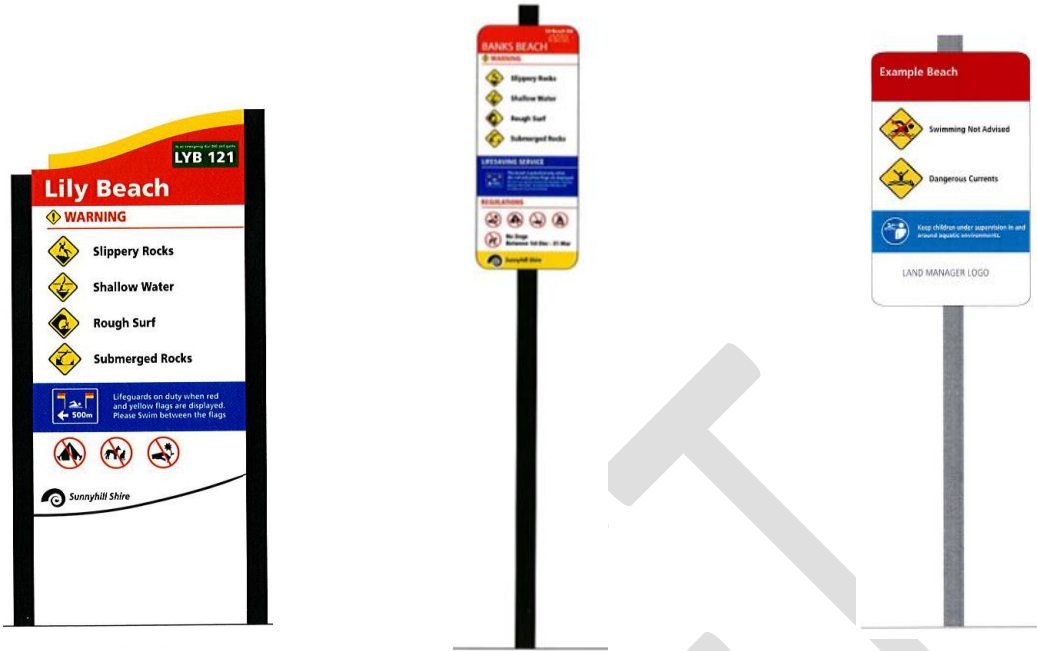
Below are examples of types of beach safety signage to be installed:

Level 3 - Open Access Sign or
Level 2 - Carpark Sign

Level 3 - Defined Access Sign

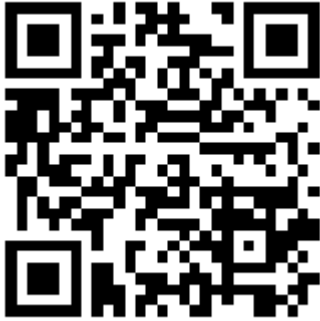
There are many opportunities at present to make use of technology in innovative ways for education and awareness programs. One such opportunity is the use of smart phones to provide location based safety messaging. One method of delivering this would be to implement a system of Quick Response (QR) Codes (Figure 5). These codes can be included on signage and linked to specific safety information relating to the beach (Figure 6). The codes can be scanned by smart phones with freely available QR scanning applications installed, such as QR Reader on the iPhone. Below is an actual example of a QR code. This system would be relatively easy and cost effective to implement and would create opportunities for the media to increase public awareness of beach safety related issues. The Shire of Augusta-Margaret River, City of Rockingham and City of Busselton have successfully retro fitted QR Codes to existing signage at beach access points.

Figure 5: An example of a QR Code linked to beach safety information

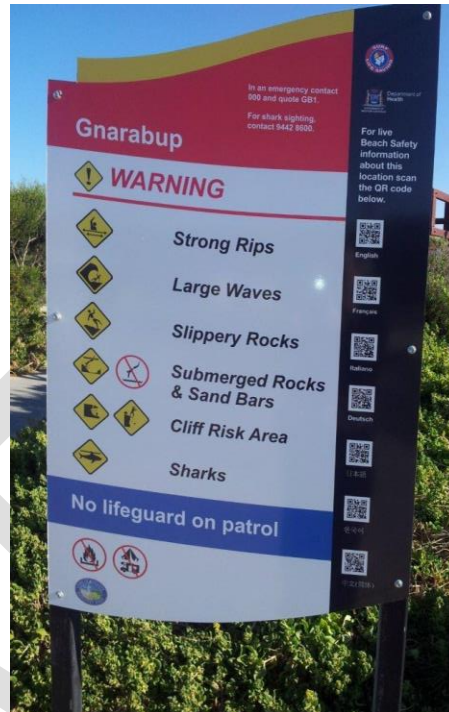
Figure 6: Example of how QR codes can be incorporated into signage.

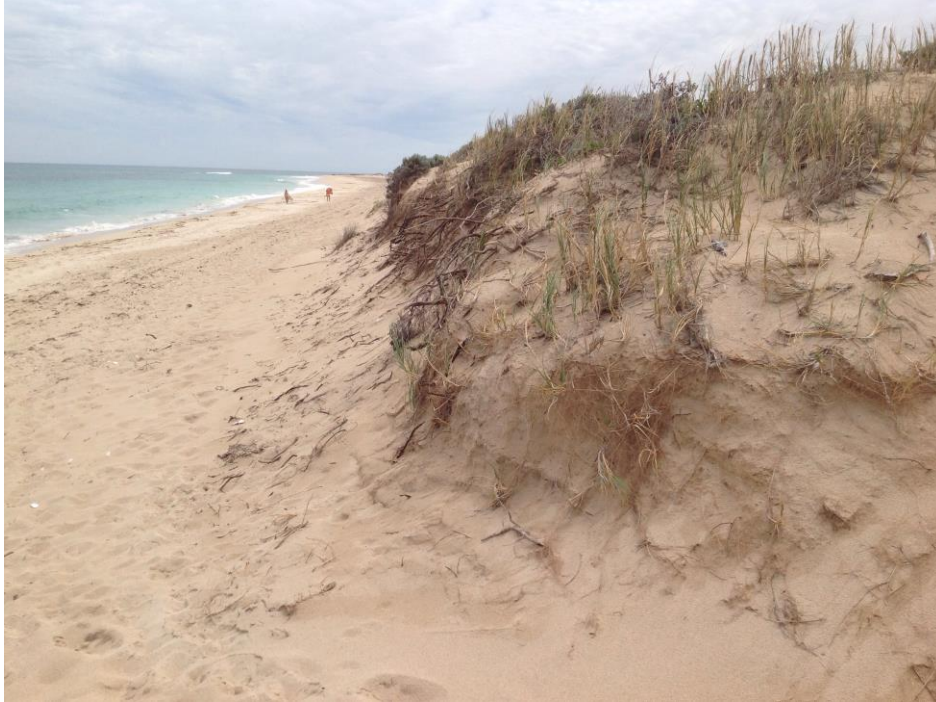
Figure 7: Example of dune erosion at an access track to Yanchep Beach.

There was some erosion noted along the face of the dunes and near informal access points (Figure 7). Formalising access tracks and limiting access through to the dunes will prevent further erosion. Other than at these access points most of the dunes are stable and well vegetated and unlikely, at this stage, to pose any hazards in terms of erosion and sand collapse. As beach visitation rates increase the formalisation of paths and access restrictions to the dunes will become increasingly important. Revegetation of areas which are used as informal tracks will help to deter usage.

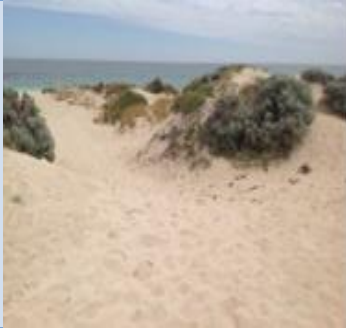
Access track south of Capricorn groyne Formal access on roadside however multiple tracks have been created through the dunes	-31.540661, 115.617287	Warning signage from carpark	Installation of beach safety signage Formalise Access Tracks	Open access	No formal access track No safety signage in place
2(8362)

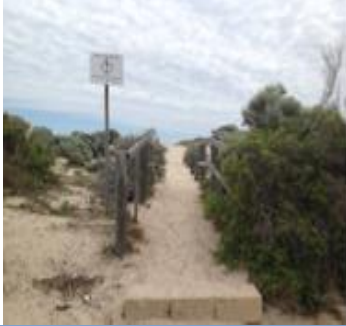
Formal access from carpark south of Capricorn groyne	-31.540678, 115.617325	Warning Signage	Installation of beach safety signage	Formal Access	No safety signage in place Access not formalised through to the beach
3(8359)

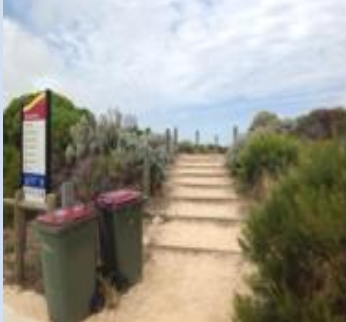
Formal Beach Access from Capricorn Esplanade	-31.542482, 115.621841	Level 3 Open Access Sign (road side) Level 3 Defined Access Sign (beach side)	Maintain access track and signage	Formal Access	Access not formalised through to the beach

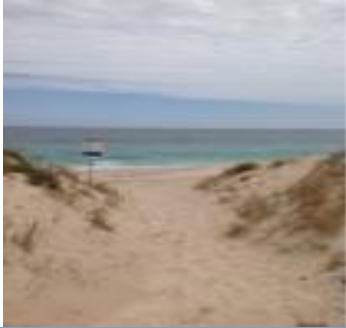
Beach Access from Capricorn Esplanade	-31.543989, 115.620178	Level 3 Defined Access Sign	Formalise Access Track all the way through to the beach	Formal Access	Access not formalised through to the beach
5(8360)

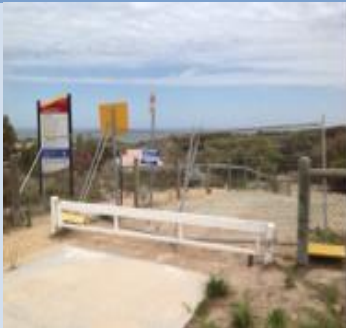
Gated vehicle access to the newly constructed car park Access restricted at time of site visit	-31.544081, 115.623787	Access restricted due to carpark upgrade works	Maintain beach safety signage	Vehicle Access Gate	Uneven surfaces Shared vehicle and pedestrian access
6(8358)

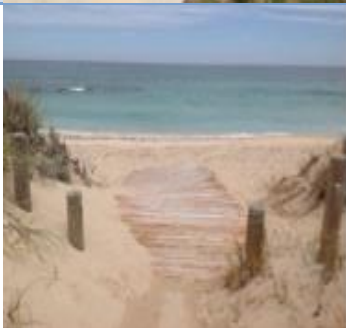
Formal access, uneven ramp on beach end. Out of date and signage that has fallen over.	-31.545992, 115.621849	Level 3 Defined Access Sign (both ends of track) 'How to escape a rip' signage 'Dog Prohibited' signage	Fix damaged fencing and signage Formalise access track all the way through to the beach	Formal access	Uneven ramp on beach end of access track Damaged fencing Signage on beach end on the ground

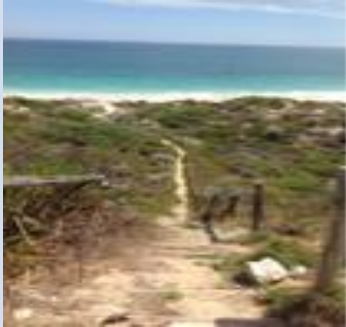
Formal at top informal at bottom	-31.537235, 115.616234	Signage located mid-way through dunes	Formalise access tracks Install Beach Safety Signage	Formal Access	Multiple 'goat tracks' thorough the dunes Environmental Damage Access path hard to identify from the beach
2(8366)

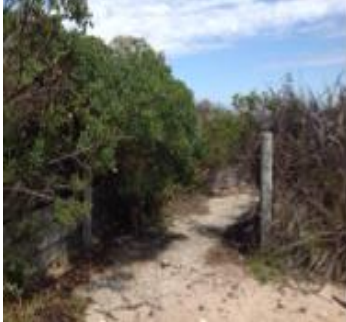
Access from previous Club Capricorn Resort Access is formal at the top of the track an informal towards the beach	-31.537678, 115.616936	Signage located mid-way through dunes	Access to be closed shown in Foreshore development plans	Formal Access	Multiple 'goat tracks' thorough the dunes Environmental Damage Access path hard to identify from the beach
3(8364)

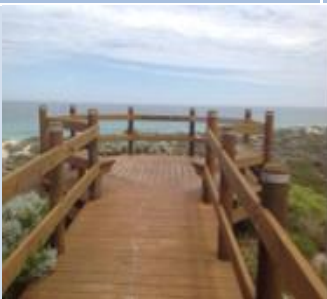
-31.543350	115.621123	Lookout located along the beach access track to Yanchep Beach
Lookout

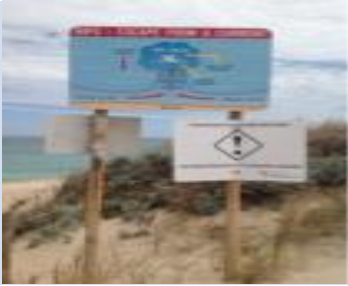
<p>Informational signage</p>	<p>Located on north side of the track at beach end. Temporary signage is out of date.</p>

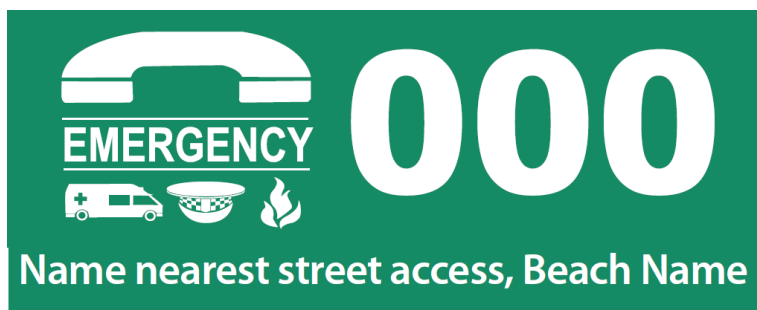
Numbering of access tracks aids location of the incident in the case of an emergency. Before any system of numbering is implemented consideration should be given to surrounding signage already in place and potential additional signage to avoid out of sync codes or location identifiers.

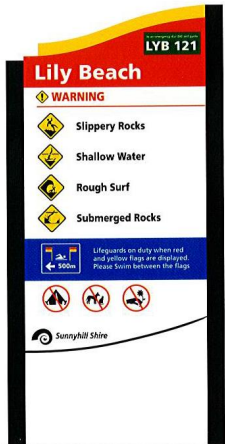
Table H1

<p>Location Identification:</p> <p>Beach Name:</p> <p>Site Reference:</p> <p>Sign Type:</p> <p>GPS Location:</p> <p>Location Description and Siting:</p>	<p>In case of emergency dial '000'</p> <p>Level 3 Open Access Sign</p> <p>Sign to be placed at the top of beach access tracks.</p> <p>Suitable for wider (vehicle) access tracks.</p>																								
<p>Hazards and Warnings:</p>

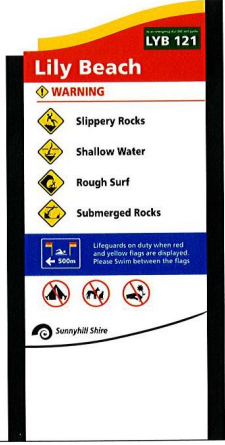
Table H2

<p>Location Identification:</p> <p>Beach Name:</p> <p>Site Reference:</p> <p>Sign Type:</p> <p>GPS Location:</p> <p>Location Description and Siting:</p>	<p>In case of emergency dial '000'</p> <p>Level 2 Carpark Sign</p> <p>Sign should be placed on the access road into carparks where most visible.</p>			
<p>Hazards and Warnings:</p>
