City of Wanneroo Coastal Monitoring Report April 2022

1 Introduction

1.1 Coastal Foreshore Monitoring

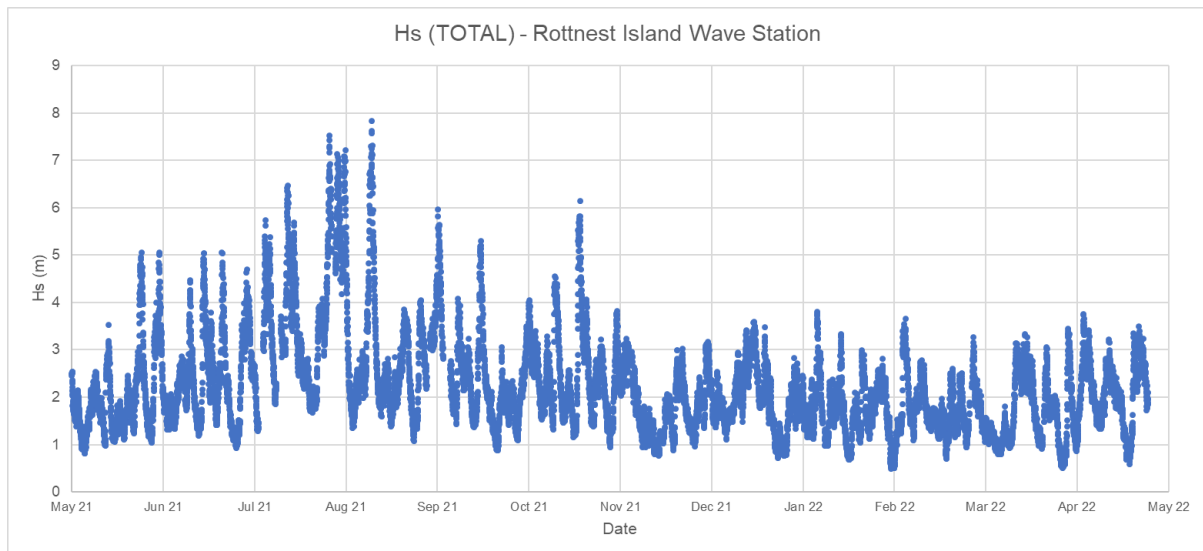
Figure 2-2 Total Significant Wave Height (Hs) recorded at the Rottnest Island Wave Station from May 2021 to April 2022.

The most notable observations from Figure 2-2 and Figure 2-3 are the storms that were recorded on 1 August, 10 August, 2 September and 19 October 2021. The storm that resulted in the most significant infrastructure damage and erosion along the City's coastline occurred on the 10th of August 2021. The storm recorded a peak total significant wave height of 7.84m at 1:55 PM on 10 August 2021.

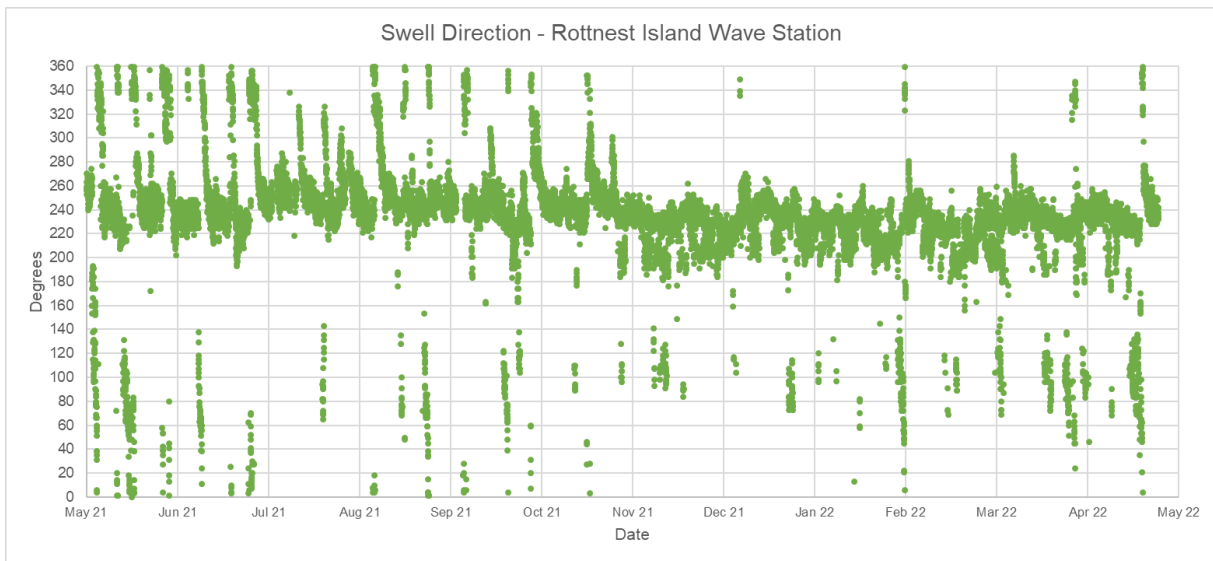
Figure 2-3 Swell Direction Recorded at the Rottnest Island Wave Station from May 2021 to April 2022.

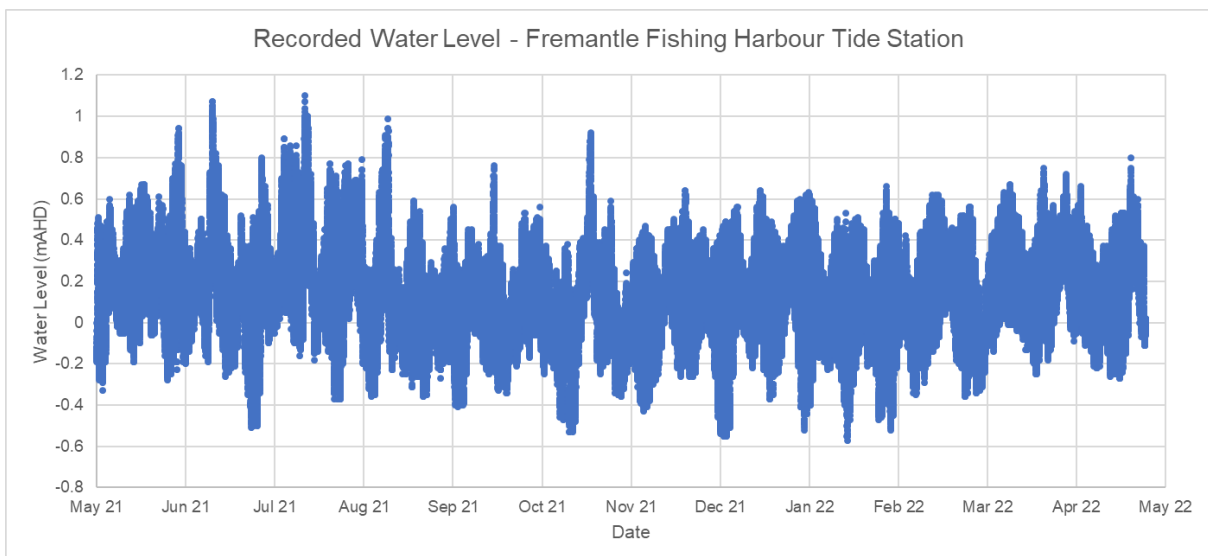
Figure 2-4 Water level (mAHD) recorded at the Fremantle Fishing Harbour Tide Station from May 2021 to April 2022.

Total recorded water level at the Fremantle Tide Station for October 2020 to October 2021 is presented in Figure 2-4. The highest water level recorded was 1.10 mAHD recorded at 11:10 on 12 July 2021. The peak storm surge (0.73m) was also observed on the 12th of July at 7:45pm. While the storm that occurred on the 12th of July resulted in significant erosion, particularly to the north of Frederick Stubbs Carpark and to the south of Groyne 4 in Quinns Rocks, the most significant erosion and infrastructure damage was identified following the August 10th storm event which had the highest maximum significant wave height (7.84m) for the observation period. With a number of significant storm events occurring in quick succession, the result of accumulated erosion events saw major damage to Claytons Beach access ways and dune system, Mindarie Breakwater, Frederick Stubbs GSC Revetment, Frederick Stubbs Carpark, Queenscliffe Dog Beach dune system, Jindalee staircases, Amberton beach access ways and Fisherman's Hollow beach access in Yanchep. More information on storm damage is outlined in **Section 3**.

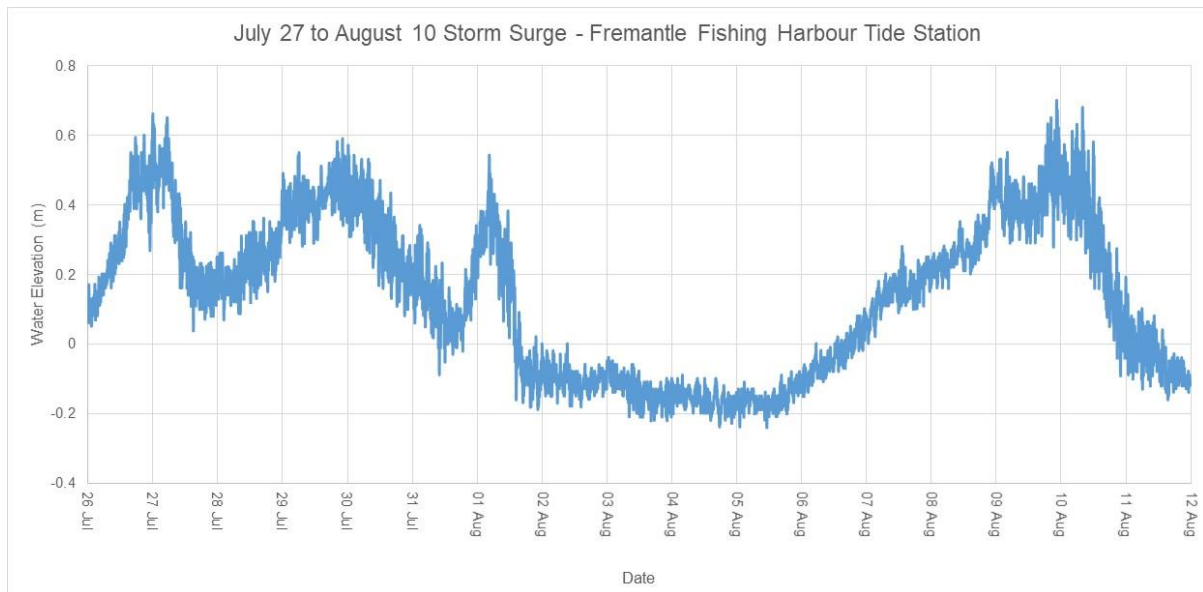
Figure 2-5 Storm surge recorded at the Fremantle Fishing Harbour Tide Station during the storms on the 26th and 27th of July and the 1st and 10th of August 2021.

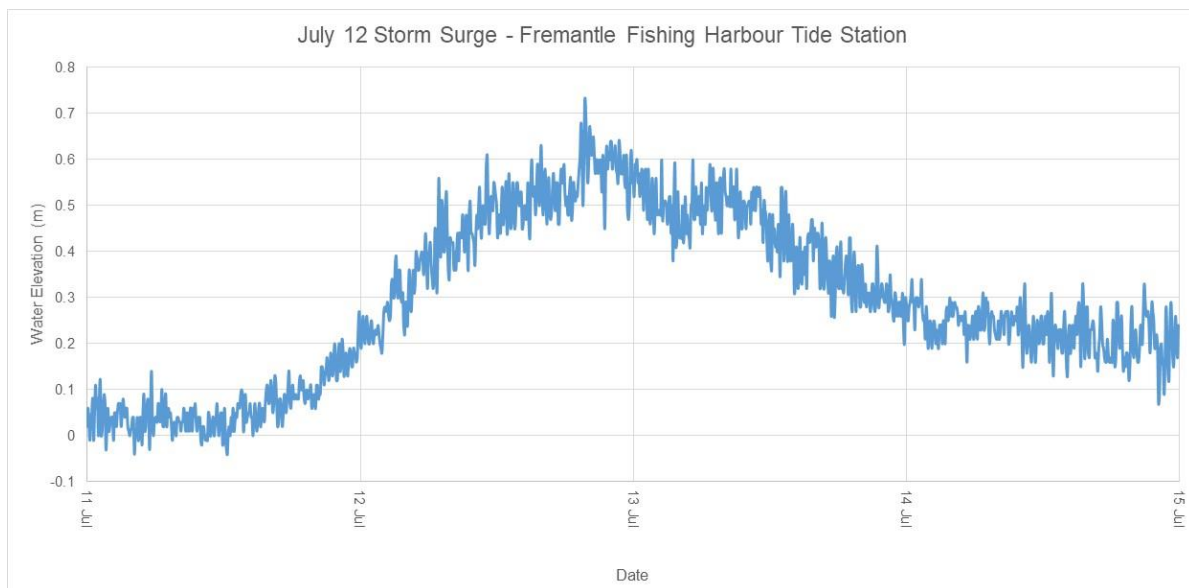
Figure 2-6 Storm surge recorded at the Fremantle Fishing Harbour Tide Station during the July 12th storm.

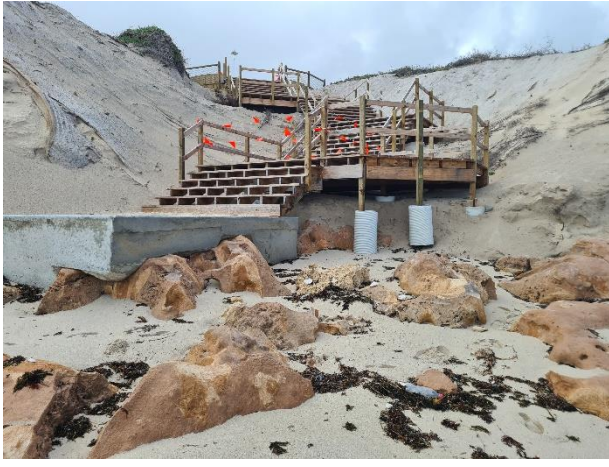
<p>Jindalee Beach Access Staircases</p>

<p>This asset is currently managed and maintained by the Jindalee Beachside Estate Residential Development. The developer has extended some staircase footings and added additional steps to the bottom of the staircase.</p>

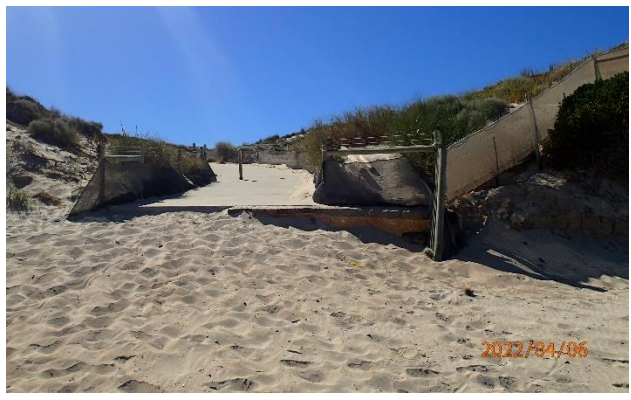
<p>This asset is currently managed and maintained by the Amberton Beach Residential Development. As a short term remediation measure the developer has backfilled this area. The City is currently working with the developer to develop a long term solution.</p>

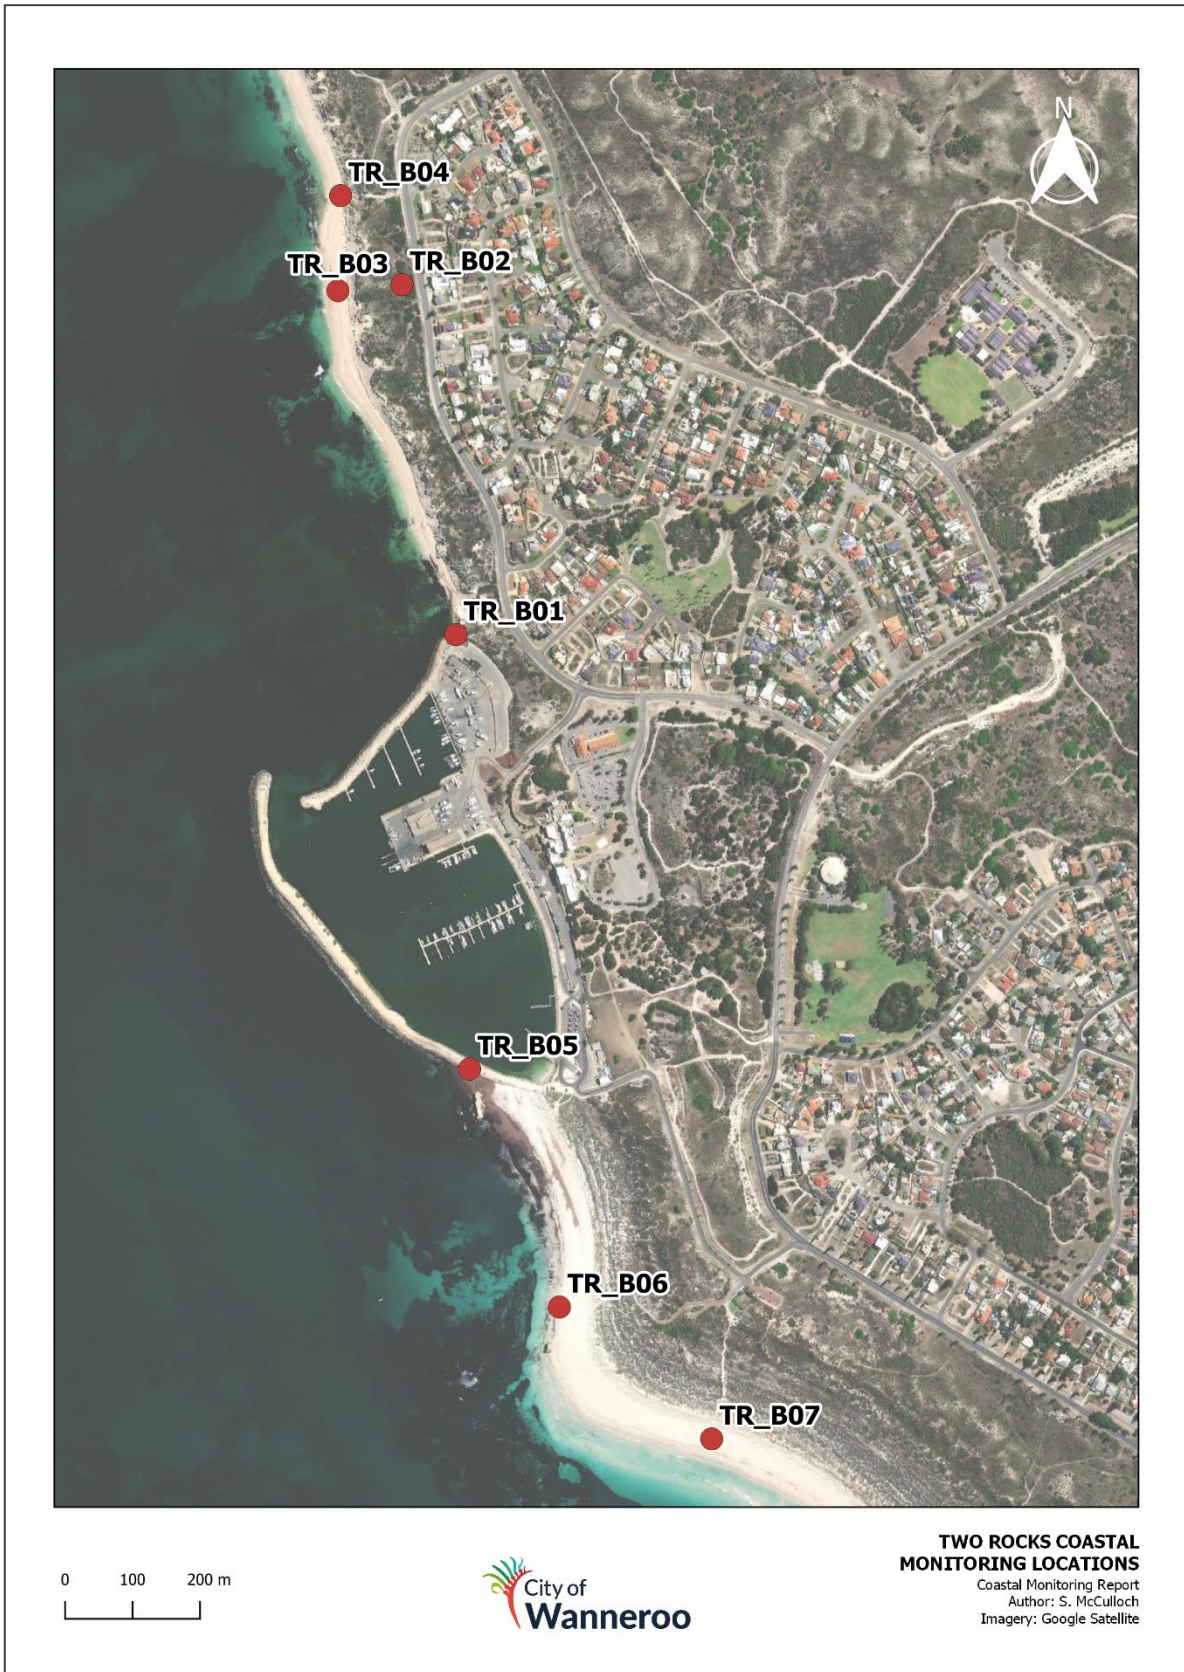
Figure 4-1 Two Rocks Coastal Monitoring Locations.

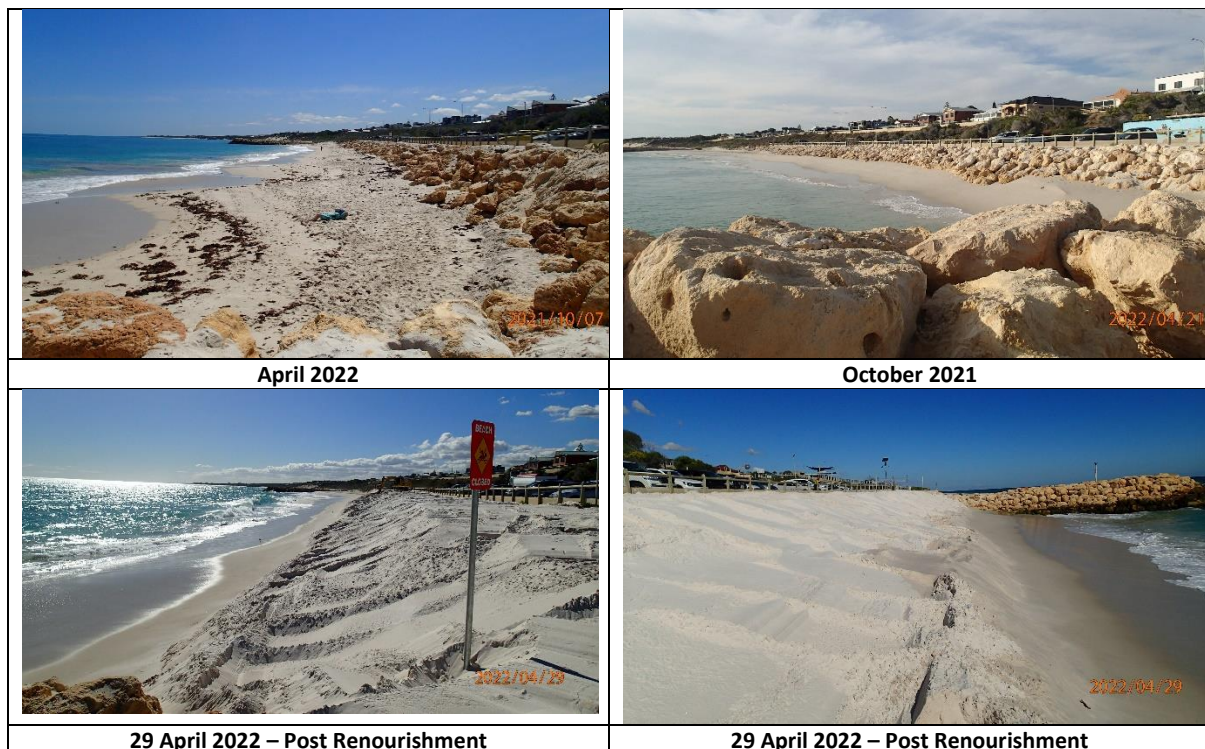
Quinns Rocks B07 Up-Coast – Major Erosion, Summer 2021/22

Figure 4-6 Major erosion over summer 2021/22 at Quinns B07 Up-Coast.

Major erosion was identified through manual imagery in the area immediately north of Quinns Groyne 1. Major seasonal erosion is experienced at this site each year and in response, the City undertakes planned re-nourishment at the site prior to each winter period. Following the April 2022 monitoring round, approximately 4000 tonnes of sand was placed at this site. The additional sand that is placed following renourishment creates a buffer against the impacts of winter storm events and limits the damage to coastal assets.

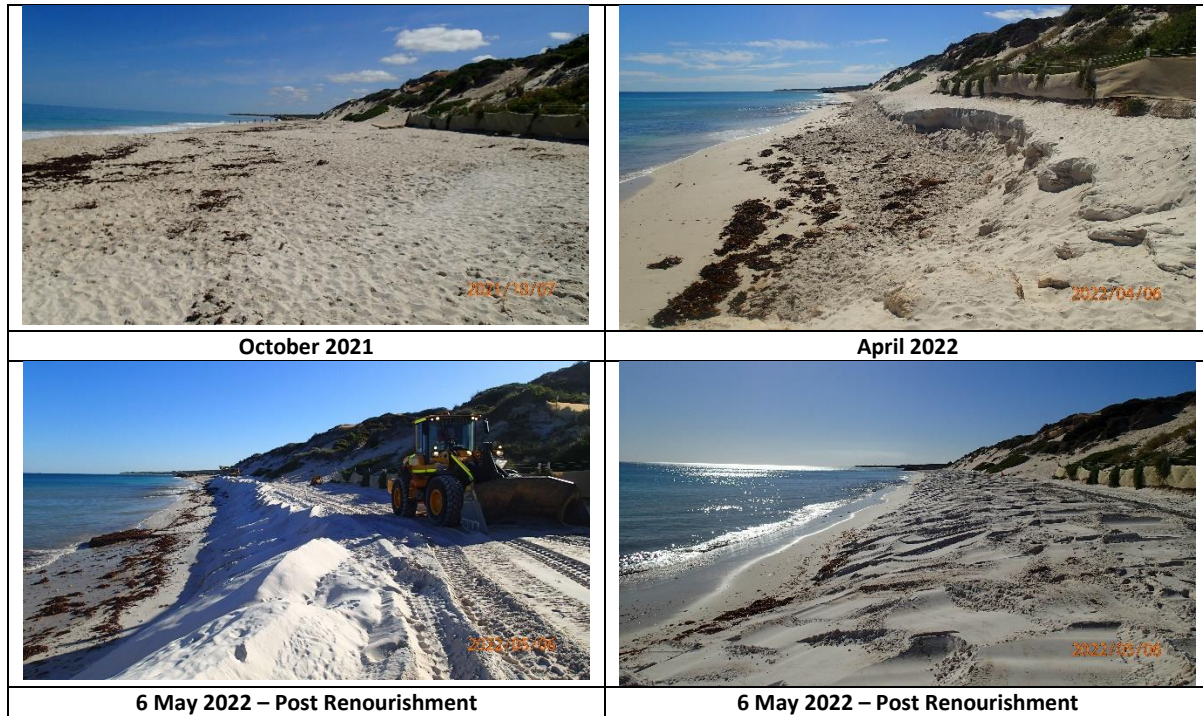
Quinns Rocks B13 Up-Coast – Major Erosion, Summer 2021/22

Figure 4-7 Major erosion over summer 2021/22 at Quinns B13 Up-Coast.

Major erosion was identified at Quinns Rocks site B13 Up-Coast between October 2021 and April 2022. Similarly to site B07 Up-Coast, significant seasonal erosion is expected at this site each year. Renourishment activities are often undertaken at the site if major seasonal erosion is identified. Following the April 2022 monitoring round, approximately 4000 tonnes of sand was placed at the site to mitigate the effects of winter storm events and limit the damage to coastal assets. Photos of the site following the nourishment, which was undertaken in April 2022, are presented in Figure 4-7.

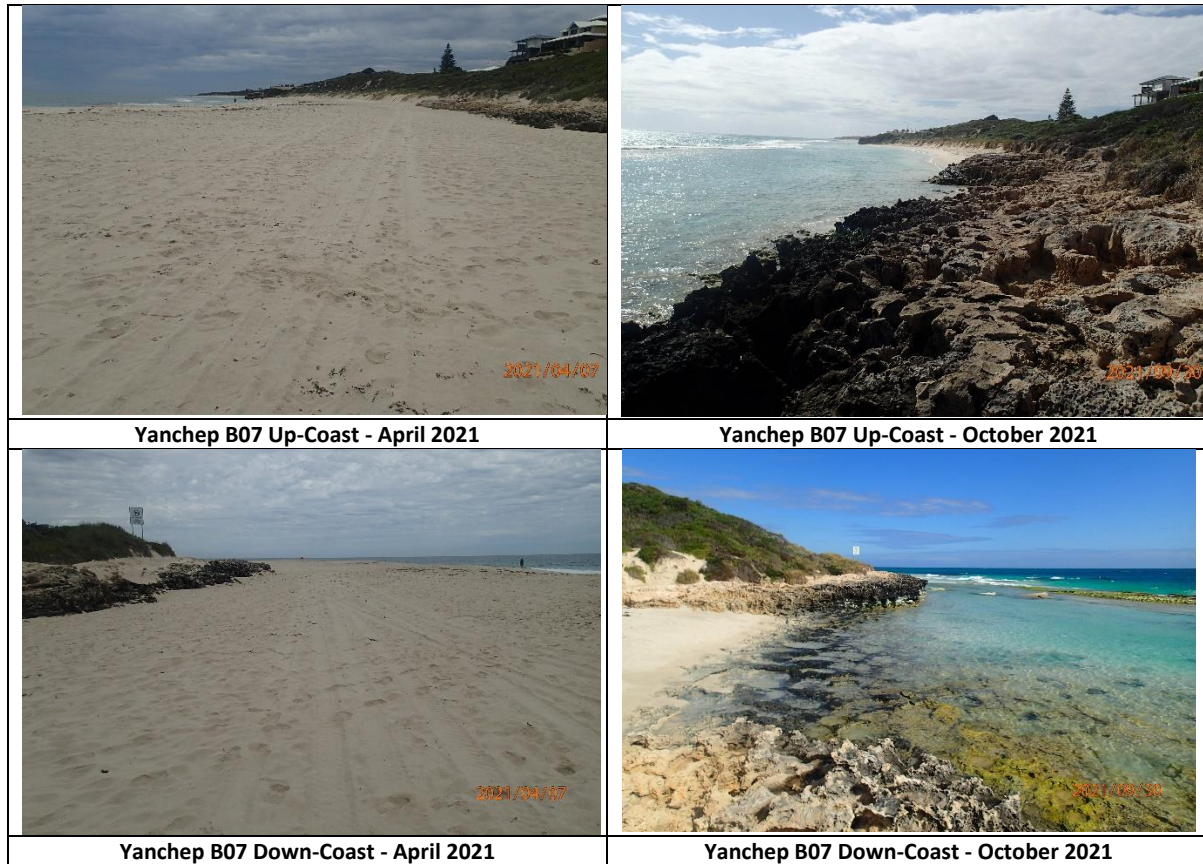
Yanchep B07 Up-Coast and Down-Coast – Major Erosion, Winter 2021

Figure 4-8 Major erosion over winter 2021 at Yanchep B07 Up-Coast and Down-Coast.

The beach captured in the photographs taken up-coast and down-coast at the Yanchep monitoring location B07 is bounded by a headland to the north and south. There was a significant reduction in beach width over the 2021 winter period with the transport of sediment southward over the winter months resulting in erosion to the south of the headland. Subsequently, however, northward movement of sediment during the summer months resulted in significant accretion at the site which provided a substantial buffer against early winter storms. While there is major seasonal changes at the site, the long term manual imagery assessment suggests that the site has experienced very minor erosion since the start of monitoring in 2019. It is important to note, however, that residential houses and road infrastructure are in close proximity to the site and could, in future, be susceptible to the effects of coastal erosion. It is therefore recommended that the site be monitored closely.

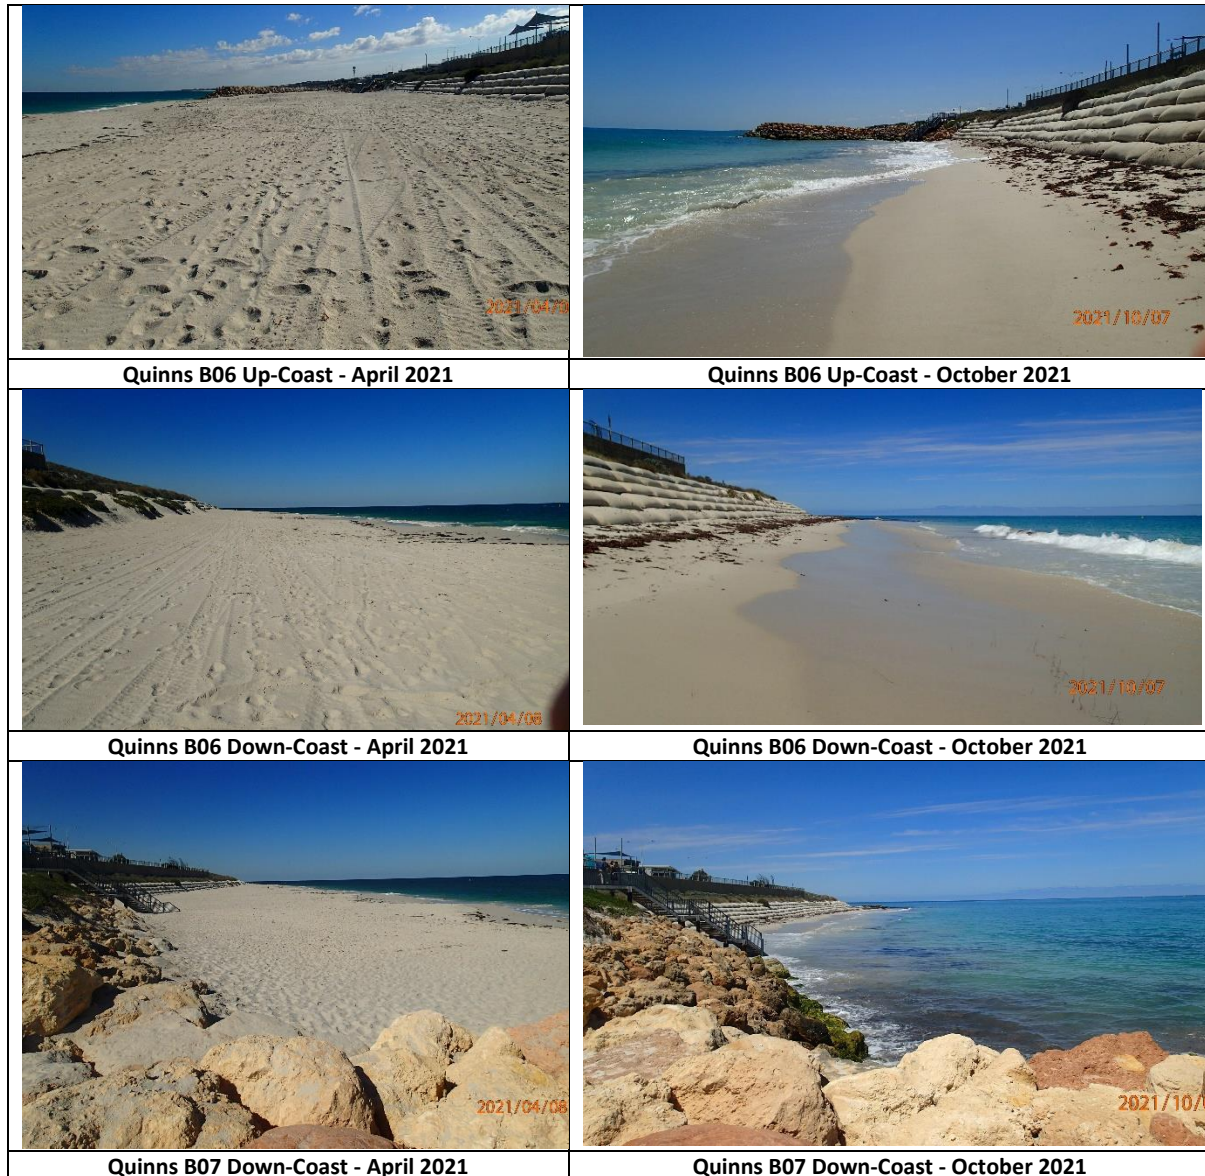
Quinns B06 and B07 Down-Coast – Major Erosion, Winter 2021

Figure 4-9 Major erosion over winter 2021 at Quinns B06 Up-Coast, Down-Coast and Quinns B07 Down-Coast.

Major seasonal erosion is experienced adjacent to the GSC and Rock Revetment at Quinns Rocks each year. The area is bound by Quinns Groyne 1 to the north and the Artificial Headland to the south. As presented in Figure 4-9 significant erosion was experienced over the 2021 winter period with very little beach remaining adjacent to the GSC Revetment. While seasonal erosion happens in the area each year, the GSC Revetment provides sufficient protection to adjacent assets and park land. In November 2021, just after the October images were taken, significant accretion was noted at the site. The area will continue to be monitored and the GSC Revetment will continue to be assessed to ensure that it continues to function as a coastal protection structure.

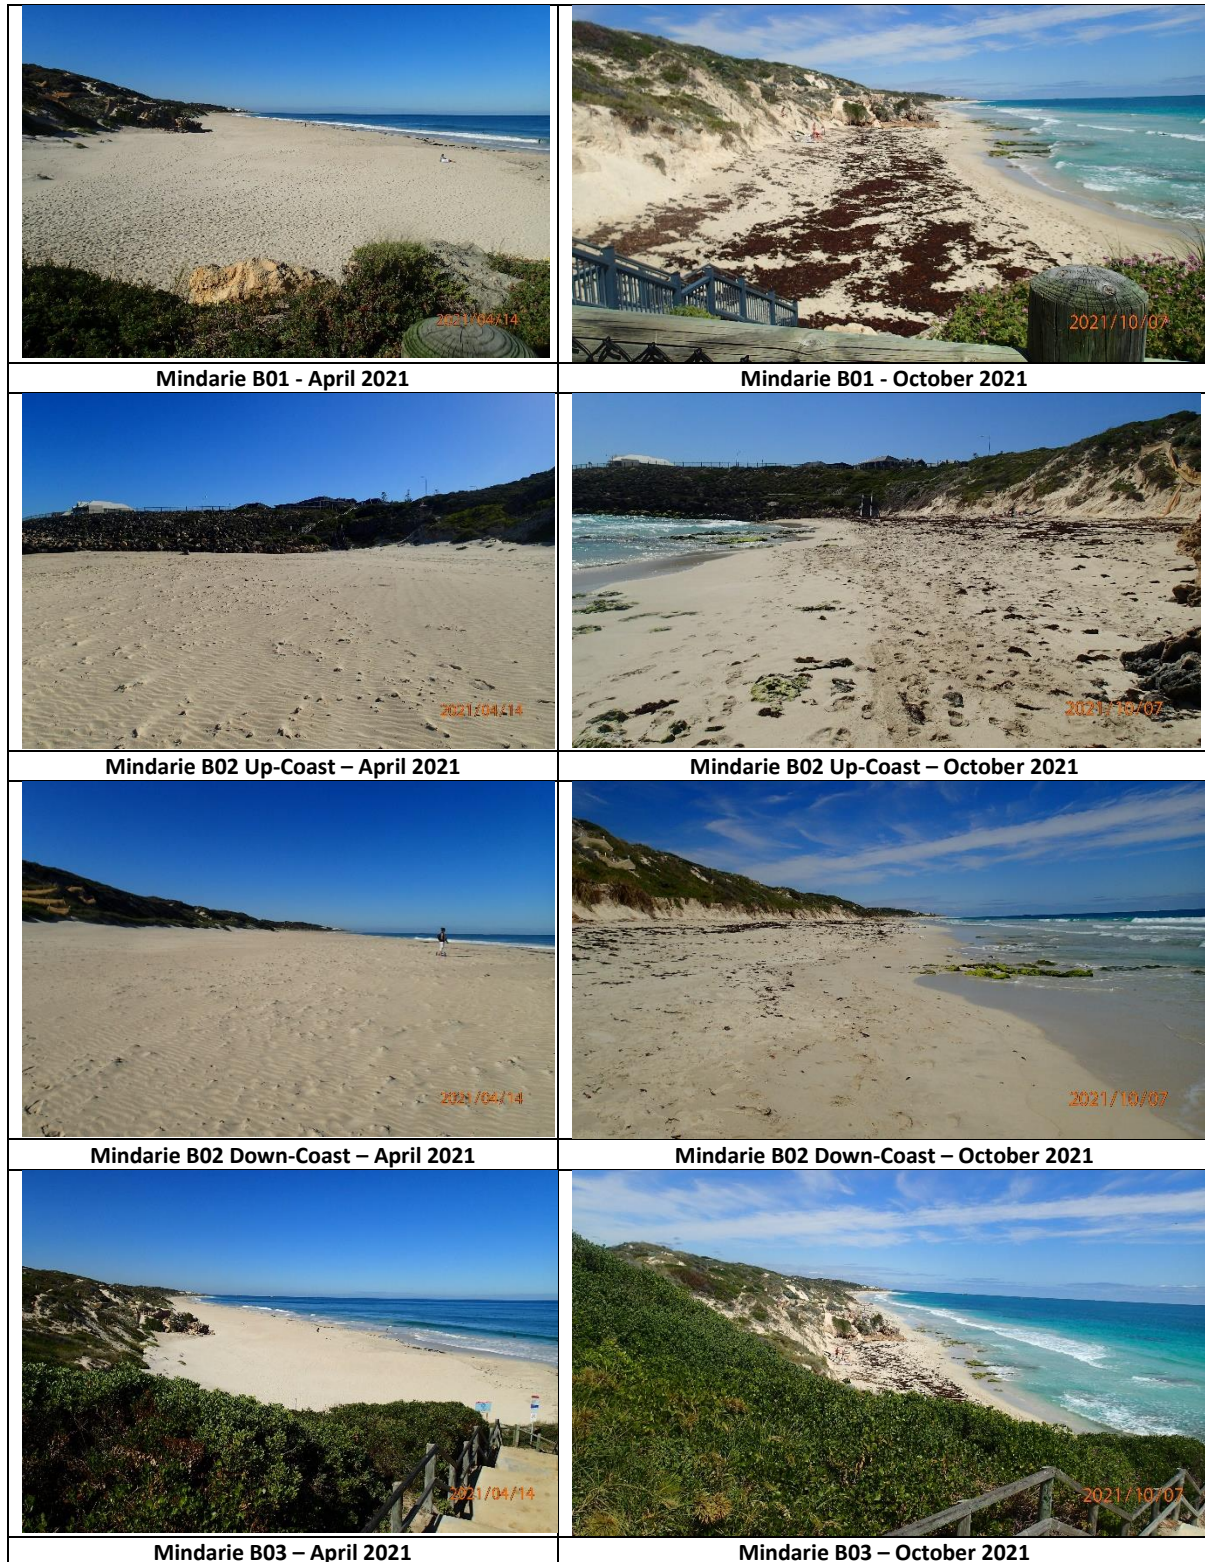
Mindarie B01, B02 and B03 – Major Erosion, Winter 2021

Figure 4-10 Major erosion over winter 2021 at Mindarie B01, B02 and B03.

Significant erosion was observed at Claytons Beach over the 2021 winter period. While the images show some beach remaining in October 2021, images taken at site B01 and B02 show significant impact to the base of the dunes at Claytons Beach. Claytons Beach experiences significant seasonal erosion and accretion each year however, the recurring winter storms in 2021 resulted in significant impact to the dune system including exposure of the concrete foundations for the Claytons beach access staircase. While there is little infrastructure landward of Claytons Beach it is recommended that the area be closely monitored in future coastal monitoring reports and if significant erosion continues coastal management measures should be investigated for the area.

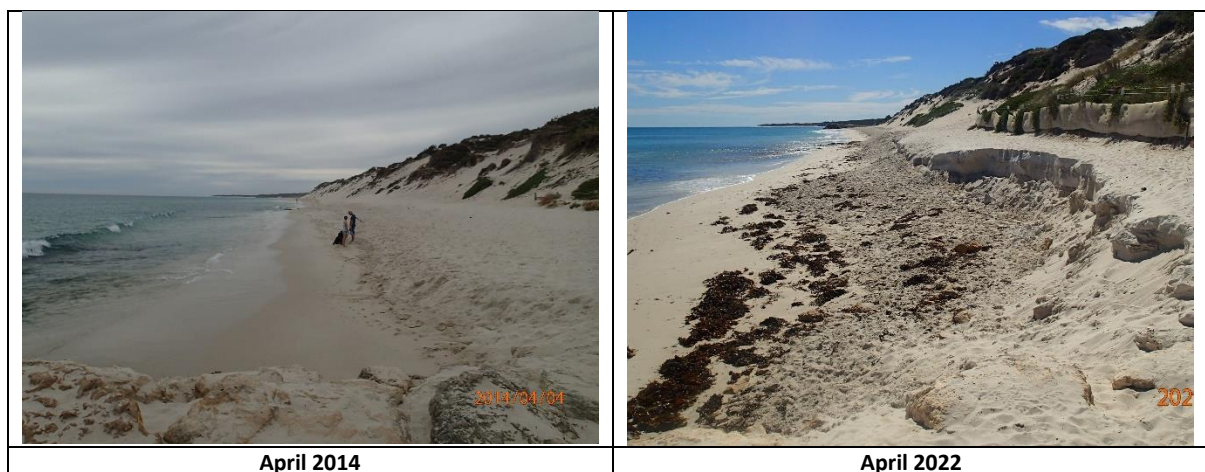
Quinns Rocks B13 Up-Coast – Long-Term Major Erosion

One site in Quinns Rocks was identified through manual imagery as having experienced major long-term erosion. The site, which is outlined below in Figure 4-11, is situated immediately north of Quinns Groyne 3, along Quinns Dog Beach. Despite the significant nourishment that has been undertaken at the site since 2004 (~80,000 m³), a narrow beach is evident in the image taken in April 2022 with notable impact to the base of the dunes. It is recommended that this site continue to be monitored closely.

Figure 4-11 Major long term erosion at Quinns Rocks B13.

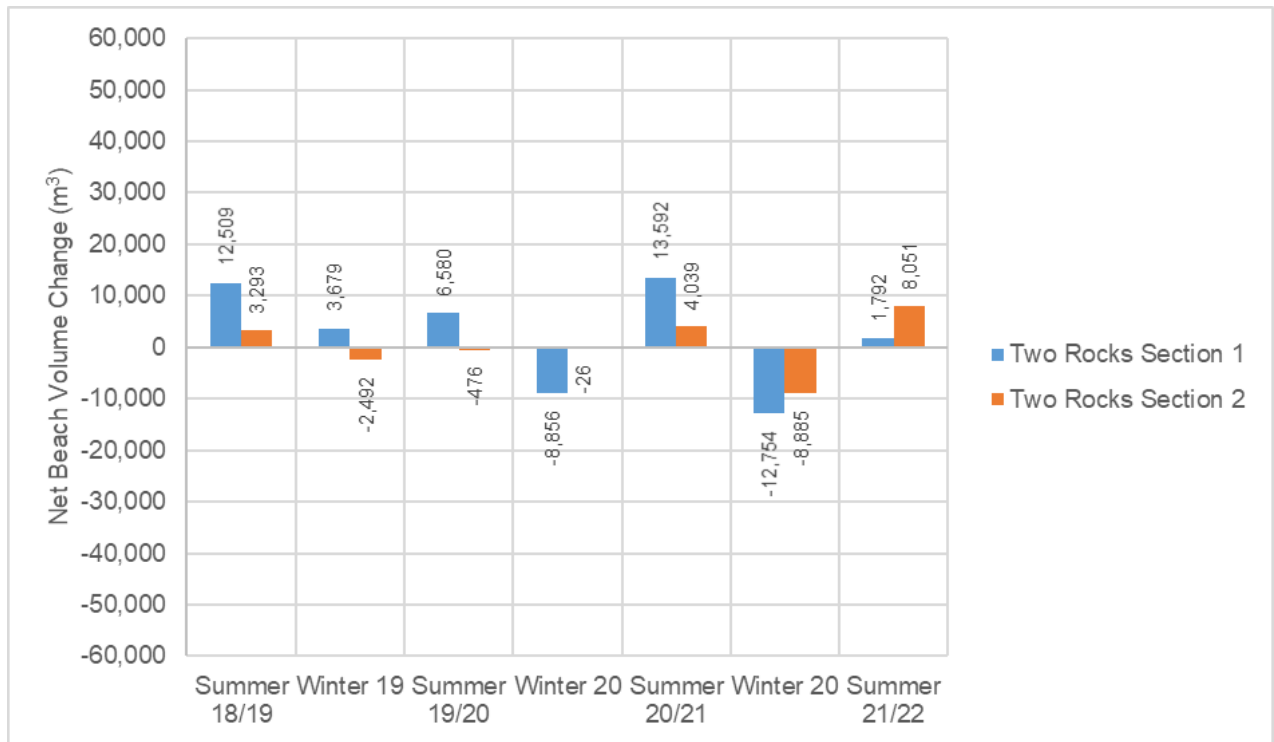
Figure 5-1 Seasonal net beach volume changes for Two Rocks Section 1 and 2.

Most areas present clear seasonal trends, often with a net beach volume loss recorded after the winter months and a net beach volume gain after the summer months. The seasonal net beach volume change plots also show that 11 out of the 13 beach sections assessed as part of the Coastal Monitoring Program display a negative trend in net beach volume change, that is, it appears as though beach volumes are decreasing overall. The most significant negative trend in net beach

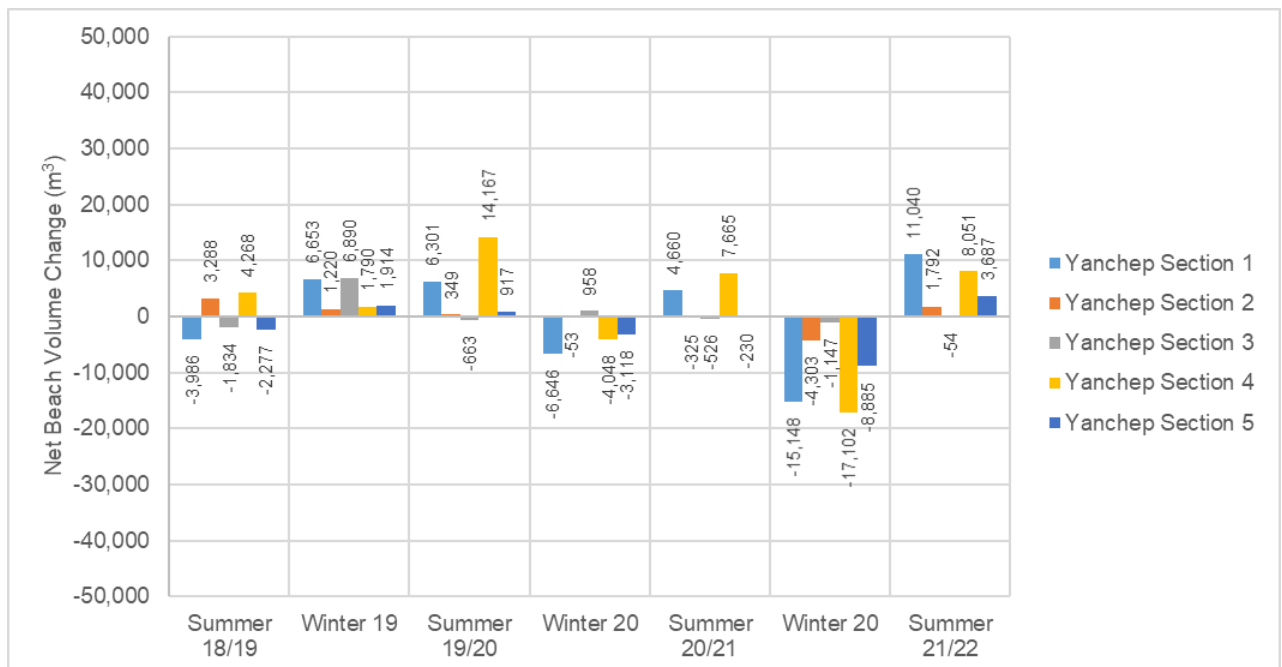
Figure 5-2 Seasonal net beach volume changes for Yancheep Section 1, 2, 3, 4 and 5.

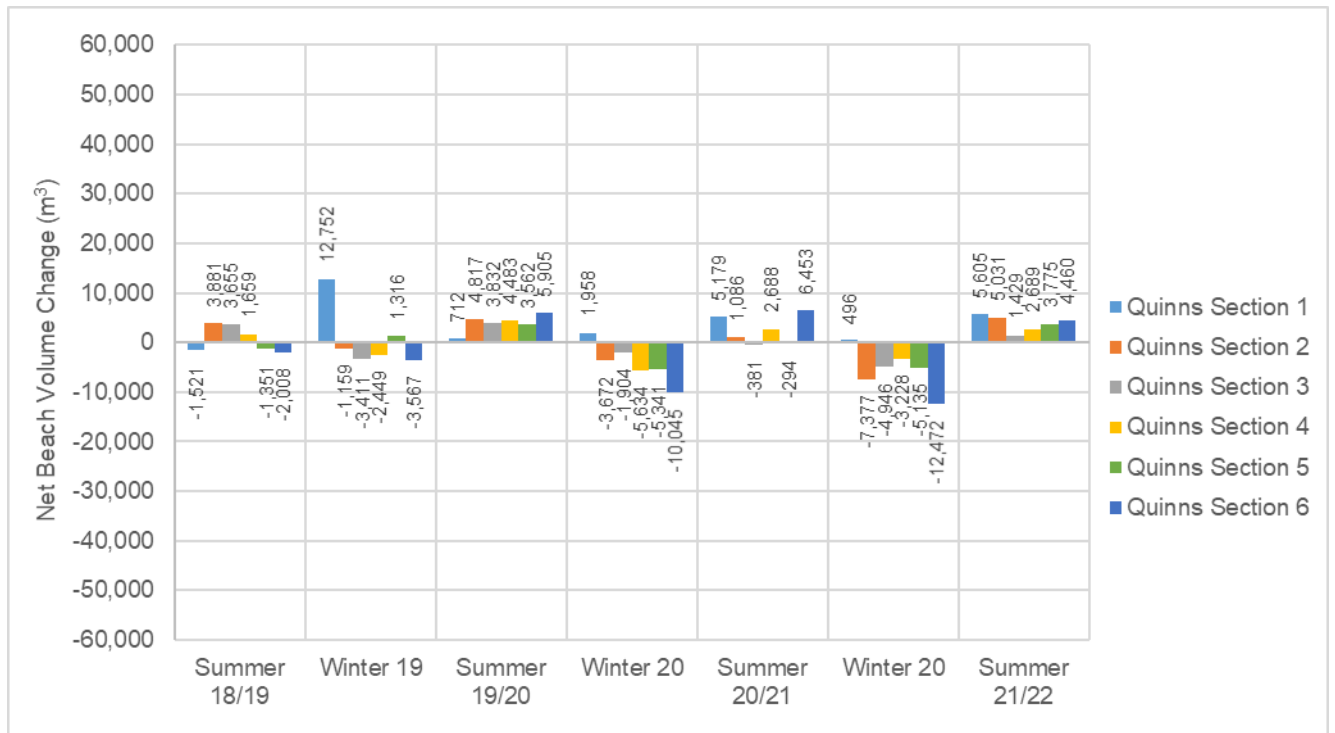
Figure 5-3 Seasonal net beach volume changes for Quinns Section 1, 2, 3, 4, 5 and 6.

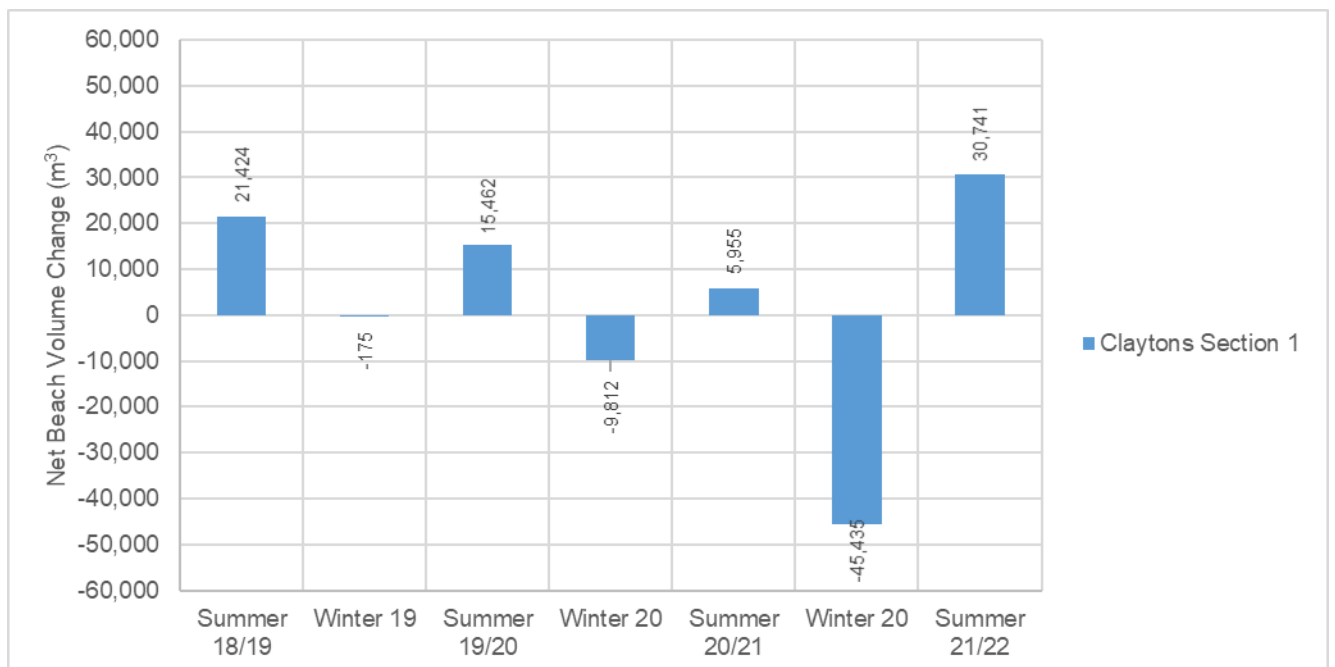
Figure 5-4 Seasonal net beach volume changes for Claytons Section 1.

volume was recorded at Claytons Beach in Mindarie which has seen a decrease in beach volume since 2018. It is recommended that Claytons Beach be closely monitored in future coastal monitoring reports to assess the long term changes in net beach volume. If net beach volume continues to decline rapidly at Claytons Beach, coastal management methods may need to be investigated and implemented.

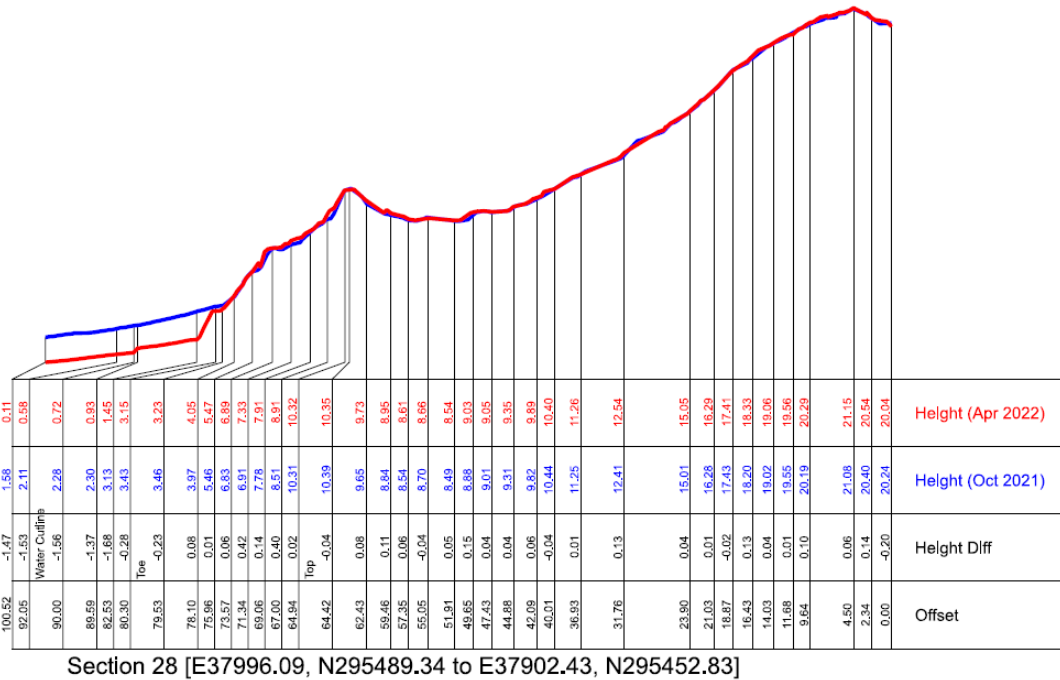
Figure 5-6 Quinns beach cross section 28 elevation comparison between October 2021 and April 2022 surveys.

Quinns beach cross-section 29 is situated within the field of view of manual imagery point 'Quinns Rocks B13 Up-Coast'. Figure 4-6 shows a significant reduction in elevation (1.68m) between the October 2021 and April 2022 surveys which is consistent with the major seasonal summer erosion that was identified at the site through manual imagery analysis (**Section 4.2.1**). Significant seasonal summer erosion is common at this site as strong sea breeze conditions promote the northward transport of sediment, away from Quinns Groyne 3.

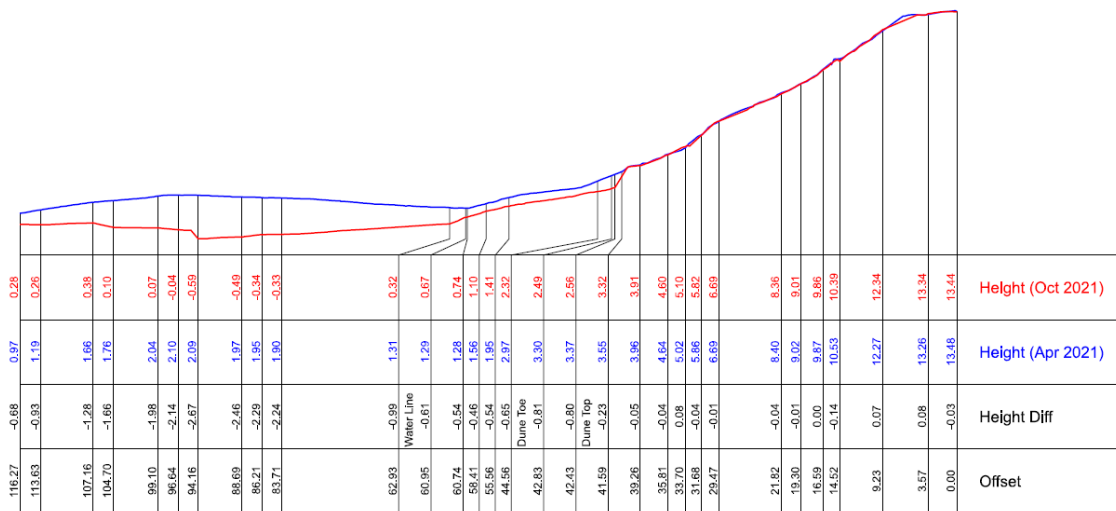
Section 21 [E32020.00, N307577.30 to E31914.25, N307528.96]

Figure 5-7 Yanchep Beach cross section 21 elevation comparison between April 2021 and October 2021 surveys.

Yanchep Beach cross section 21 is situated within the field of view of manual imagery point ‘Yanchep B07 Up-Coast’ where significant erosion was observed between April and October 2021 in manual imagery. While levels above the water line show only a minor drop in elevation, levels below the water line show quite a significant reduction in elevation, with the maximum height difference between the April and October 2021 survey was 2.67m. These results outline the benefits of undertaking additional ground based nearshore survey transects as without the nearshore transects we would only see the elevation difference above the waterline which is minimal in comparison to the elevation difference below the waterline. The significant drop in elevation below the waterline suggests significant erosion in area over winter 2021 which is consistent with manual imagery observations.

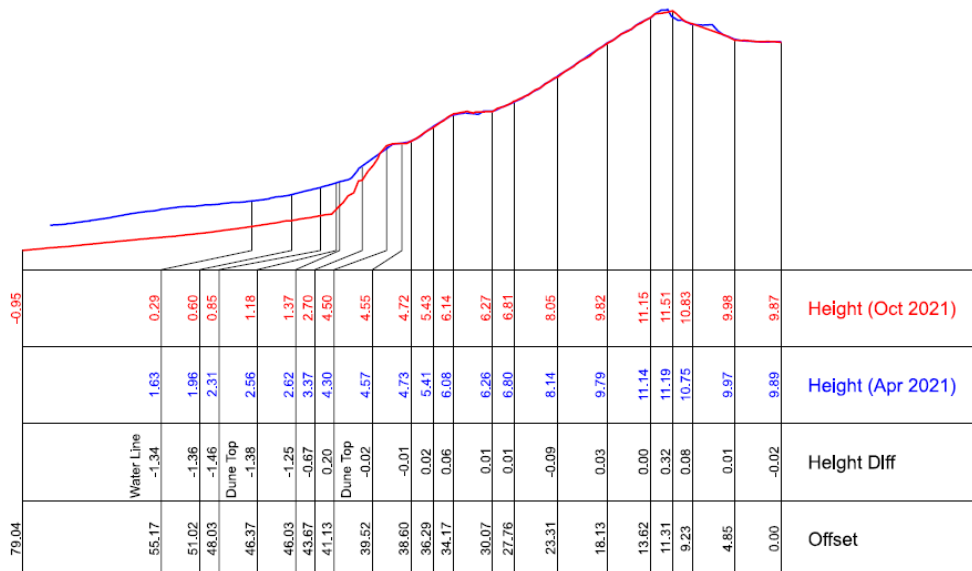
Section 13 [E38125.29, N294290.91 to E38046.74, N294282.21]

Figure 5-8 Quinns Beach cross section 13 elevation comparison between April 2021 and October 2021 surveys.

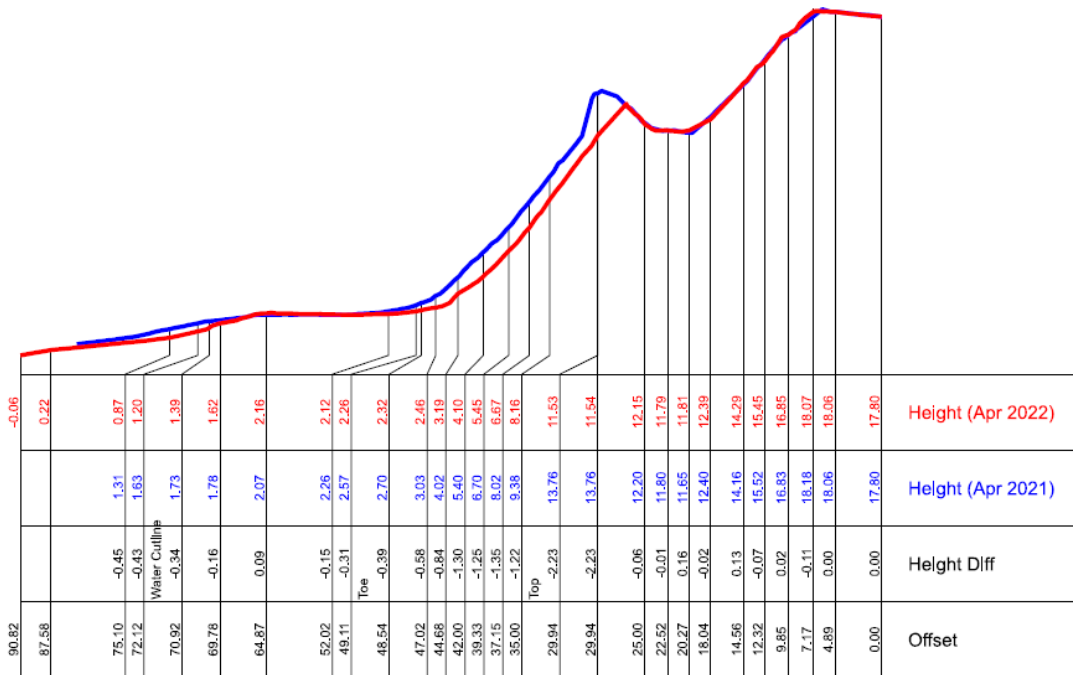
Section 32 [E37837.70, N295882.31 to E37753.08, N295849.32]

Figure 5-14 Cross section 32 at Quinns Beach which shows dune recession of 3m between April 2022 and April 2021.

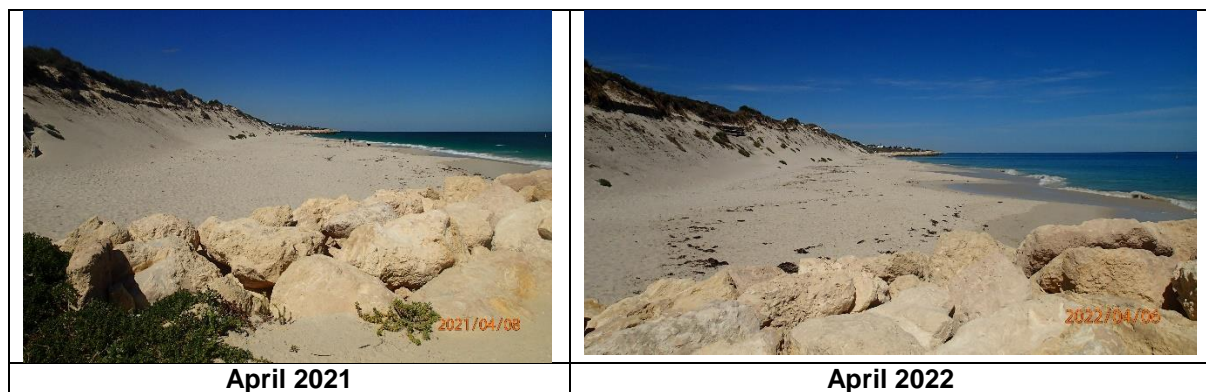
Figure 5-15 Manual images taken at Quinns B14 Down-Coast.

The cross section presented in Figure 5-14 shows a significant recession of the dune face between the April 2021 survey and the April 2022 survey. This was not identified in manual imagery (Figure 5-15) as the dune face is not a main focus of the manual imagery field of view and recession in the dune face is difficult to interpret using manual imagery alone.
