City of Wanneroo Coastal Monitoring Report April 2022

1 Introduction

1.1 Coastal Foreshore Monitoring

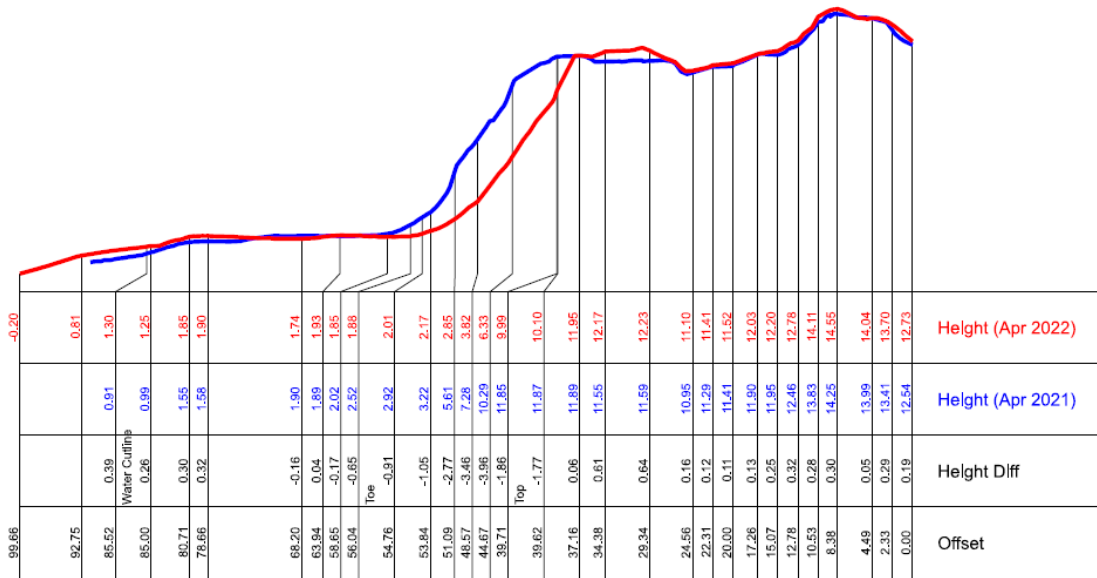
Section 53 [E37229.95, N297359.72 to E37139.95, N297316.92]

Figure 5-16 Cross section 53 at Quinns Beach which shows an elevation difference of 3.96m at the top of the dune between April 2022 and April 2021 which translates to a recession of approximately 4m of the dune.

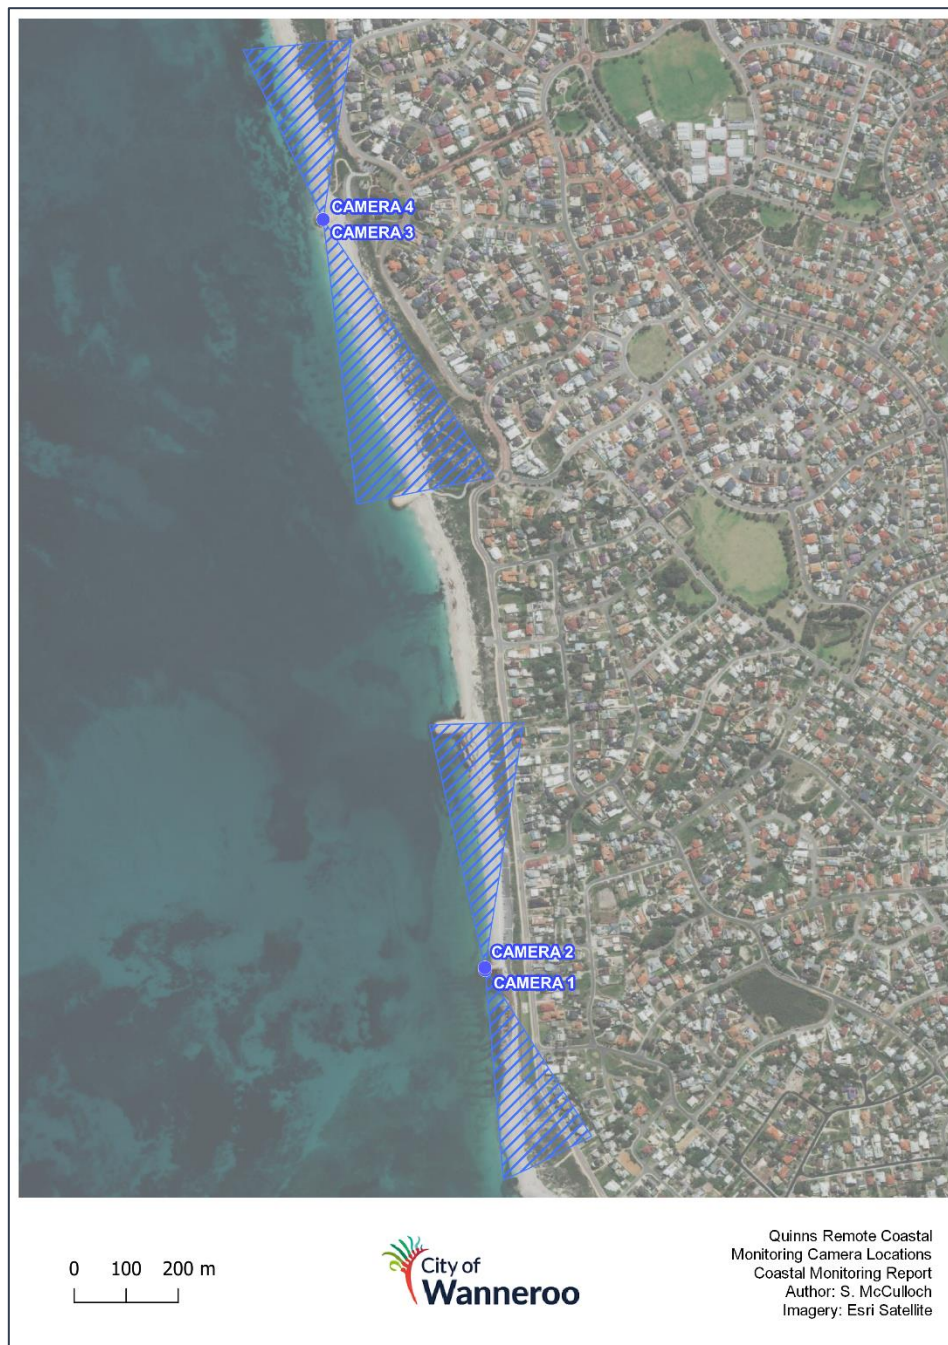
Five remote monitoring cameras were installed along Quinns and Yanchep Beach in November 2021. The location and field of view of the cameras was selected to monitor vulnerable sections of the City's coastline, these locations are presented below in Figure 6-1 and Figure 6-2. The remote monitoring cameras take photos hourly between 7:00am and 6:00pm. Timelapse videos were created for each camera to assess morphological changes to the coastline between November 2021 and the beginning of April 2022.

Quinns Rocks Remote Coastal Monitoring Camera Locations.

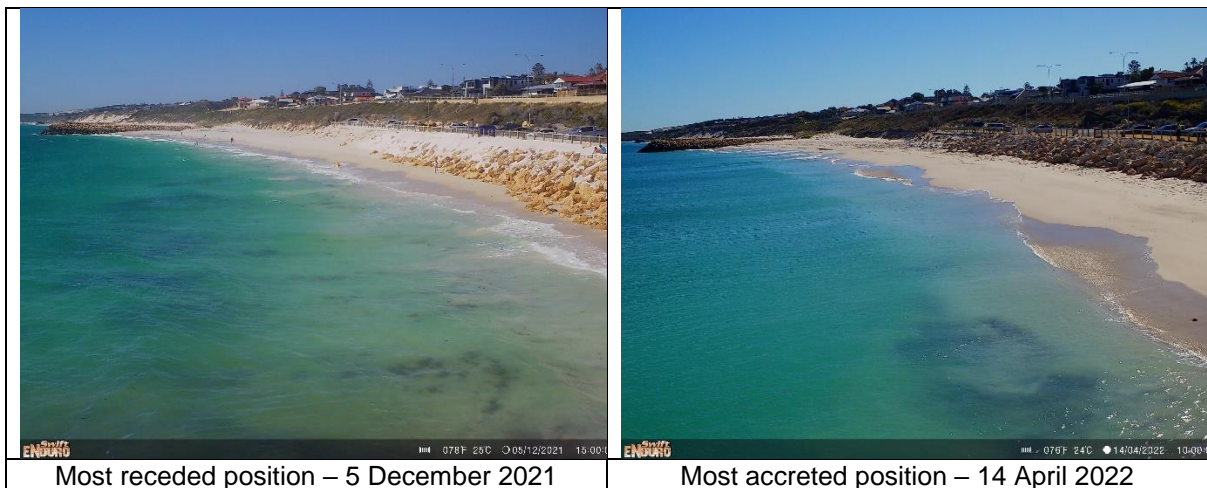
Quinns Camera 2 captures the beach immediately north of Groyne 1, adjacent to the Frederick Stubbs Carpark. Hourly images from the camera show the beach eroding significantly over November 2021 through to January at which point the beach begins accreting up until the end of the study period in April 2022. Accretion of the beach in the summer period is not expected, as prevailing southerly winds generally transport sand north where it is deposited to the south of the Groyne 2 however it is believed that the significant build up to the south of Groyne 1 has resulted in bypassing of sand around the Groyne and onto the beach, adjacent to the carpark.

Figure 6-4 Most receded position – 5 December 2021 Most accreted position – 14 April 2022
Most receded and most accreted shoreline position to the north of Quinns Groyne 1 during the study period.

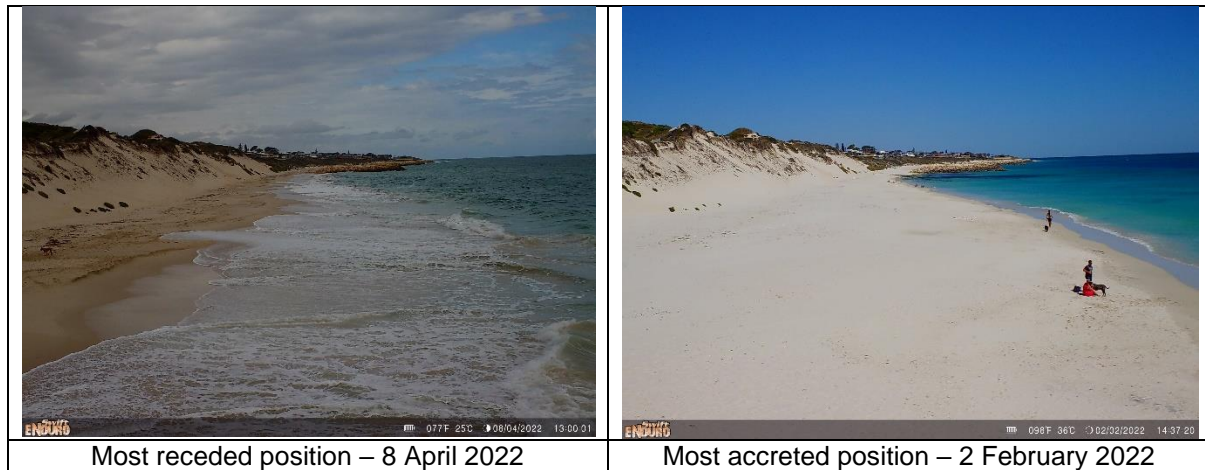
Figure 6-5

image taken towards the end of the monitoring period in April 2022. It is important to note that these images were only taken two months apart and represent a significant change in beach condition over a short time period.

Most receded and most accreted shoreline position to the south of Quinns Groyne 4 during the study period.

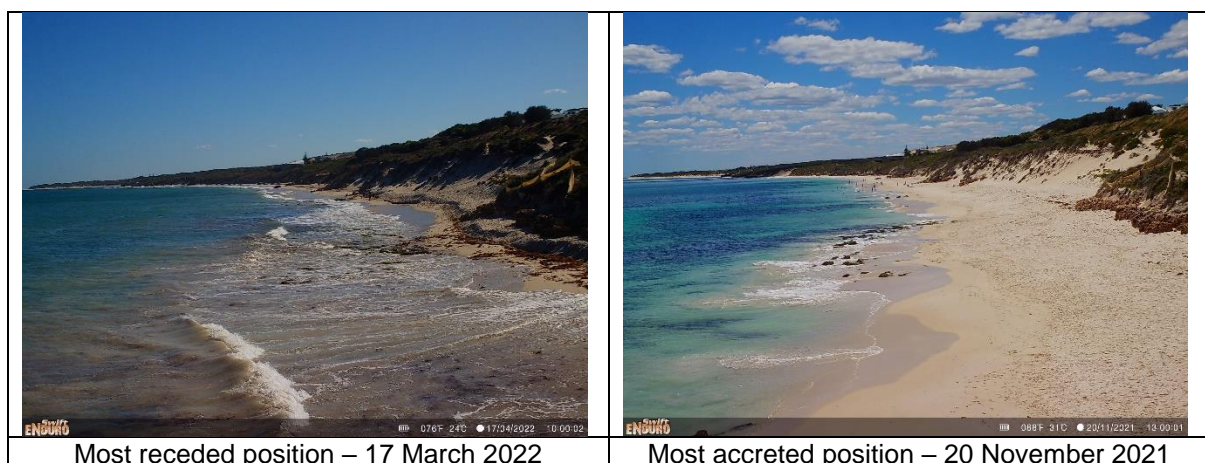
Figure 6-6

The area to the north of Quinns Groyne 4, along the Quinns Dog Beach, continuously eroded throughout the study period. The beach was at its most accreted position at the beginning of the study period in November 2021 and its most eroded position towards the end of study period, in March 2022. Seasonal erosion over the summer period is expected in this area as prevailing southerly winds generally transport sand to the north, away from the Groyne. The significant seasonal summer erosion leaves the beach, and adjacent dune areas, vulnerable to the impacts of winter storms however over the winter months it is expected that the beach will build up as a result of southerly longshore transport.

Most receded and most accreted shoreline position to the north of Quinns Groyne 4 during the study period.

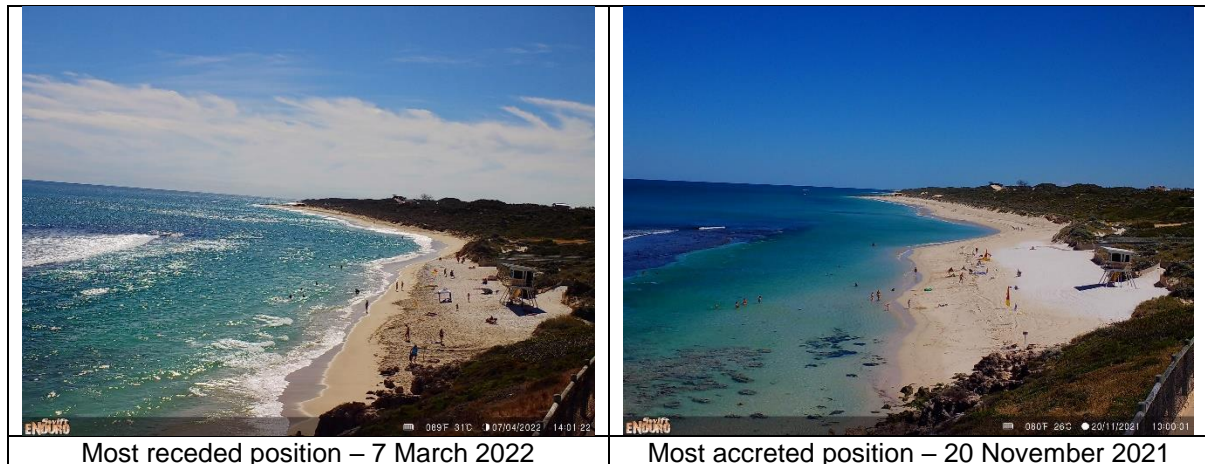
Figure 6-7

The Yanchep Lagoon beach area that is monitored by Camera 5 experienced erosion over the study period, with the most receded beach position at the site identified toward the end of the study period, in March 2022. Again, seasonal erosion over the summer period is expected in this area as prevailing southerly winds generally transport sand to the north, away from the limestone outcrop to the south of the Lagoon.

Most receded and most accreted shoreline position at Yanchep Lagoon Beach.

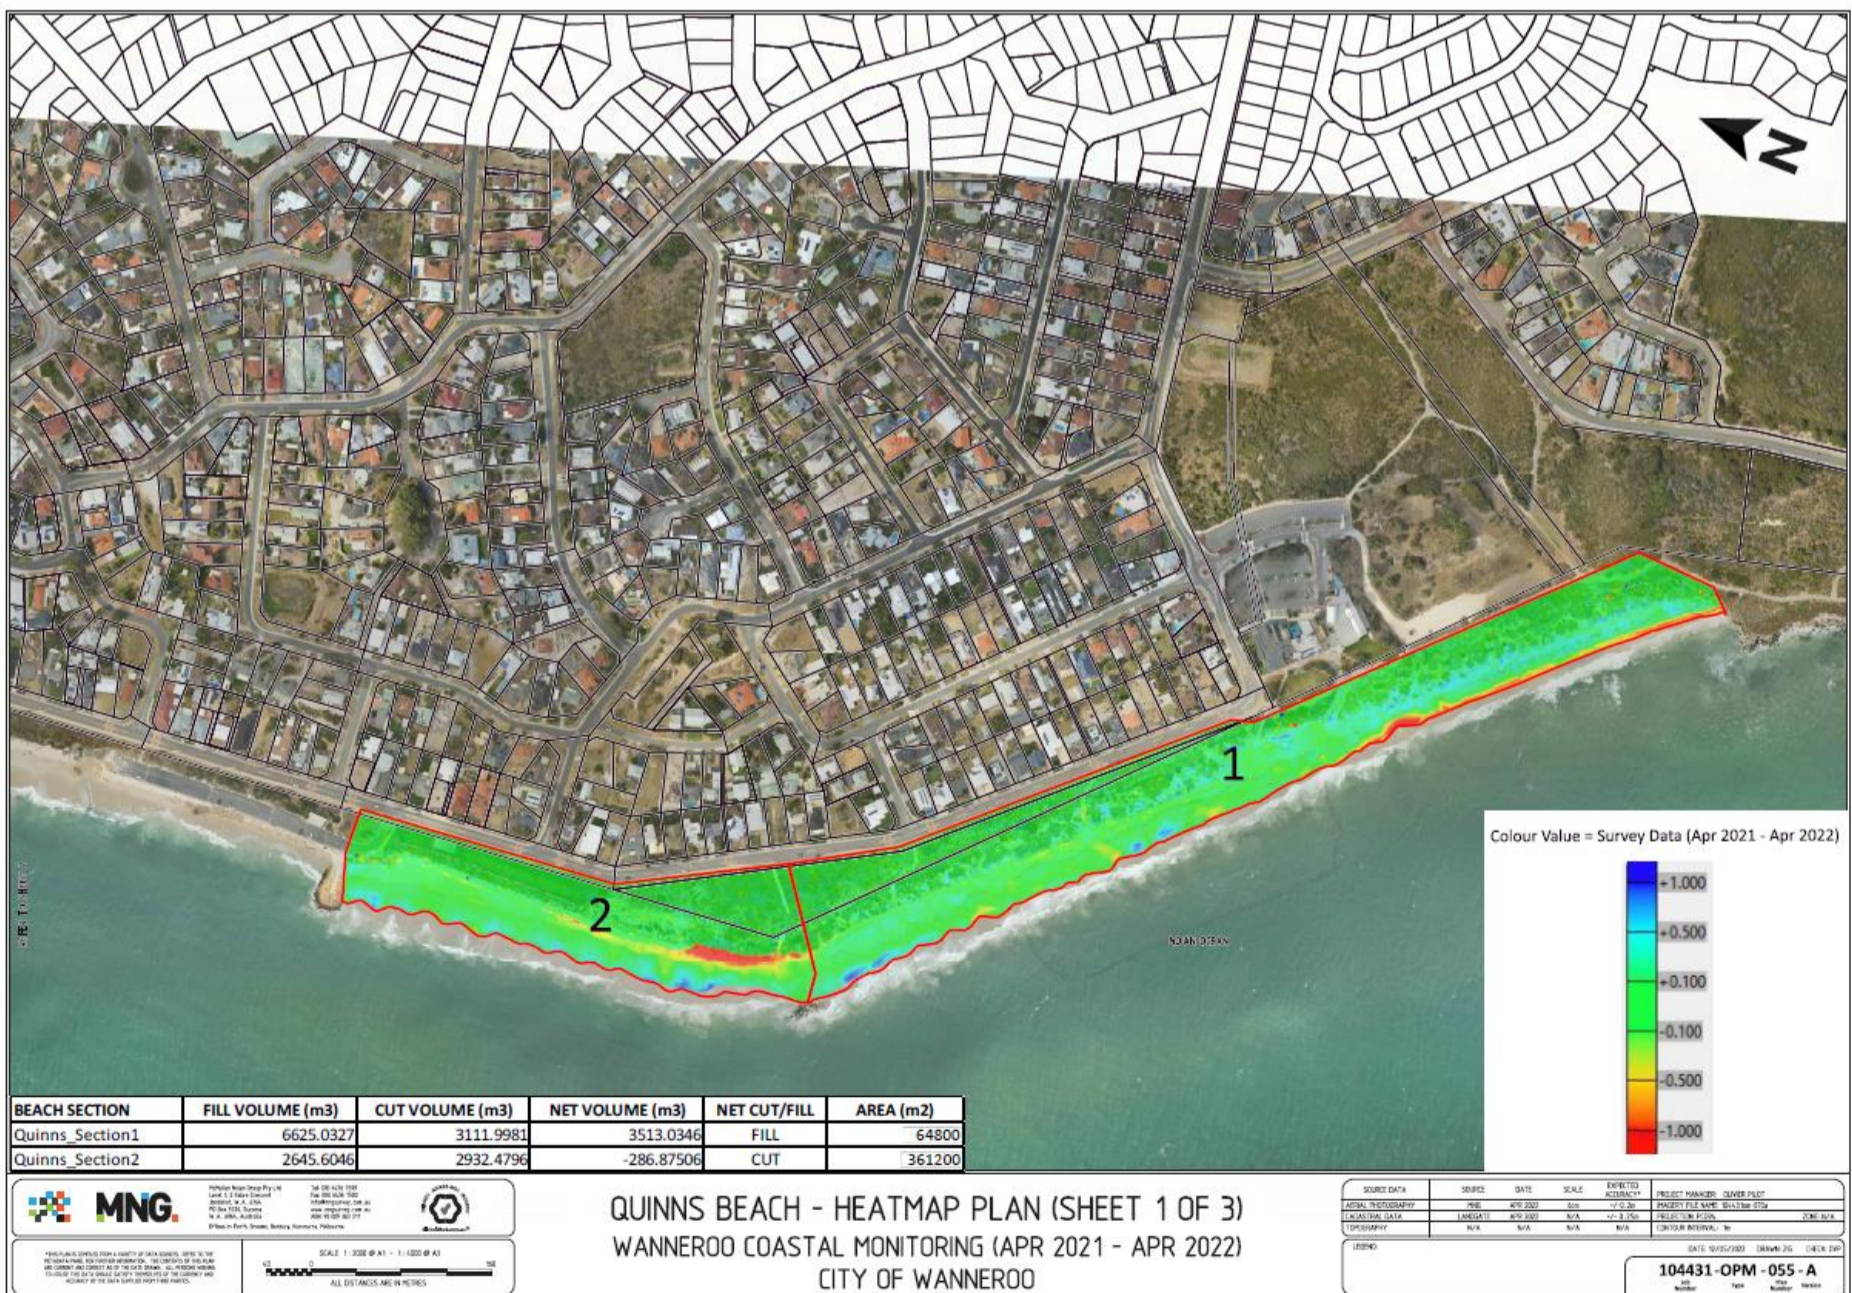
Beach Volume Changes between April 2021 and April 2022

QUINNS BEACH - HEATMAP PLAN (SHEET 2 OF 3)
 WANNEROO COASTAL MONITORING (APR 2021 - APR 2022)
 CITY OF WANNEROO
