City of Wanneroo Coastal Monitoring Report October 2022

1 Introduction

1.1 Coastal Foreshore Monitoring

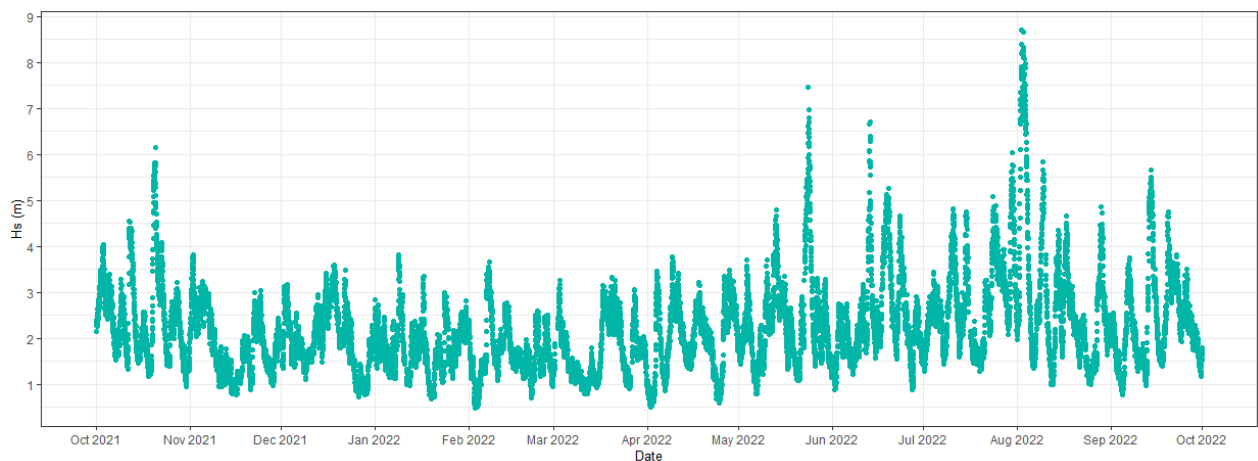
Figure 2-2 Total Significant Wave Height (Hs) recorded at the Rottnest Island Wave Station from October 2022 to October 2022.

The most notable observations from Figure 2-2 are the storm events that were recorded on the 20th of October 2021, 24th of May 2022, 13th of June 2022 and the 3rd of August 2022. The storm that resulted in the most significant infrastructure damage and erosion along the City's coastline occurred on the 3rd of August 2022 which had a peak total significant wave height of 8.67m which was recorded at 2:09 AM on 3rd August 2022.

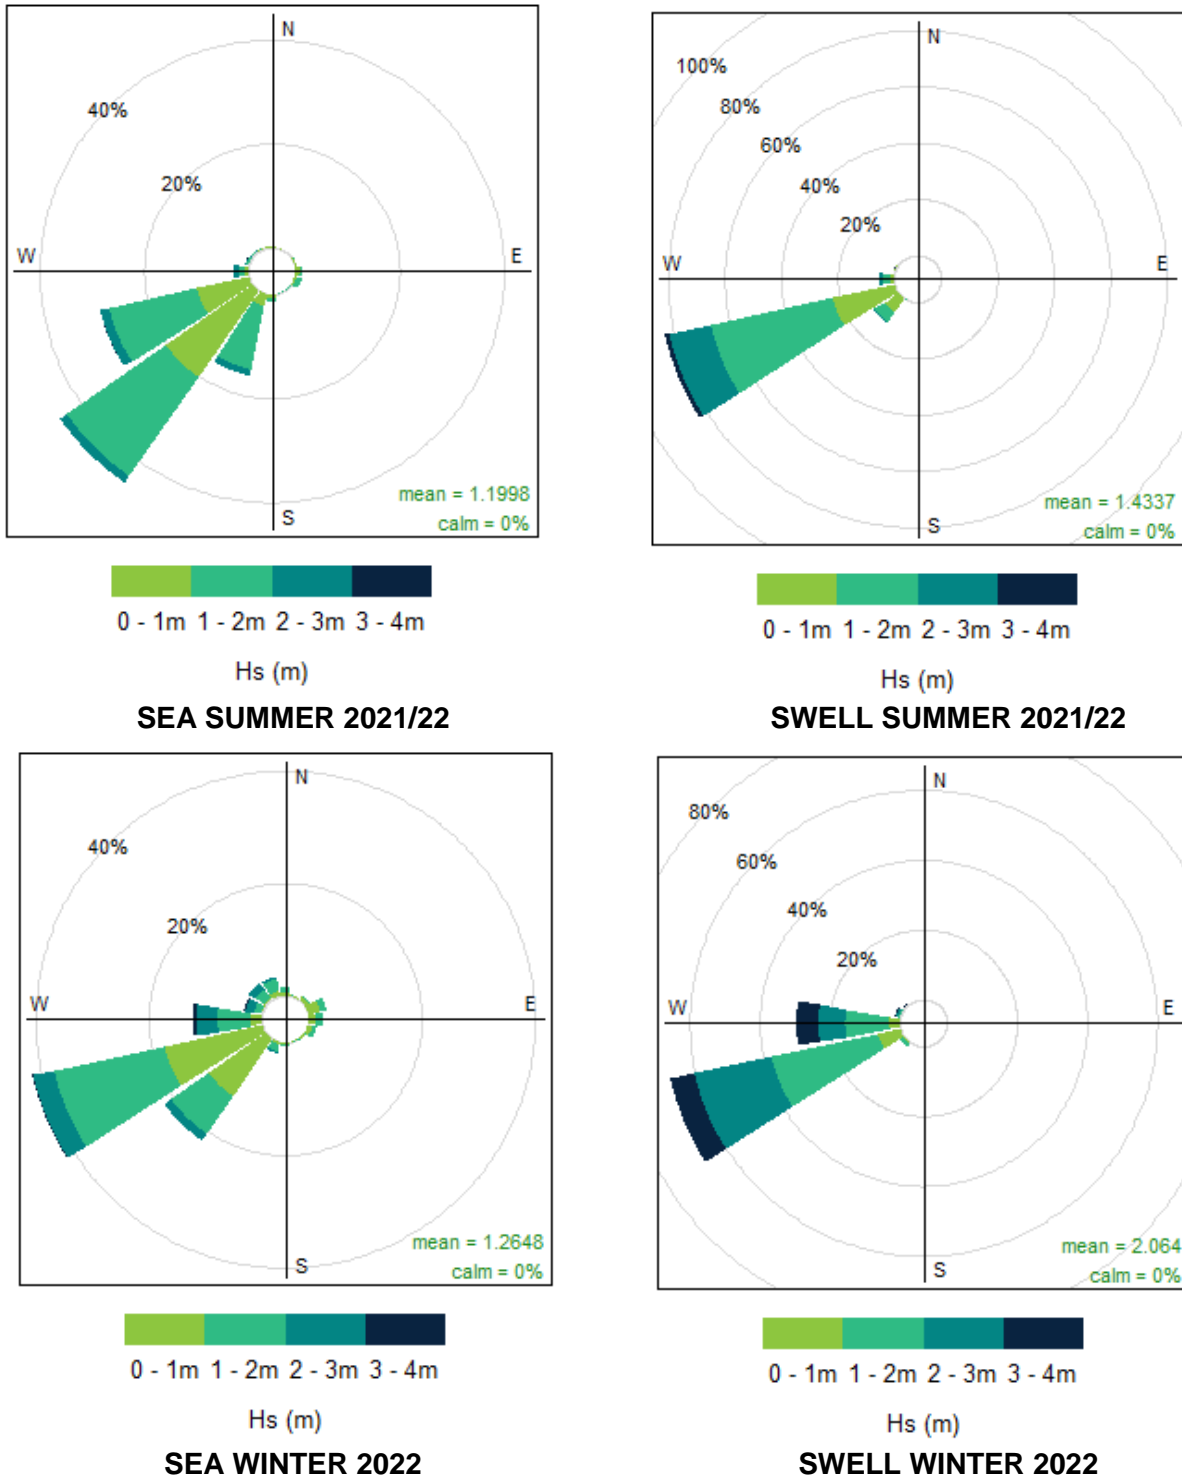
Figure 2-3 Wind rose plots of sea and swell significant wave heights from the summer season (October 2021 to March 2022) and the winter season (April to September 2022)

As seen in Figure 2-3, the wave climate for both the summer and winter periods is characterised by west south westerly waves and, as expected, there is an increase in swell height during the winter period. Wave direction across the year was typically recorded from a WSW direction.

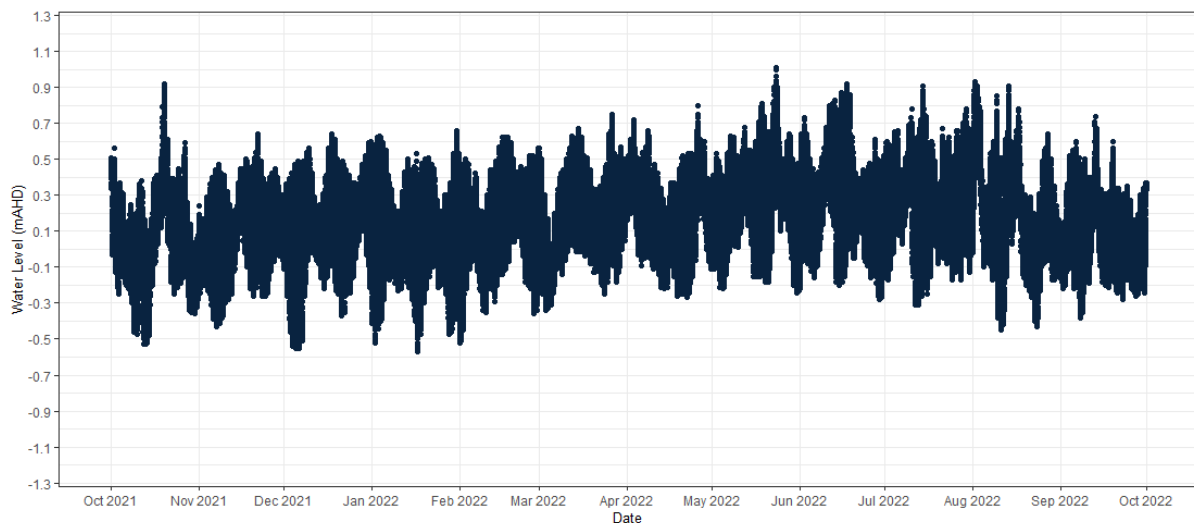
Figure 2-4 Water level (mAHD) recorded at the Fremantle Fishing Harbour Tide Station from October 2021 to October 2022.

Total recorded water level at the Fremantle Tide Station for October 2021 to October 2022 is presented in Figure 2-4. The highest water level recorded was 1.10 mAHD recorded at 1:15PM on 23rd of May 2022 and the peak storm surge (0.83m) was observed on the 2nd of August at 3:30AM. The winter storm that extended over three days at the beginning of August 2022 was characterised by an extended storm surge and high significant wave heights. This resulted in significant erosion and infrastructure damage to Mindarie Breakwater, Frederick Stubbs Staircase, Queenscliffe Dog Beach Dune System, Jindalee Staircases and Amberton Beach Access Ways. Further details of the storm damage are outlined in Section 3.

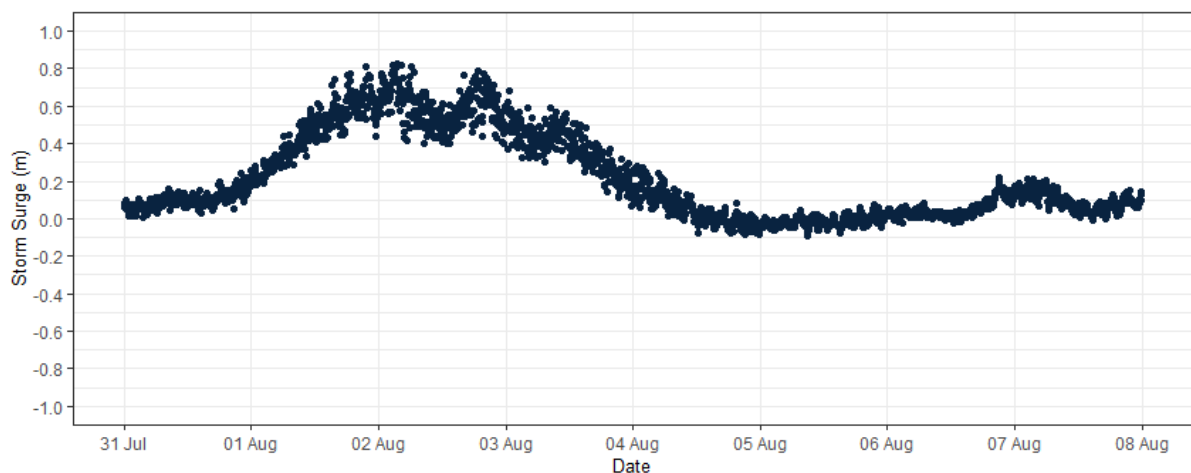
Figure 2-5 Storm surge recorded at the Fremantle Fishing Harbour Tide Station during the August 3rd storm event.

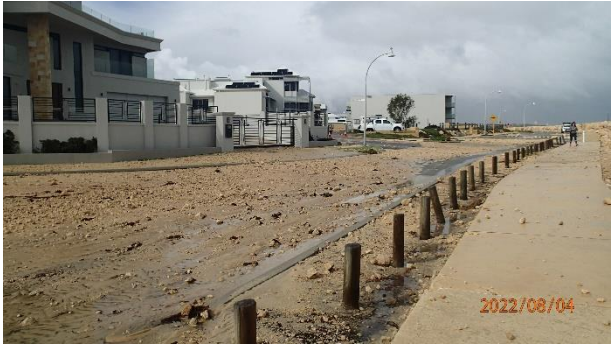
Damaged Asset	Damage	Action Taken by the City	Photograph of the asset following actions
Mindarie Breakwater and adjacent road infrastructure

<p>Immediately following the August storm event, the road was cleaned and any debris was removed.</p> <p>Complete asset upgrade/renewal works are planned to begin in February 2023.</p>

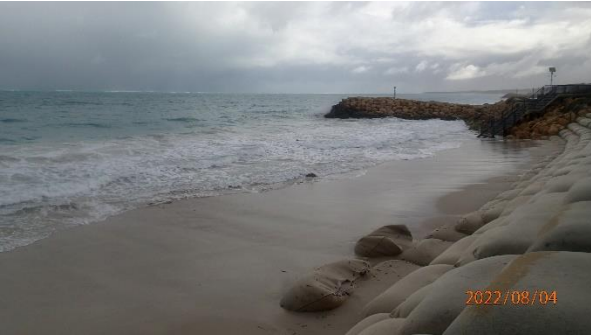
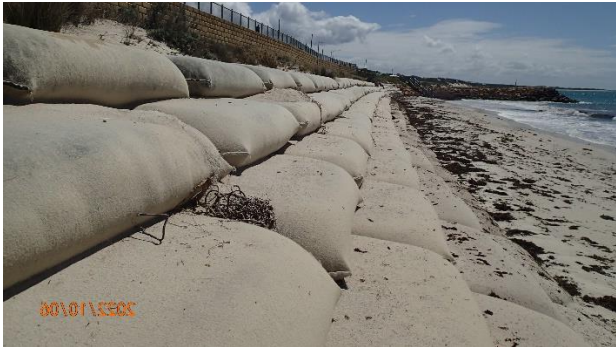
Damaged Asset	Damage	Action Taken by the City	Photograph of the asset following actions
<p>Frederick Stubbs GSC Revetment, Quinns Rocks</p>

<p>Some of the geotextile sand containers (GSCs) were buried shortly after being dislodged from the revetment. The GSCs that could be recovered were removed from the beach. Any additional repair works will be investigated if the structure begins to slump.</p>

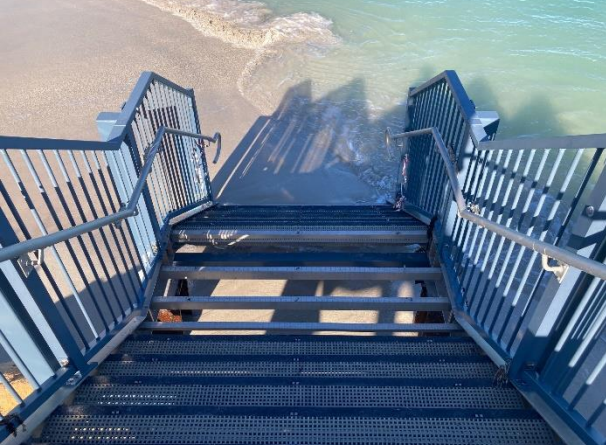
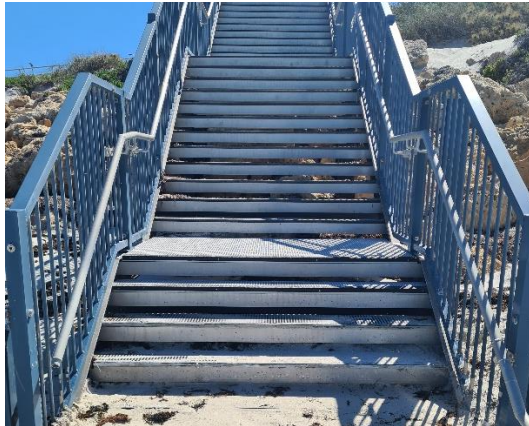
<p>Beach Access Staircase, Quinns Beach</p>

<p>The base of the beach access staircase at Quinns Rocks was damaged following the August storms. A contractor was engaged to repair the decking and fixings.</p>

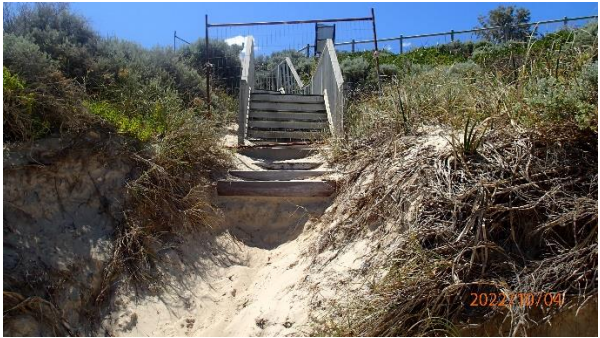
Damaged Asset	Damage	Action Taken by the City	Photograph of the asset following actions
<p>Fisherman's Hollow Beach Access, Yanchep</p>

<p>The City is currently in the process of obtaining the required approvals to install an extension to the southern arm of the staircase. Due to significant seasonal erosion, this site is only accessible in the months of April and May.</p>	<p>Action is yet to be taken as the City are awaiting heritage approval for the works. Works are scheduled for April 2023.</p>
<p>Southern Fisherman's Hollow Beach Access, Yanchep</p>

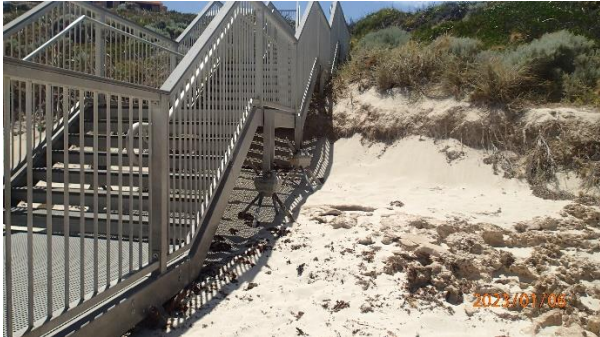
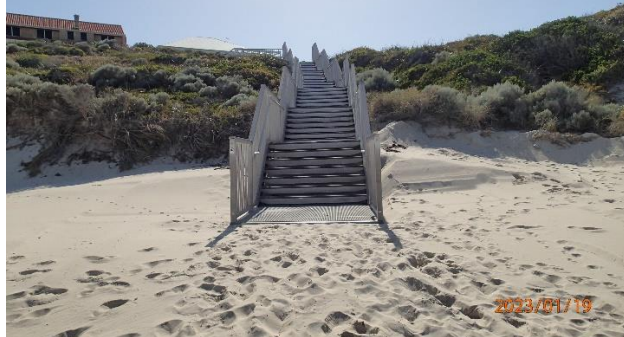
<p>The southern staircase at Fisherman's Hollow was undermined following a significant erosion event. The City have backfilled underneath the staircase to ensure safe access. The footings for this staircase are anchored into rock and it remains safe to use.</p>

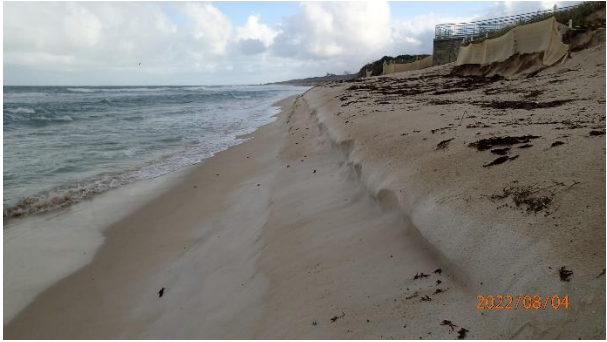
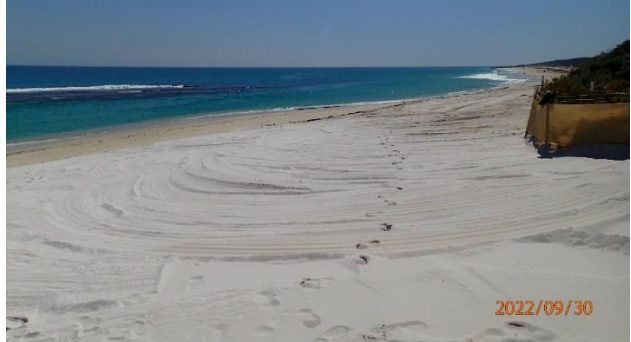
Damaged Asset	Damage	Action Taken by the City	Photograph of the asset following actions
<p>Yanchep Lagoon Beach Access, Yanchep</p>

<p>2022/08/04</p>	<p>The City undertook reactive beach nourishment at Yanchep Lagoon in September 2022 to provide a safe beach for beach users. Further details of the nourishment are outlined in Section 8.5.</p>

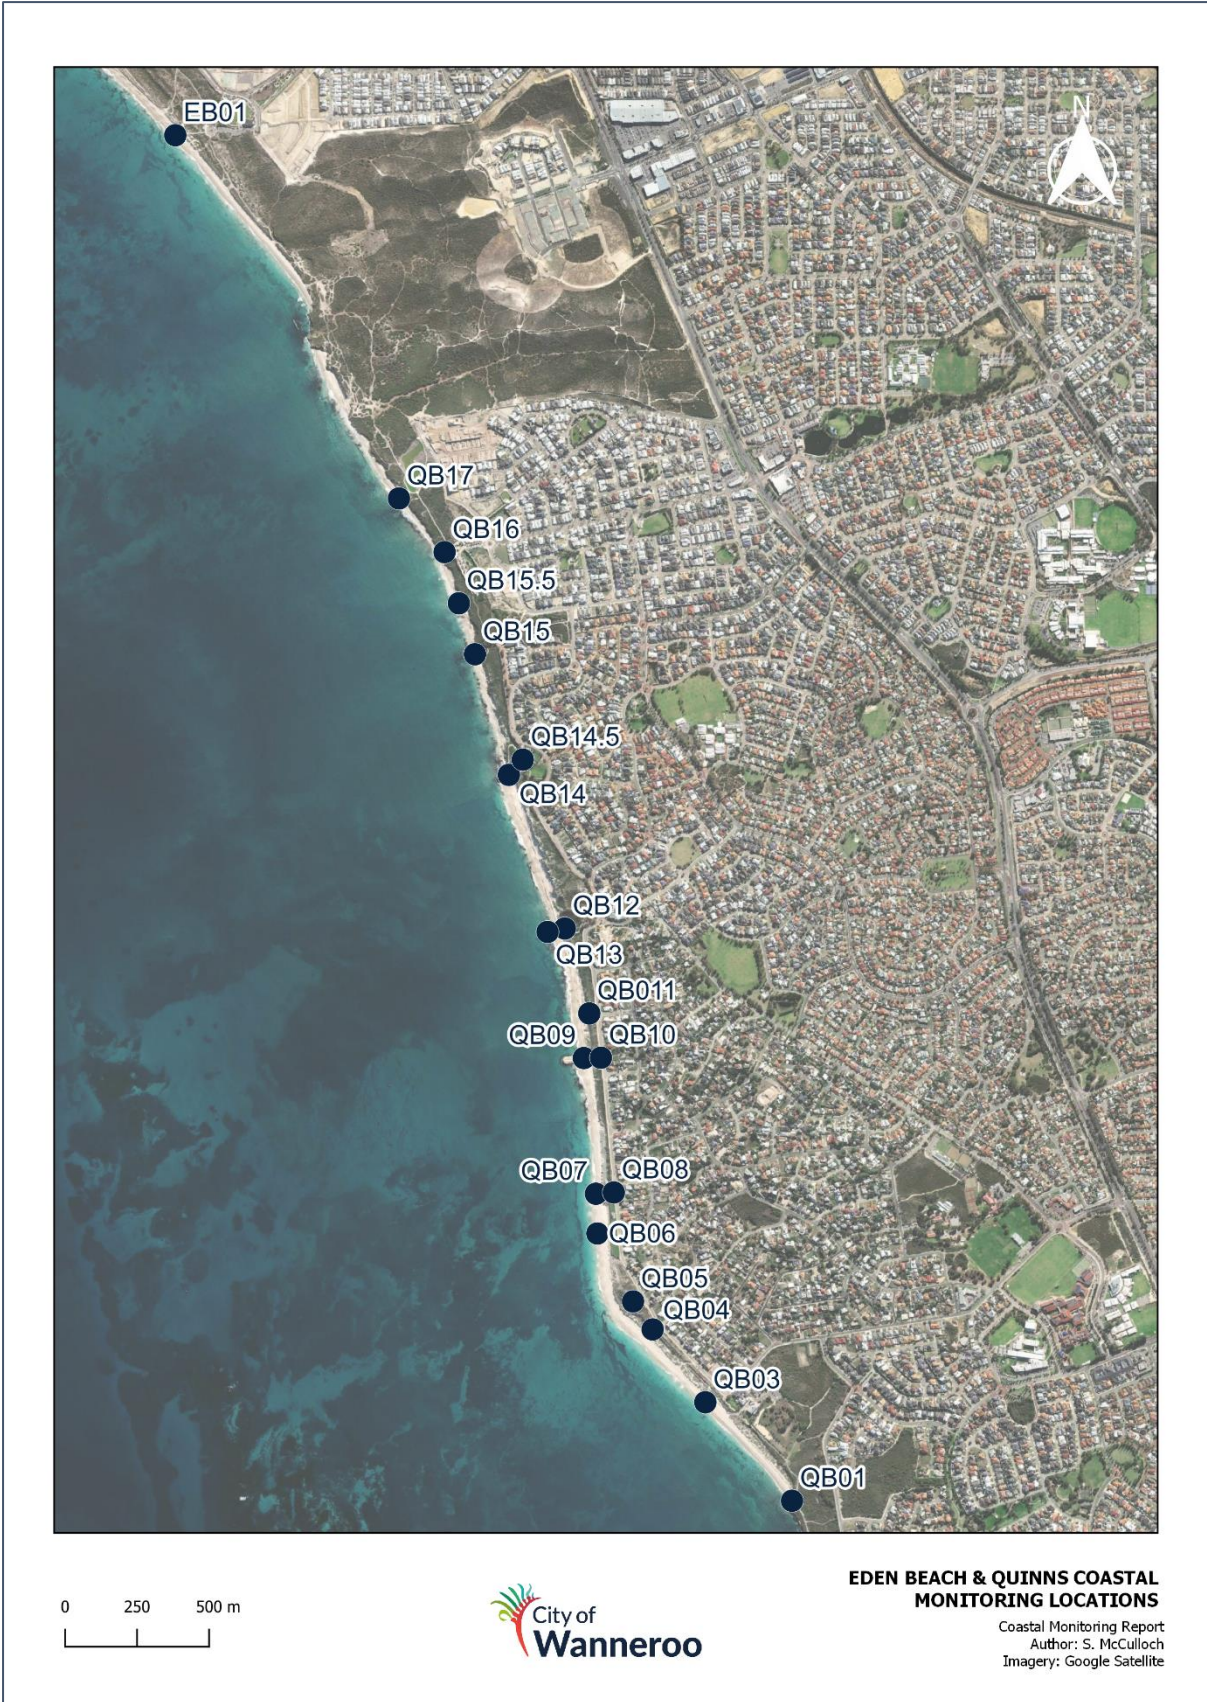
Figure 4-4 Eden, Jindalee and Quinns Rocks Coastal Monitoring Locations

There are a total of 49 manual imagery beach monitoring sites located in key vulnerable coastal areas along the CoW coastline. The position of these sites are presented in Figure 4-1 to Figure 4-4. Images are taken 6 monthly in April and October each year to assess seasonal and long term changes to beach morphology. Images are taken by CoW's Coastal Engineer and are taken at the same location and with same field of view each time.

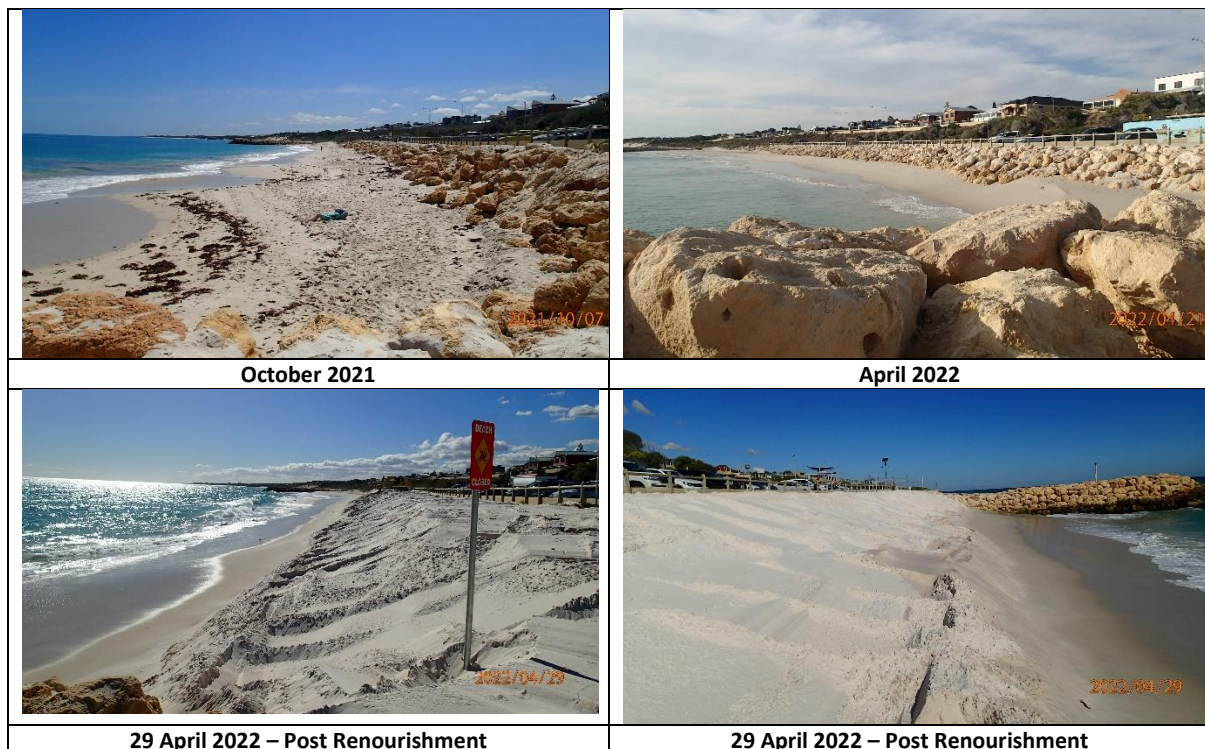
Quinns Rocks B07 Up-Coast – Major Erosion, Summer 2021/22

Figure 4-6 Major erosion over summer 2021/22 at Quinns B07 Up-Coast.

Major erosion was identified through manual imagery in the area immediately north of Quinns Groyne 1. Major seasonal erosion is experienced at this site each year and in response, the City undertakes planned re-nourishment at the site prior to each winter period. Following the April 2022 monitoring round, approximately 4000 tonnes of sand was placed at this site. The additional sand that is placed following renourishment creates a buffer against the impacts of winter storm events and limits the damage to coastal assets.

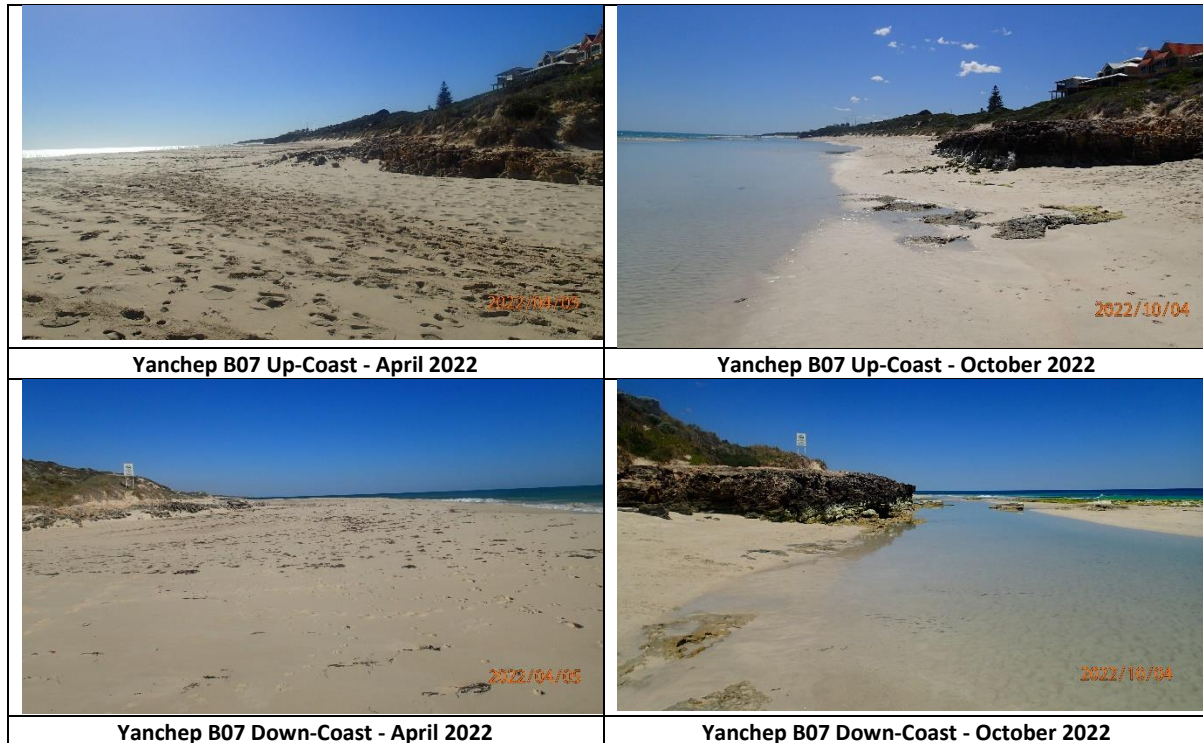
Yanchep B07 Up-Coast and Down-Coast – Major Erosion, Winter 2022

Figure 4-7 Major erosion over winter 2021 at Yanchep B07 Up-Coast and Down-Coast.

The beach captured in the photographs taken up-coast and down-coast at the Yanchep monitoring location B07 is bounded by a headland to the north and south. There was a significant reduction in beach width over the 2022 winter period with the transport of sediment southward over the winter months, bypassing the southern headland and feeding the southern beach, resulting in erosion at the site. Northward movement of sediment during the summer months resulted in significant accretion at the site which provided a substantial buffer against early winter storms. While there is major seasonal changes at the site, the long term manual imagery assessment suggests that the site has experienced very minor erosion since the start of monitoring in 2019. It is important to note, however, that residential houses and road infrastructure are in close proximity to the site and could, in future, be susceptible to the effects of coastal erosion. It is therefore recommended that the site be monitored closely.

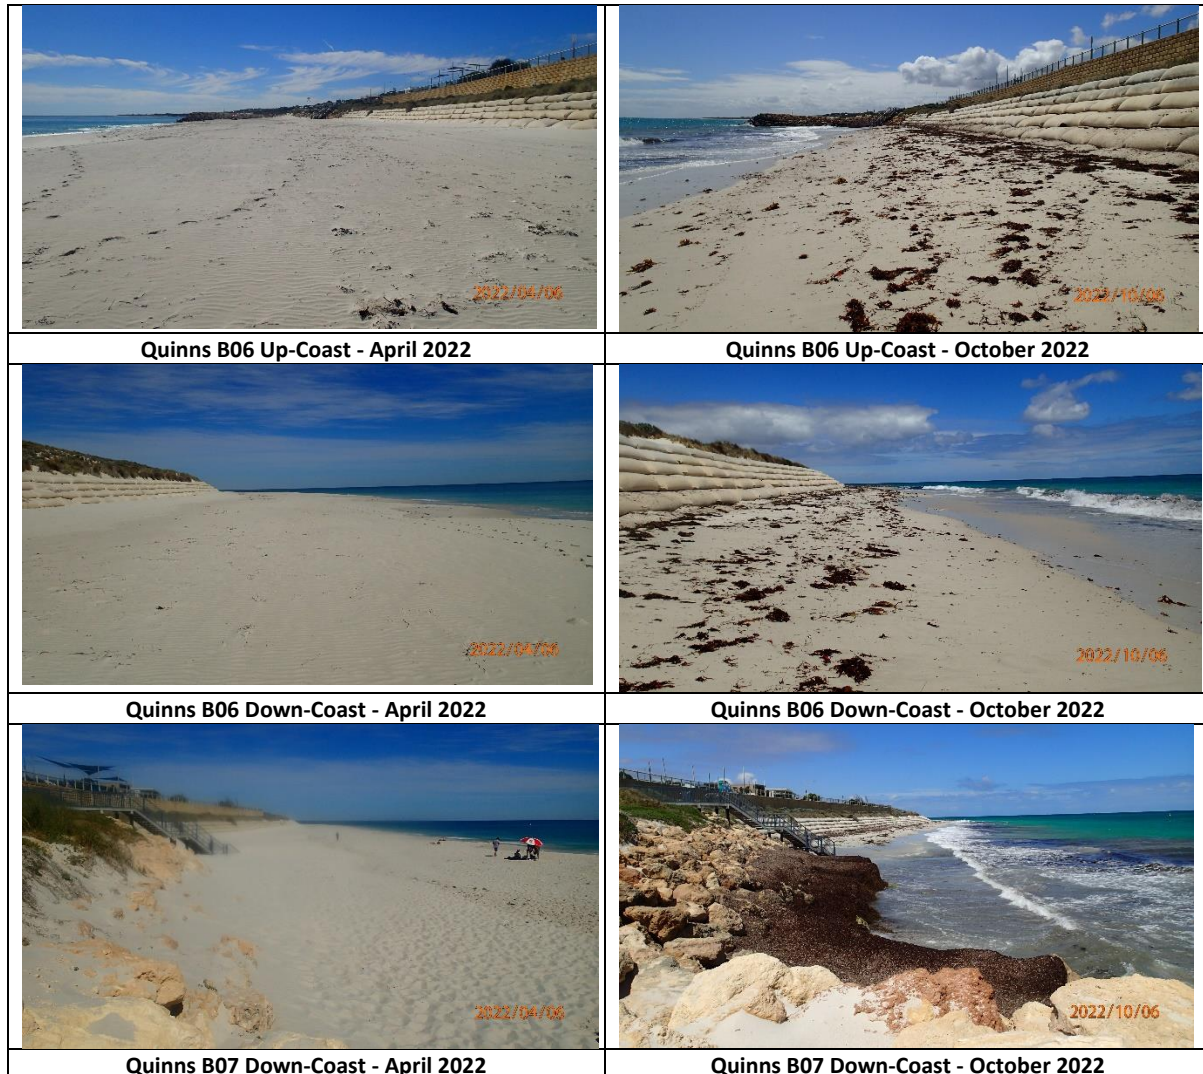
Quinns B06 and B07 Down-Coast – Major Erosion, Winter 2022

Figure 4-8 Major erosion over winter 2021 at Quinns B06 Up-Coast, Down-Coast and Quinns B07 Down-Coast.

Major seasonal erosion is experienced adjacent to the GSC and Rock Revetment at Quinns Rocks each year. The area is bound by Quinns Groyne 1 to the north and the Artificial Headland to the south. As presented in Figure 4-8 significant erosion was experienced over the 2022 winter period with very little beach remaining adjacent to the GSC Revetment. While seasonal erosion happens in the area each year, the GSC Revetment provides sufficient protection to adjacent assets and park land. The area will continue to be monitored and the GSC Revetment will continue to be assessed to ensure that it continues to function adequately as a coastal protection structure.

3. **Quinns Beach GSC Revetment South of Groyne 1:** A major reduction in beach width over winter 2022 was noted in the manual imagery review of the beach immediately south of Quinns Groyne 1. There was very little remaining beach in October 2022 and there was wave impact to the GSC revetment over winter causing some damage to the structure. Similar to the beach in front of Frederick Stubbs Carpark, this is an area that is known to experience significant erosion annually and has caused major maintenance issues in the past. The GSC Revetment was constructed in 2014 and despite the minor damage sustained from the 2021 and 2022 storm events, the structure works effectively in protecting adjacent coastal infrastructure.

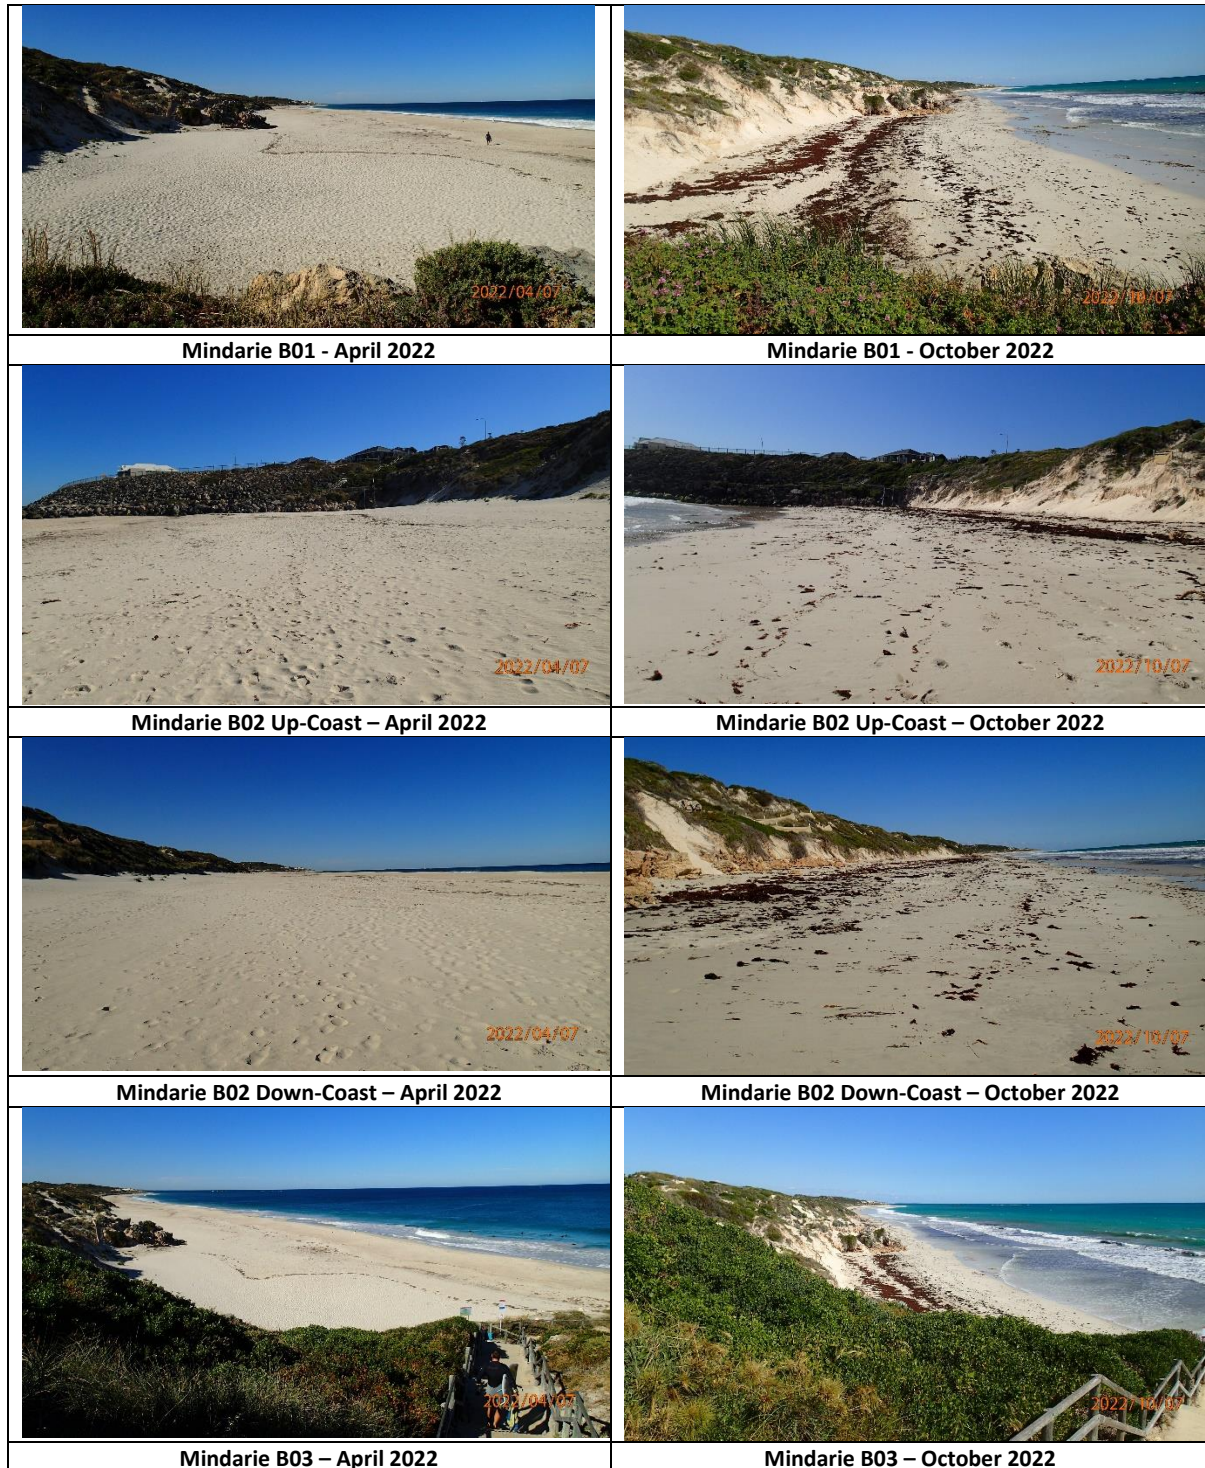
Mindarie B01, B02 and B03 – Major Erosion, Winter 2022

Figure 4-9 Major erosion over winter 2021 at Mindarie B01, B02 and B03.

Significant erosion was observed at Clayton's Beach in Mindarie over the 2022 winter period. While the images show some beach remaining in October 2022, images taken at site B01 and B02 show significant impact to the base of the dunes at Clayton's Beach. Clayton's Beach experiences

significant seasonal erosion and accretion each year however, there was significant dune erosion in 2021 which left the area vulnerable to further erosion in 2022. While there is little infrastructure landward of Claytons Beach it is recommended that the area be closely monitored in future coastal monitoring reports and if significant erosion continues, coastal management measures should be investigated for the area.

4. **Clayton's Beach, Mindarie:** Claytons Beach in Mindarie is bound by the Mindarie Breakwater to the north which interrupts longshore transport along the beach leading to significant seasonal erosion over the winter months. While seasonal erosion is expected at this site, the extent of erosion has been considerably greater in winter 2021 and 2022 than in previously recorded years. The estimated net beach volume change over winter 2022 for this site was 89,048 m³ and manual imagery and survey results show significant impact to the dune condition.

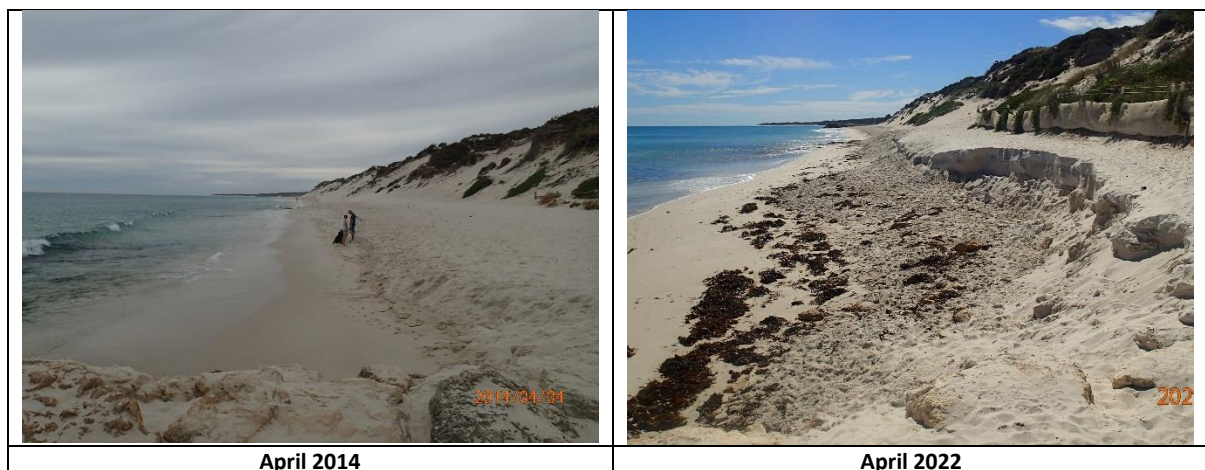
Quinns Rocks B13 Up-Coast – Long-Term Major Erosion

One site in Quinns Rocks was identified through manual imagery as having experienced major long-term erosion. The site, which is outlined below in Figure 4-10, is situated immediately north of Quinns Groyne 3 along Quinns Dog Beach. Despite the significant nourishment that has been undertaken at the site since 2004 (80,000 m³), a narrow beach is evident in the image taken in April 2022 with notable impact to the base of the dunes. It is recommended that this site continue to be monitored closely.

Figure 4-10 Significant long term erosion at Quinns Dog Beach, north of Quinns Groyne 3.

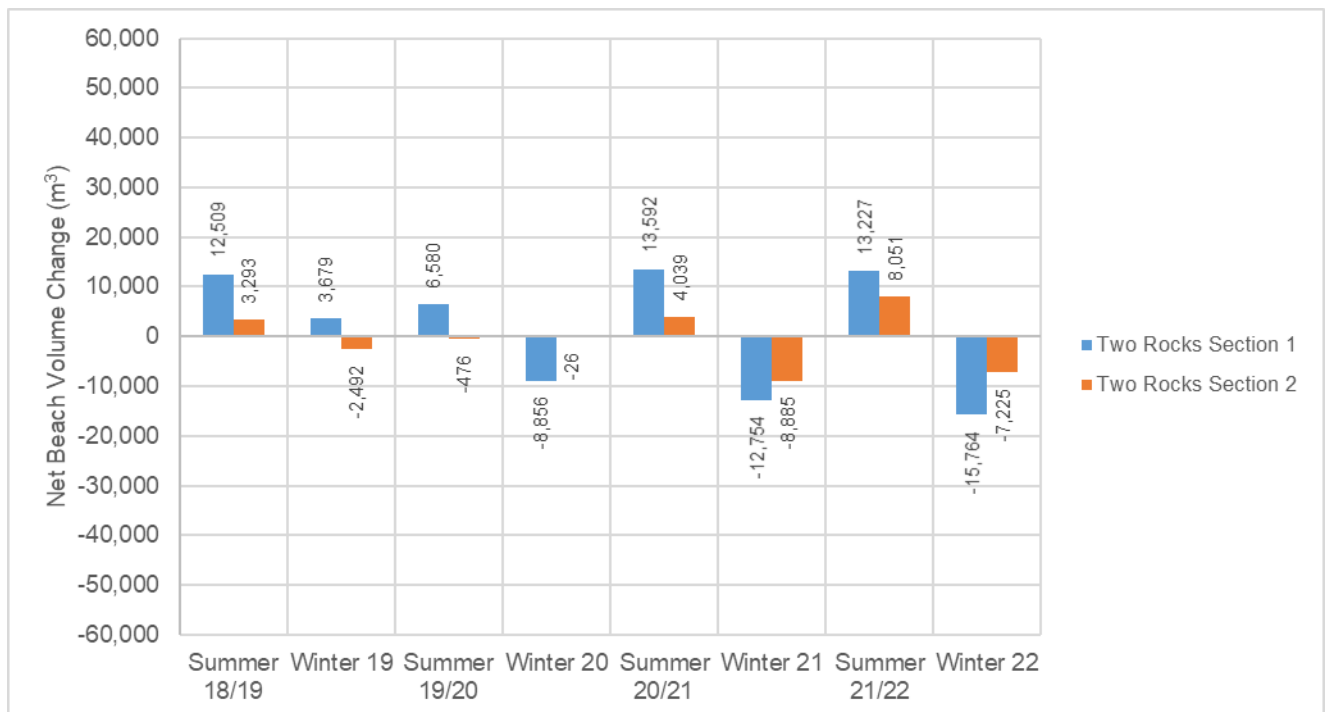
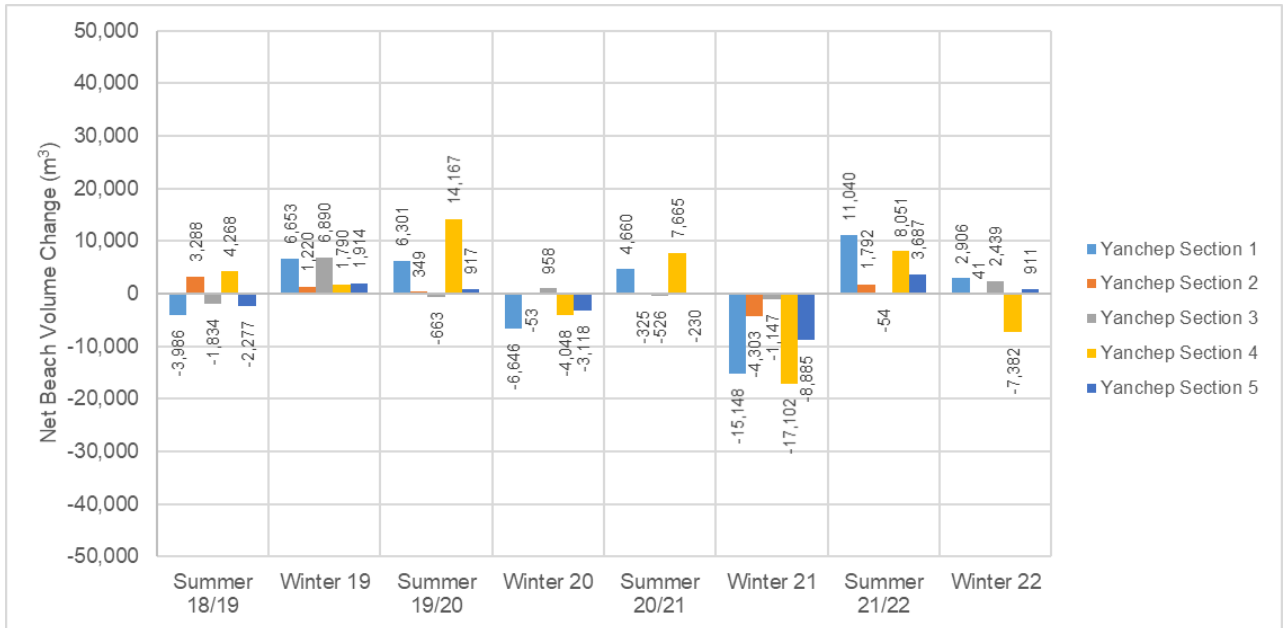
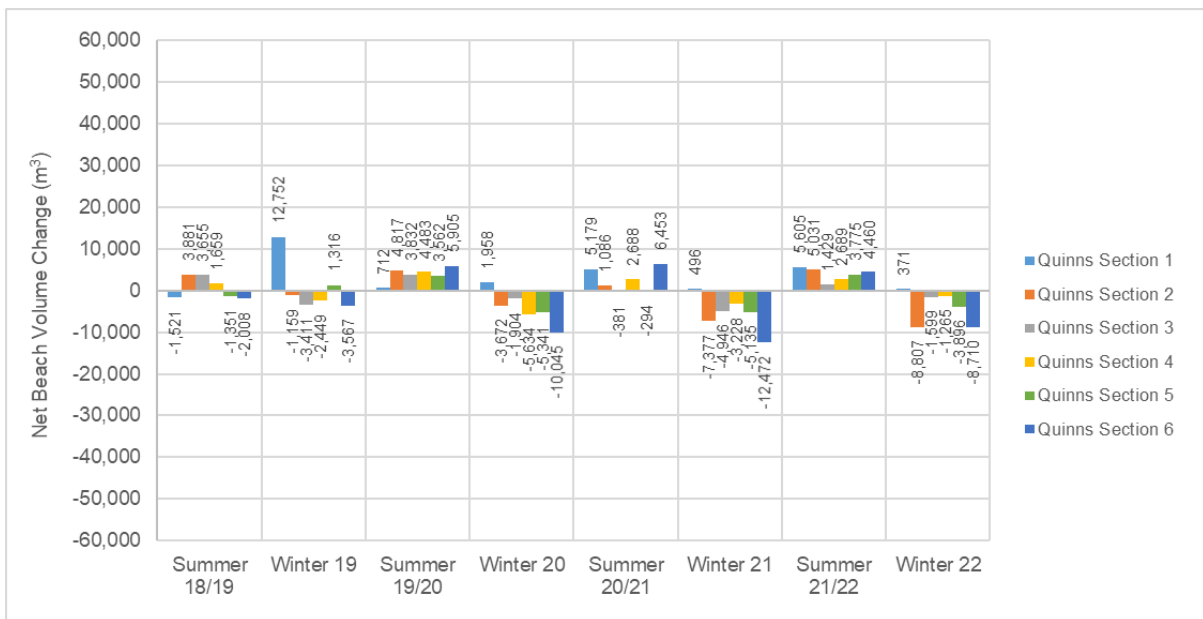
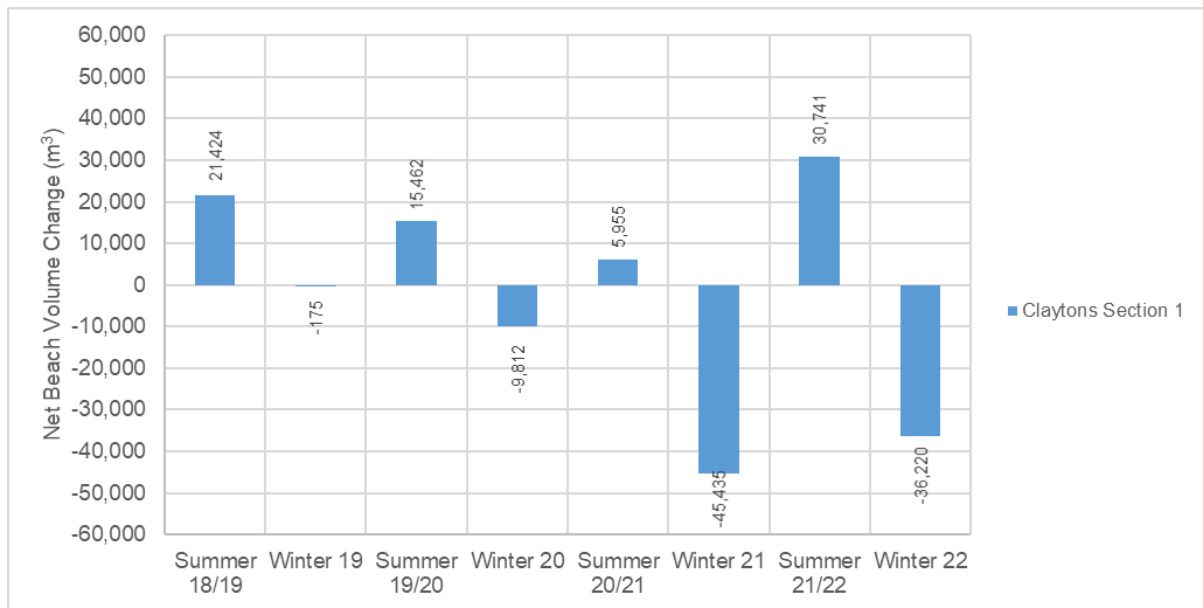
Figure 5-1 Seasonal net beach volume changes for Two Rocks Section 1 and 2.

Figure 5-2 Seasonal net beach volume changes for Yanchep Section 1, 2, 3, 4 and 5.

Figure 5-3 Seasonal net beach volume changes for Quinns Section 1, 2, 3, 4, 5 and 6.

Figure 5-4 Seasonal net beach volume changes for Claytons Section 1.

Most areas present clear seasonal trends, often with a net beach volume loss recorded following the winter months and a net beach volume gain after the summer months however some sites within Yanchep do not necessarily follow this trend. It is recommended that further investigation be undertaken within Yanchep to investigate the drivers of sediment transport within the area.

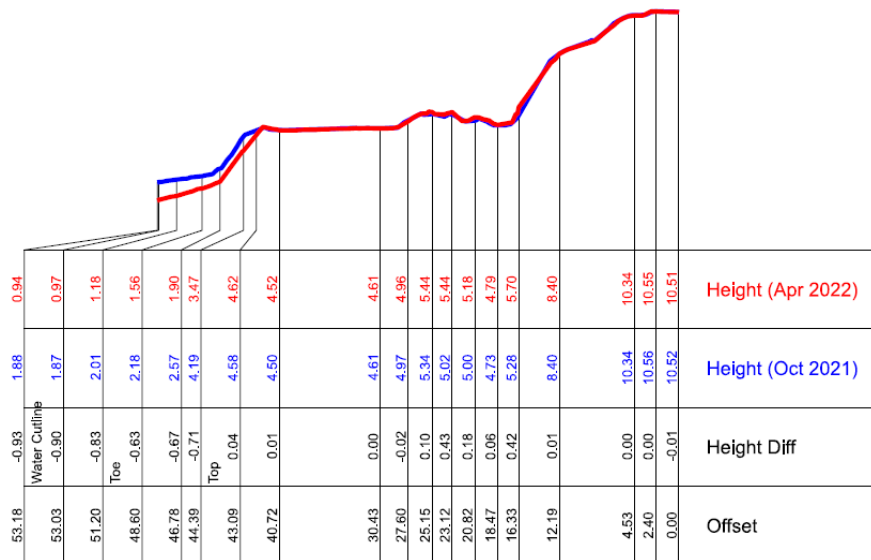
Section 16 [E38103.88, N294544.73 to E38051.03, N294538.88]

Figure 5-5 Quinns cross section 16 elevation comparison between April 2022 and October 2021 surveys.

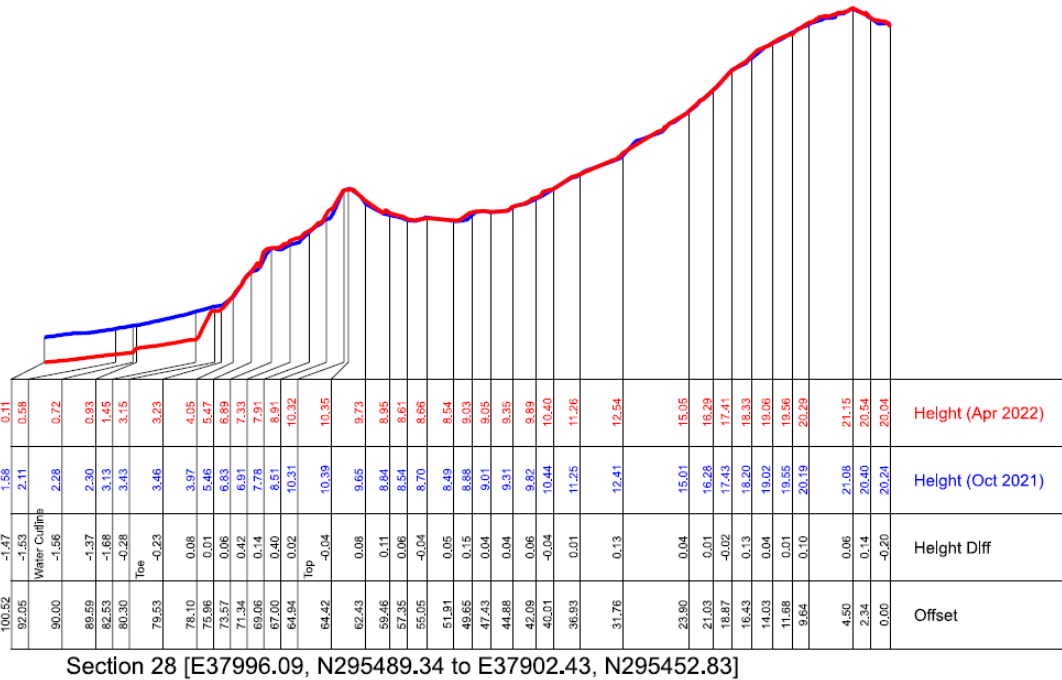
Figure 5-6 Quinns beach cross section 28 elevation comparison between October 2021 and April 2022 surveys.

Quinns beach cross-section 29 is situated within the field of view of manual imagery point 'Quinns Rocks B13 Up-Coast'. Figure 5-6 shows a significant reduction in elevation (1.68m) between the October 2021 and April 2022 surveys which is consistent with the major seasonal summer erosion that was identified at the site through manual imagery analysis (**Section 4.2.1**). Significant seasonal summer erosion is common at this site as strong sea breeze conditions promote the northward transport of sediment, away from Quinns Groyne 3.

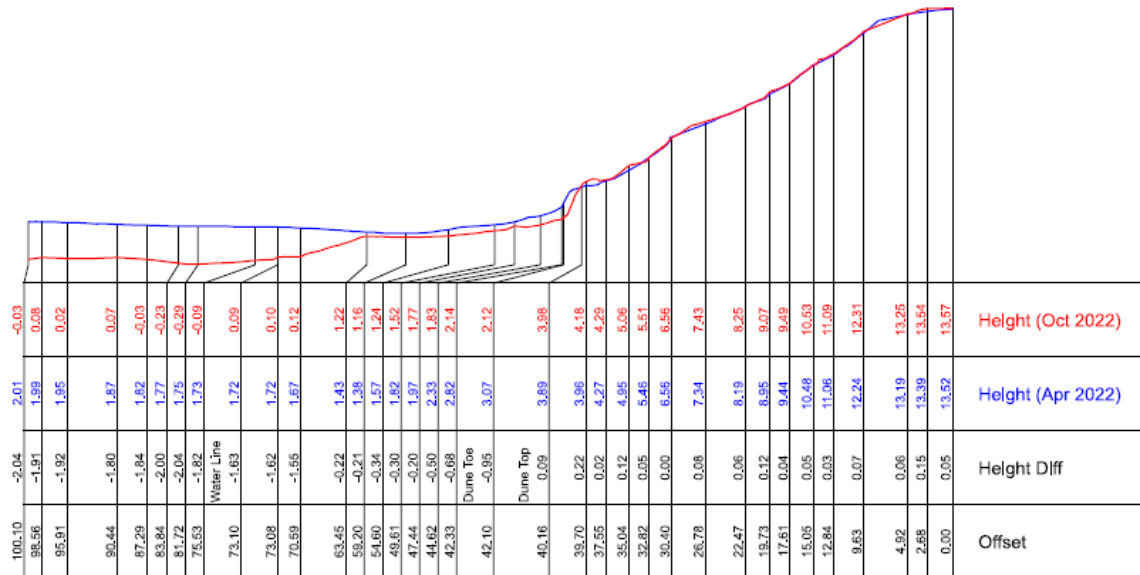
Section 21 [E32020.00, N307577.30 to E31928.96, N307535.69]

Figure 5-7 Yanchep Beach cross section 21 elevation comparison between April 2022 and October 2022 surveys.

Yanchep Beach cross section 21 is situated within the field of view of manual imagery point 'Yanchep B07 Up-Coast' where significant erosion was observed between April and October 2022 in manual imagery. While levels above the water line show only a minor drop in elevation, levels below the water line show quite a significant reduction in elevation, with the maximum height difference between the April and October 2022 survey was 2.04m. These results outline the benefits of undertaking additional ground based nearshore survey transects as the results from these surveys can capture areas of significant erosion that is otherwise not captured through LiDAR Aerial Surveys. The results from this cross section are consistent with manual imagery observations.

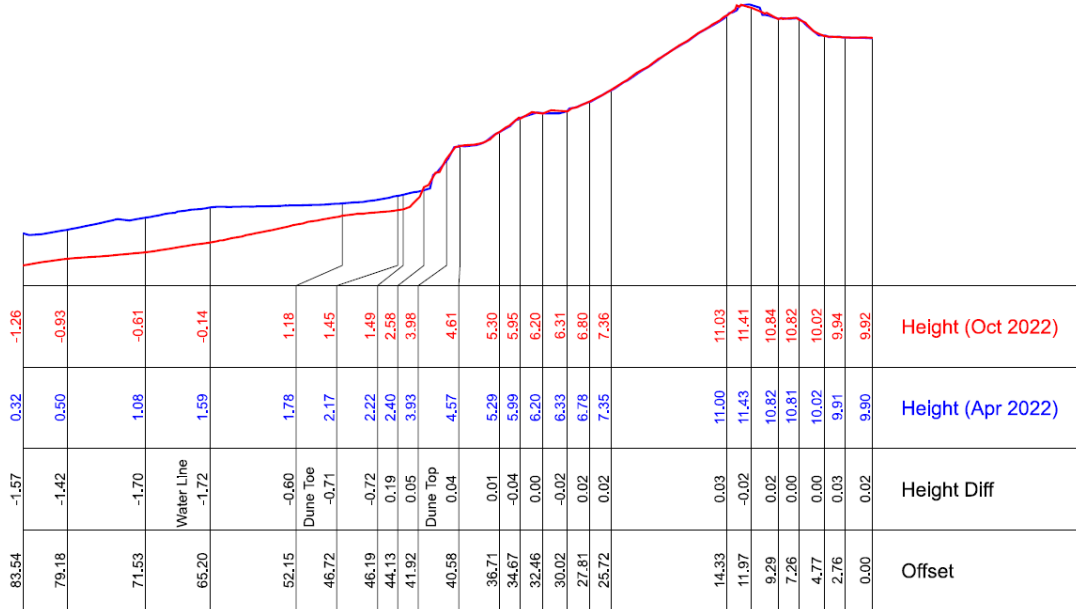
Section 13 [E38125.29, N294290.91 to E38042.26, N294281.72]

Figure 5-8 Quinns Beach cross section 13 elevation comparison between April 2022 and October 2022 surveys.

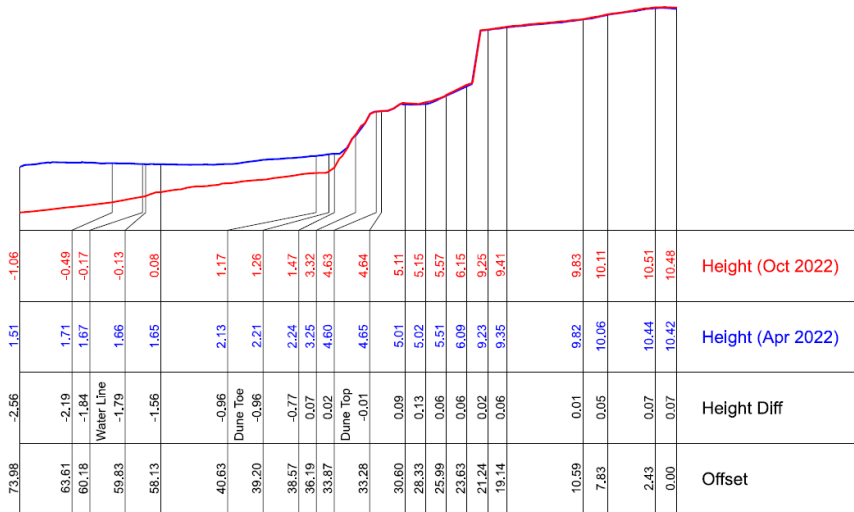
Section 14 [E38116.88, N294390.59 to E38043.36, N294382.45]

Figure 5-9 Quinns Beach cross section 14 elevation comparison between April 2022 and October 2022 surveys.
