City of Wanneroo Coastal Monitoring Report October 2022

1 Introduction

1.1 Coastal Foreshore Monitoring

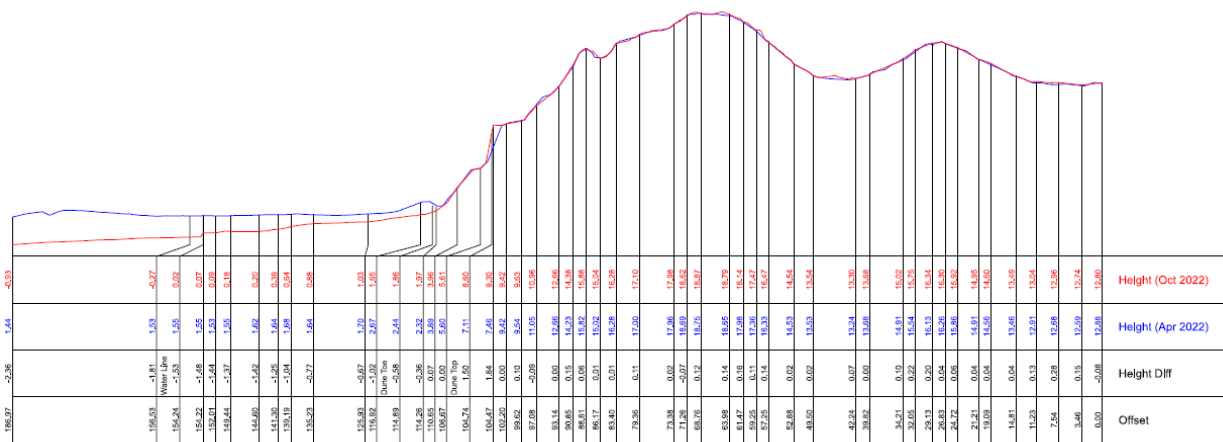
Section 20 [E39332.11, N291894.21 to E39152.31, N291842.92]

Figure 5-10 Mindarie cross section 20 elevation comparison between April 2022 and October 2022 surveys.

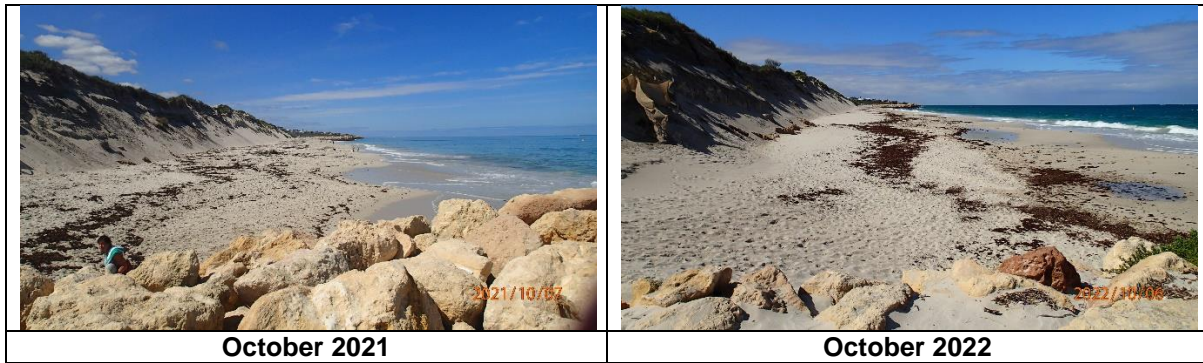
Figure 5-12 Manual images taken at Quinns B14 Down-Coast.

The cross section presented in Figure 5-11 indicates a significant recession of the dune face between the October 2021 survey and the October 2022 survey. This was not identified in manual imagery (Figure 5-12) as the dune face is not a main focus of the manual imagery field of view and recession in the dune face is difficult to interpret using manual imagery alone.

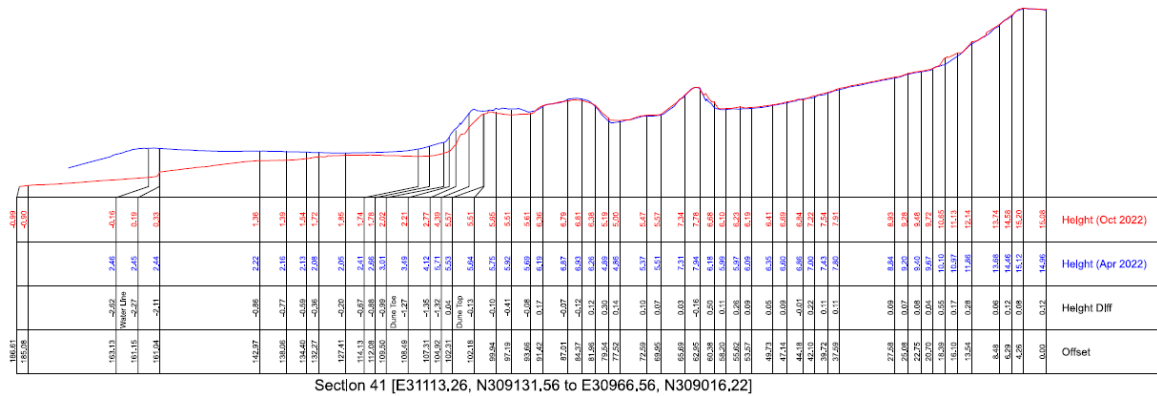
Figure 5-13 Additional Yanchep cross sections that experienced major erosion between April 2022 and October 2022 surveys.

The results from cross section 41 along Yanchep Beach show a significant drop in elevation of the beach profile between April 2022 and October 2022. This site is located immediately south of Capricorn Groyne and is not within the field of view of formal manual imagery sites. The area was noted as having experienced major erosion while on site where considerable dune erosion had exposed a historical beach access staircase.

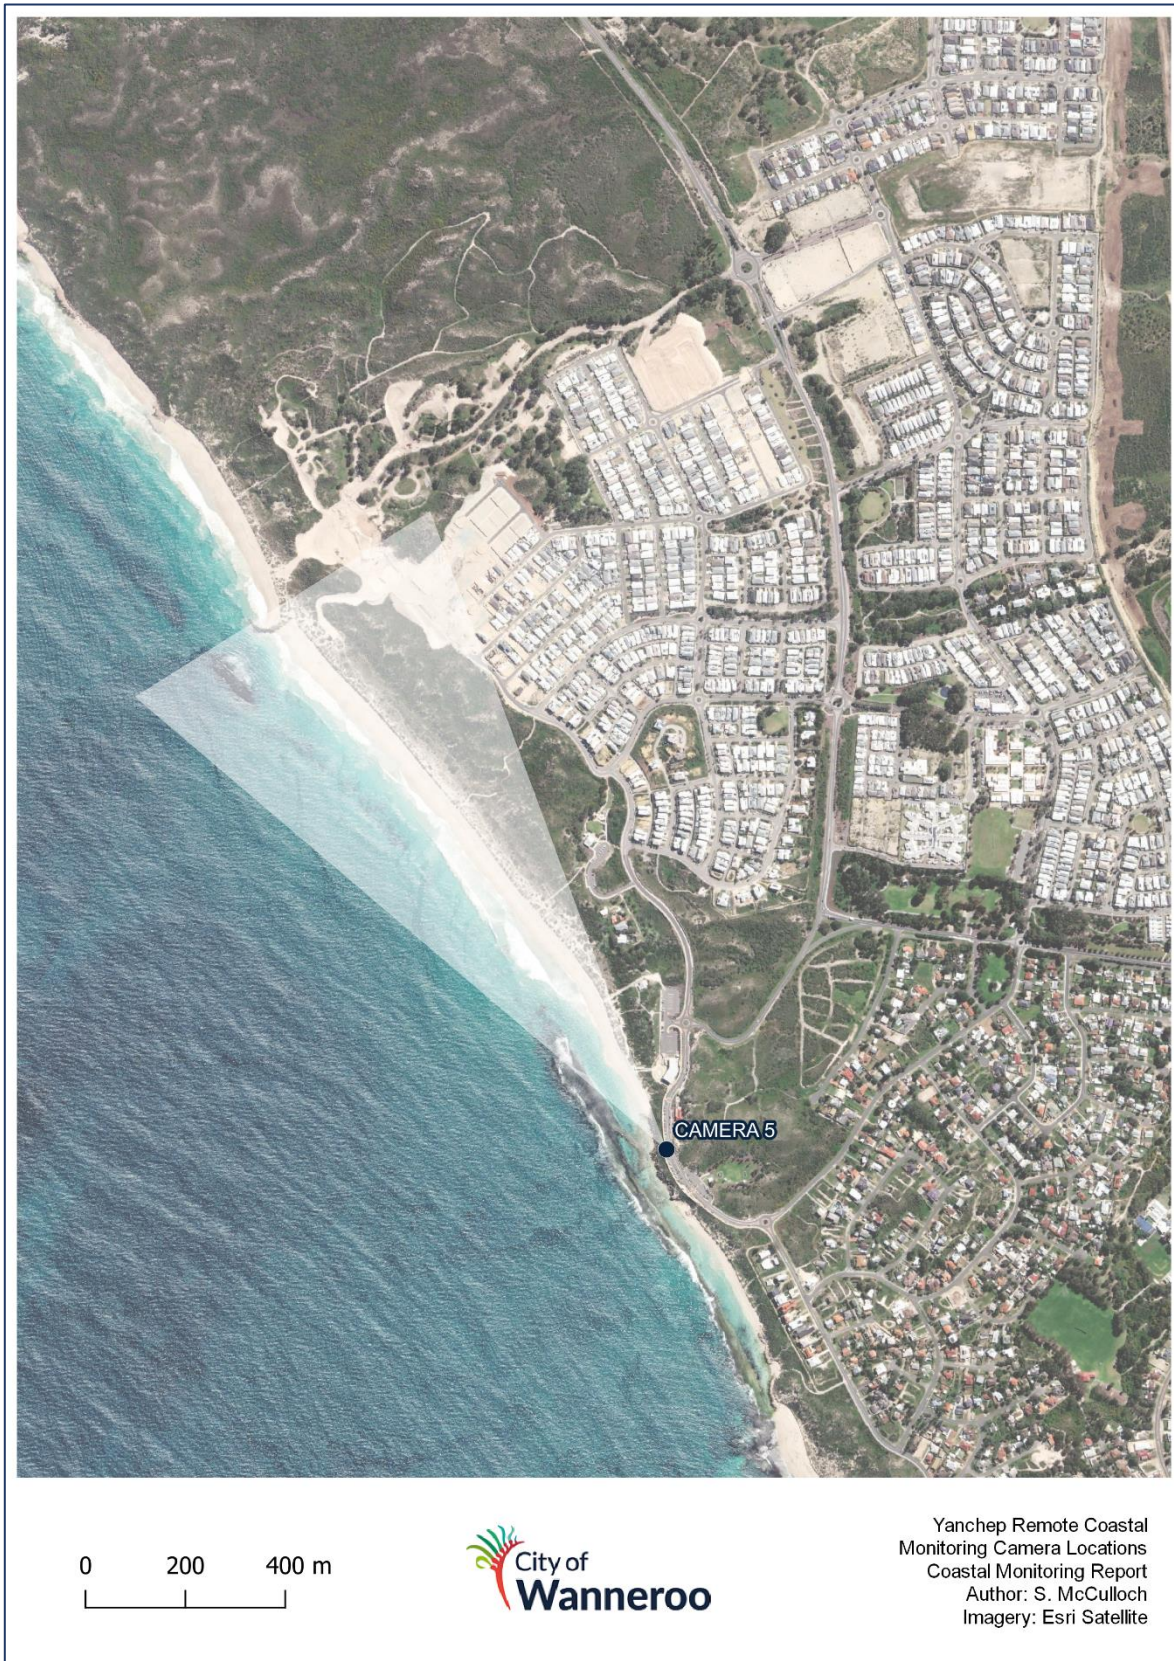
Figure 6-2

Five remote monitoring cameras were installed along Quinns and Yanchep Beach in November 2021. The location and field of view of the cameras was selected to monitor vulnerable sections of the City coastline, these locations are presented below in Figure 6-1 and Figure 6-2. These cameras take photos hourly between the hours of 7:00 and 18:00. Timelapse videos were created for each camera to assess morphological changes to the coastline between November 2021 and the beginning of October 2022.

Yanchep Remote Coastal Monitoring Location.

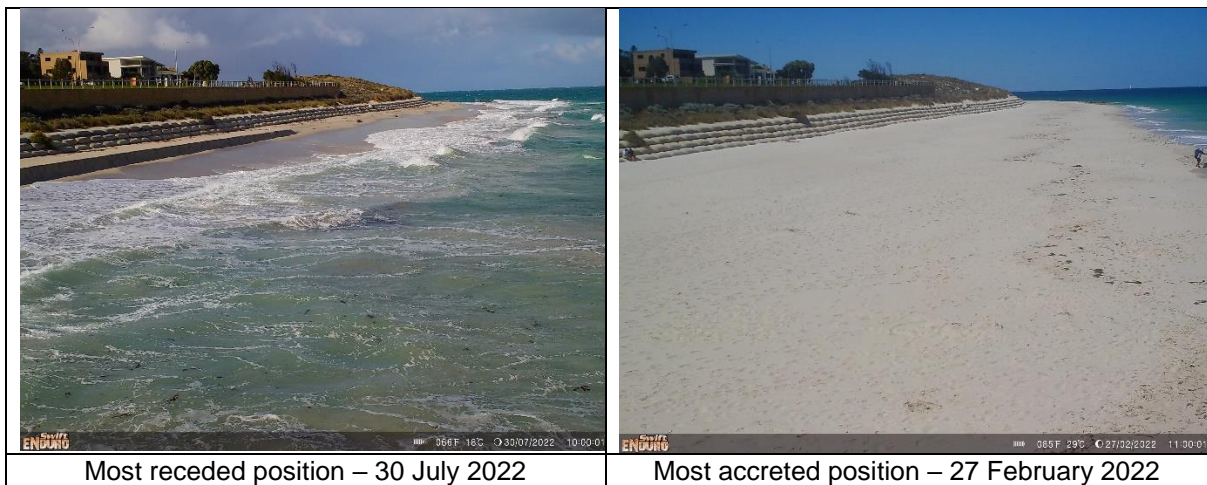
Quinns Camera 1 captures the beach immediately to the south of Groyne 1, adjacent to the GSC Revetment. The time series of images taken from Quinns Camera 1 between November 2021 and October 2022 show the beach accreting up until the beginning of March 2022. After March the beach begins to erode and continues to erode until the end of the dataset in August 2022. The August 3rd storm event impacted the condition of Camera 1 and there was no additional data captured following the storm event at this site. Significant seasonal erosion is experienced at this site each year and manual imagery monitoring suggests that following the early August storm event, there was minor accretion at the site between August and October.

Figure 6-3 Most receded and most accreted shoreline position to the south of Quinns Groyne 1 during the study period.

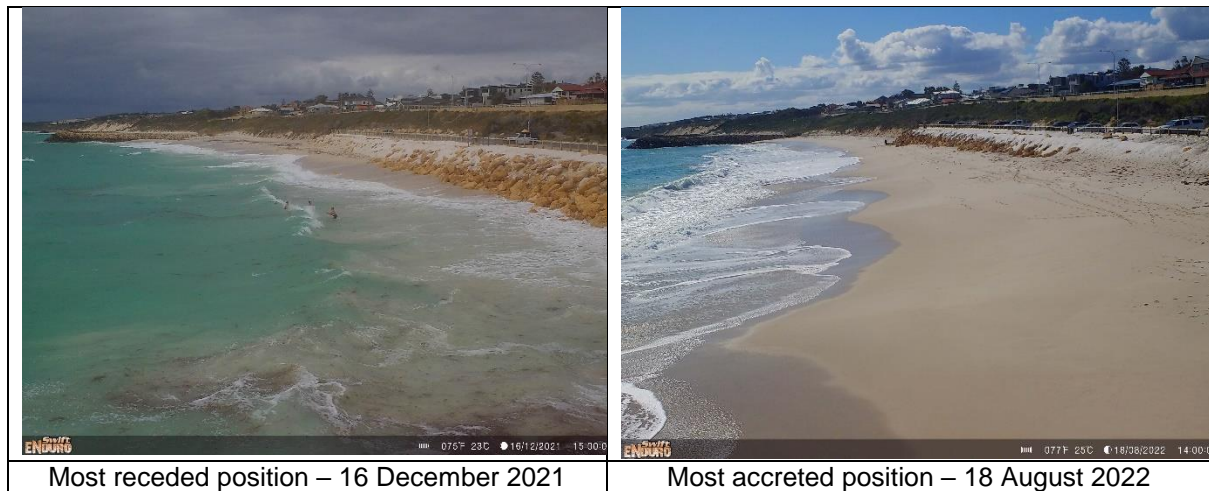
Quinns Camera 2 captures the beach immediately north of Groyne 1, adjacent to the Frederick Stubbs Carpark. Hourly images from the camera show the beach eroding significantly over November 2021 through to January at which point the beach begins accreting up until August 2022. While accretion at this site is expected during the winter period, accretion of the beach in the summer period is not expected, as prevailing southerly winds generally transport sand north where it is deposited to the south of the Groyne 2. However, it is believed that the significant build up to the south of Groyne 1 has resulted in bypassing of sand around the Groyne and onto the beach, adjacent to the carpark. Beach renourishment was also undertaken at this site in April 2022 which contributed to the accretion at the site.

Figure 6-4 Most receded and most accreted shoreline position to the north of Quinns Groyne 1 during the study period.

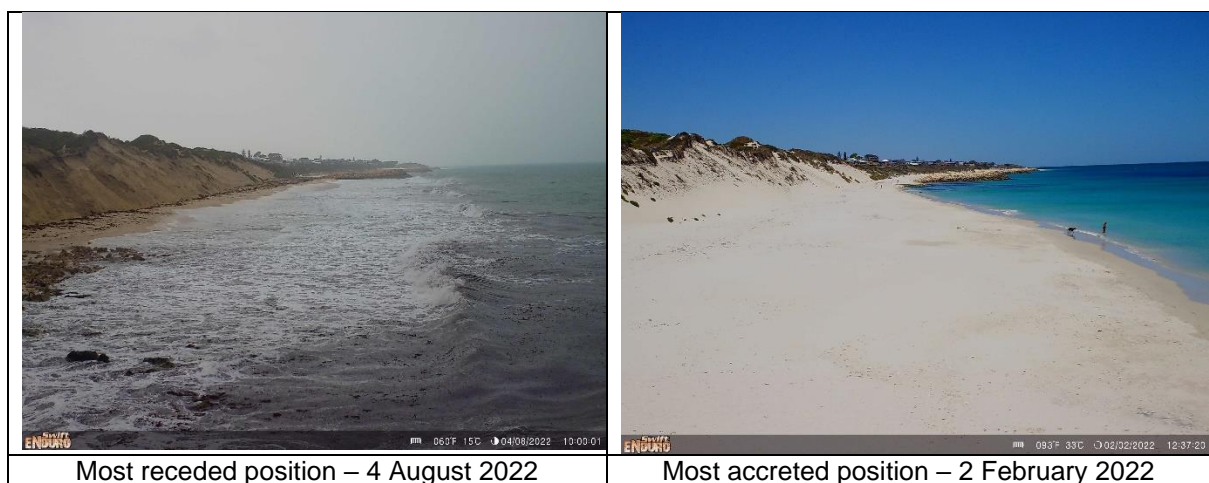
Quinns Camera 3 monitors the beach and dunes to the south of Quinns Groyne 4. Hourly images of the site show slow steady accretion of the beach from the start of the monitoring period until early February where the beach then begins to erode. The most receded shoreline position was observed just after the August storm event, which resulted in significant dune erosion at the site and exposure of limestone bedrock on the beach. There was considerable erosion at this site prior to the August storm event which left the beach and dunes vulnerable to impacts of the storm. Throughout September until the end of the monitoring period the beach appears to be steadily accreting.

Figure 6-5 Most receded and most accreted shoreline position to the south of Quinns Groyne 4 during the study period.

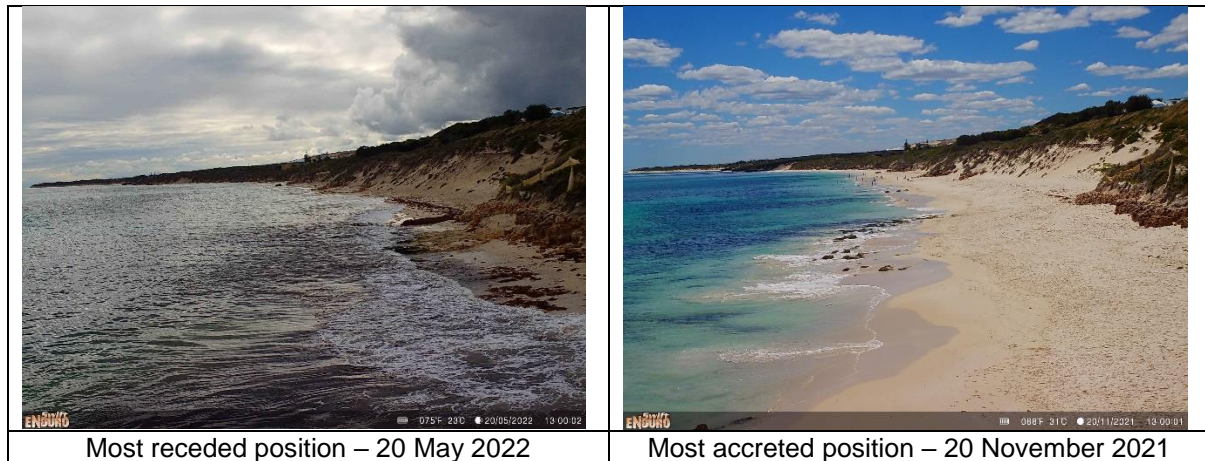
was notable accretion at the site following the winter period, particularly in September and October where considerable accretion was observed at the site.

Figure 6-6 Most receded and most accreted shoreline position to the north of Quinns Groyne 4 during the study period.

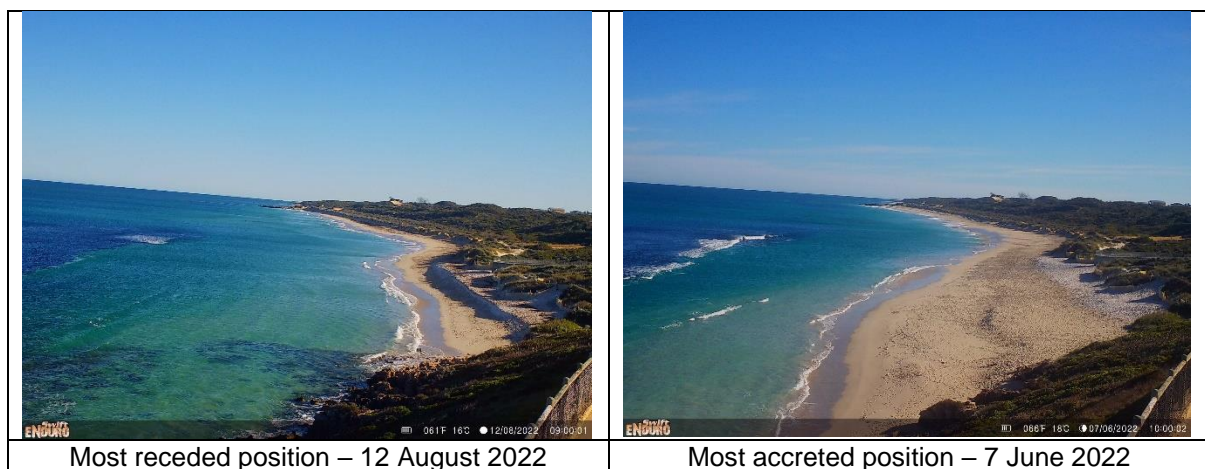
Following steady accretion in summer there was significant erosion of the beach in June and July which resulted in a narrow beach with a steep beach slope in August 2022 (Figure 6-7). In response, the City undertook reactive beach renourishment at the site in September 2022 to create a safe and accessible beach at Yanchep Lagoon prior to the 2022/23 summer period.

Figure 6-7 Most receded and most accreted shoreline position at Yanchep Lagoon Beach.
