BUSHFIRE MANAGEMENT PLAN

Lot 173 Cowaramup Loop, Two Rocks

City of Wanneroo

Site visited 3 October 2018; Report completed 4 October 2018

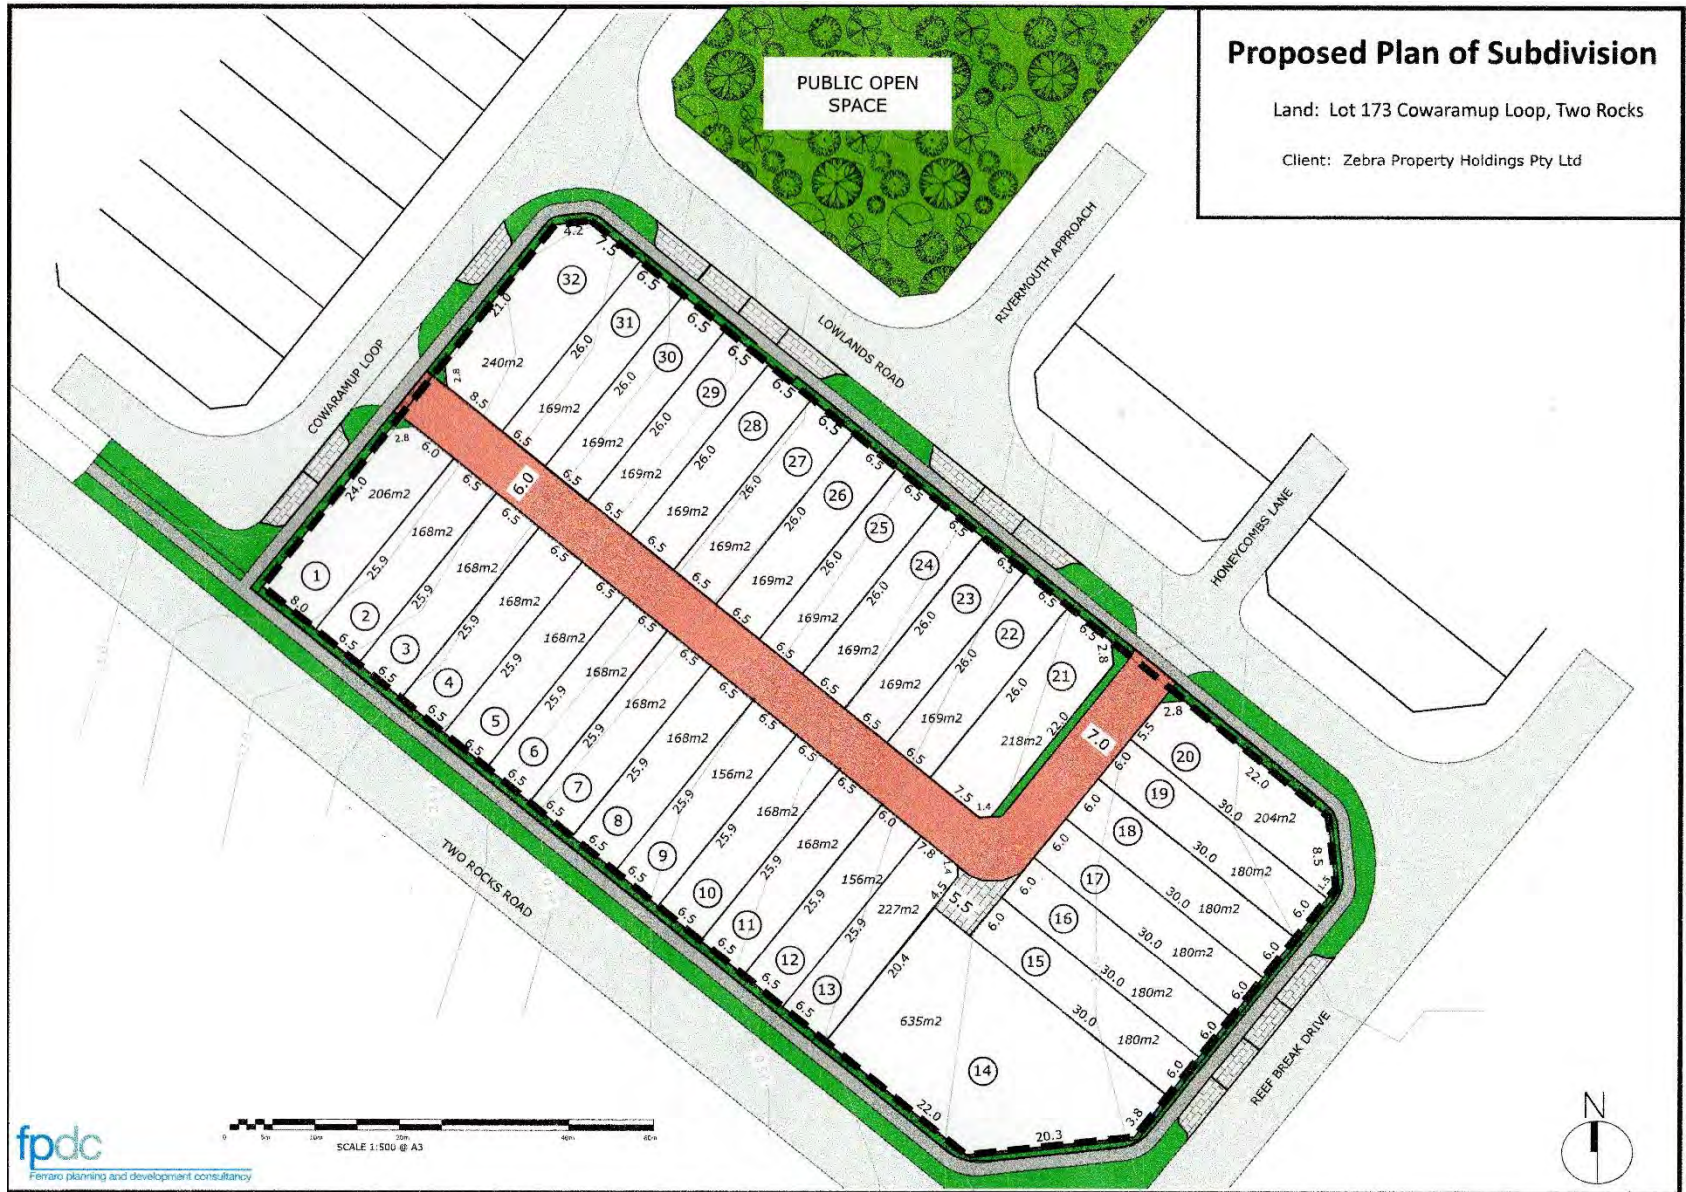
Figure 1. The site plan as provided with the development application.

The proposal is to create 32 lots in a new subdivision. This subdivision is located very close to other recently subdivided areas. The area is designated as bushfire prone. The subdivision site is cleared.

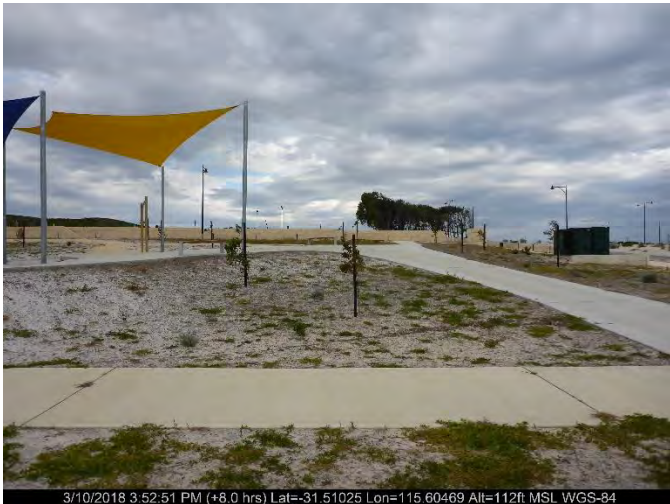
Plot 1
 Exclusion
 Clause 2.2.3.3 (e) and (f)

3/10/2018 3:52:51 PM (+8.0 hrs) Lat=-31.51025 Lon=115.60469 Alt=112ft MSL WGS-84
Photo ID: Photo 1 The POS with planted trees, road infrastructure and playground.

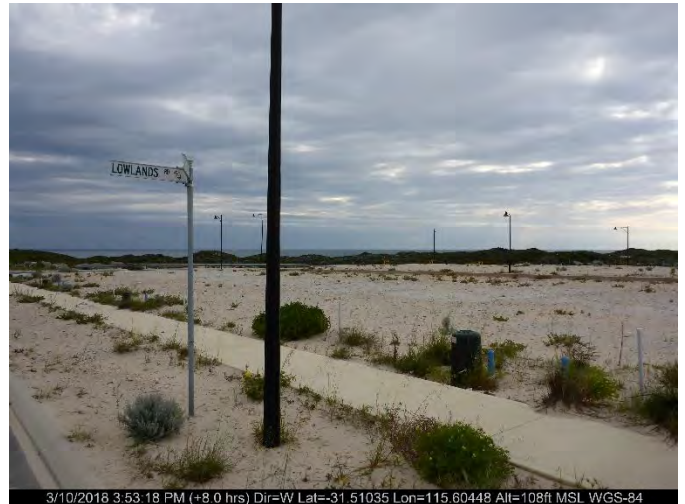
3/10/2018 3:53:18 PM (+8.0 hrs) Dir=W Lat=-31.51035 Lon=115.60448 Alt=108ft MSL WGS-84
Photo ID: Photo 2 The cleared neighbouring land.

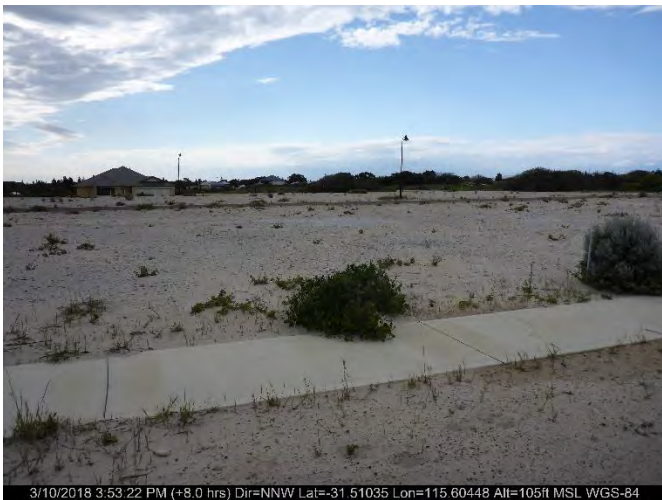
3/10/2018 3:53:22 PM (+8.0 hrs) Dir=NNW Lat=-31.51035 Lon=115.60448 Alt=105ft MSL WGS-84
Photo ID: Photo 3 The cleared land on the neighbouring properties.

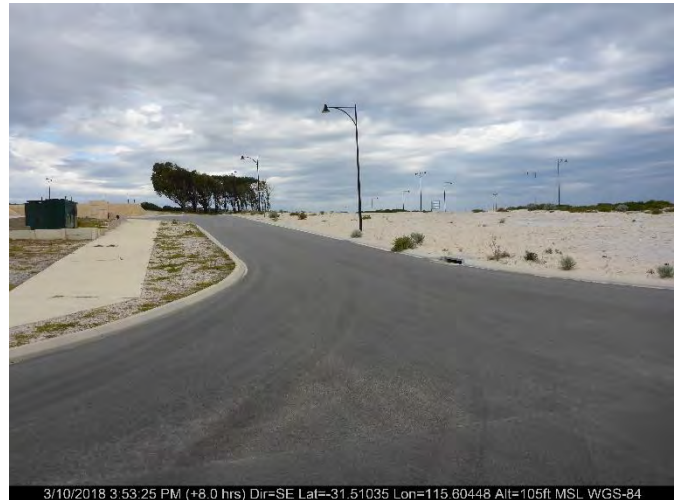
3/10/2018 3:53:25 PM (+8.0 hrs) Dir=SE Lat=-31.51035 Lon=115.60448 Alt=105ft MSL WGS-84
Photo ID: Photo 4 The development site on the right of the road and the road and other infrastructure.

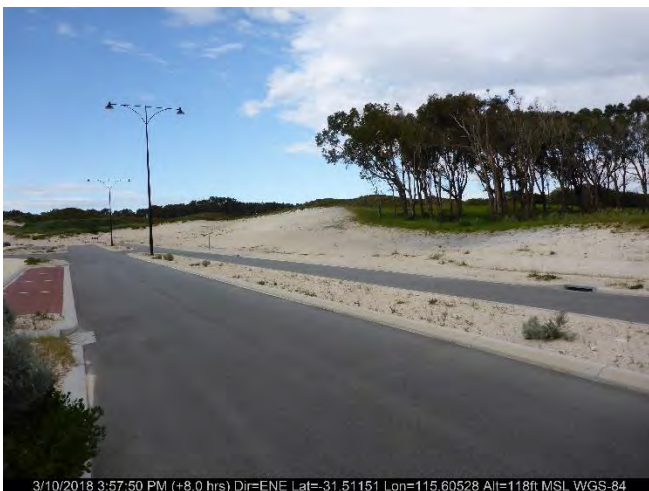
3/10/2018 3:57:50 PM (+8.0 hrs) Dir=ENE Lat=-31.51151 Lon=115.60528 Alt=118ft MSL WGS-84
Photo ID: Photo 5 The road infrastructure adjacent to the development site and forest vegetation on the right.

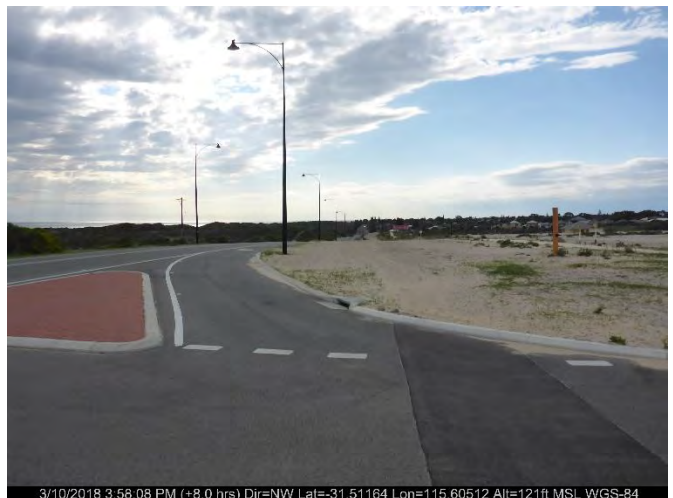
3/10/2018 3:58:08 PM (+8.0 hrs) Dir=NW Lat=-31.51164 Lon=115.60512 Alt=121ft MSL WGS-84
Photo ID: Photo 6 Two Rocks Road and cleared road reserve at the west of the development site.

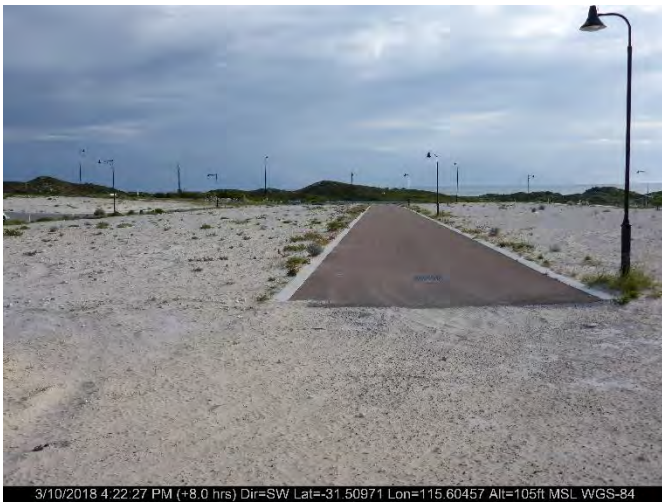
3/10/2018 4:22:27 PM (+8.0 hrs) Dir=SW Lat=-31.50971 Lon=115.60457 Alt=105ft MSL WGS-84
Photo ID: Photo 7 The cleared land and associated road infrastructure north of the development site.

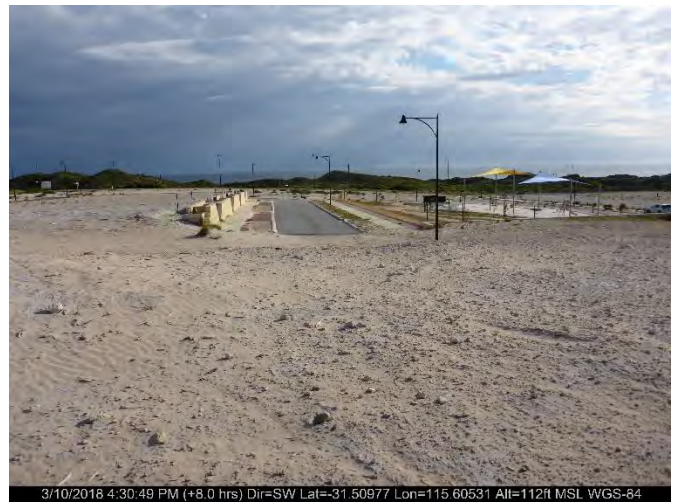
3/10/2018 4:30:49 PM (+8.0 hrs) Dir=SW Lat=-31.50977 Lon=115.60531 Alt=112ft MSL WGS-84
Photo ID: Photo 8 The cleared land and associated road infrastructure east of the development site.

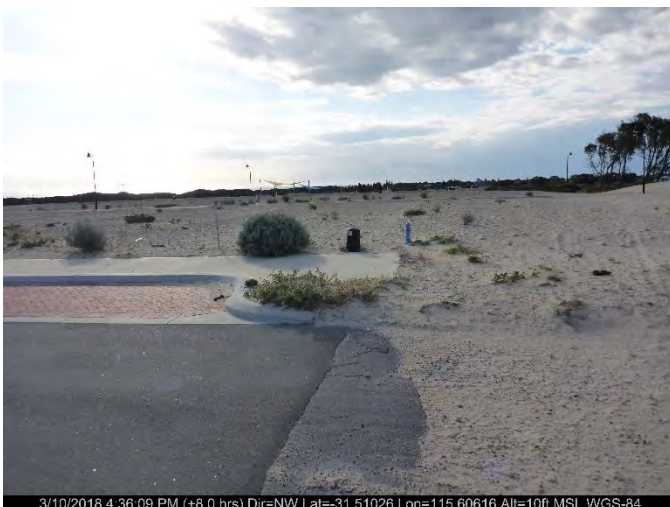
3/10/2018 4:36:09 PM (+8.0 hrs) Dir=NW Lat=-31.51026 Lon=115.60616 Alt=10ft MSL WGS-84
Photo ID: Photo 9 The cleared land and associated road infrastructure south-east of the development site.

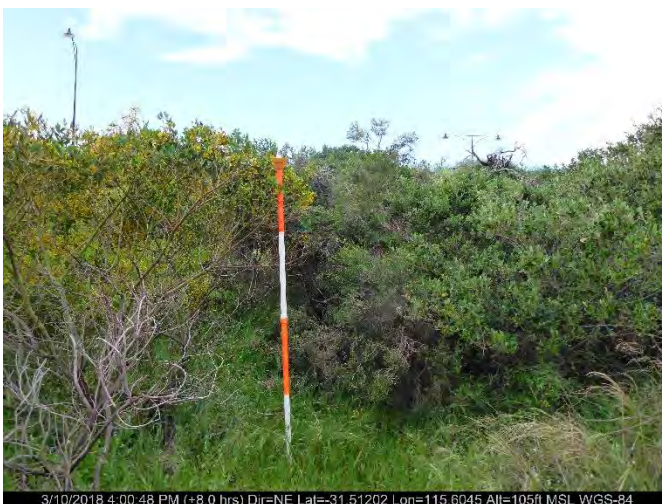
Class D – Scrub (AS 3959 vegetation classification D – 13)

3/10/2018 4:00:48 PM (+8.0 hrs) Dir=NE Lat=-31.51202 Lon=115.6045 Alt=105ft MSL WGS-84
Photo ID: Photo 10 The scrub vegetation west of Two Rocks Road.

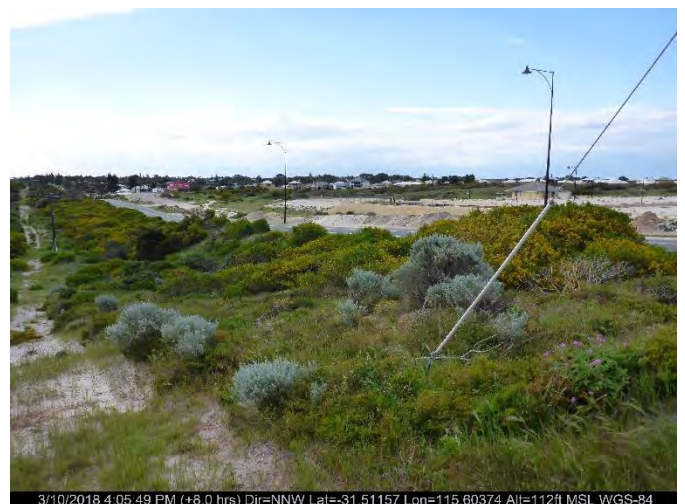
3/10/2018 4:05:49 PM (+8.0 hrs) Dir=NNW Lat=-31.51157 Lon=115.60374 Alt=112ft MSL WGS-84
Photo ID: Photo 11 The mixed scrub and shrubland vegetation west of Two Rocks Road.

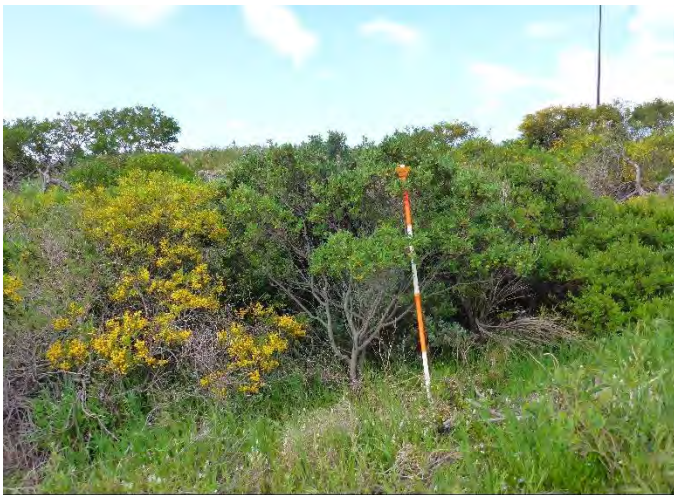
3/10/2018 4:07:54 PM (+8.0 hrs) Dir=NE Lat=-31.51134 Lon=115.60326 Alt=85ft MSL WGS-84
Photo ID: Photo 12 The scrub vegetation with grass surface vegetation.

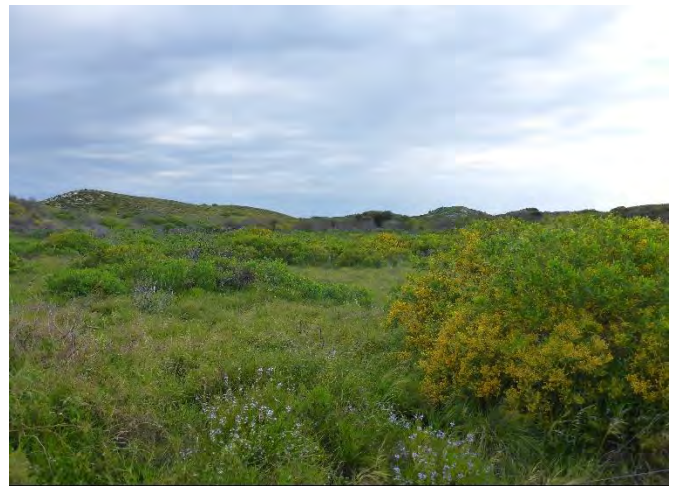
3/10/2018 4:08:18 PM (+8.0 hrs) Dir=SW Lat=-31.51106 Lon=115.60328 Alt=85ft MSL WGS-84
Photo ID: Photo 13 The mixed scrub and shrubland vegetation.

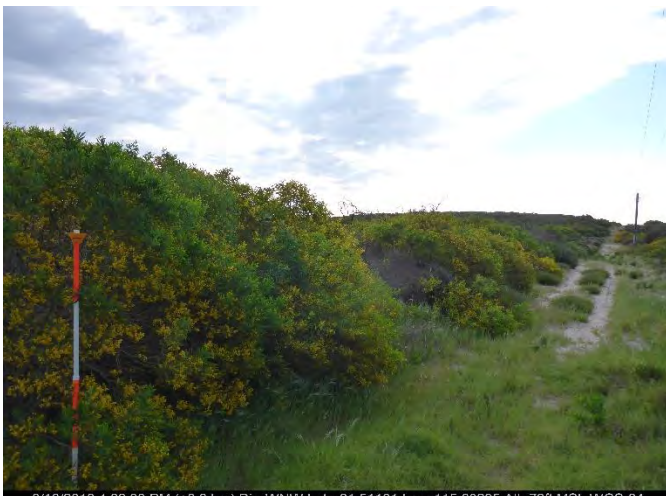
3/10/2018 4:09:33 PM (+8.0 hrs) Dir=WNW Lat=-31.51101 Lon=115.60295 Alt=72ft MSL WGS-84
Photo ID: Photo 14 The scrub vegetation with a grass surface vegetation.

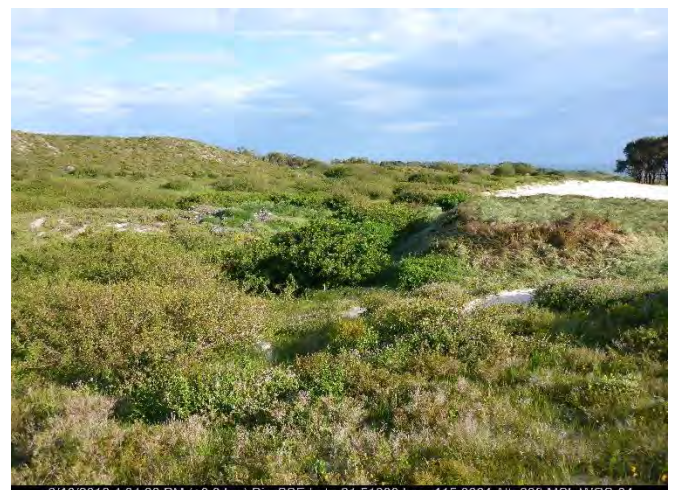
3/10/2018 4:34:26 PM (+8.0 hrs) Dir=SSE Lat=-31.51003 Lon=115.6064 Alt=33ft MSL WGS-84
Photo ID: Photo 15 The scrub vegetation with a mixed shrubland and grass vegetation.

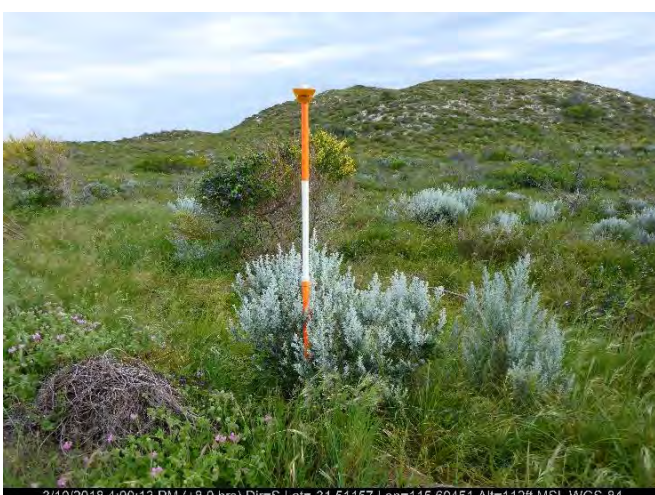
Plot 3
Class C – Shrubland (AS 3959 vegetation classification C – 10)

3/10/2018 4:00:13 PM (+8.0 hrs) Dir=S Lat=-31.51157 Lon=115.60451 Alt=112ft MSL WGS-84
Photo ID: Photo 16 The shrubland west of Two Rocks Road.

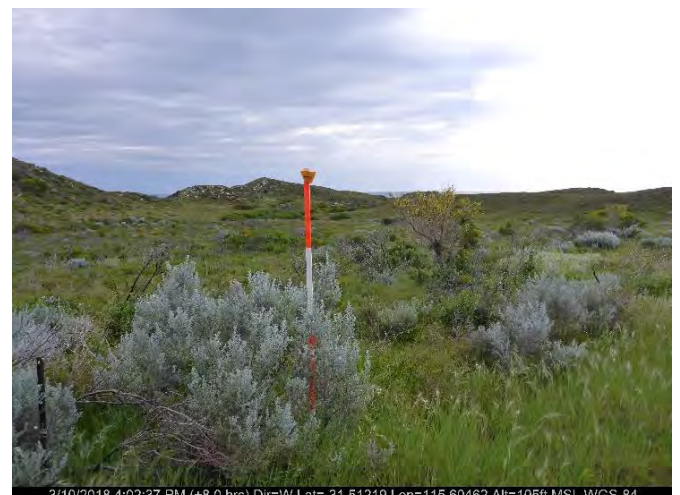
3/10/2018 4:02:37 PM (+8.0 hrs) Dir=W Lat=-31.51219 Lon=115.60462 Alt=105ft MSL WGS-84
Photo ID: Photo 17 The shrubland west of Two Rocks Road.

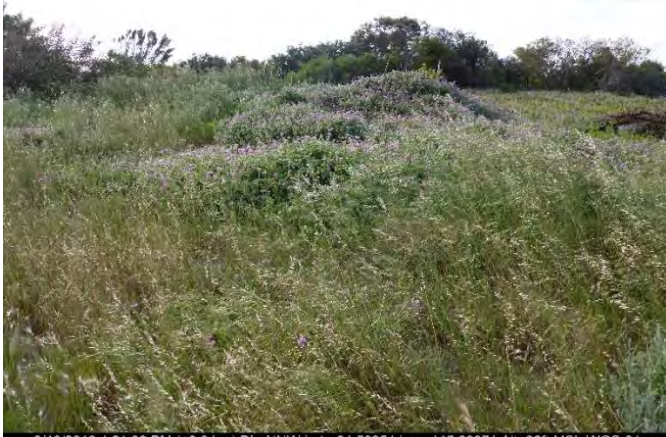
3/10/2018 4:21:32 PM (+8.0 hrs) Dir=NNW Lat=-31.50954 Lon=115.60371 Alt=92ft MSL WGS-84
Photo ID: Photo 18 The mixed shrubland and grass vegetation.

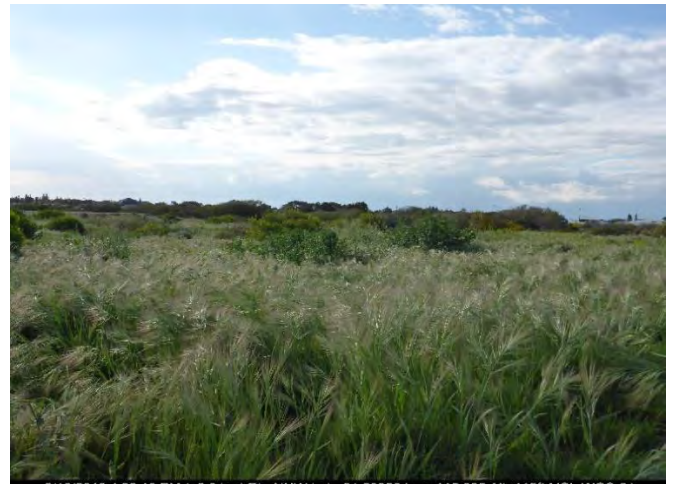
3/10/2018 4:23:10 PM (+8.0 hrs) Dir=NNW Lat=-31.50956 Lon=115.605 Alt=115ft MSL WGS-84
Photo ID: Photo 19 The mixed shrubland and grass north of subdivision site.

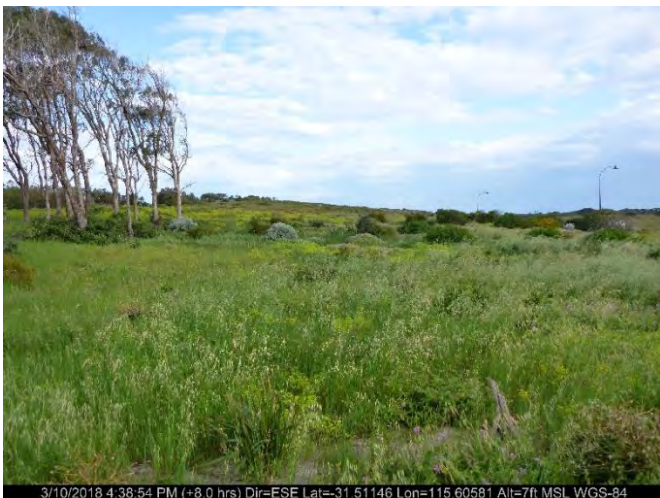
3/10/2018 4:38:54 PM (+8.0 hrs) Dir=ESE Lat=-31.51146 Lon=115.60581 Alt=7ft MSL WGS-84
Photo ID: Photo 20 The mixed shrubland and grass vegetation and the forest vegetation on the left.

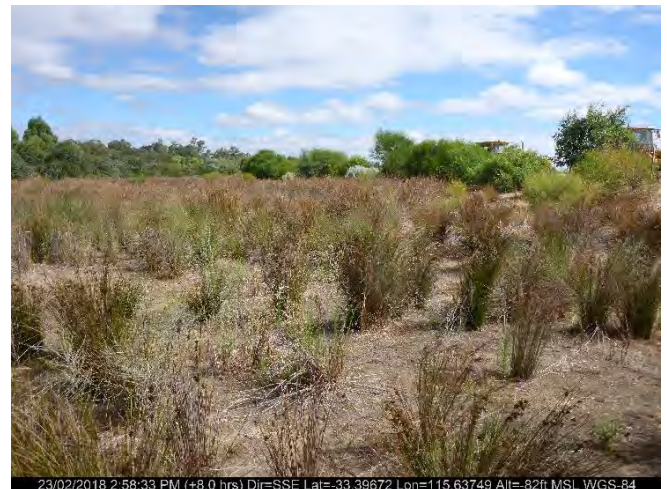
23/02/2018 2:58:33 PM (+8.0 hrs) Dir=SSE Lat=-33.36672 Lon=115.63749 Alt=82ft MSL WGS-84
Photo ID: Photo 21 The wetland revegetation in the seasonal water overflow site.

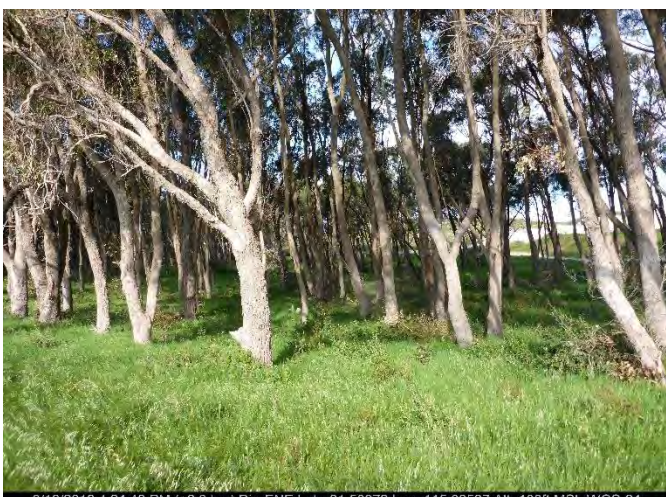
Class A – Forest (AS 3959 vegetation classification A – 03)

3/10/2018 4:24:48 PM (+8.0 hrs) Dir=ENE Lat=-31.50972 Lon=115.60537 Alt=108ft MSL WGS-84
Photo ID: Photo 21 The forest with a grass surface vegetation.

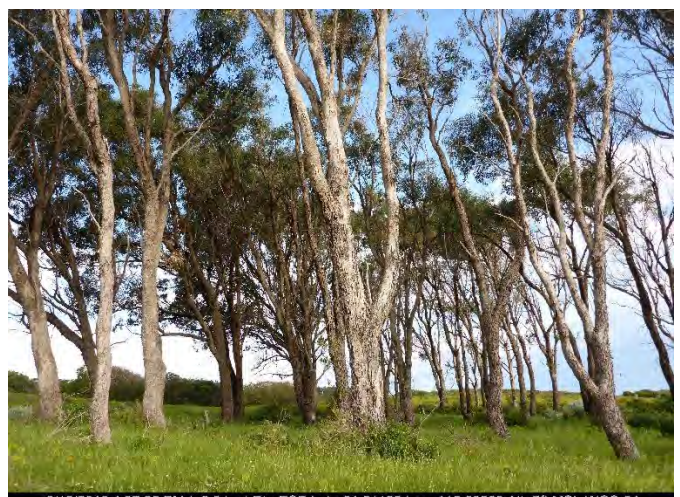
3/10/2018 4:37:25 PM (+8.0 hrs) Dir=ESE Lat=-31.51133 Lon=115.60568 Alt=7ft MSL WGS-84
Photo ID: Photo 22 The forest with a grass surface vegetation.

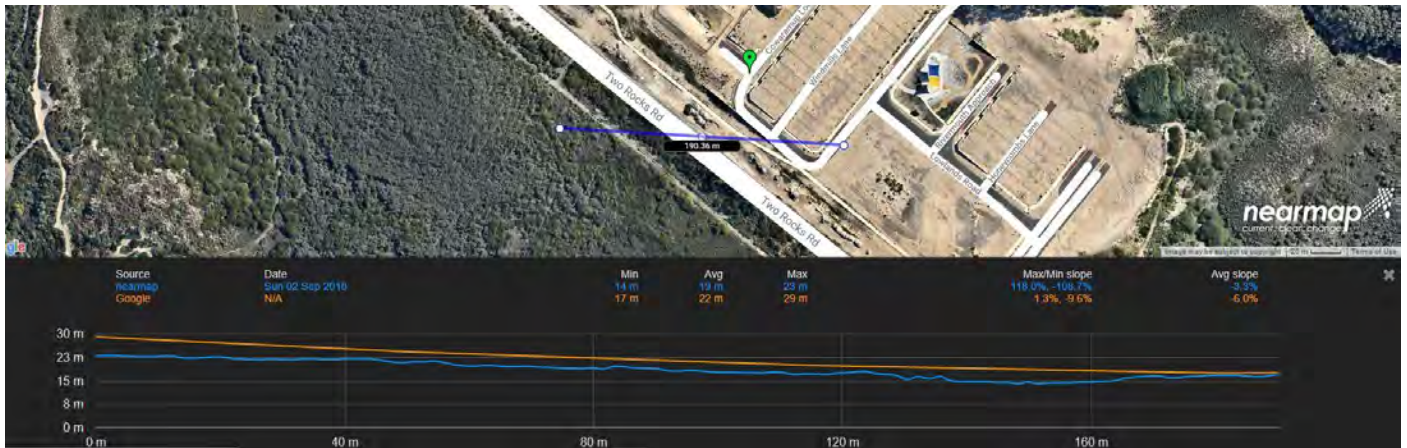
The orange lines on the slope aerials show the surface slope and the blue line the vegetation and buildings above the surface. The slope is shown commencing at the development site and going away from the site.

Figure 5. Aerial photo to the west of the development site (3.43°).

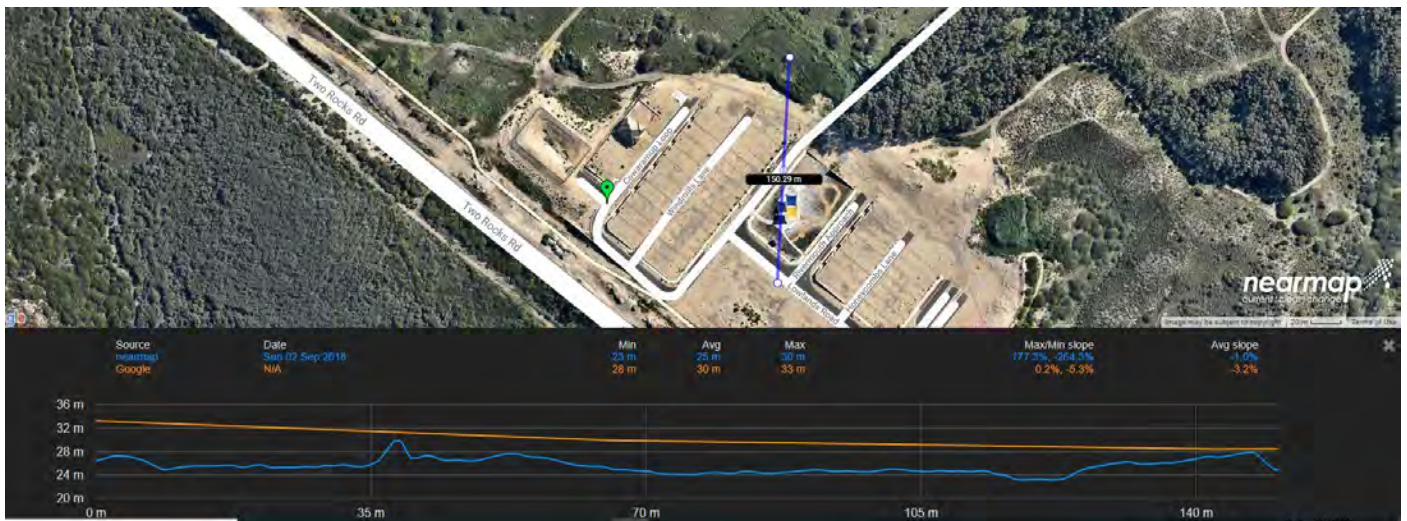
Figure 6. Aerial photo to the north of the development site (1.83°).

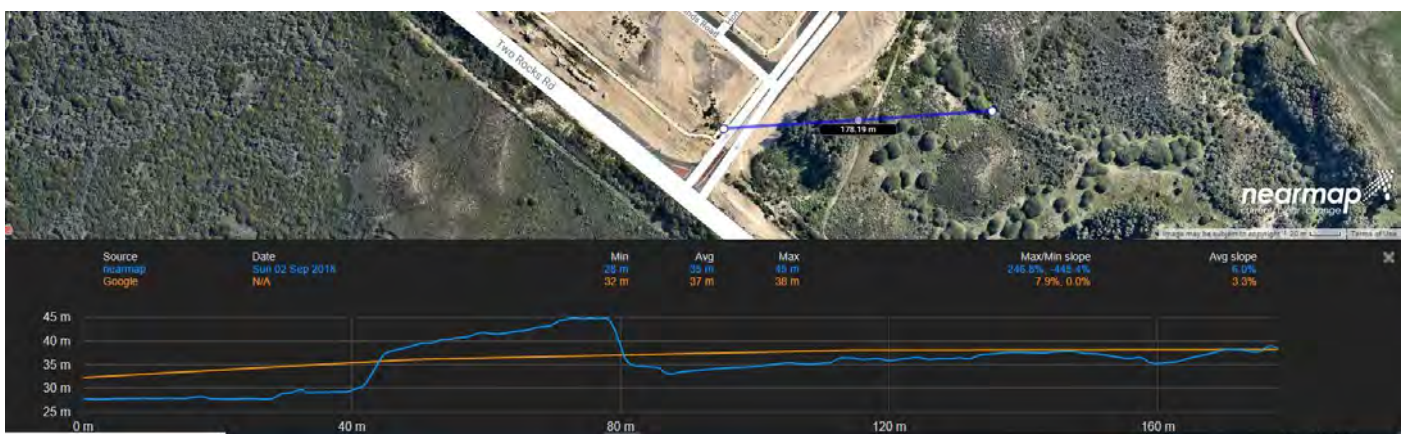
Figure 7. Aerial photo to the east of the development site (1.89°).

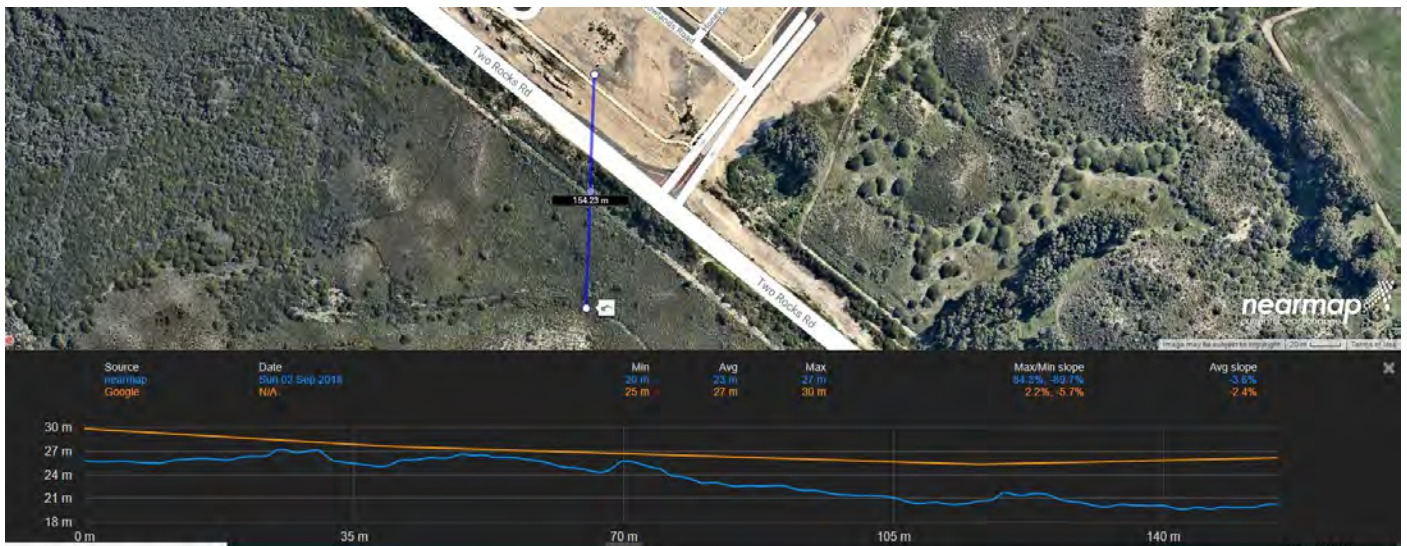
Figure 8. Aerial photo to the south of the development site (1.37°).

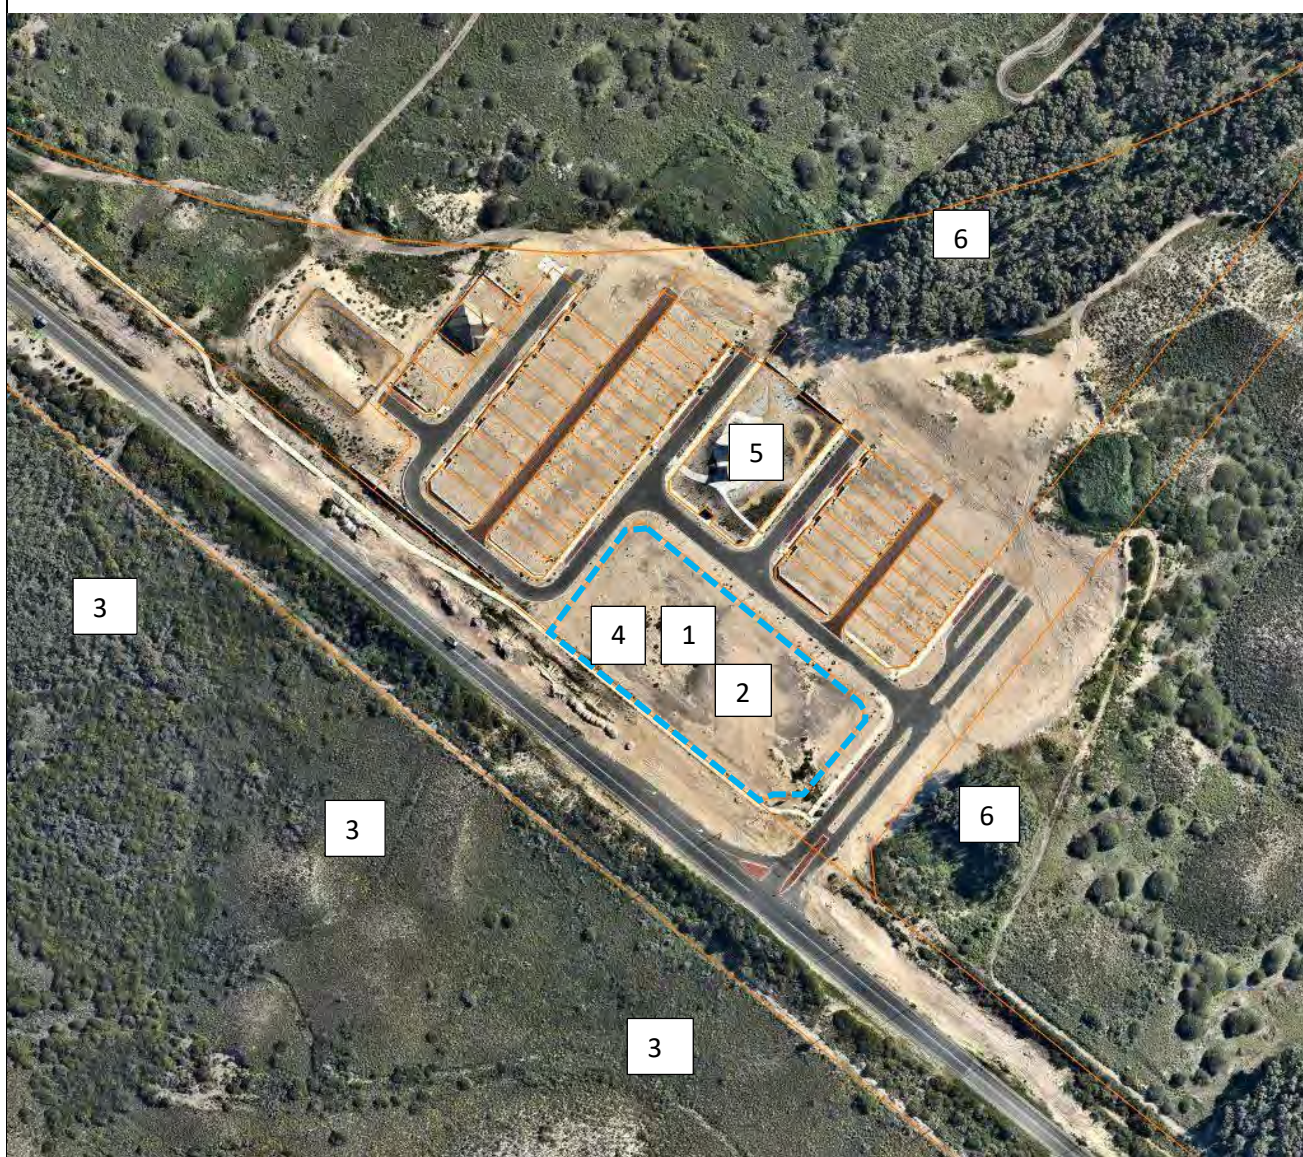
Figure 9. Spatial representation of the bushfire management strategies.

1. AS 3959 construction standards apply to the entire area as it is declared bushfire prone areas and the lot is BAL rated at BAL-12.5 or above.
2. The site will have reticulated mains water supply.
3. Scrub and shrubland to the west are a significant vegetation plot that provide an ongoing bushfire threat.
4. The site has been cleared during the development.
5. The POS has been developed as 'low threat vegetation'.
6. The forest plots have a grass surface vegetation and have a similar bushfire threat as the mixed shrubland and grass areas.

DEVELOPER/LANDOWNER – PRIOR TO SALE OR OCCUPANCY	
No.	Implementation Action
1	Install the access ways, and associated signs to the City standards.
2	Install the required water supply that meets State Government's specifications.
3	All dwellings to be constructed to AS 3959 standards.

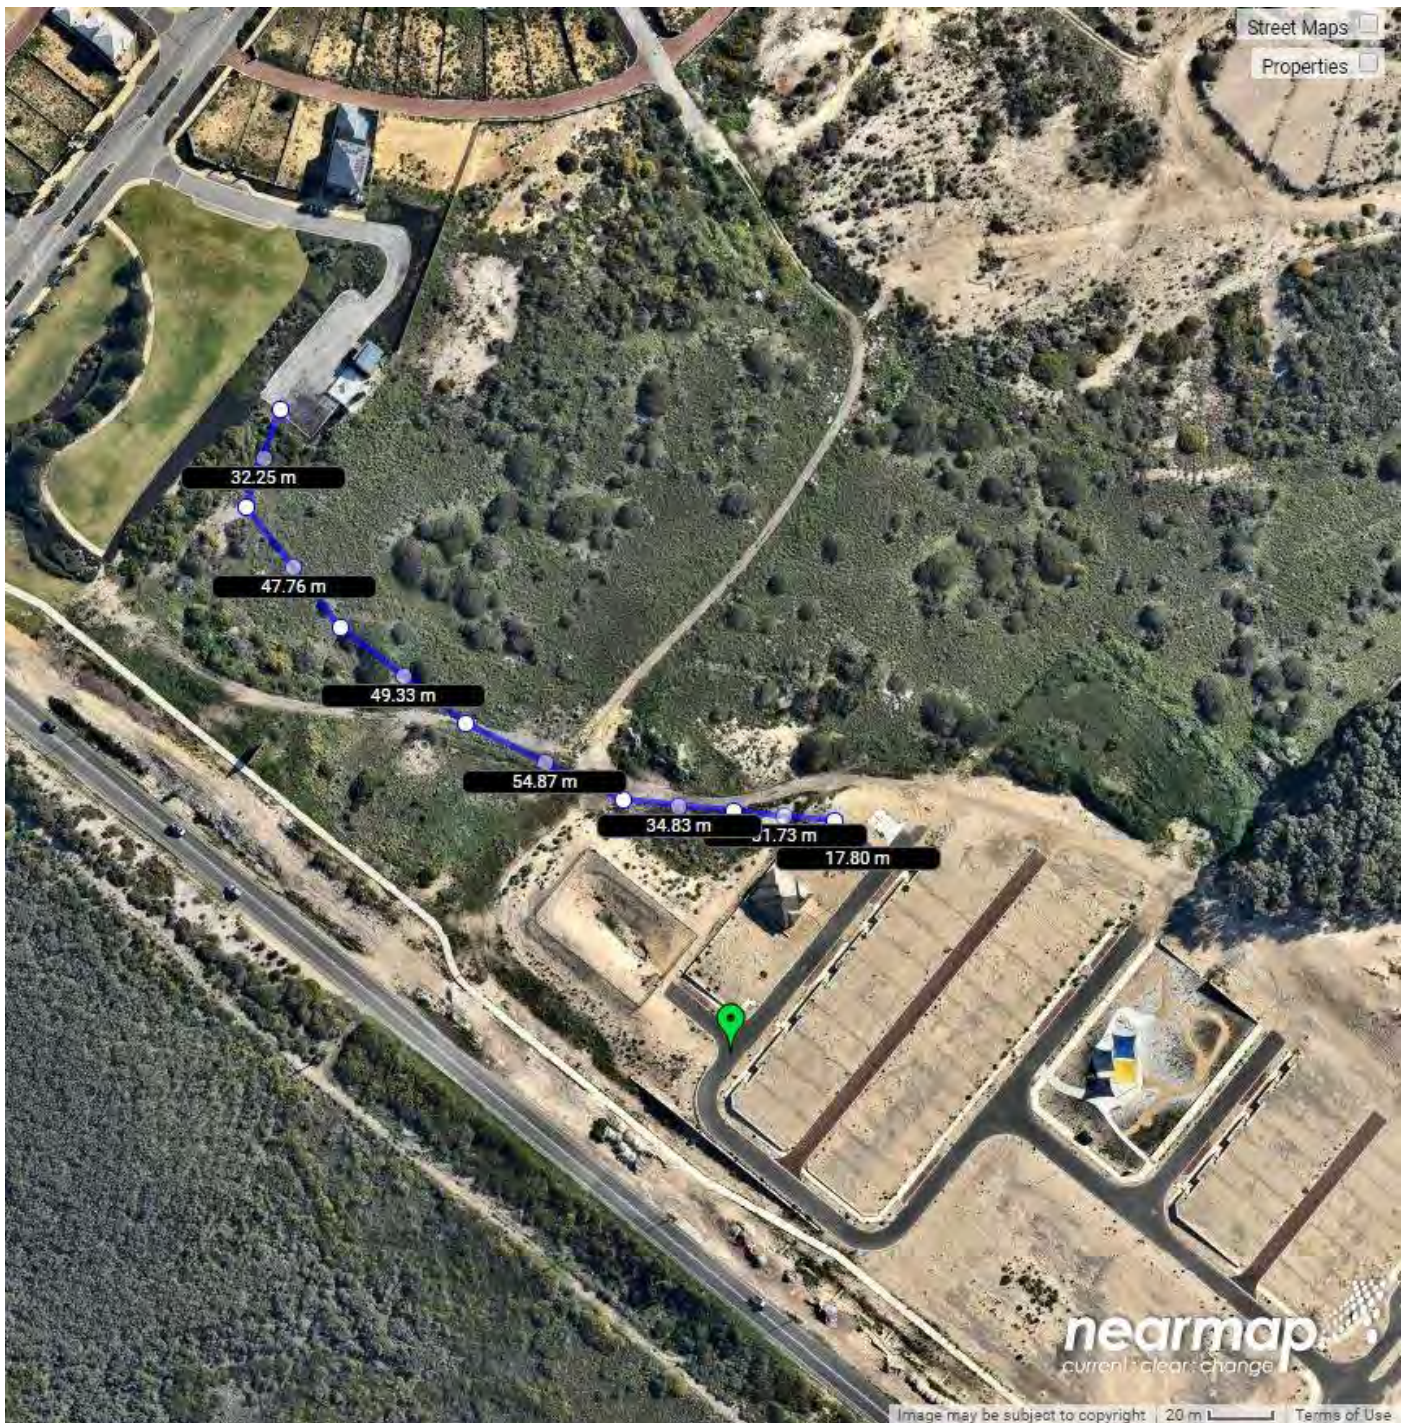
Appendix 1

Showing the location and distance of the emergency access way (268 metres in length) that links two bitumen roads and provides multiple entry and exit options and destinations.

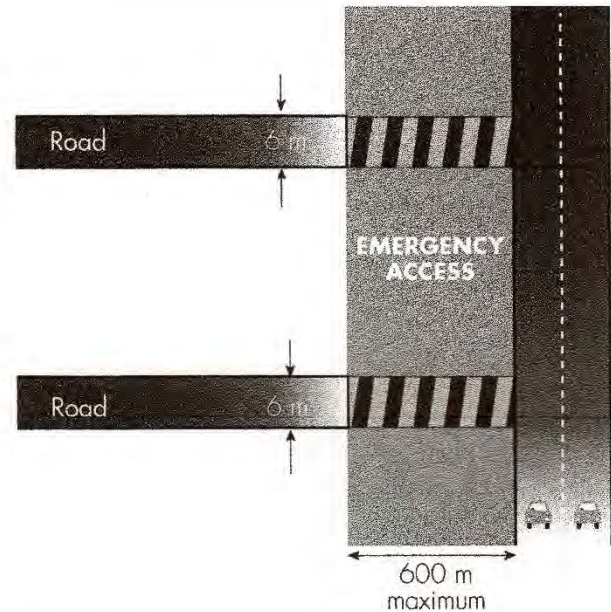
Figure 23: Minimum design requirements for an emergency access way

The access should comply with minimum standards for a public road and should be signposted. Where gates are used to control traffic flow during non-emergency periods, these must not be locked. Emergency access ways are to be no longer than 600 metres and must be adequately signposted where they adjoin public roads.
