# City of Wanneroo Coastal Monitoring Report

October 2023

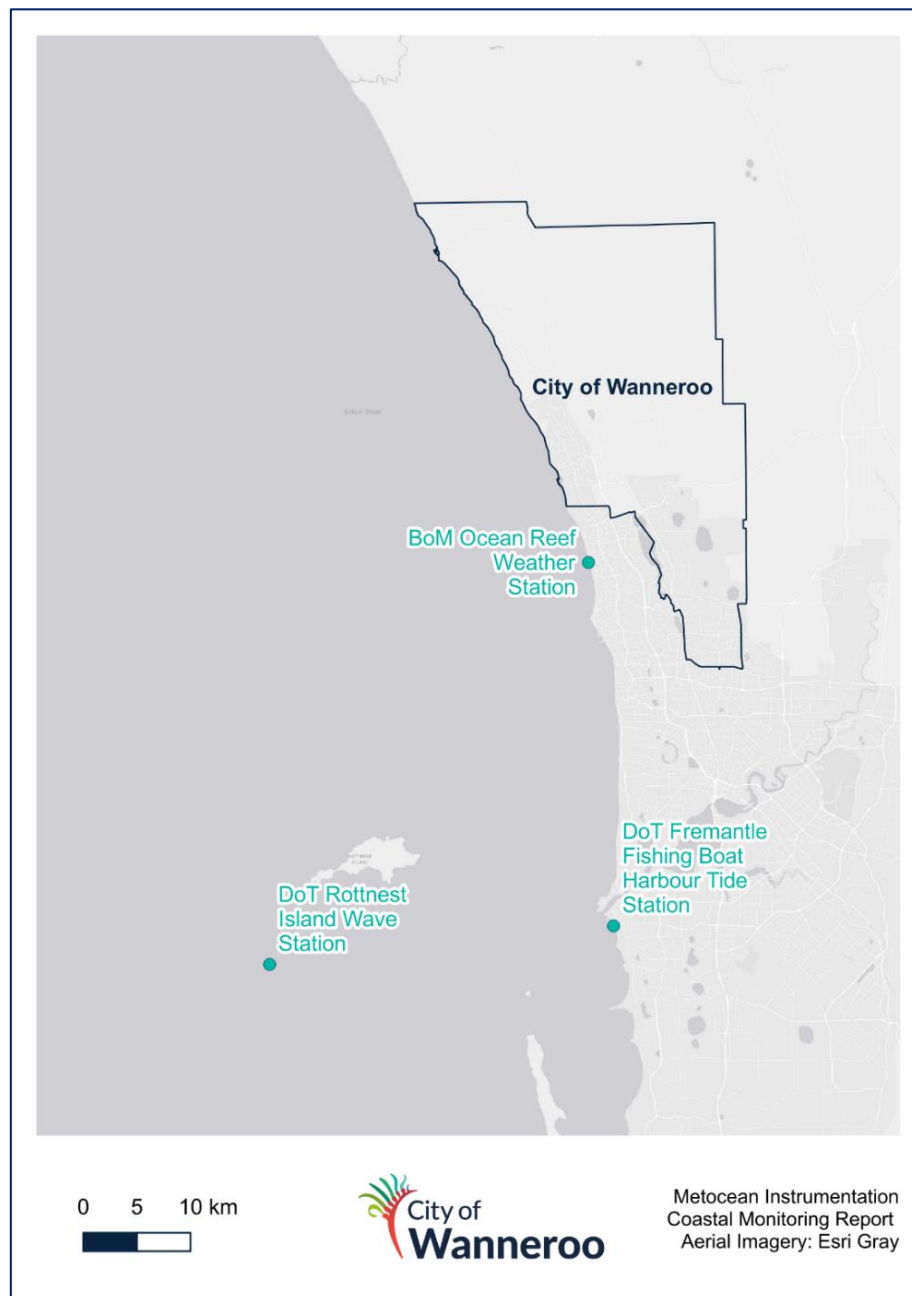
Figure 2-1

Locations of these instruments are presented in Figure 2-1.

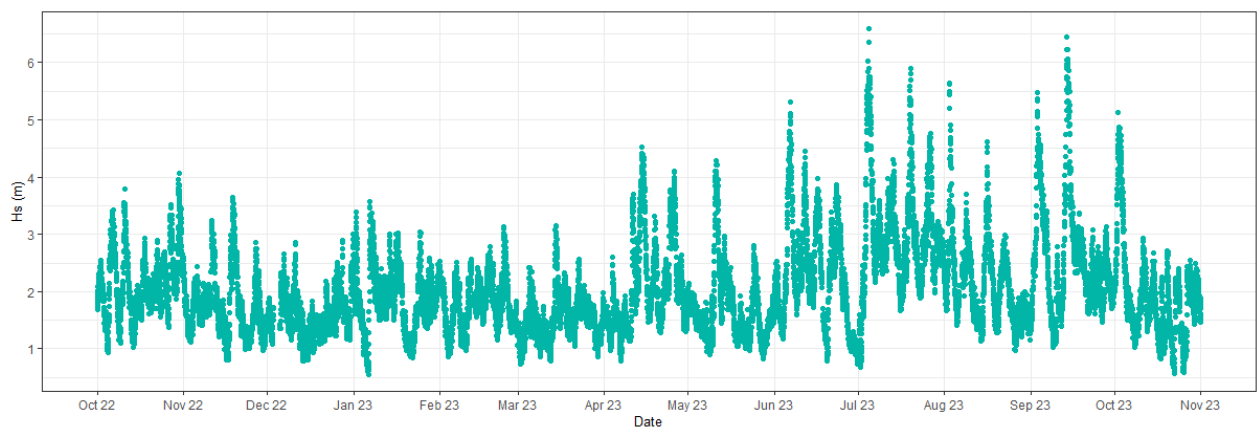
Figure 2-2 *Total Significant Wave Height (Hs) recorded at the Rottnest Island Wave Station from October 2022 to October 2023.*

The most notable observations from Figure 2-2 are the storm events that were recorded on the 4<sup>th</sup> of July 2023 and 13<sup>th</sup> of September 2023. Notably, the conditions of the 2023 winter period were calm relative to recent years, with these storm events resulting in peak significant wave heights of 6.59m and 6.44m respectively. Comparatively, the peak significant wave height for the 2022 winter period was 8.67m which was recorded on the 3<sup>rd</sup> of August 2022. Calm winter conditions resulted in minimal storm damage and limited coastal erosion as outlined in Sections 3, 4 and 5.

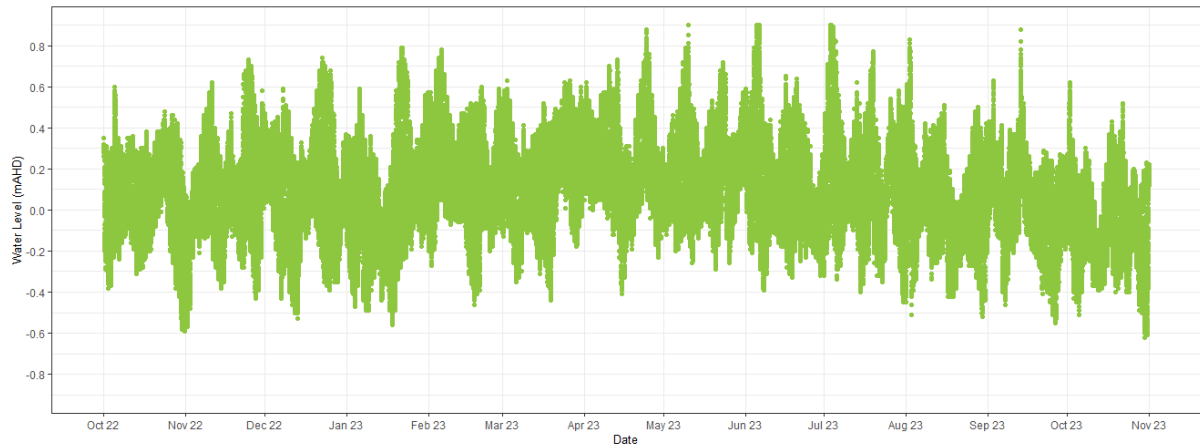
Figure 2-4 Water level (mAHD) recorded at the Fremantle Fishing Harbour Tide Station from October 2022 to October 2023.

Total recorded water level at the Fremantle Tide Station for October 2022 to October 2023 is presented in Figure 2-4. The highest water level recorded was 1.05 mAHD recorded at 10:20AM on 6 June 2023 and the peak non tidal residual (storm surge), 0.76m, was observed on 13 September 2023 at 1:00PM. As outlined above, conditions during the 2023 winter period were extremely mild and storm events caused very little damage to infrastructure. Further assessment on the impacts of the mild winter period are outlined in Section 4, 5 and 6.

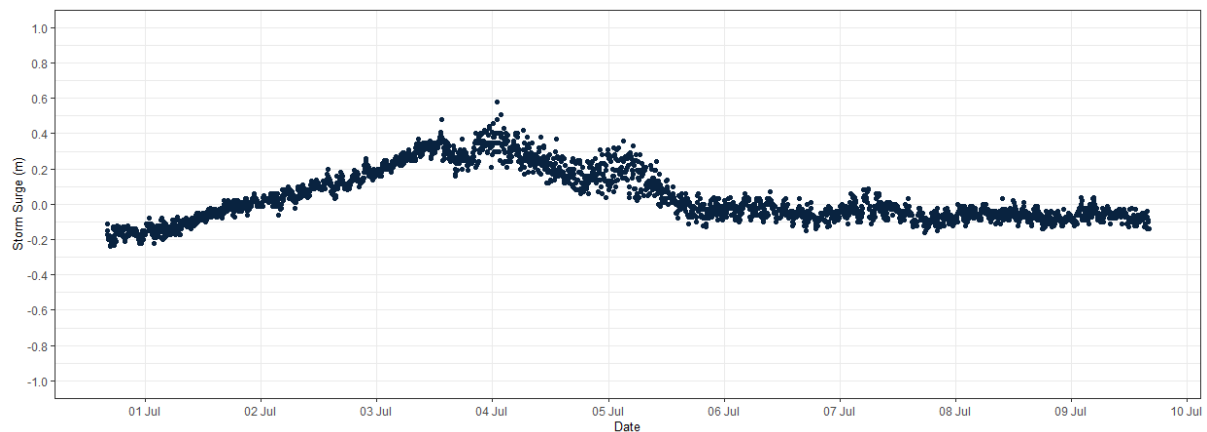
Figure 2-5 Non tidal residual recorded at the Fremantle Fishing Harbour Tide Station during the July 4<sup>th</sup> storm event.

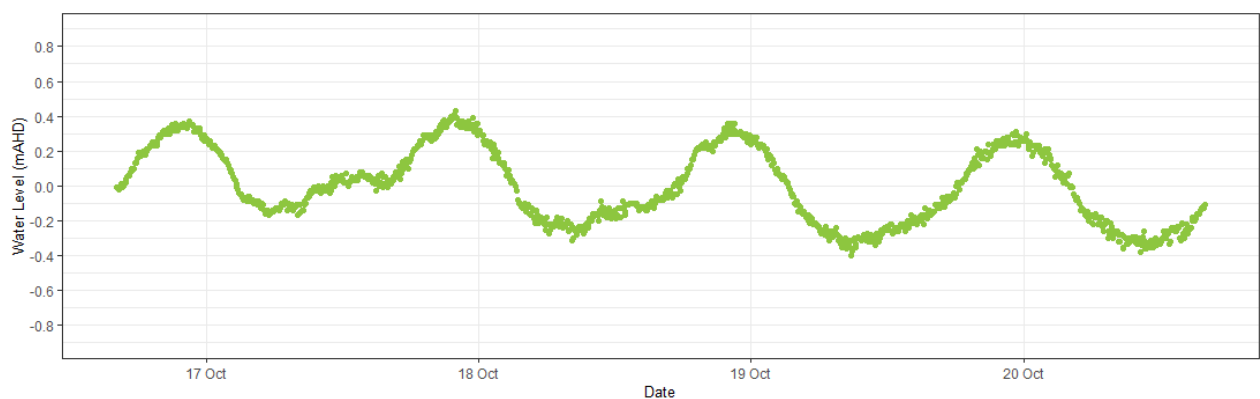
Manual imagery and aerial surveys for this monitoring period were undertaken between 17 October 2023 and 19 October 2023. The water levels during these monitoring periods are presented below in Figure 2-6.

Figure 2-6 Recorded water level during October 2023 monitoring activities.

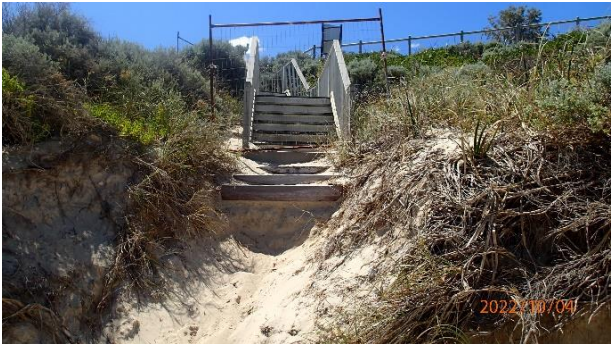
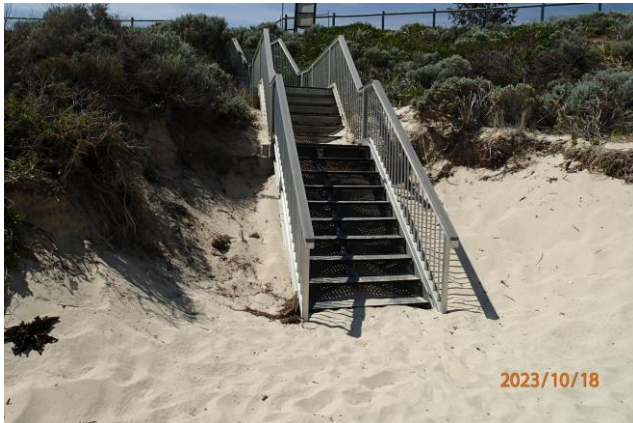
Damaged Asset	Damage	Action Taken by the City	Photograph of the asset following actions
Northern Fisherman's Hollow Twin Beach Access, Yanchep

<p>2022/10/09</p>	<p>A significant drop off was observed at the base of the beach access structure following a number of storm events in 2022. An extension was added to beach access staircase in August 2023 to ensure safe access the beach.</p>

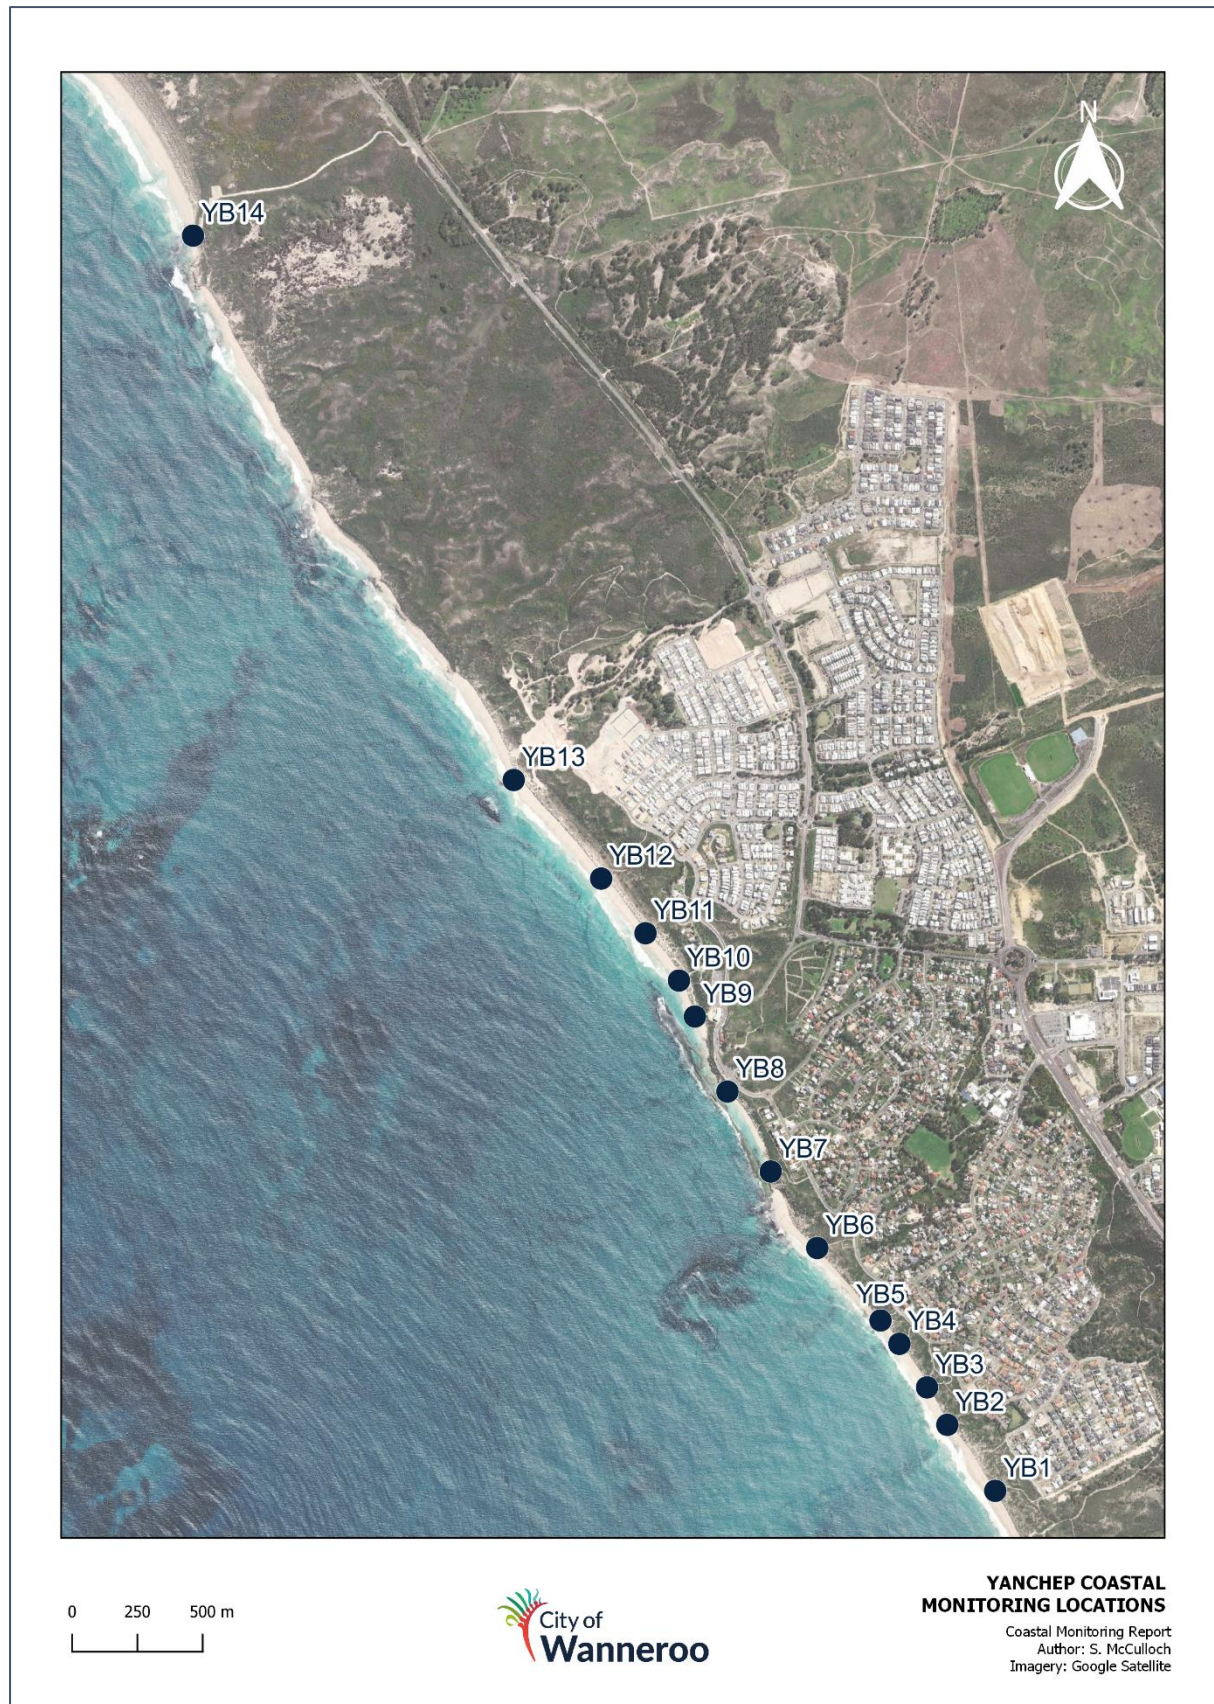
Figure 4-1 Two Rocks Coastal Monitoring Locations

There are a total of 51 manual imagery beach monitoring sites located in key vulnerable coastal areas along the CoW coastline. The position of these sites are presented in Figure 4-1 to Figure 4-5. Images are taken 6 monthly in April and October each year to assess seasonal and long term changes to beach morphology. Images are taken by CoW's Coastal Engineer and are taken at the same location and with same field of view each time.

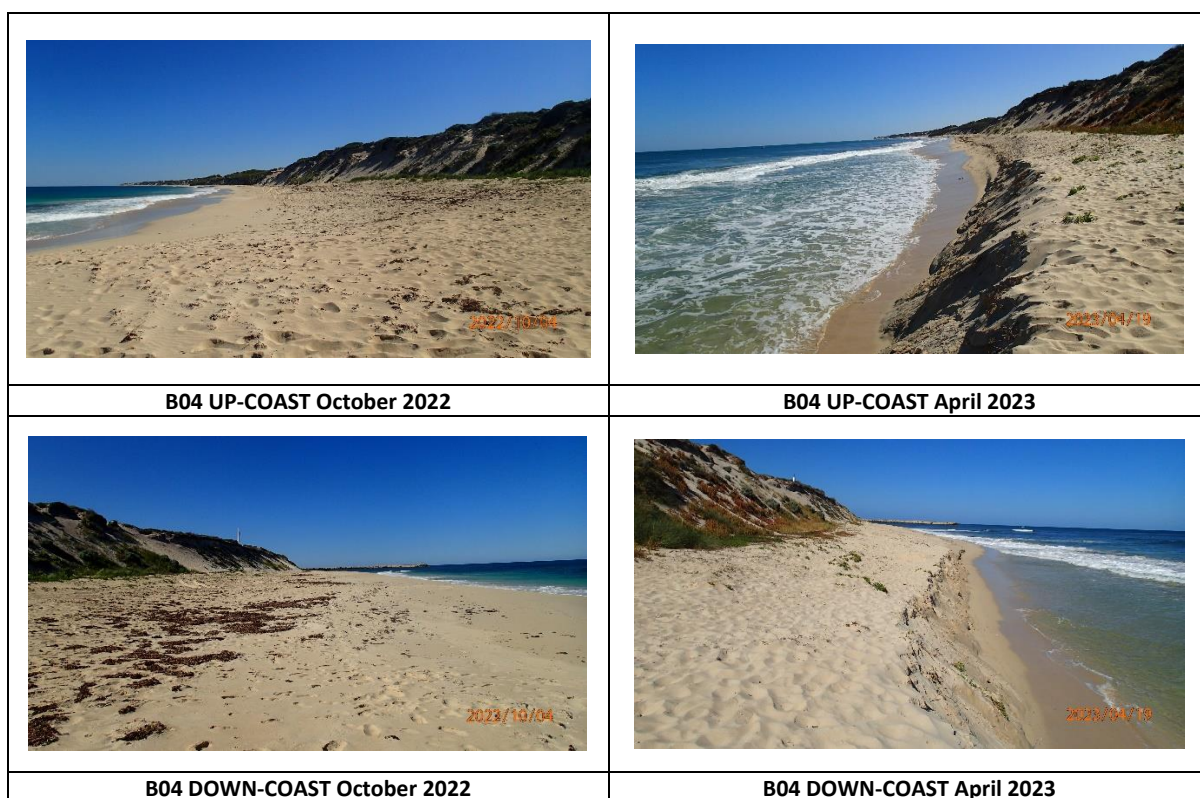
Figure 4-7 Major erosion over summer 2022/23 at Two Rocks B04.

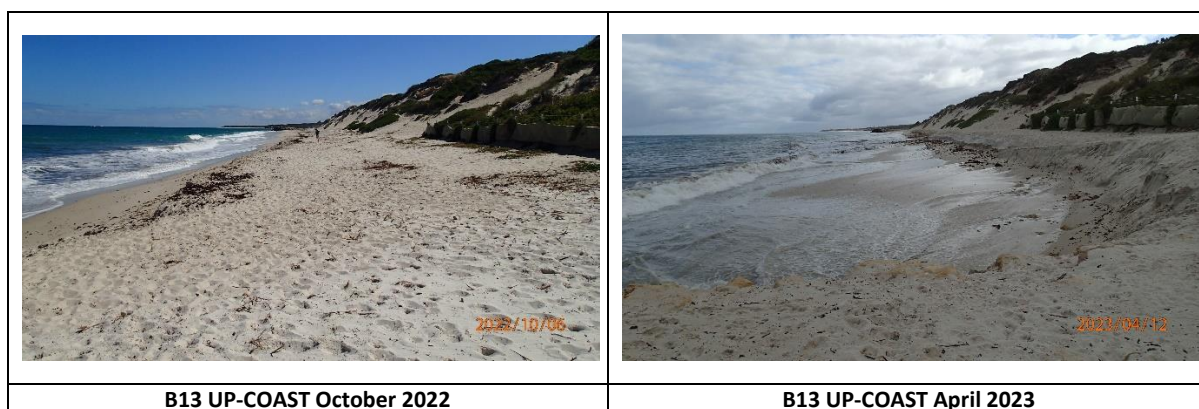
Figure 4-9 Major erosion over summer 2022/23 at Quinns B13 Up-Coast.

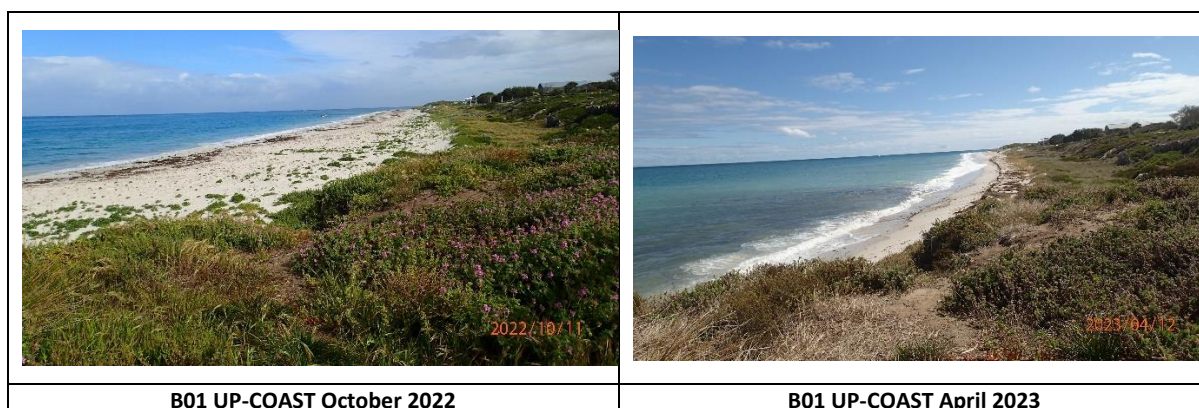
Figure 4-10 Major erosion over summer 2022/23 at Quinns B01 Up-Coast.

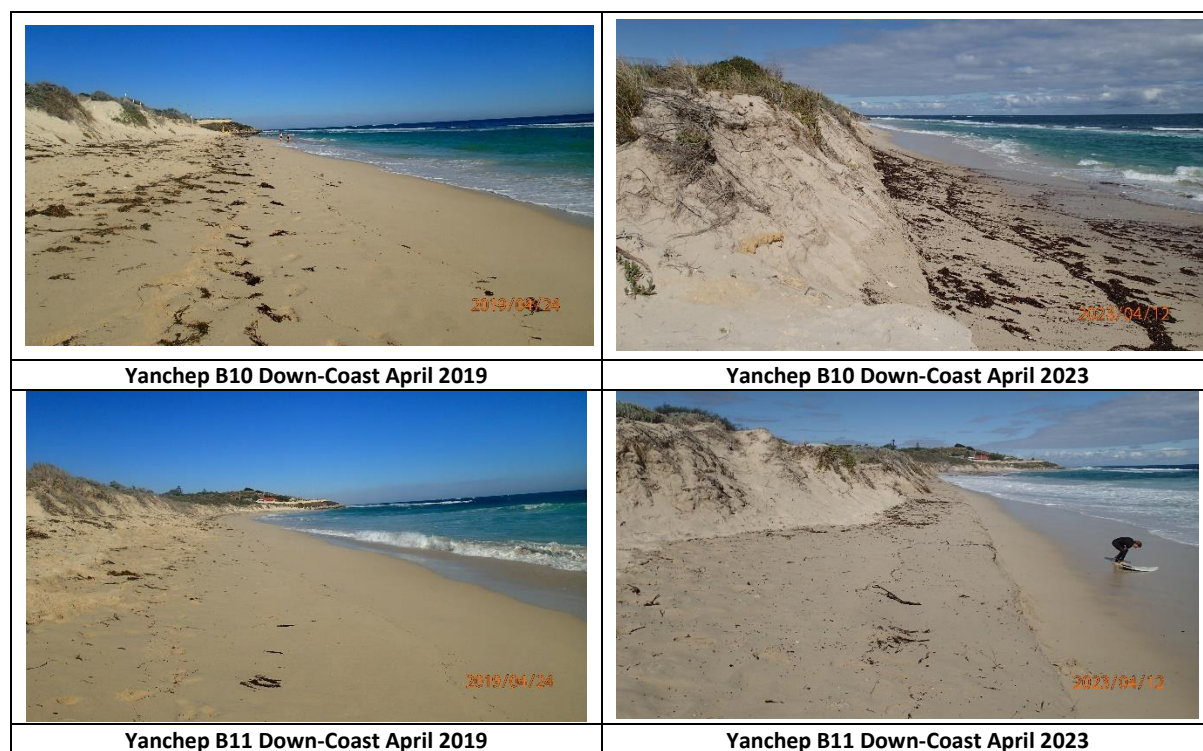
Figure 4-11 Significant long-term erosion at Yanchep Beach, north of Yanchep Lagoon.

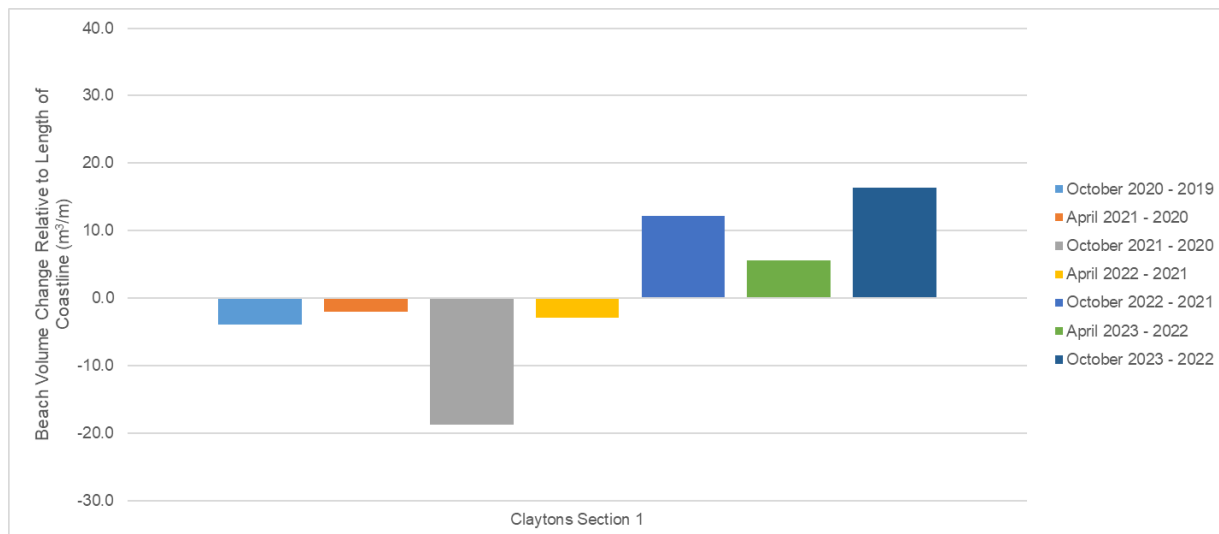
Figure 5-1 Seasonal net beach volume changes for Claytons Section 1.

Figure 5-1 shows an increase in beach volume along Claytons Beach in the three annual study periods assessed between October 2021 and October 2023. The net beach volume gain observed during the study periods October 2021 to 2022, April 2022 to 2023 and October 2022 to 2023 is likely attributed to strong seabreezes observed throughout the seasonal summer period. Claytons Section 1 is situated immediately south of the Mindarie Marina Breakwater, which interrupts the northward longshore sediment transport, trapping sand within the beach section defined by Claytons Section 1.

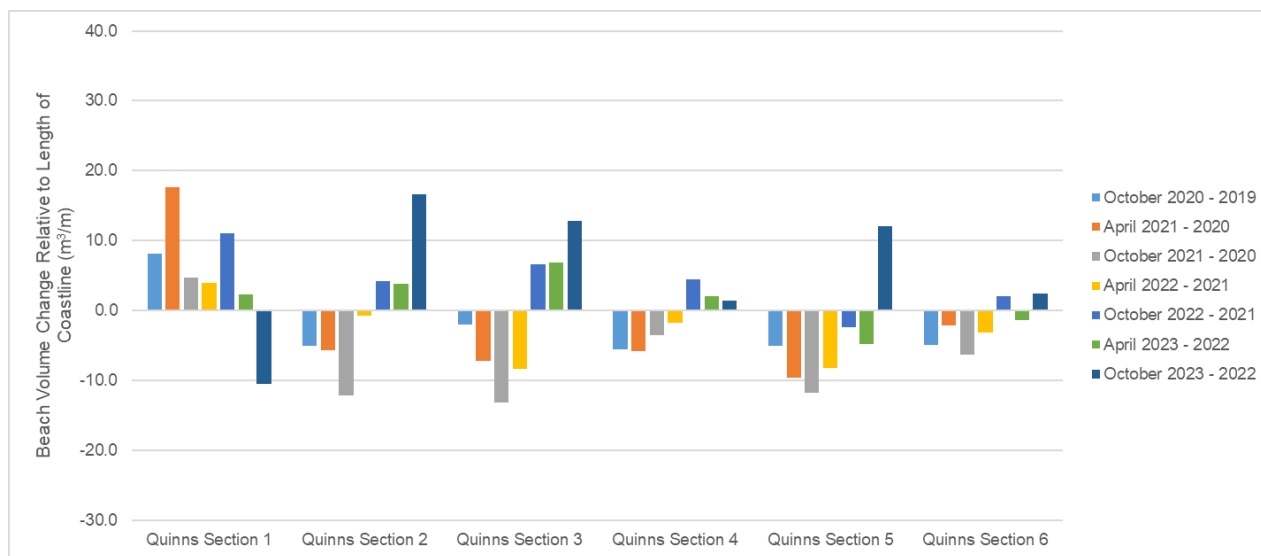
Figure 5-2 Annual net beach volume changes for Quinns Section 1, 2, 3, 4, 5 and 6.

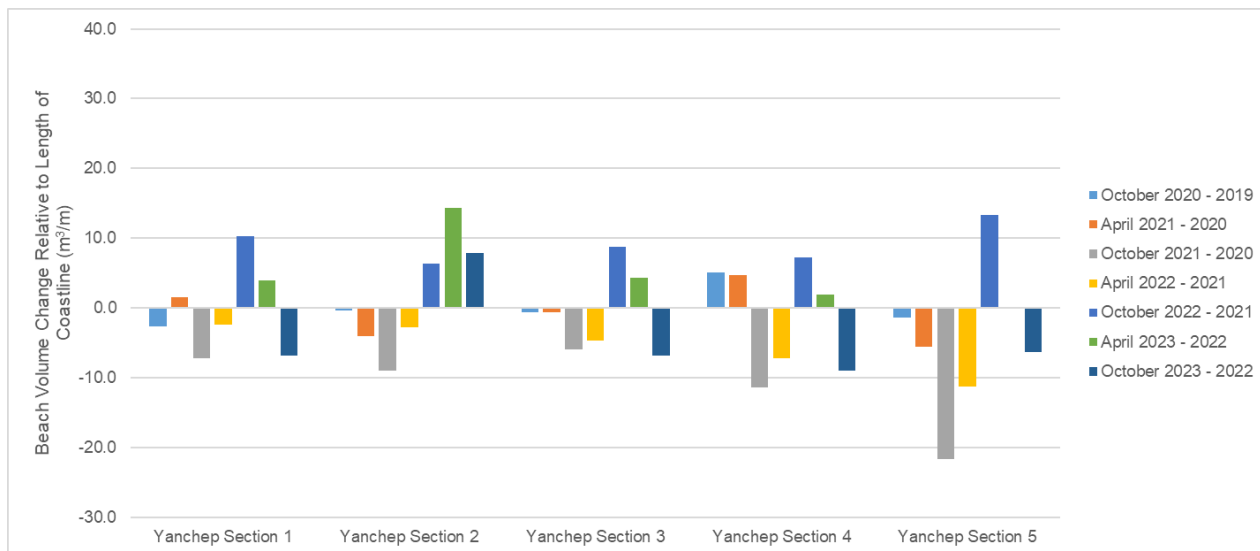
Figure 5-3 Annual net beach volume changes for Yanchep Section 1, 2, 3, 4 and 5.

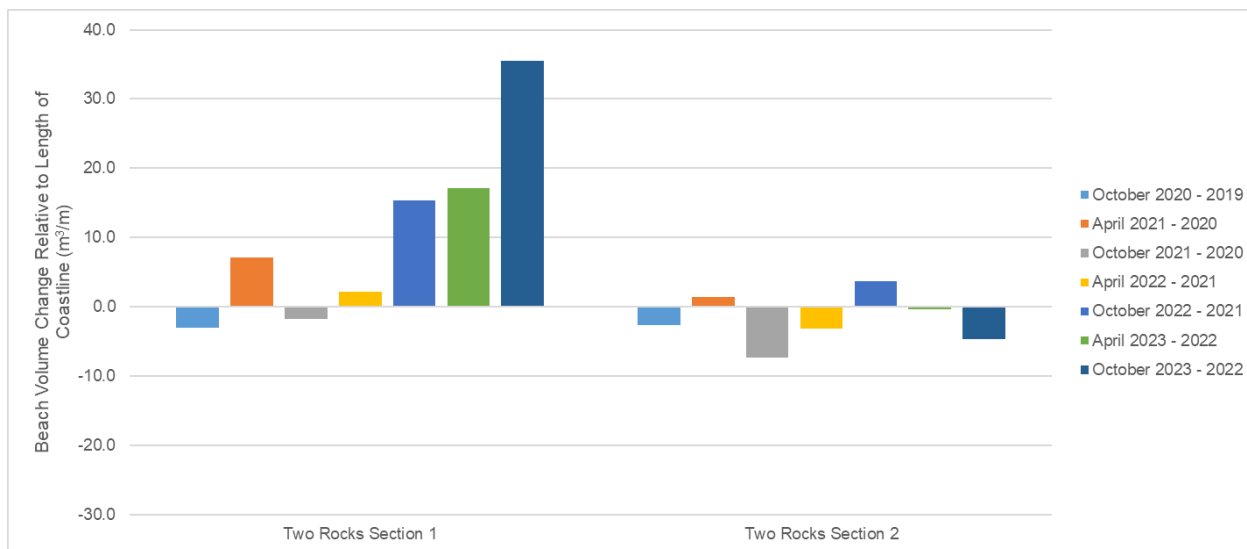
Figure 5-4 Seasonal net beach volume changes for Two Rocks Section 1 and 2.

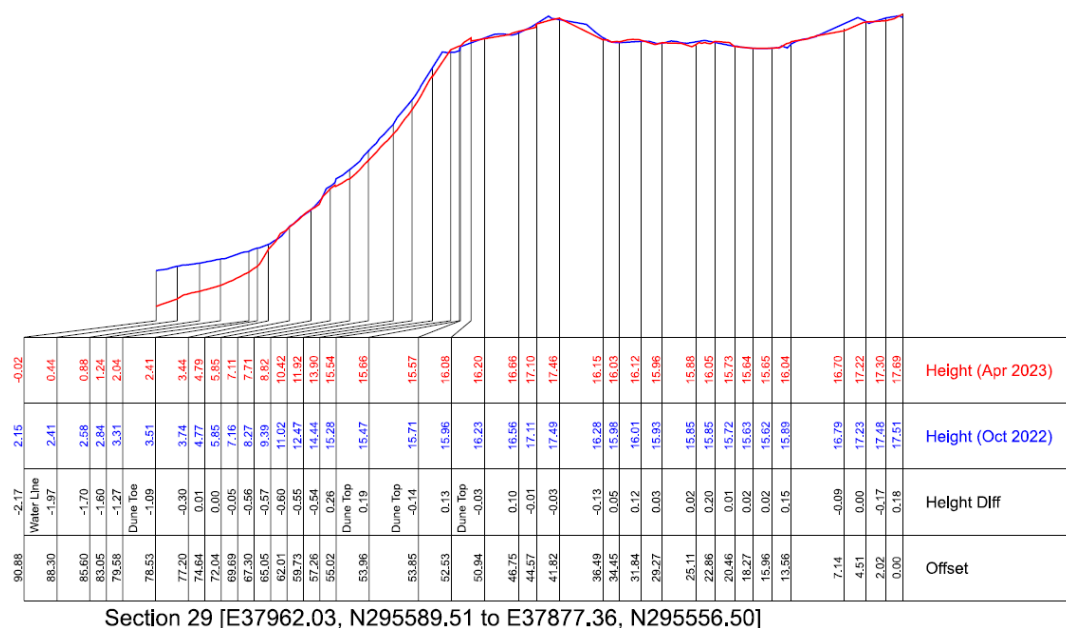
Figure 5-8 Quinns beach cross section 29 elevation comparison between October 2022 and April 2023 surveys.

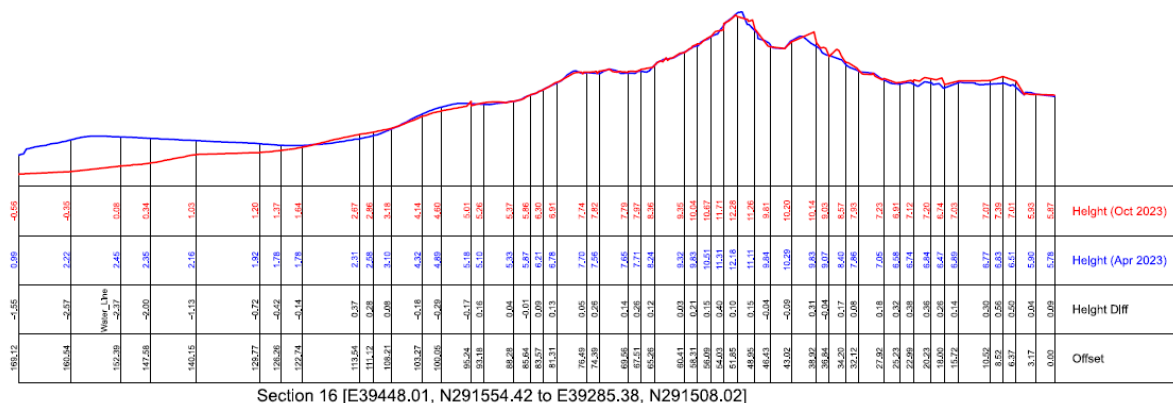
Figure 5-9 Cross section 16 at Claytons Beach, Mindarie which shows a reduction in beach height of up to 2.6m just below the waterline between April 2023 and October 2023.

The cross section presented in Figure 5-9 shows a significant reduction in the beach height between the April 2023 survey and the October 2023 survey. This was not identified in manual imagery (Figure 5-10) as there was a significant storm surge during the April 2023 monitoring period which led to high waterlines making it difficult to assess seasonal changes through manual imagery.

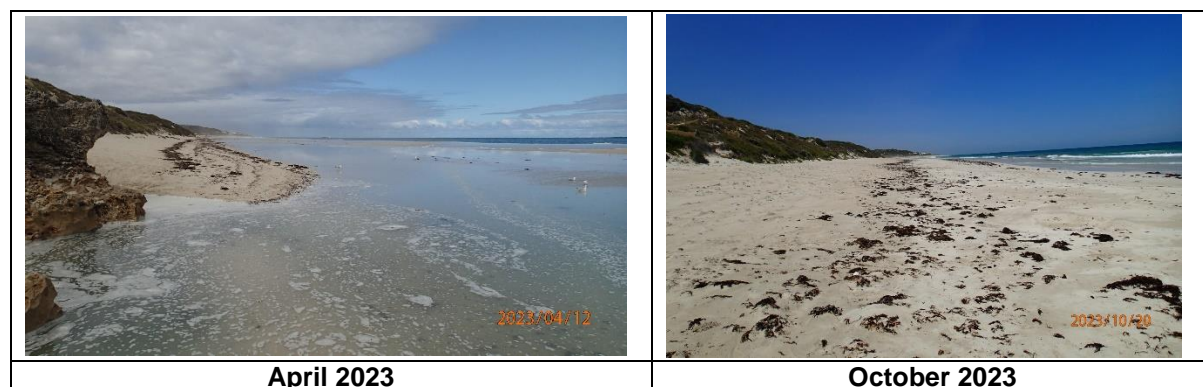
Figure 5-10 Manual images taken at Mindarie B02 Down-Coast.

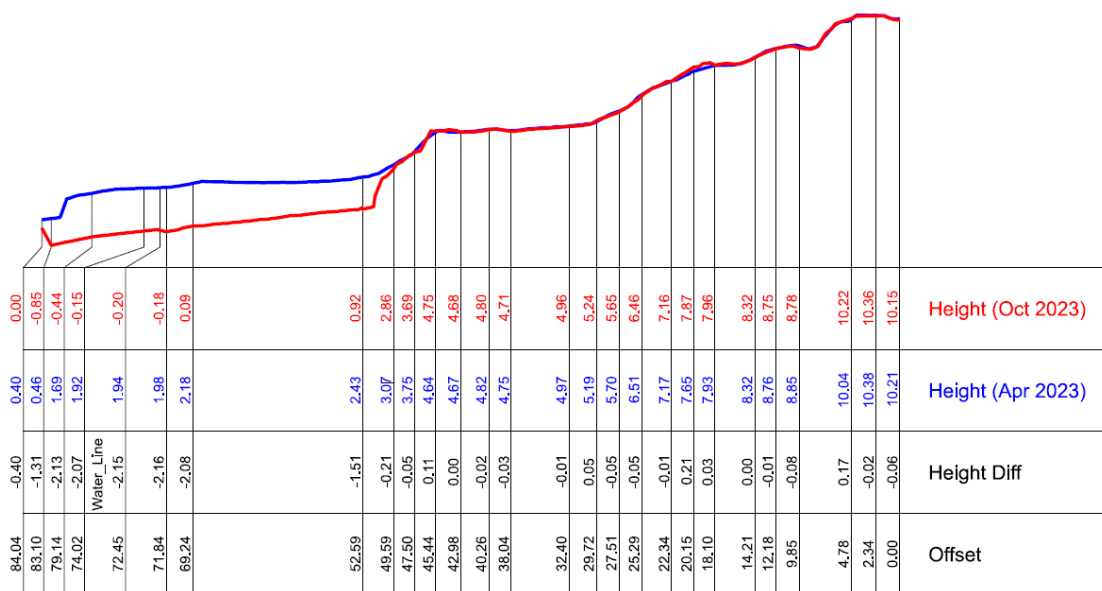
Section 15 [E38106.66, N294511.73 to E38023.14, N294502.48]

The beach profile comparison for Quinns Beach cross section 15 shows a reduction in beach elevation of up to 2.15m between the April 2023 survey and the October 2023 survey, which represents significant erosion along this section of coastline. Seasonal erosion at this location is common as the site is confined by Quinns Groyne 1 to the north which limits southward transport of sand in the winter months. As the reduction in elevation was mostly limited to the beach area close to the waterline, this site was not identified as having experienced major seasonal erosion in manual imagery analysis.

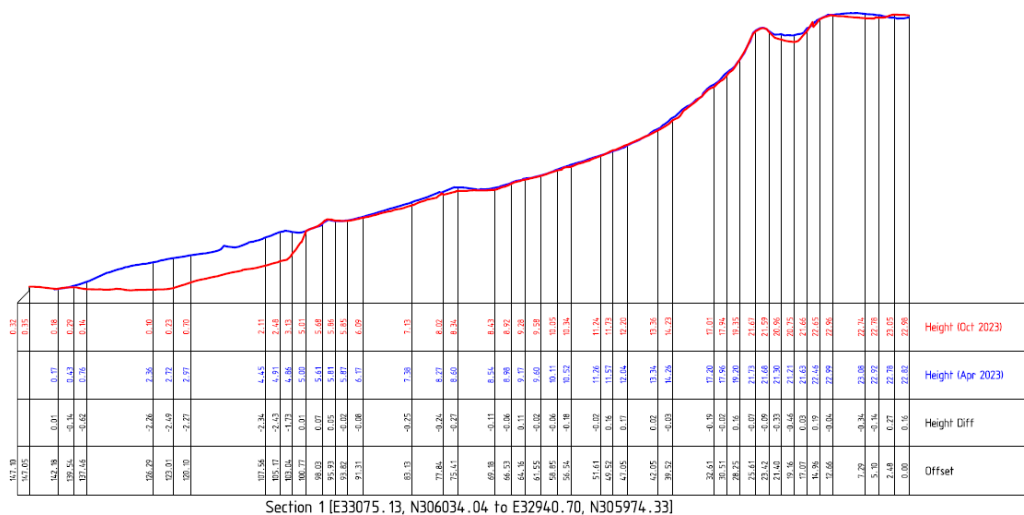
Figure 5-13 Cross section 1 at Yanchep Beach which shows a reduction in beach height of up to 2.49m between April 2023 and October 2023.

The results from cross section 1 along Yanchep Beach show a significant drop in elevation of the beach profile between April 2023 and October 2023 as well as between October 2022 and October 2023. This site is located along the southern Yanchep coastline, away from infrastructure. The site is situated 400m south of Yanchep manual imagery site B01 (Figure 5-15) and is likely not captured within the field of view of this site.

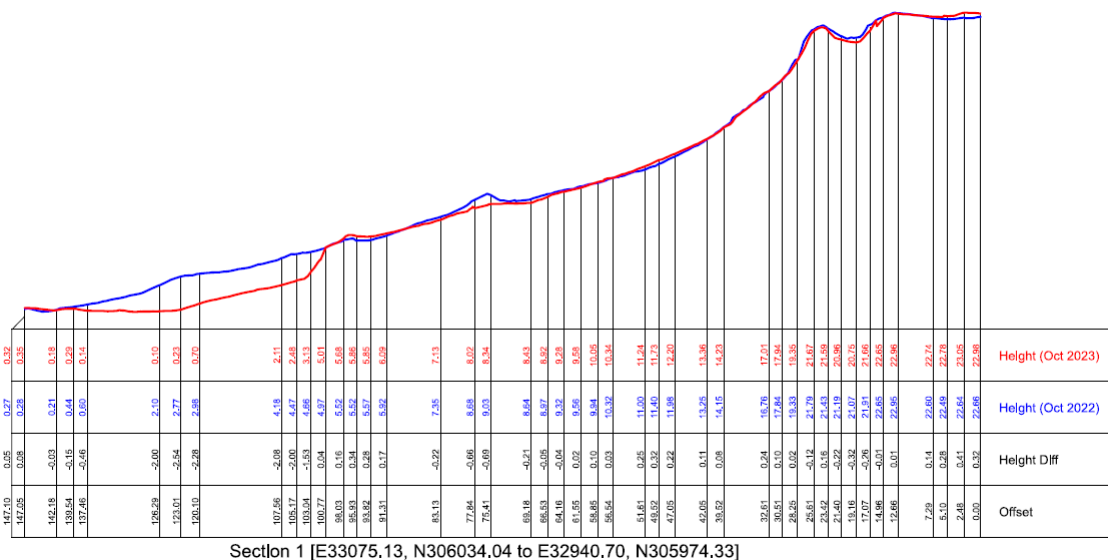
Figure 5-14 Cross section 1 at Yanchep Beach which shows a reduction in beach height of up to 2.54m between October 2022 and October 2023.

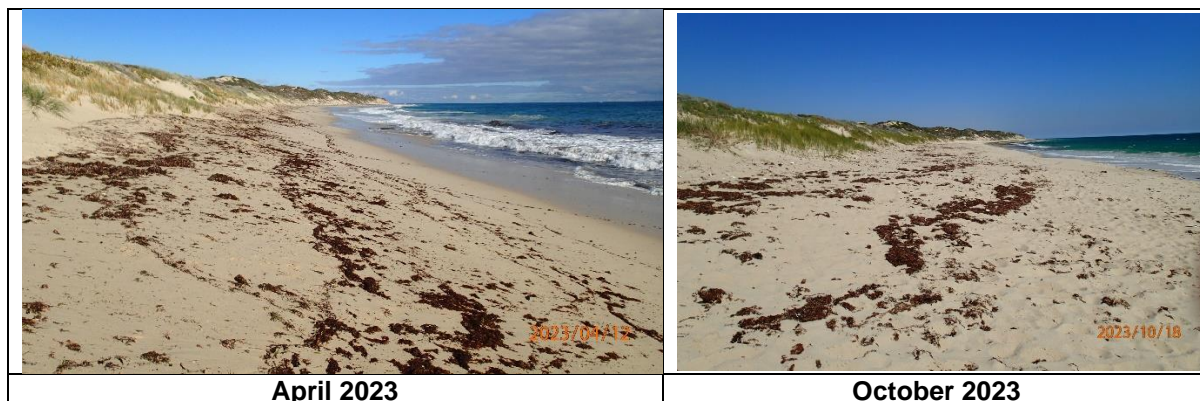
Figure 5-15 Manual imagery taken at Yanchep B01 Down-Coast in April 2023 and October 2023.

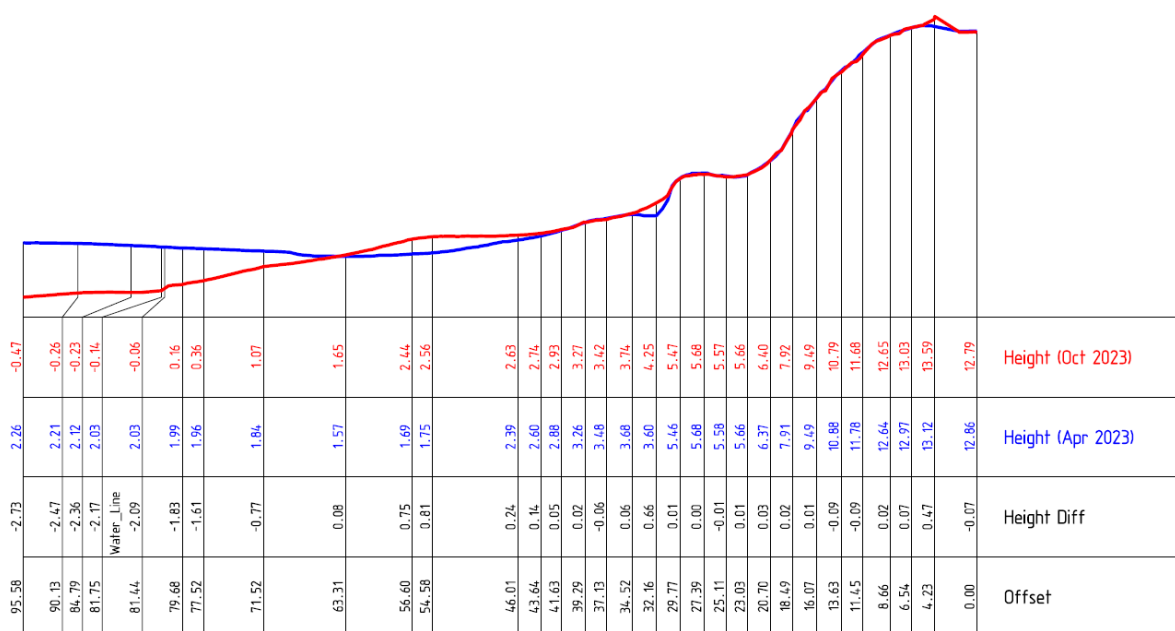
Section 23 [E31924.04, N307767.63 to E31837.11, N307727.89]

Yanchep Cross Section 23 is situated within the field of view of manual imagery site Yanchep B07 Up-Coast (Figure 5-17) and while major seasonal erosion was not identified in manual imagery analysis, beach profile cross section comparisons show a reduction in elevation of 2.73m between April 2023 and October 2023. While minor erosion is noted in the manual imagery observations, the reduction in elevation identified in beach profile cross sections was mostly limited to the beach area close to the waterline, and outside of the field of view, which is why this site was not identified as having experienced major seasonal erosion in manual imagery analysis. Seasonal erosion at this site is common, as the site is confined by two natural rock headlands to the north and south, and sediment is often captured within the site across the summer months as the northern headland interrupts the northward sediment transport.

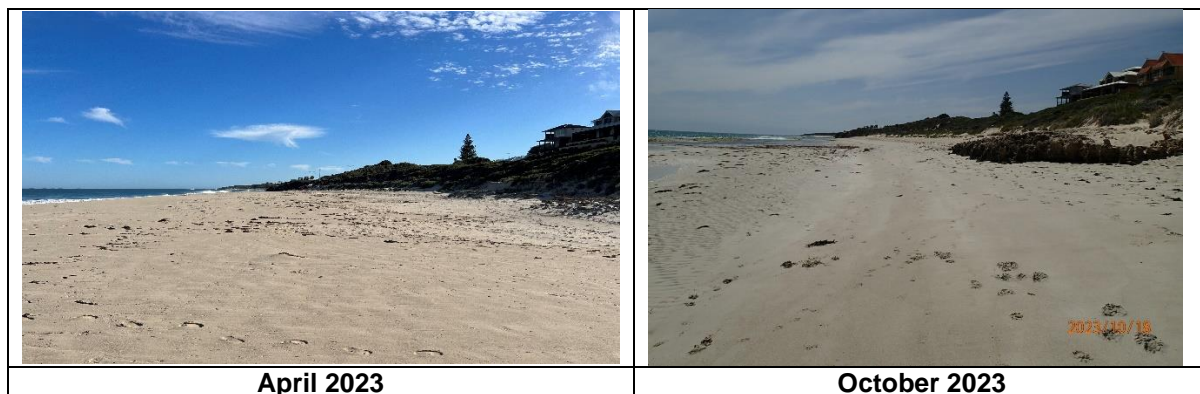
Figure 5-17 Manual imagery taken at Yanchep B07 Up-Coast in April 2023 and October 2023.

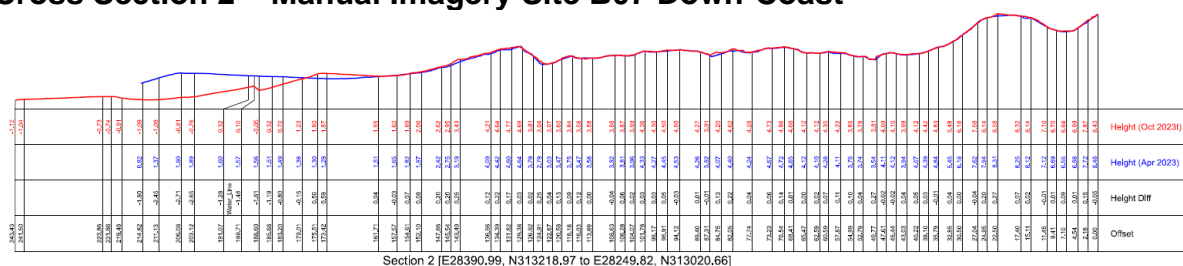
Figure 5-18 Significant reduction in beach elevation below the waterline between April and October 2023 recorded at Two Rocks Cross Section 2.

Two Rocks cross section 2 is within the field of view of Two Rocks manual imagery site B07 (Figure 5-19) and while there was minor erosion observed at the site with a notable reduction in beach width (Section 4), the extent of erosion below the waterline was not captured.

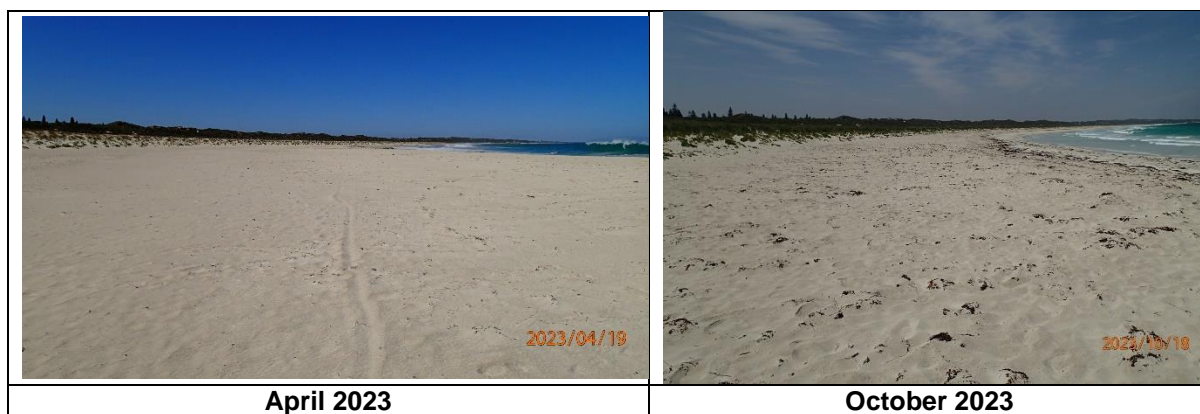
Figure 5-19 Manual imagery taken at Two Rocks B07 Down-Coast in April 2023 and October 2023.

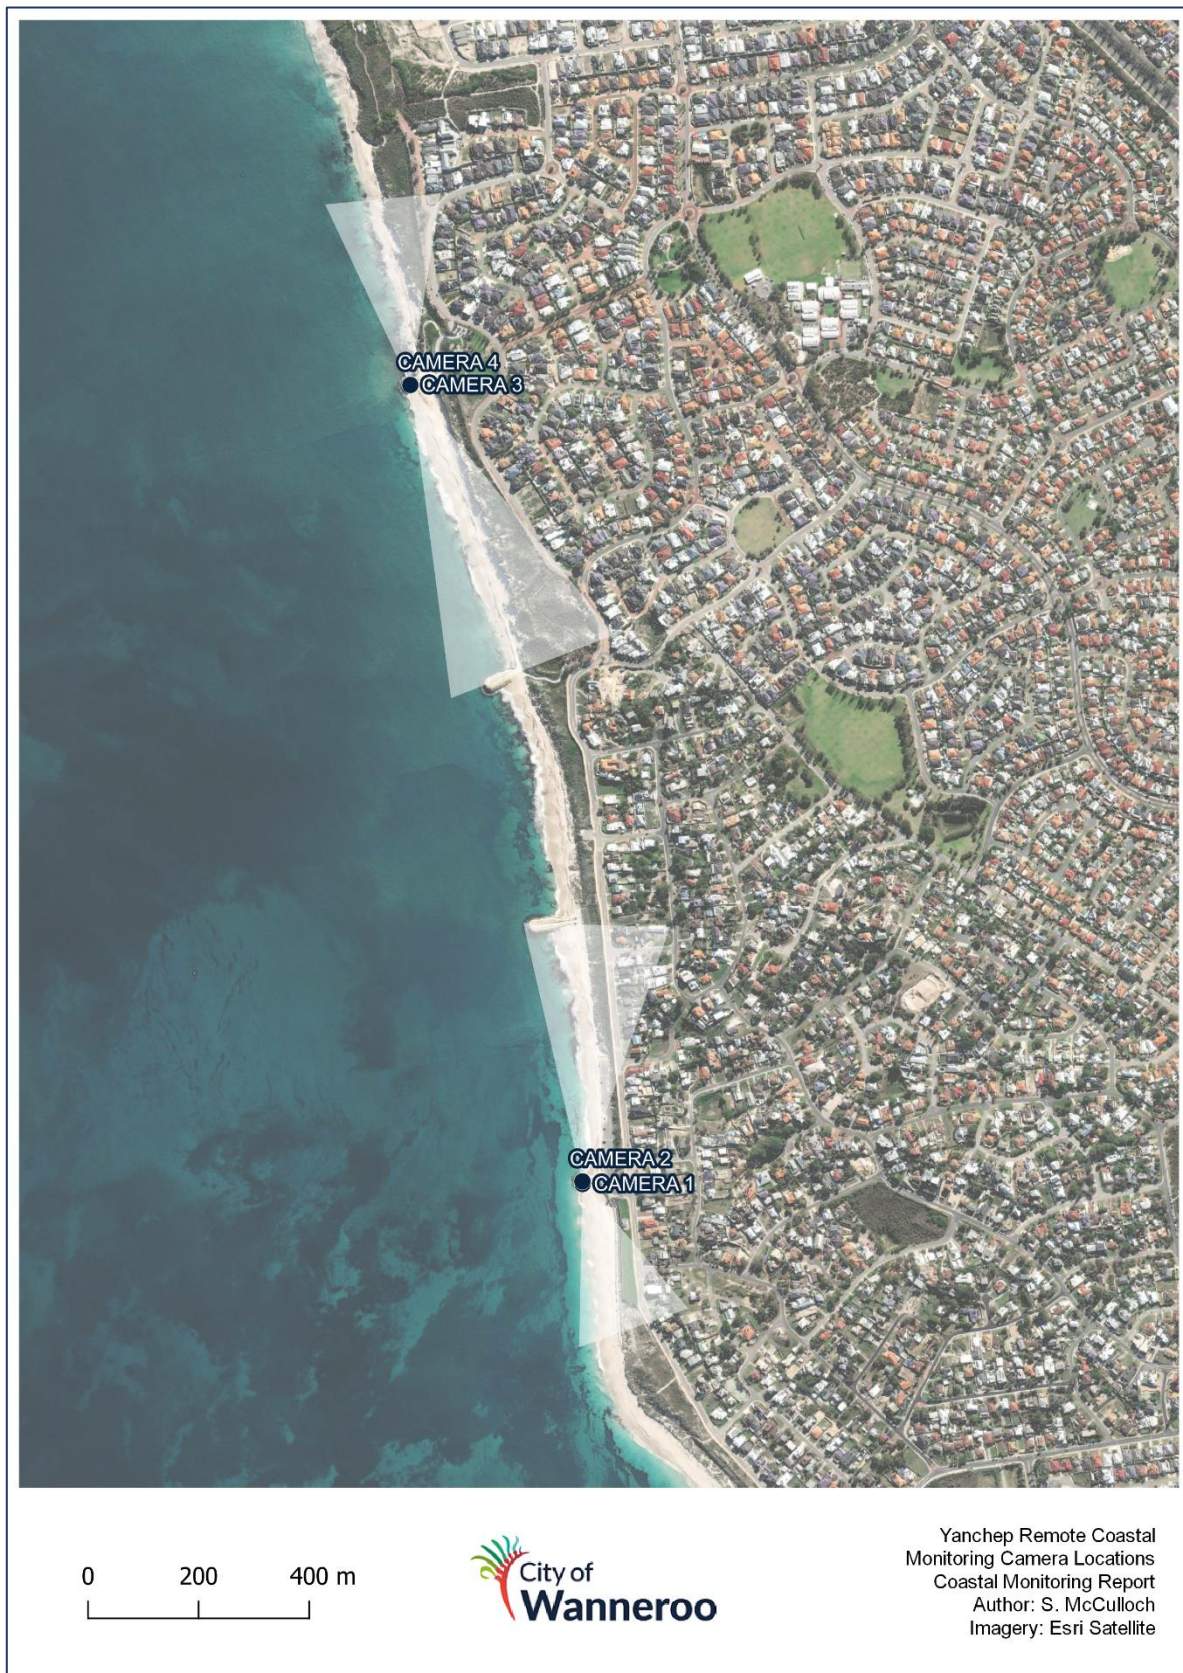
Five remote monitoring cameras were installed along Quinns and Yanchep Beach in November 2021. The location and field of view of the cameras was selected to monitor vulnerable sections of the City's coastline, these locations are presented below in Figure 6-1 and Figure 6-2. The cameras take photos hourly between the hours of 7:00 and 18:00. Timelapse videos were created for each camera to assess morphological changes to the coastline between October 2022 and October 2023.

Quinns Rocks Remote Coastal Monitoring Camera Locations.
