# City of Wanneroo Coastal Monitoring Report

October 2023

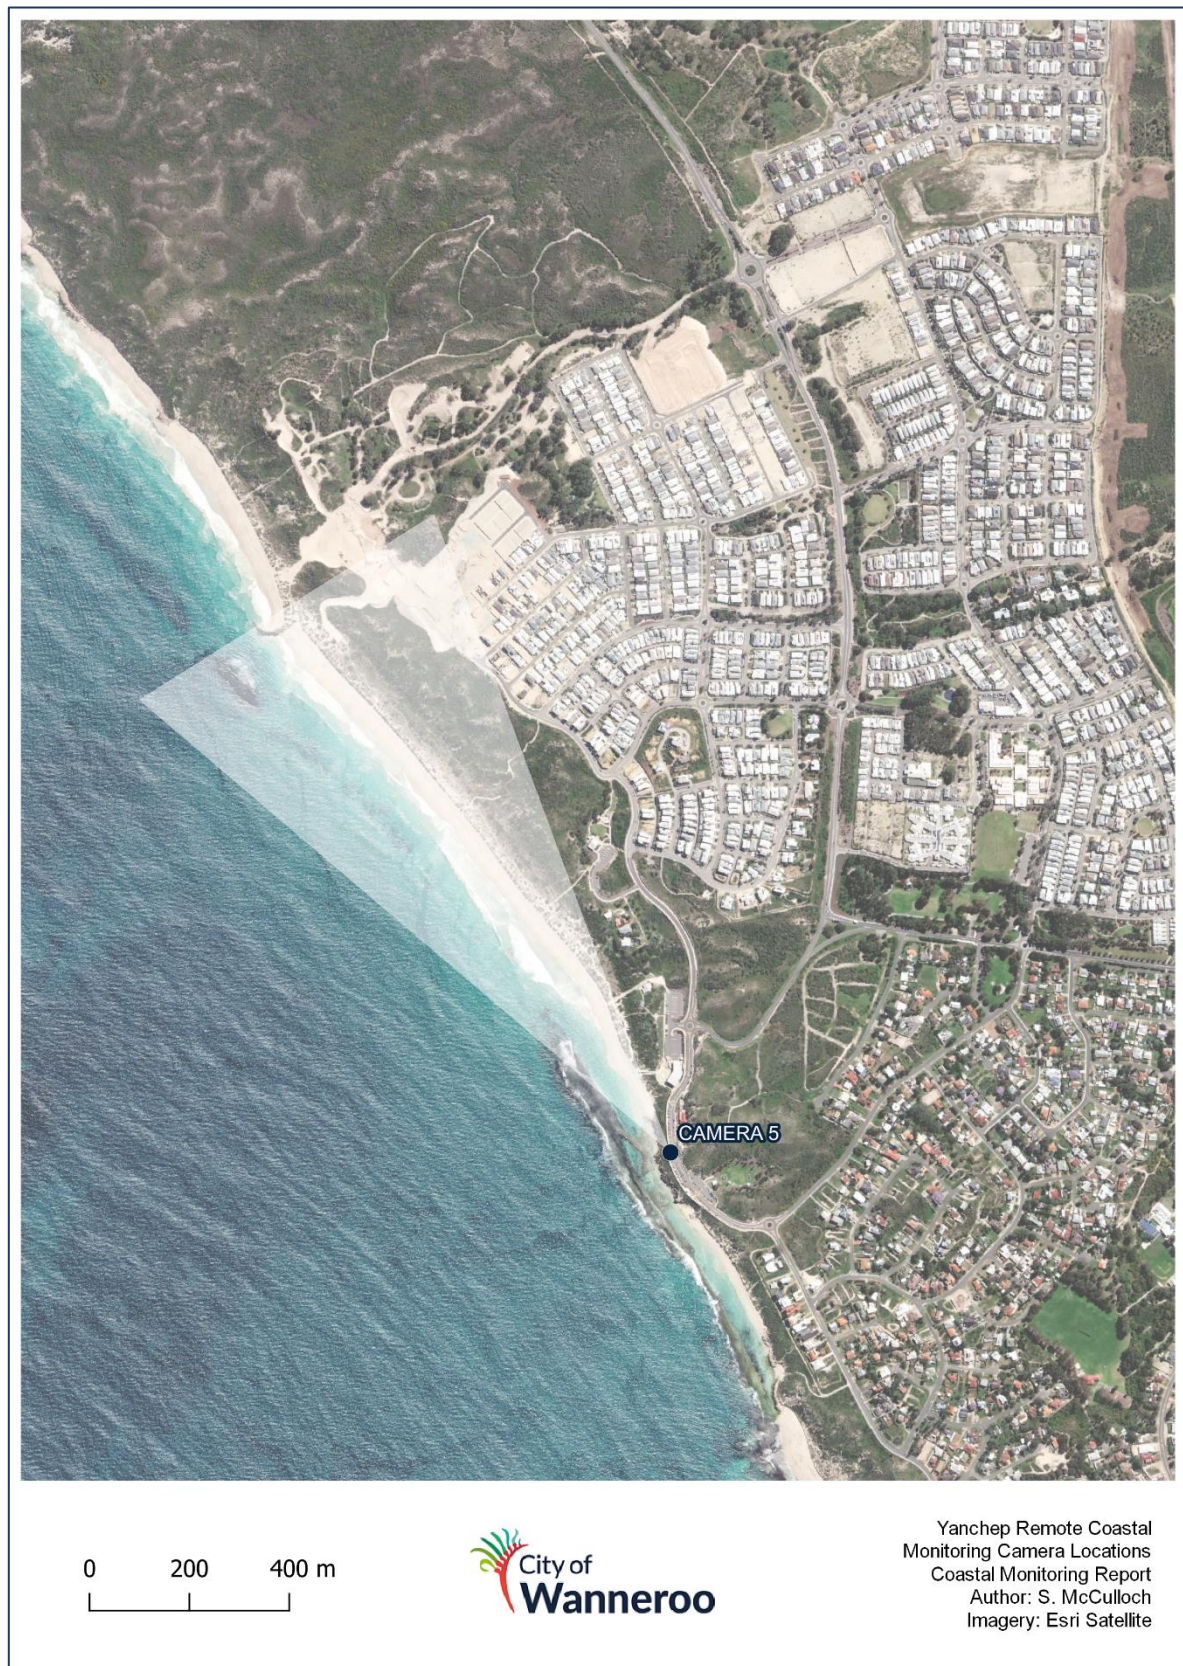
Figure 6-2

Five remote monitoring cameras were installed along Quinns and Yanchep Beach in November 2021. The location and field of view of the cameras was selected to monitor vulnerable sections of the City's coastline, these locations are presented below in Figure 6-1 and Figure 6-2. The cameras take photos hourly between the hours of 7:00 and 18:00. Timelapse videos were created for each camera to assess morphological changes to the coastline between October 2022 and October 2023.

Yanchep Remote Coastal Monitoring Location.

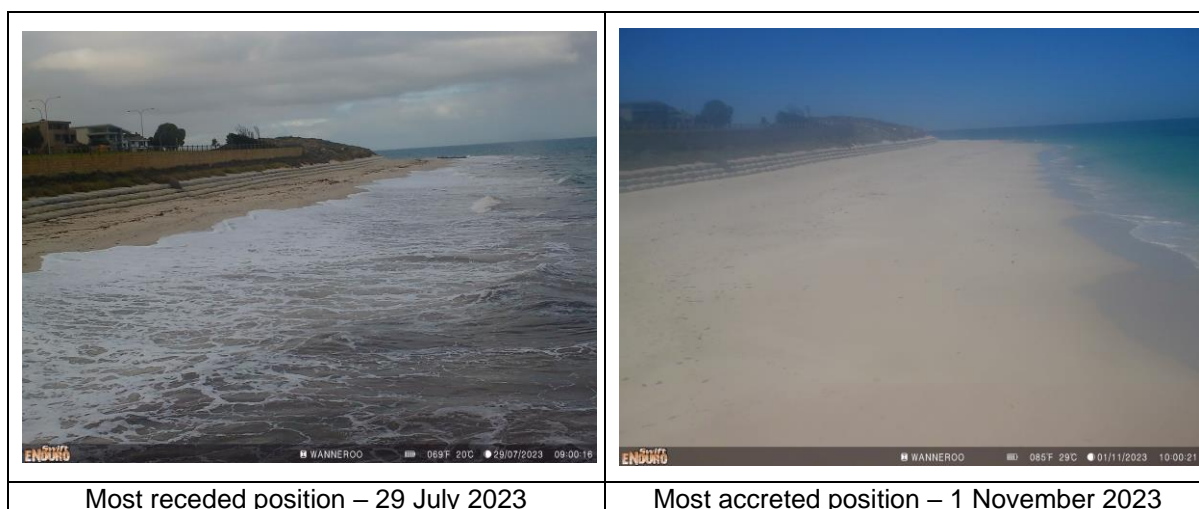
Quinns Camera 1 captures the beach immediately south of Groyne 1, adjacent to the GSC Revetment. The condition of Camera 1 was impacted in October 2022 and unfortunately was out of action until June 2023. The time series of images taken from Quinns Camera 1 between June 2023 and October 2023 shows a wide beach at the beginning of the monitoring period in June 2023 that is subject to erosion until the end of July 2023. The beach begins to build up from August to the end of the monitoring period in October 2023. This section of coastline is at its most accreted position at the end of the monitoring period, as outlined in Figure 6-3. As outlined in Section 2.2.1 there was a significant increase in southerly winds between September and October 2023 which is likely to have contributed to the build-up of sand to the south of Groyne 1.

Figure 6-3 Most receded and most accreted shoreline position to the south of Quinns Groyne 1 during the study period.

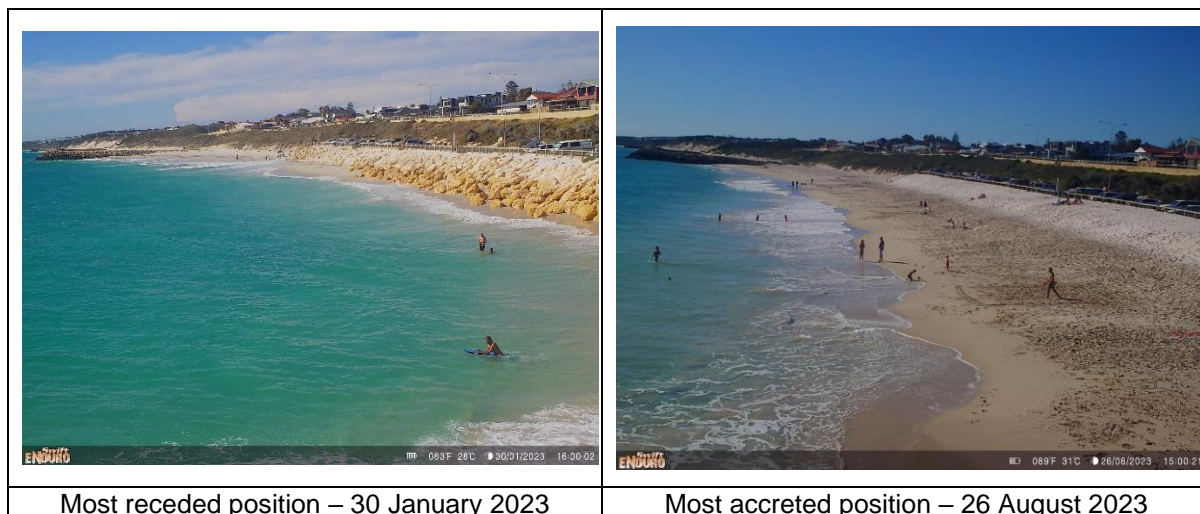
Quinns Camera 2 captures the beach immediately north of Groyne 1, adjacent to the Frederick Stubbs Carpark. Northward longshore drift is particularly evident from the start of the monitoring period, in October 2022, with northward longshore transport depositing sand to the south of Groyne 2. Steady erosion of the beach area immediately adjacent to the Frederick Stubbs Carpark continues until late January 2023 where sediment trapped to the south of Groyne 1 bypasses the Groyne and is deposited on the beach. Nourishment was undertaken at this site in May 2023, where 4,950 tonnes of sand was placed to provide a buffer against the impacts of winter storm events and create a safe and accessible beach. The placement of nourishment sand and additional sand transported south via early August storm events is likely to have led to the beach's most accretion position in August 2023 as identified through automatic imagery.

Figure 6-4 *Most receded and most accreted shoreline position to the north of Quinns Groyne 1 during the study period.*

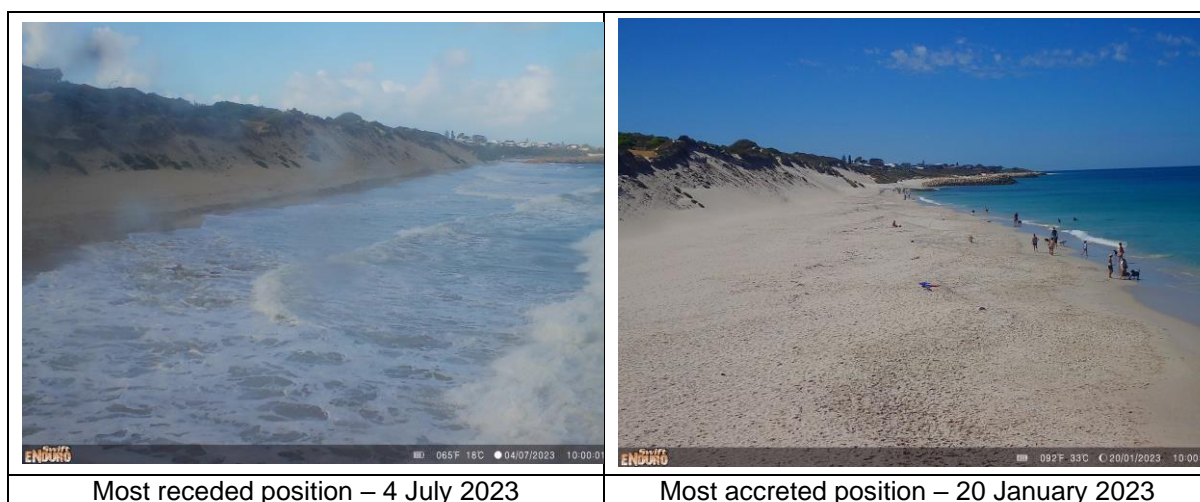
Quinns Camera 3 monitors the beach and dunes to the south of Quinns Groyne 4. Hourly images of the site show slow steady accretion of the beach from the start of the monitoring period until January 2023 where the beach then begins to erode. The most receded shoreline position was observed in July, just following a minor storm event, which resulted in minor erosion at the dune toe site and exposure of limestone bedrock on the beach. Beach scraping was undertaken at this site in early February 2023 where sand that had built up to the south of Groyne 4 was taken from the nearshore and used to create a buffer at the base of the dunes. This buffer limited the impact of winter storm events on the dune system. Throughout August, until the end of the monitoring period, the beach appears to be steadily accreting.

Figure 6-5 *Most receded and most accreted shoreline position to the south of Quinns Groyne 4 during the study period.*

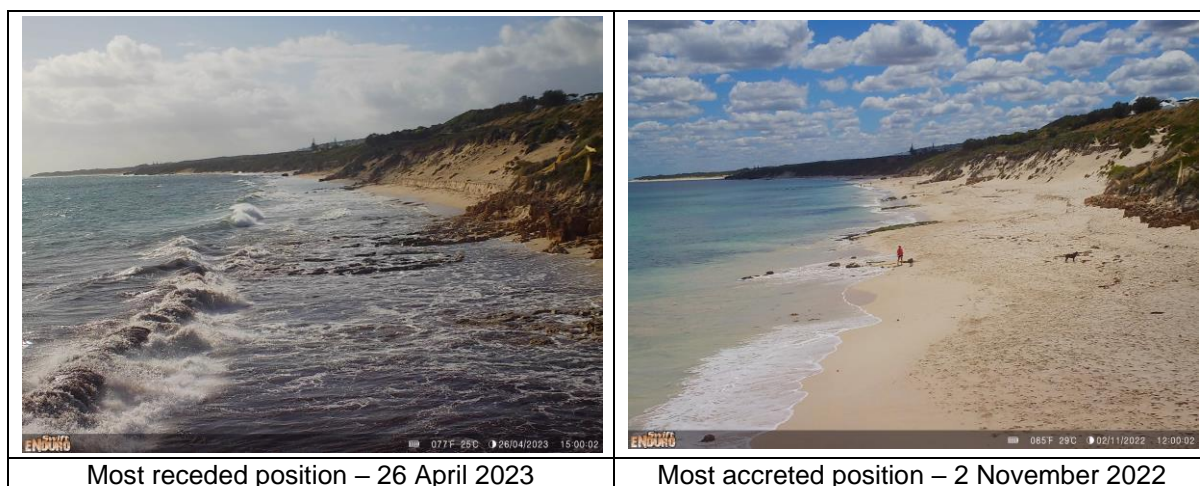
this area as prevailing southerly winds generally transport sand to the north, away from the Groyne. Across the winter months, until the end of the monitoring period, the beach appears to be steadily accreting. Again, this is expected for this site as sand moves south during the winter months, driven by southward-flowing currents generated by north-westerly storms and is captured at the site by Quinns Groyne 4.

Figure 6-6 Most receded and most accreted shoreline position to the north of Quinns Groyne 4 during the study period.

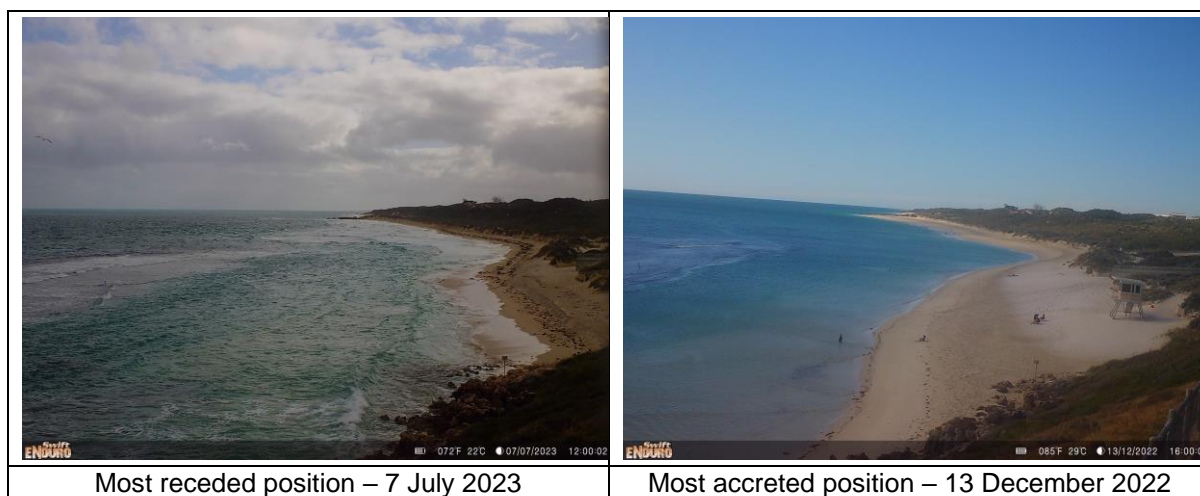
The beach area captured within the field of view of the Yanchep Remote Monitoring Camera is bounded by a rocky headland to the south and a small rock groyne to the north. Yanchep Lagoon Beach is at an accreted position at the start of the monitoring period, October 2022. This is expected as southward-flowing currents generated by north-westerly storms move sand to the south which is then captured at Yanchep Lagoon Beach by the headland. The beach then appeared to steadily erode across the summer period, with the beach eroding further following a minor storm even in July 2023.

Figure 6-7 Most receded and most accreted shoreline position at Yanchep Lagoon Beach.

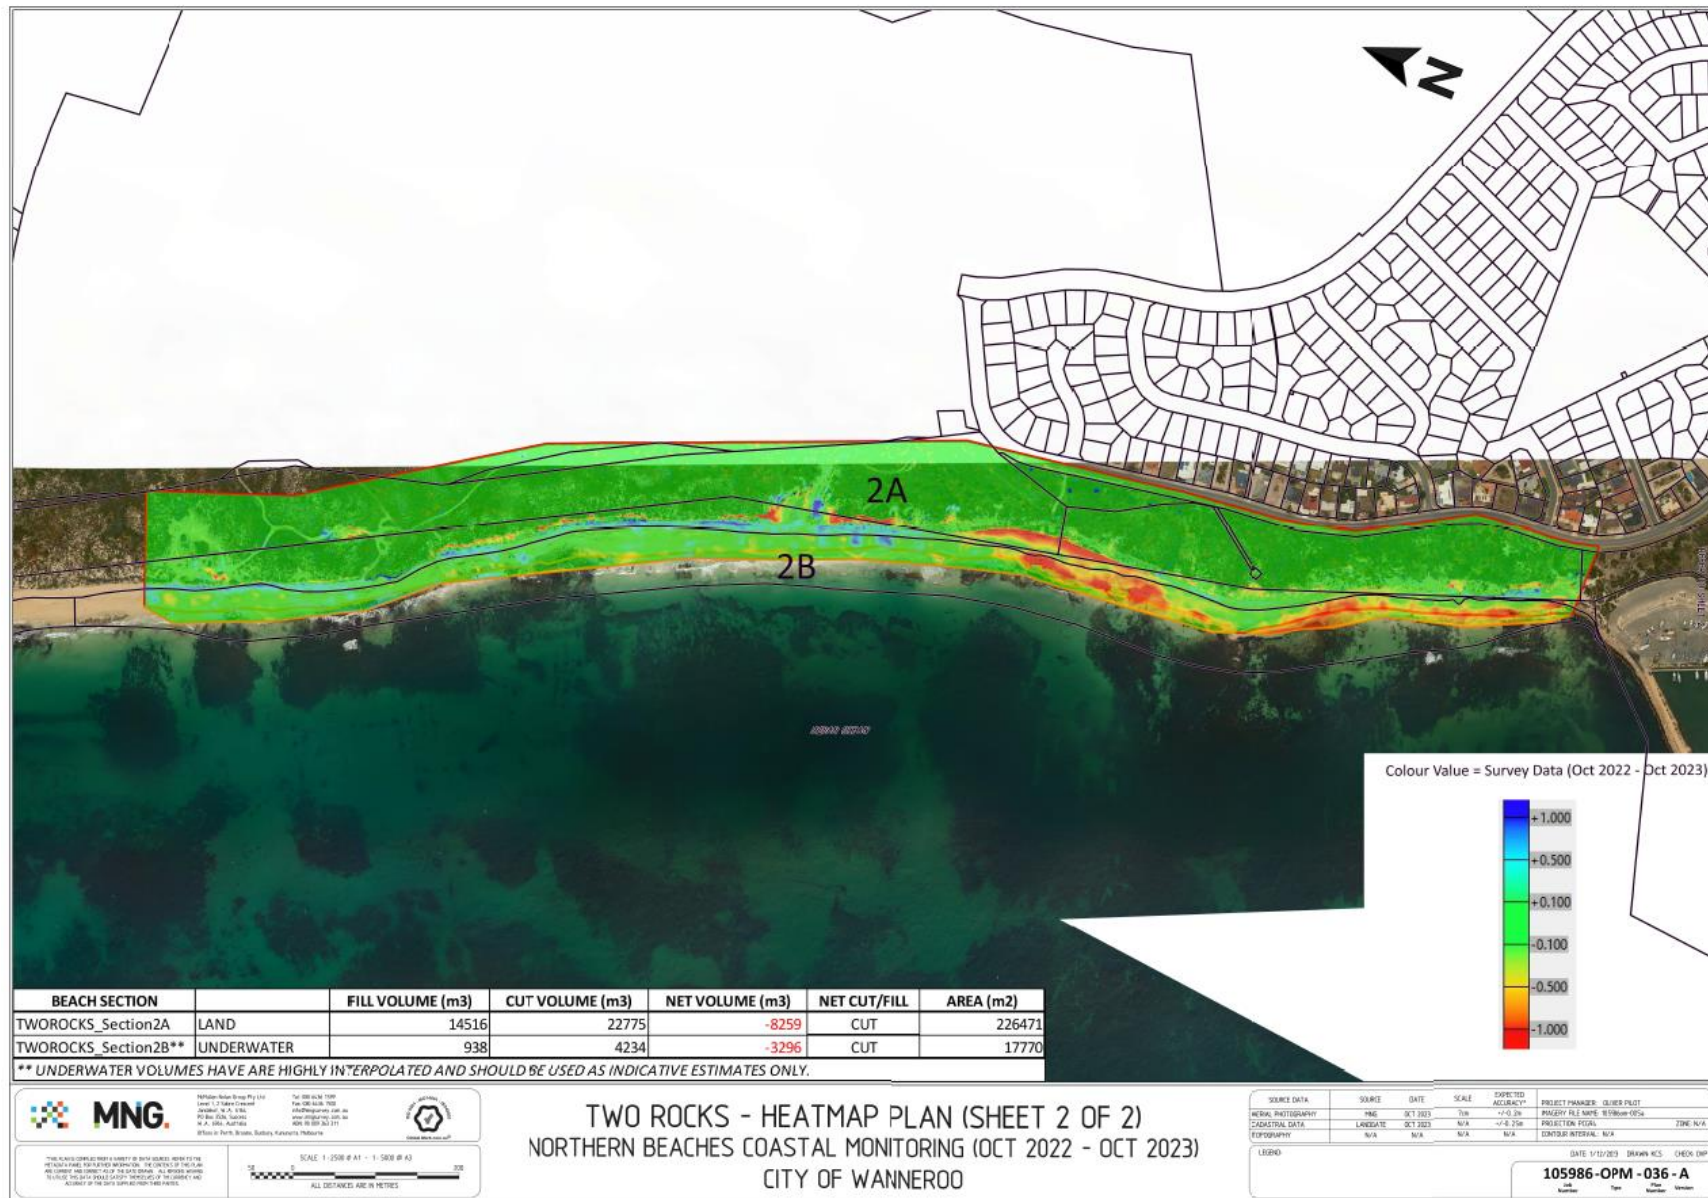
Figure 0-9

Net annual beach volume change plot for Two Rocks Beach section 2.
