R808 Rev 2

September 2016

City of Wanneroo

**Two Rocks Beach Access Stairs
Inspection Report**

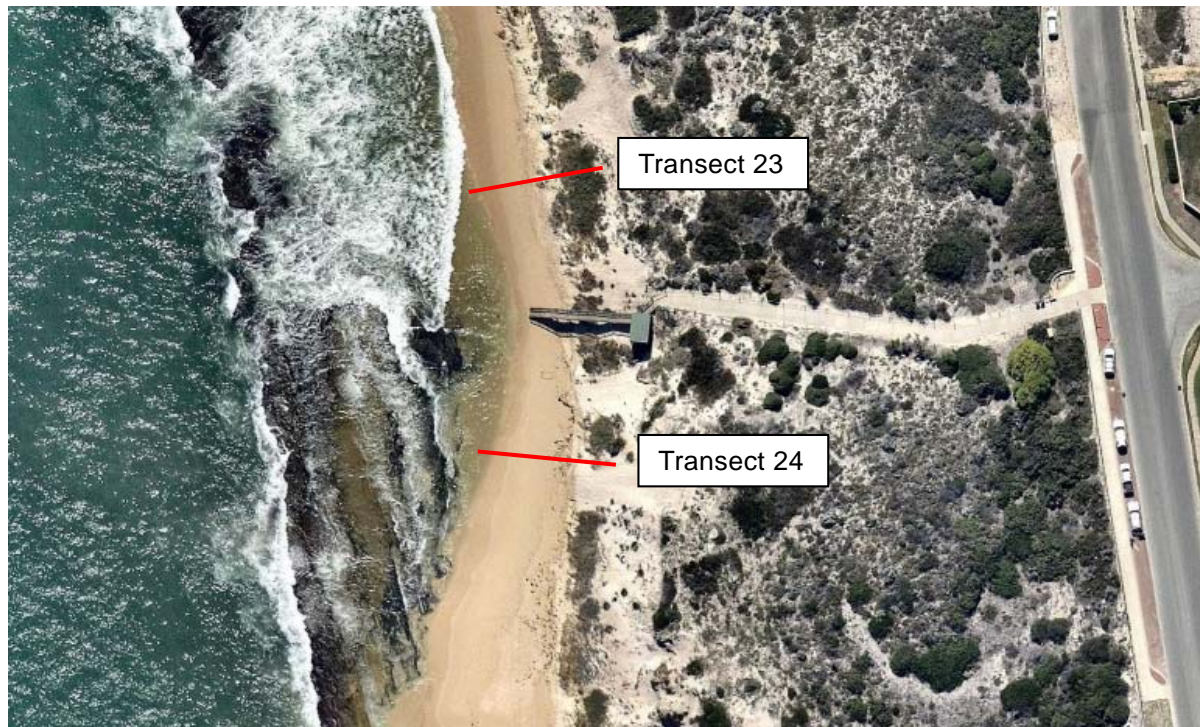
Figure 2.4 Location of Survey Profiles Provided by the City

The extent of storm erosion between May and June 2016 was estimated using survey profiles provided by the City. The location of these survey profiles are presented in Figure 2.4. The survey profiles before and after the storm events are presented in Figure 2.5 and 2.6 respectively.
