**RE: BUSHFIRE HAZARD ASSESSMENT  
LOT 100 PINJAR ROAD, MARIGINIUP**

**APPENDIX 5:**  
**KCTT Earthworks**  
**Plans**

CLIENT <b>PAUL SILVESTRO</b>			
PROJECT <b>No 264 (Lot 2) and 206 (Lot 100) Pinjar Road Mariginiup</b>			
DRAFTER V.VUJIC	DRAFTING CHECK C. KLEYWEG	REVIEWED PROJECT MANAGER	APPROVED PROJECT DIRECTOR
DESIGNED V.VUJIC	DESIGN REVIEW C. KLEYWEG

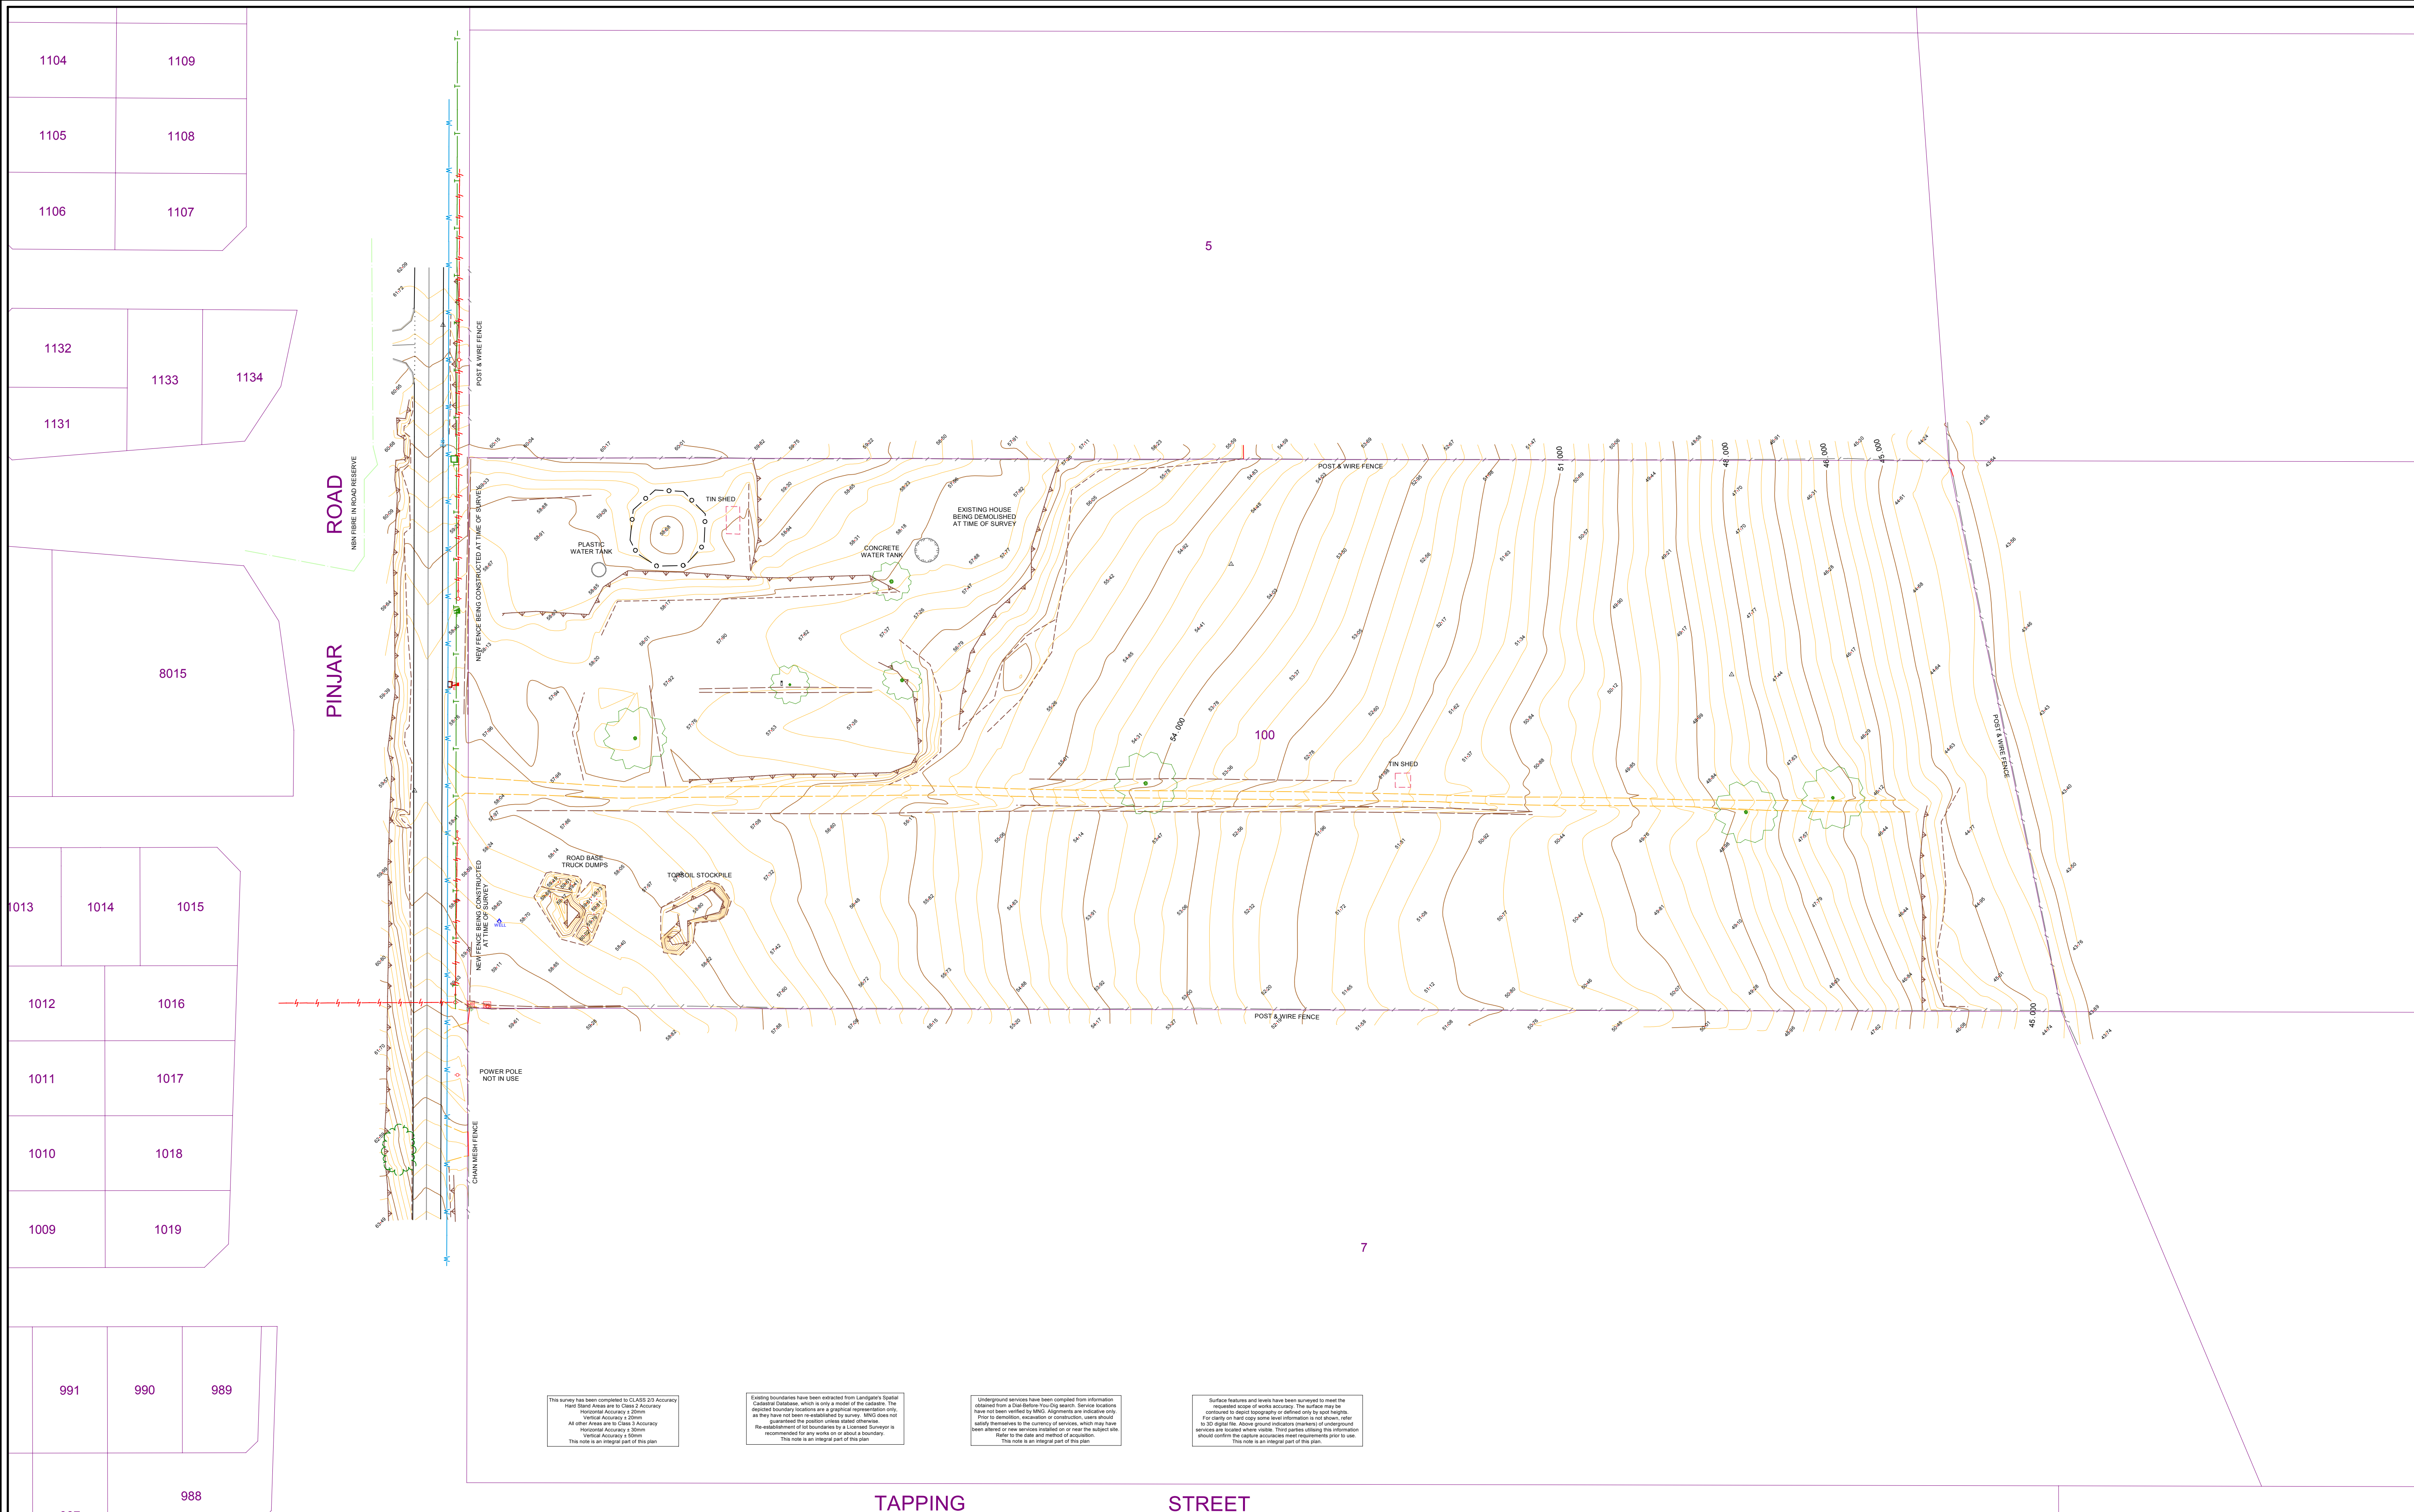
This survey has been completed to CLASS 2/3 Accuracy  
 Hard Stand Areas are to Class 2 Accuracy  
 Horizontal Accuracy is 20mm  
 Vertical Accuracy is 20mm  
 All other Areas are to Class 3 Accuracy  
 Horizontal Accuracy is 30mm  
 Vertical Accuracy is 50mm  
 This note is an integral part of this plan.

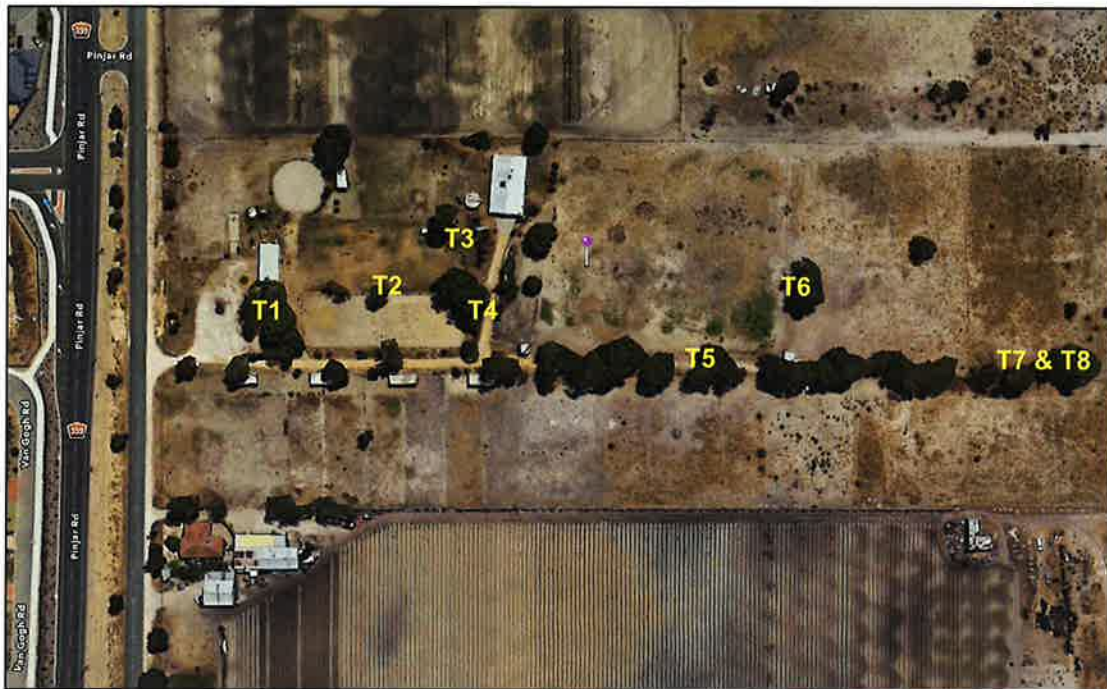
Figure 1. Aerial photo of site with the approximate tree locations (T1-T8) at Lot 100, 206 Pinjar Road, Mariginiup.

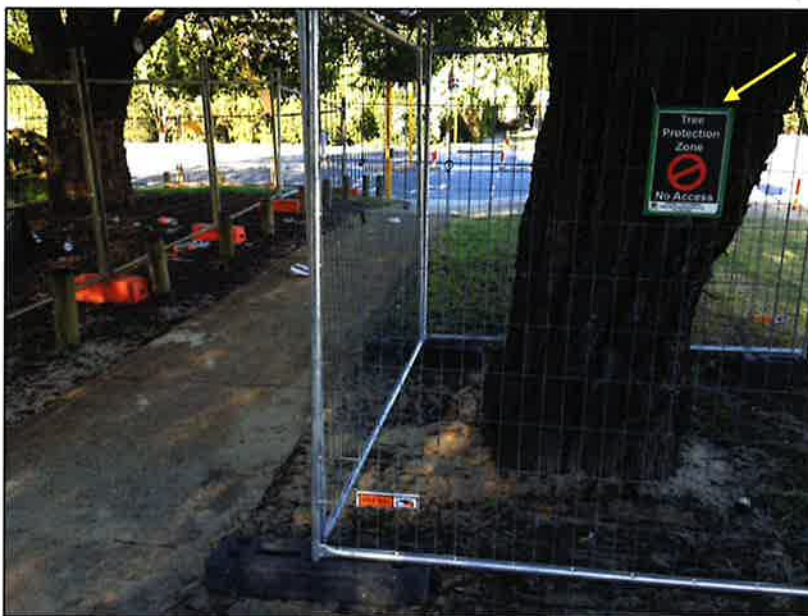
**Figure 3.** Protective fencing comprised of 1.8m high chain-wire mesh panels and signage providing information (see arrow) regarding access within the fencing should be erected prior to the commencement of construction activities that involve machinery and have the potential for collision injury.

3.6 Tree protection measures include a range of activities and structures and should be in place prior to any site works including demolition (AS4970, 2009). Protective fencing comprised of 1.8m high chain-wire mesh panels should be erected, where possible, at the periphery of the Tree Protection Zone radius (trunk diameter x 12) for each tree assessed as a material constraint and subsequently retained as part of the project.

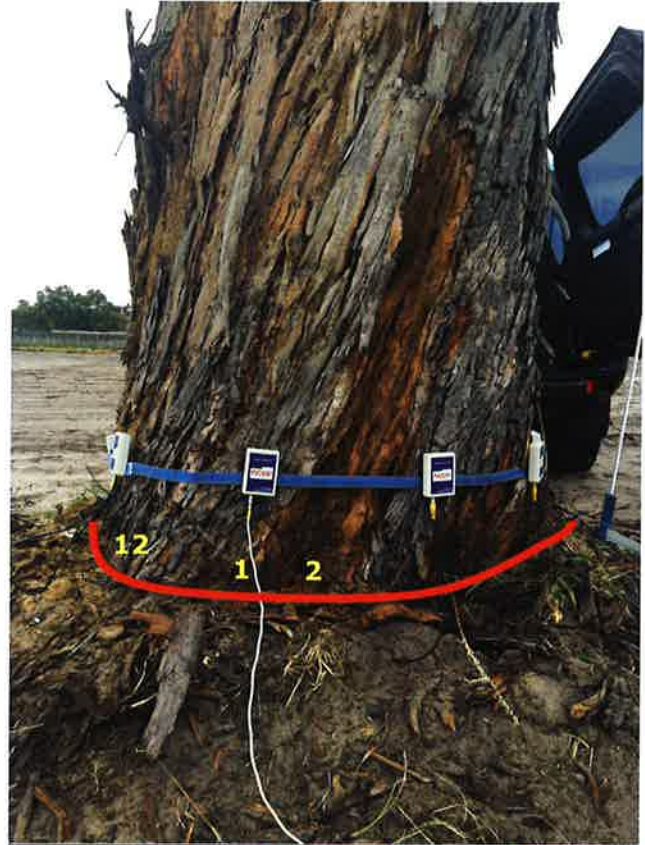
The PiCUS® Sonic Tomograph test result indicates 21% of the test area is solid (high density) wood. There is 10% incipient wood (wood being altered). The remaining 69% is active degradation (low density) wood or cavity.

The radial amount of solid wood adjacent to sensor number 4 was measured at 19cm, adjacent to sensor number 10 was measured at 10cm and adjacent to sensor number 12 was measured at 14cm.

It is observed that new wood growth increments are evident at sensor numbers 3-6 and 8-12.

The test result provides evidence that the tree is still structurally sound at the test point and in average condition. Whilst response growth (new wood) is evident as the tree attempt at self-optimisation, extensive degradation of wood tissue resulting from termite infestation was revealed and is likely to augment the likelihood of failure in the short term. Subsequently, removal to ground level is recommended where a high pedestrian/ vehicle frequency is proposed within/ adjacent to the dripline of the tree.

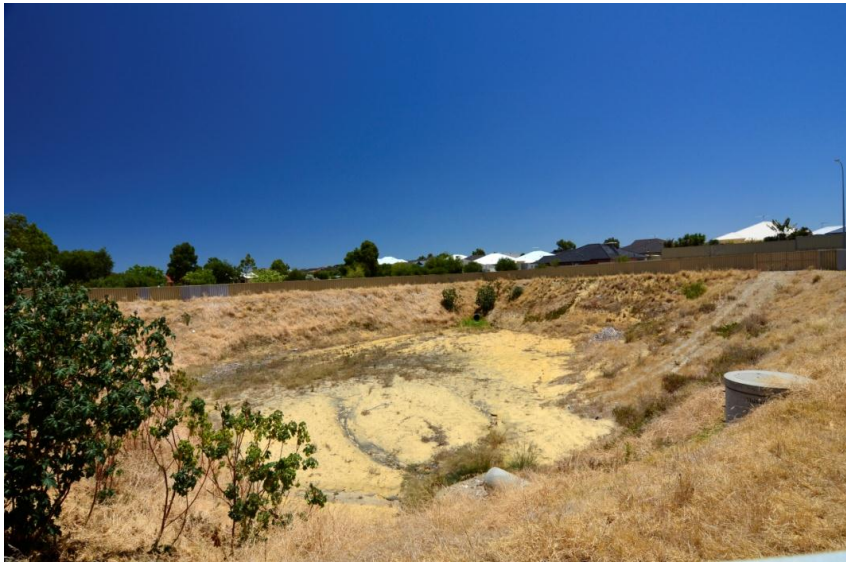
**Image 5: Unmanaged grassland (drainage sump)**

A parcel of unmanaged grassland is located west of the site, within a City of Wanneroo Drainage Sump (refer **Image 5**). The vegetation is less than 1ha in area, and is not within 100 metres of other vegetation being classified. As such, it has been excluded under Section 2.2.3.2(b) of AS3959.

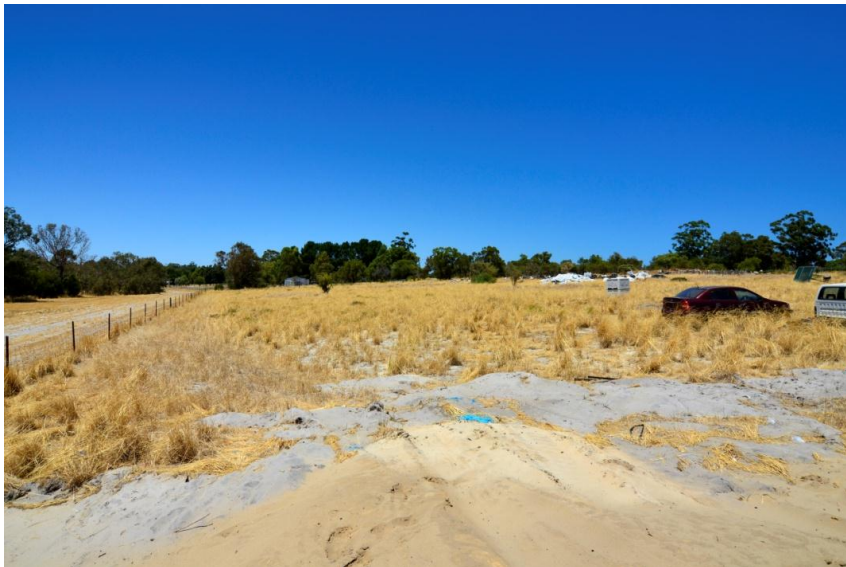
**Image 6: Unmanaged grassland**

A further parcel of unmanaged grassland exists south east of the subject site (refer **Image 6**). For the purposes of this assessment, it is assumed to be a permanent risk. As such, this vegetation, together with land within 50 metres of its edge, is considered to have a ‘moderate’ bushfire hazard level (BHL) rating.

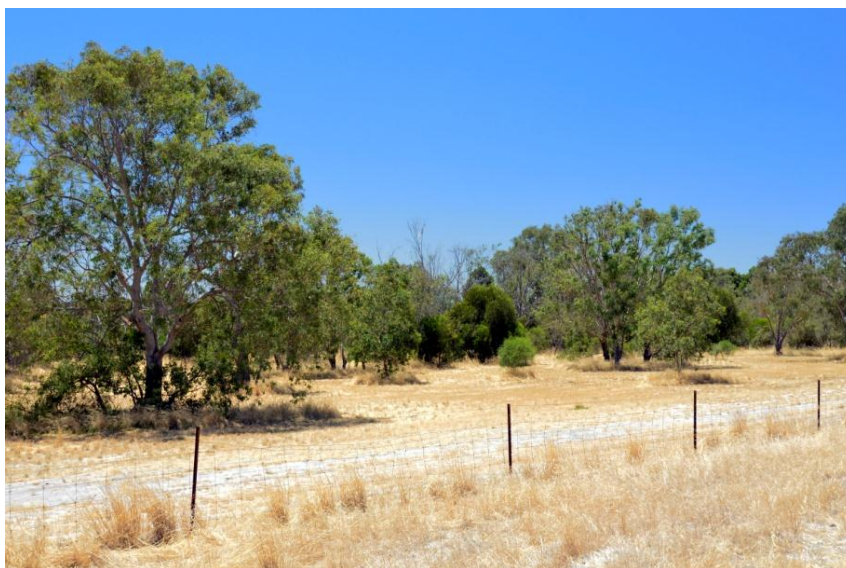
**Image 7: Woodland over managed grassland**

Land east of the subject site ranges from ‘open woodland over managed grassland’ (**Image 7**) to ‘closed scrub’ (**Images 8 & 9**) to ‘woodland to low woodland over unmanaged grassland’ (**Image 10**).

In accordance with AS3959, the portion of 'open woodland over managed grassland' has been classified according to its understory (i.e. managed grassland) and has been excluded.

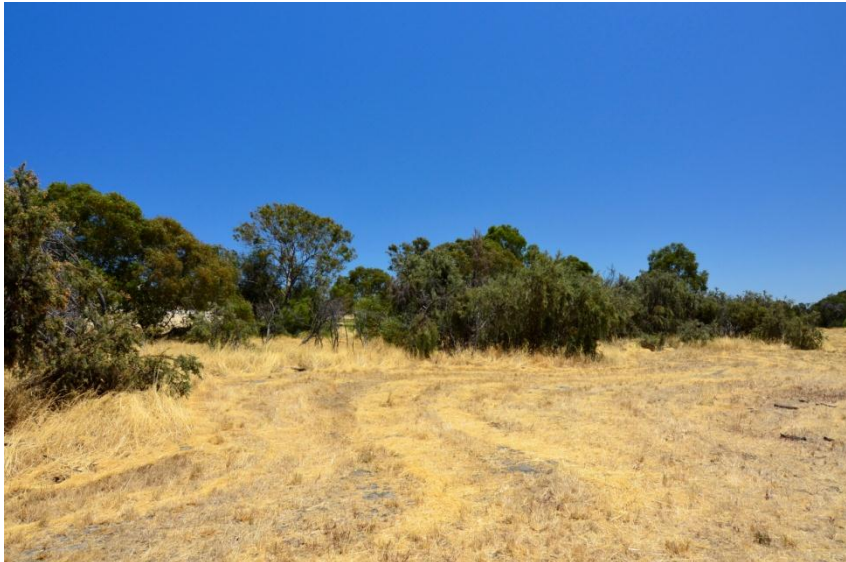
**Image 8: Closed scrub**

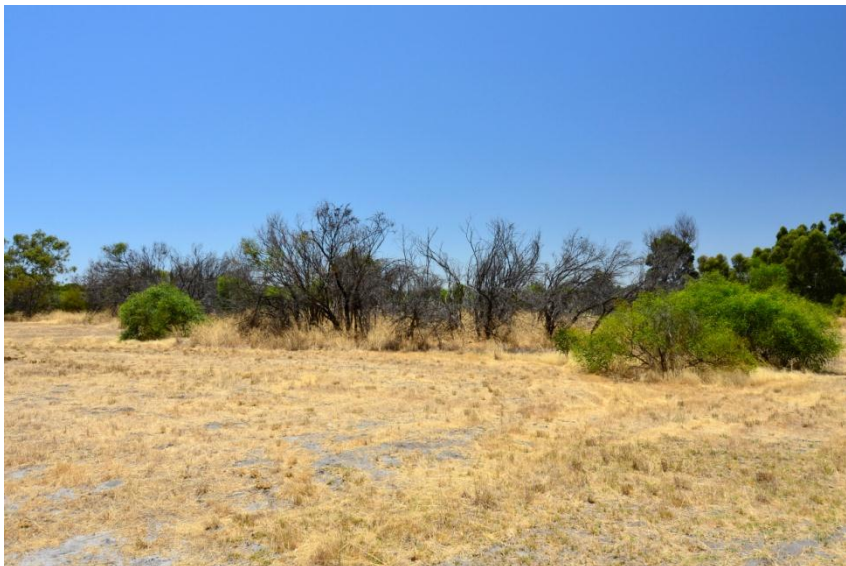
**Image 9: Closed scrub**

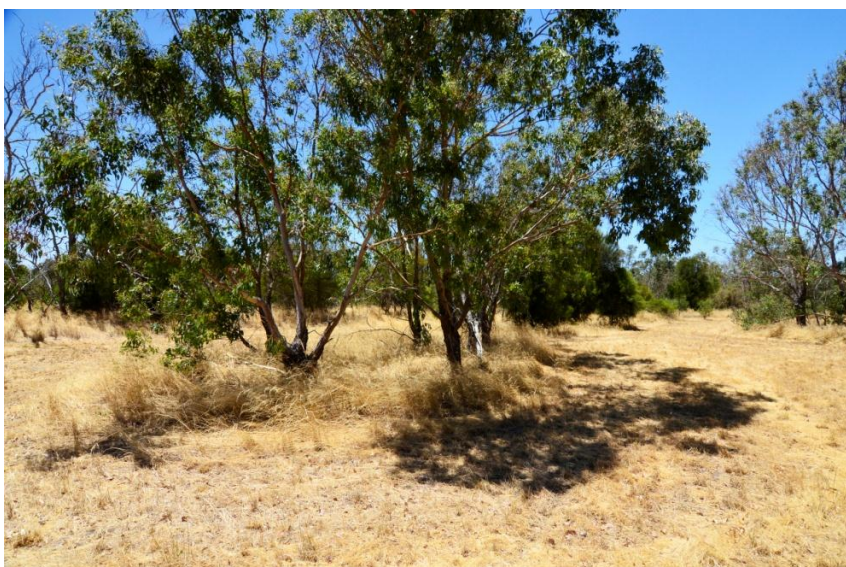
**Image 10: Woodland to low woodland over unmanaged grassland**
