# City of Wanneroo Coastal Monitoring Report April 2023

# **1** Introduction

A long-term coastal monitoring program has been undertaken by the City of Wanneroo (CoW) since 2014. The purpose of the program is to evaluate the seasonal, annual and long-term trends in erosion and accretion along the City's coastline. This helps to better inform coastal management decisions, identify key areas with future management requirements and to provide data for future coastal hazard studies.

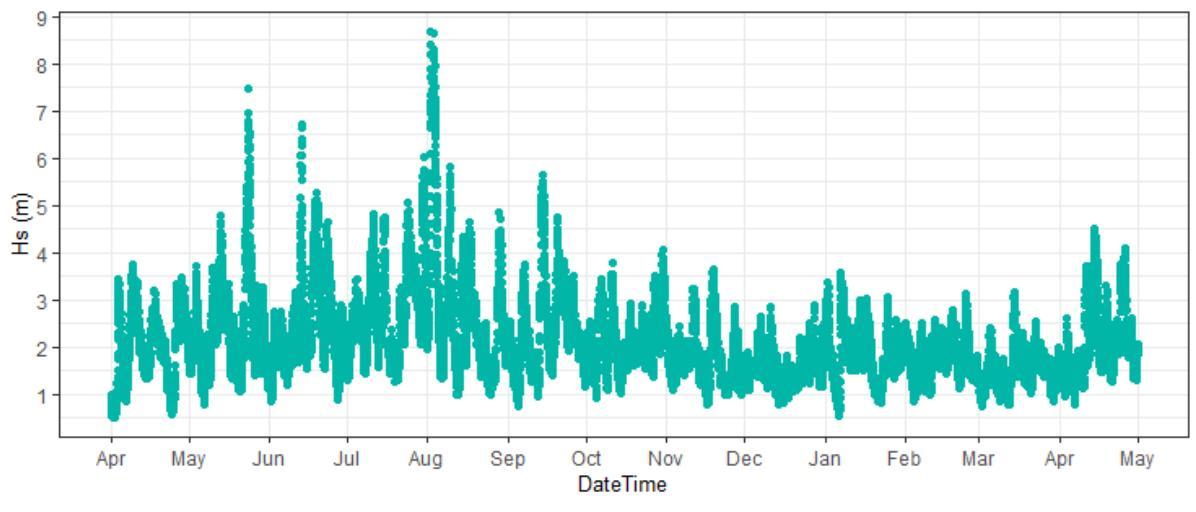
A time series plot of the total significant wave height (Hs) recorded at the Rottnest Island Wave Station from April 2022 to April 2023 is presented below in Figure 2-2.

The most notable observations from Figure 2-2 are the storm events that were recorded on the 24<sup>th</sup> of May 2022, 13<sup>th</sup> of June 2022 and the 3<sup>rd</sup> of August 2022. The storm that resulted in the most significant infrastructure damage and erosion along the City's coastline occurred on the 3<sup>rd</sup> of August 2022 which had a peak total significant wave height of 8.67m which was recorded at 2:09 AM on 3<sup>rd</sup> August 2022.

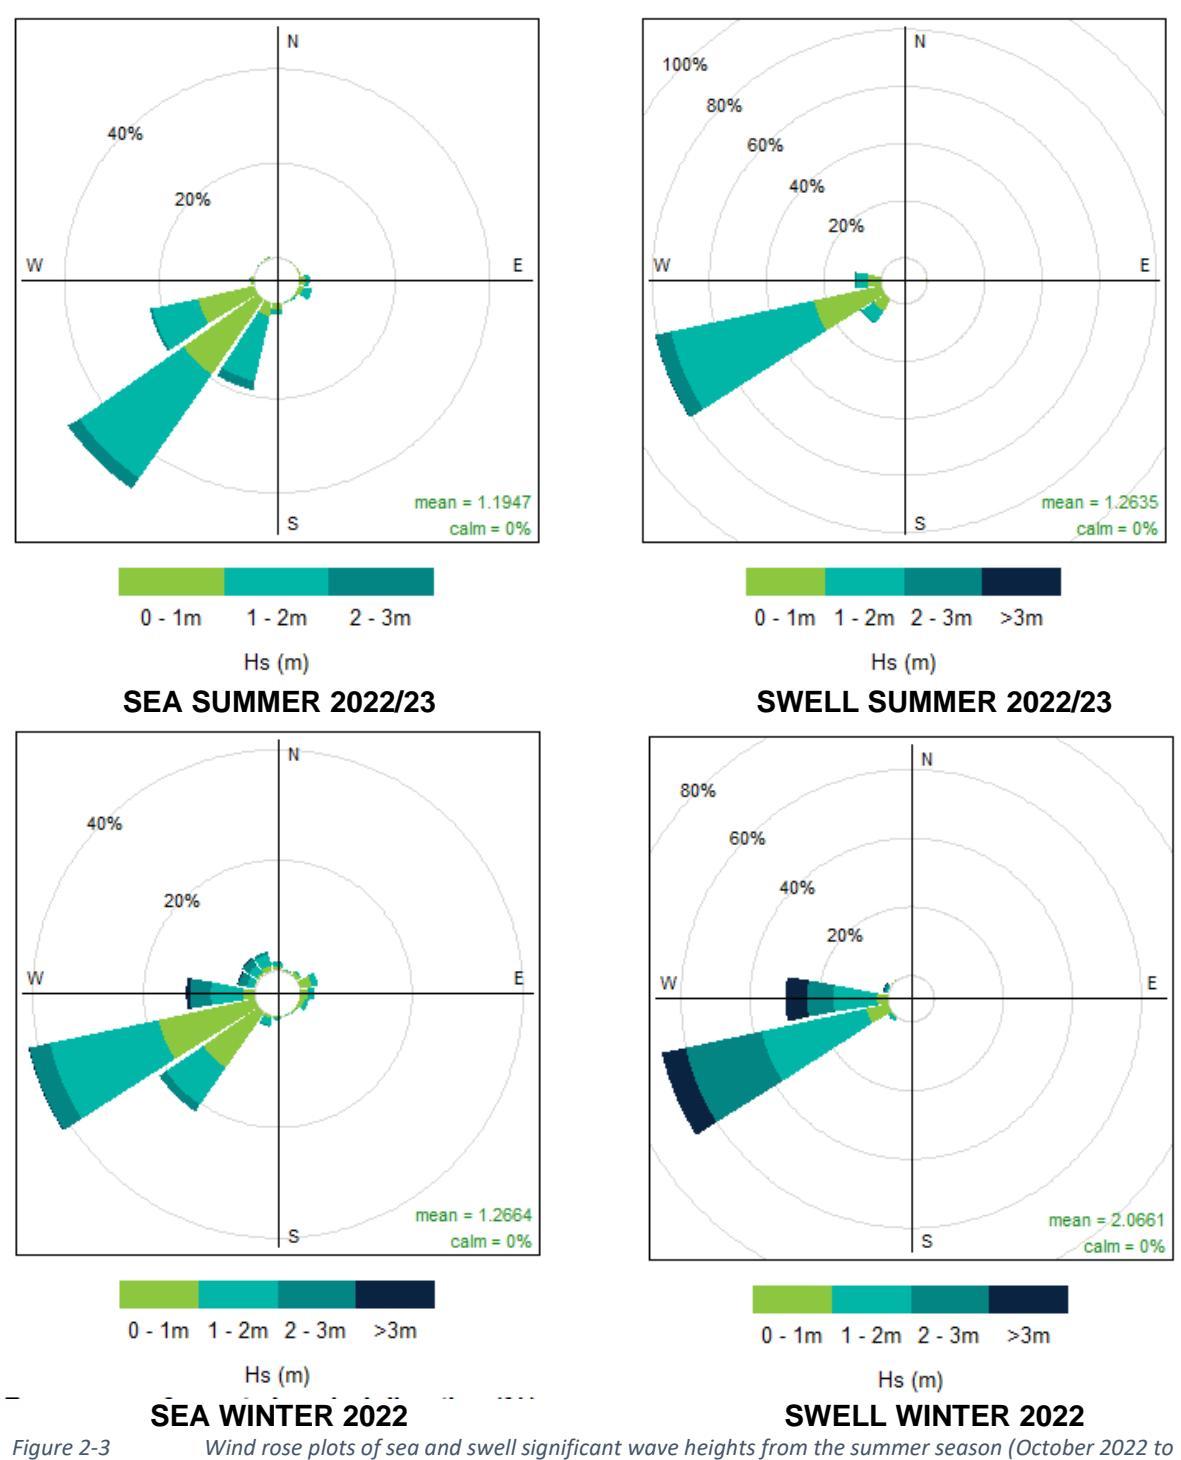
March 2023) and the winter Season (April to September 2022)

As seen in Figure 2-3, the wave climate for both the summer and winter periods is characterised by west south westerly waves and, as expected, there is a significant increase in swell height during the winter period. Wave direction across the year was typically recorded from a WSW direction.

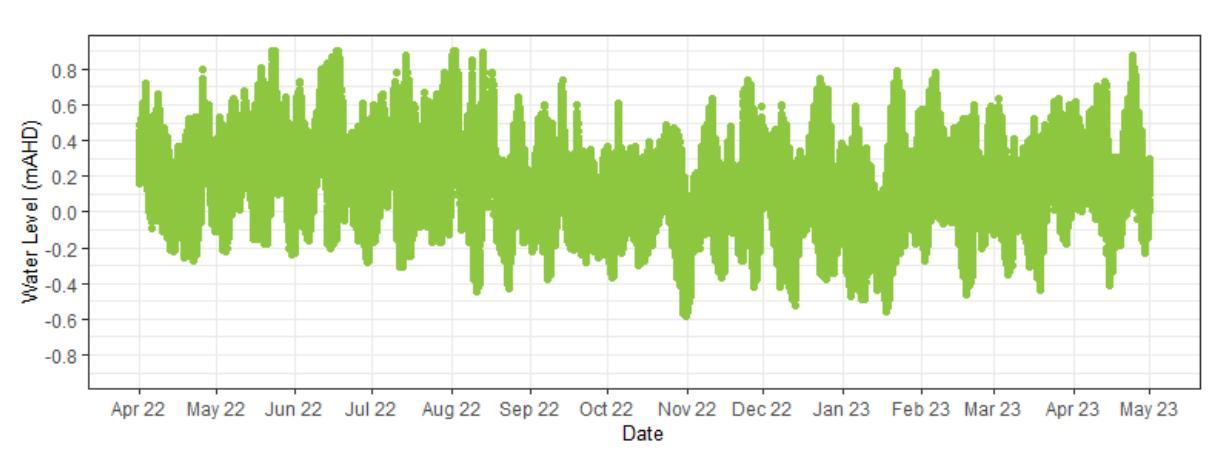
Figure 2-4 Water level (mAHD) recorded at the Fremantle Fishing Harbour Tide Station from April 2022 to April 2023.

Total recorded water level at the Fremantle Tide Station for April 2022 to April 2023 is presented in Figure 2-4. The highest water level recorded was 1.01 mAHD recorded at 1:15PM on 23rd of May 2022 and the peak storm surge (0.83m) was observed on the 2nd of August at 3:30AM. The winter storm that extended over three days at the beginning of August 2022 was characterised by an extended storm surge and high significant wave heights. This resulted in significant erosion and infrastructure damage to Mindarie Breakwater, Frederick Stubbs Staircase, Queenscliffe Dog Beach Dune System, Jindalee Staircases and Amberton Beach Access Ways. Further details of the storm damage are outlined in Section 3.

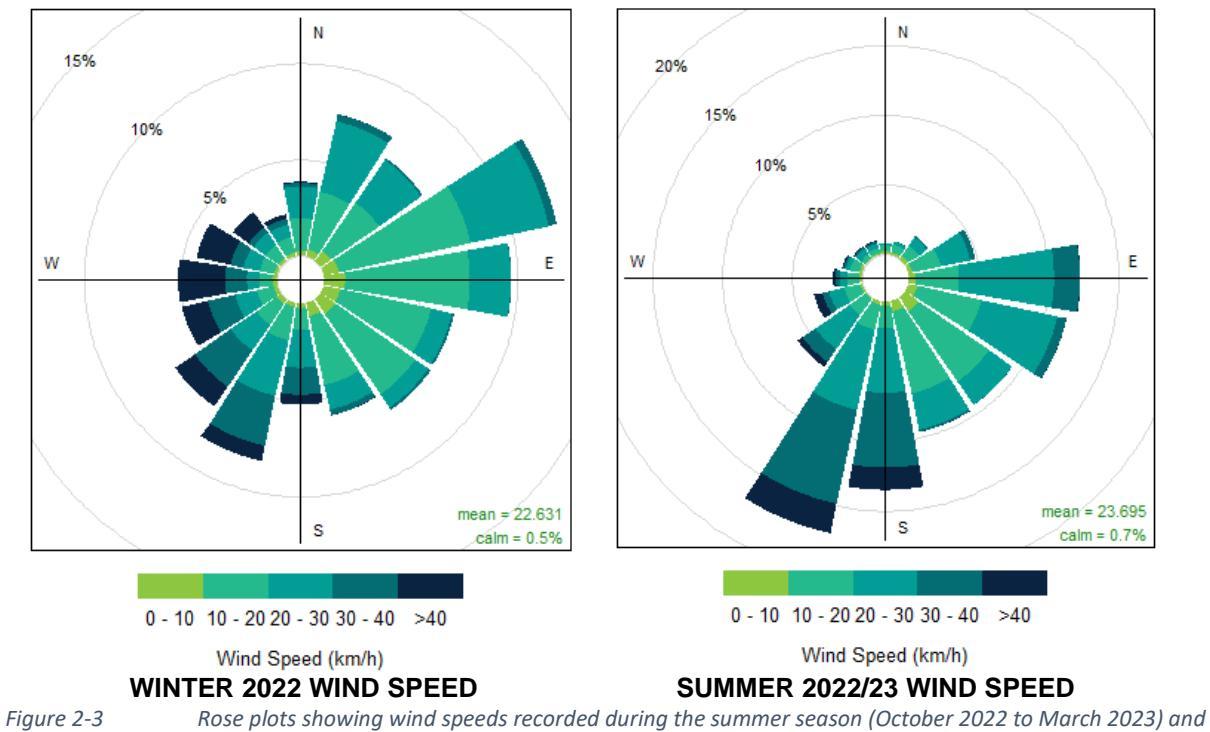
Figure 2-3 Rose plots showing wind speeds recorded during the summer season (October 2022 to March 2023) and the winter season (April to September 2022).

As expected, the summer of 2022/23 was largely characterised by strong southerly and south-south westerly winds, which are typical conditions along the West Australian coastline during the summer months. Notably, this year, south-south westerly winds were more prominent than southerly winds and a larger percentage of winds over 40km/h were recorded than previous years. The winter period was mostly characterised by easterly winds with significant periods of strong westerly winds, which is typical of winter storm events.

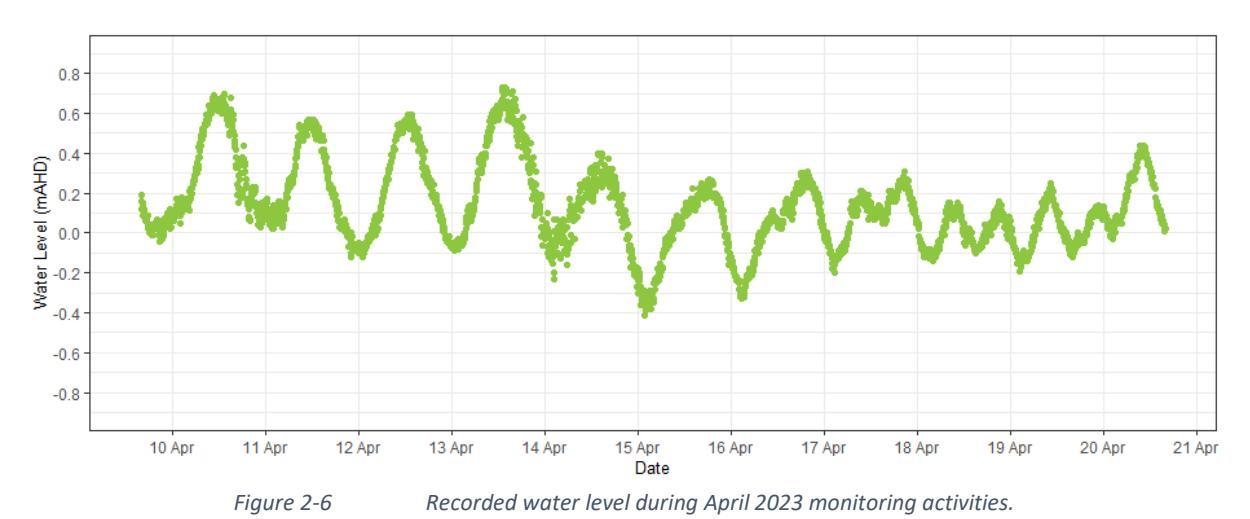
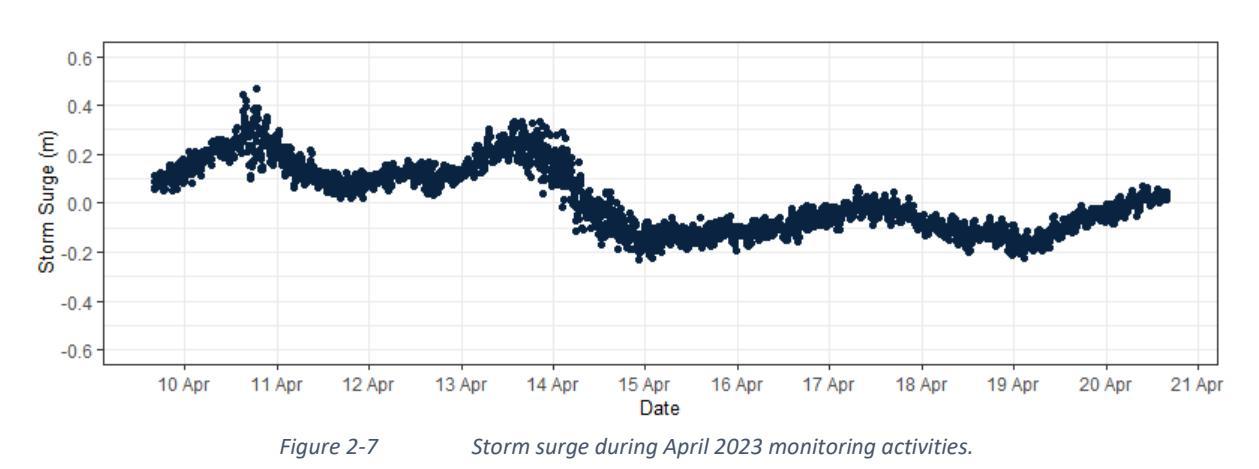
Manual imagery and aerial surveys for this monitoring period were undertaken between 12 April 2023 and 19 April 2023. The water levels during these monitoring periods are presented below in Figure 2-6.

Manual imagery was undertaken on 12 April and 19 April 2023 and it important to note when assessing manual imagery that the maximum water level on 12 April was significantly higher (0.6mAHD) than that observed on 19 April (0.25mAHD). It is important to note when assessing manual imagery that most images were taken at a water level between -0.0 and 0.6 mAHD.

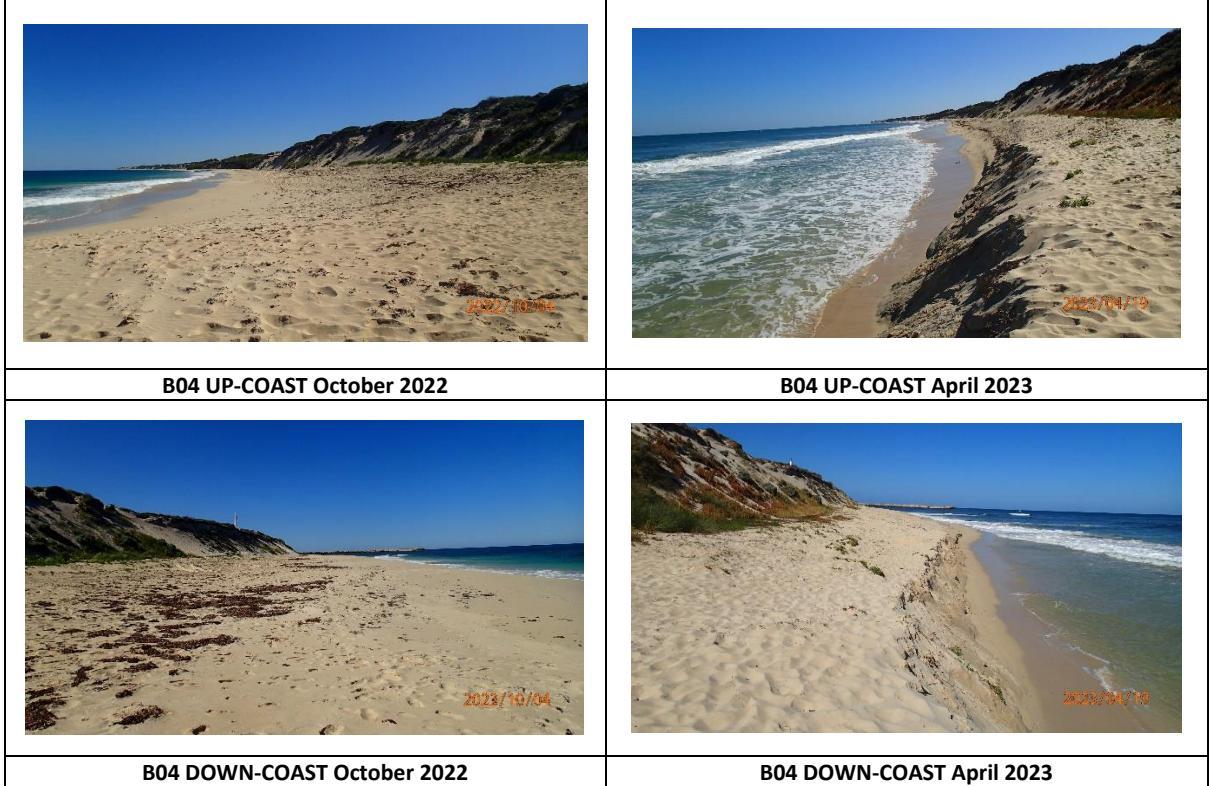
Figure 4-6

Major erosion over summer 2022/23 at Two Rocks B04.

Two Rocks beach cross-section 17 is situated within the field of view of manual imagery point 'Two Rocks B04 Up-Coast and Down-Coast'. The cross section shows a maximum height difference of 2.64m between surveys, just below the water line. The results of the cross section are consistent with manual imagery observations and show a significant reduction in elevation at this site.

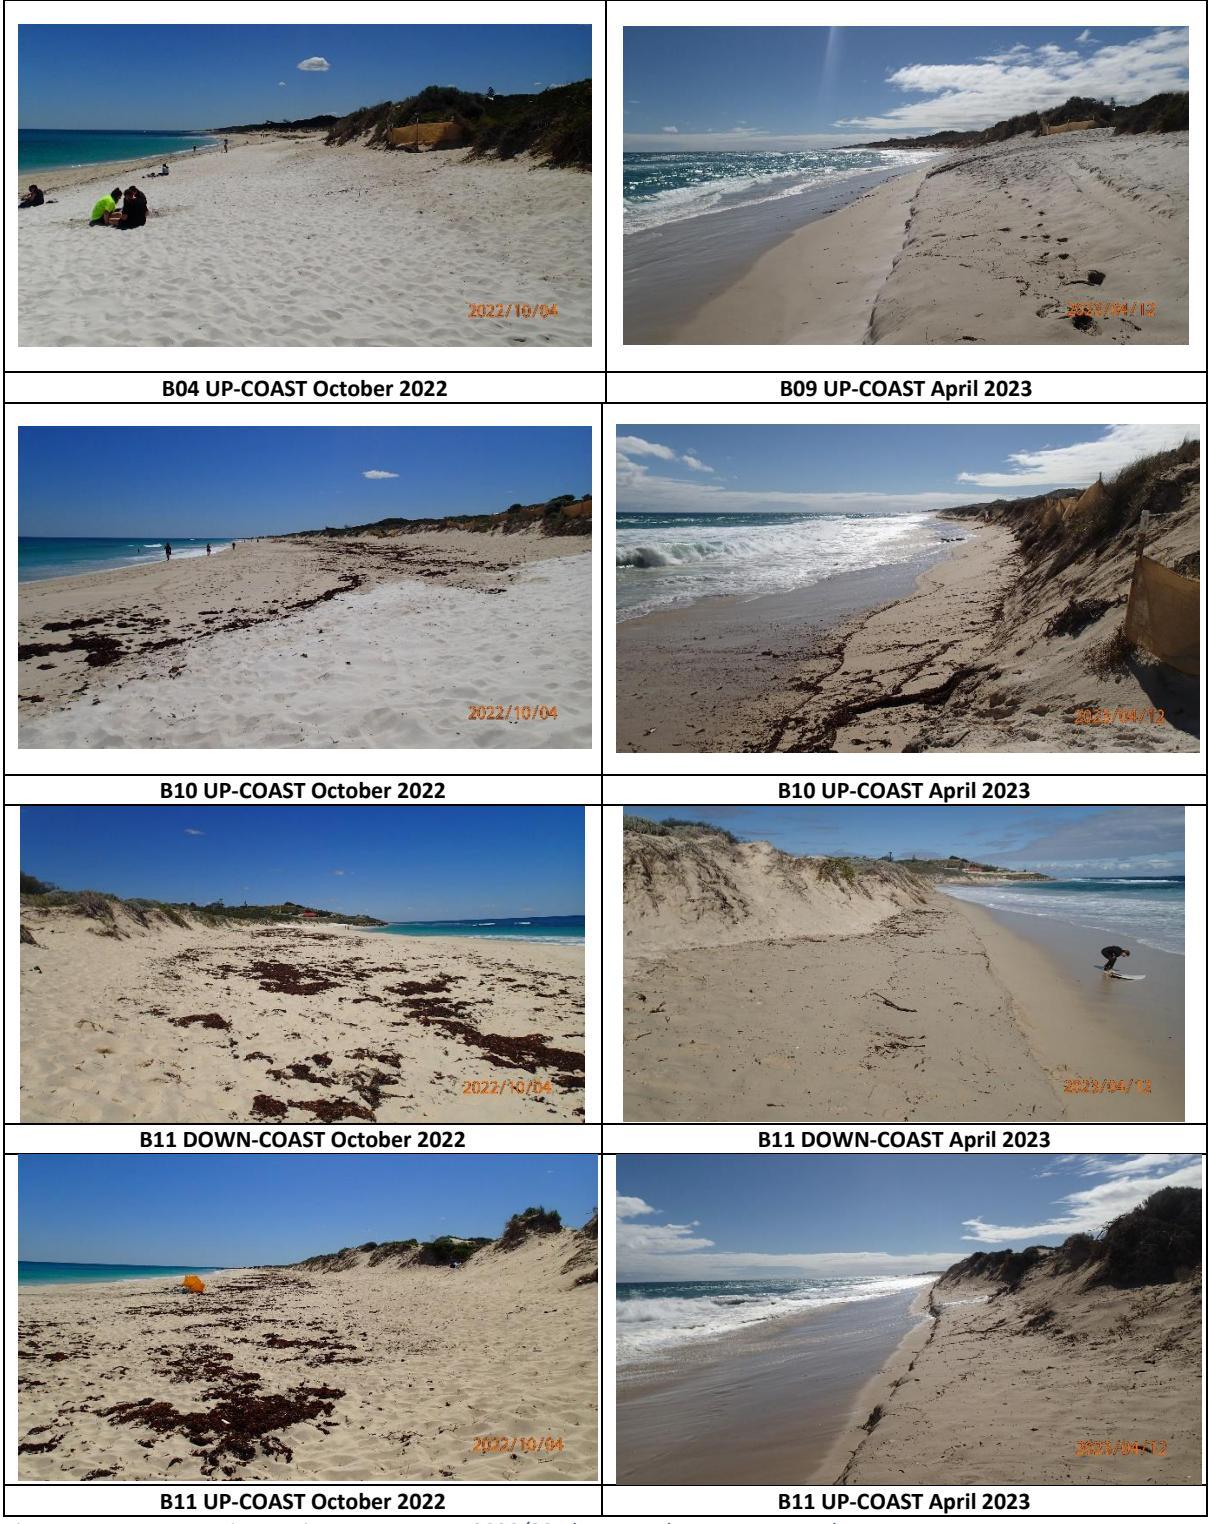
Figure 4-7

Major erosion over summer 2022/23 along Yanchep Lagoon Beach.

Significant seasonal erosion was identified at Yanchep Lagoon Beach following the 2022/23 summer period. Yanchep Lagoon Beach is bound by a rock headland to the south which interrupts the longshore transport of sediment during the summer months. By the April 2023 monitoring period sediment had begun to move around the headland and build up at the southern end of Yanchep Lagoon Beach (Figure 4-7) however the major erosion was observed along the northern end of the beach.

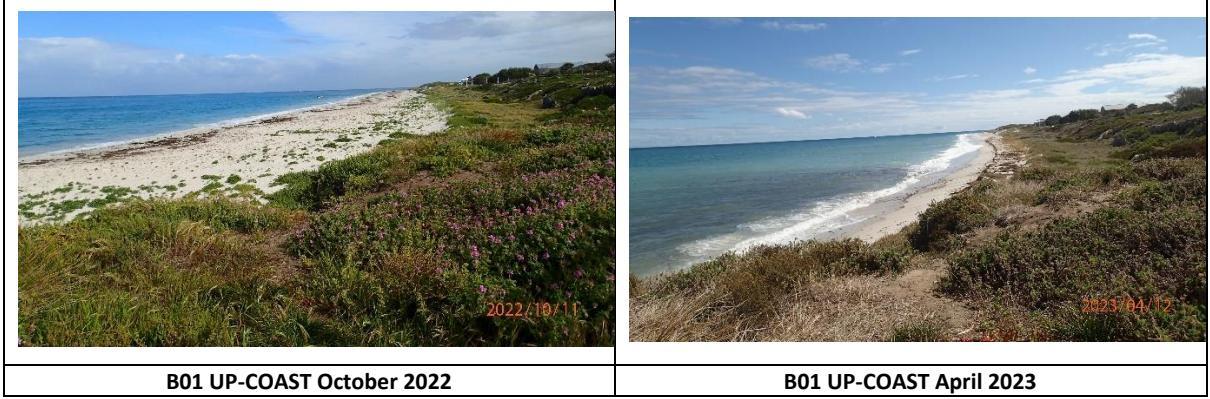
Figure 4-8 Major erosion over summer 2022/23 at Quinns B01 Up-Coast.

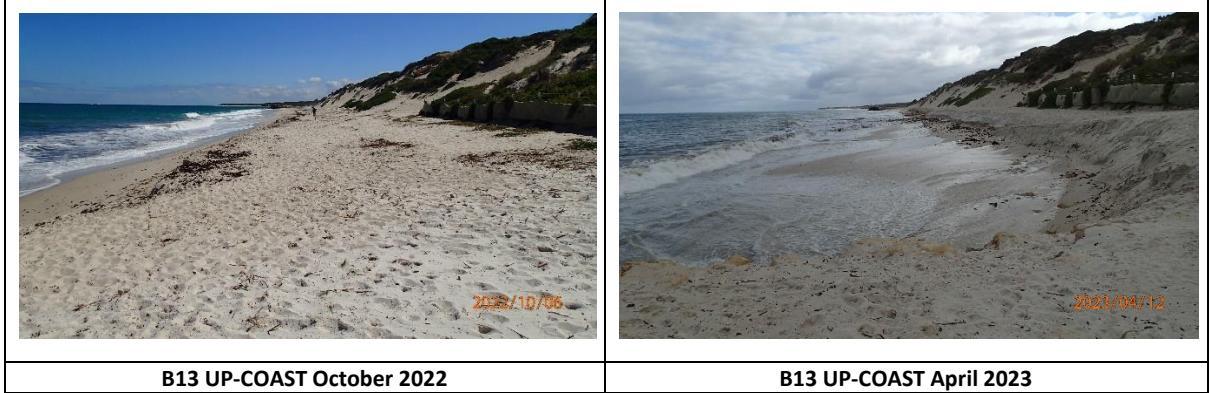
Figure 4-9

Major erosion over summer 2022/23 at Quinns B13 Up-Coast.

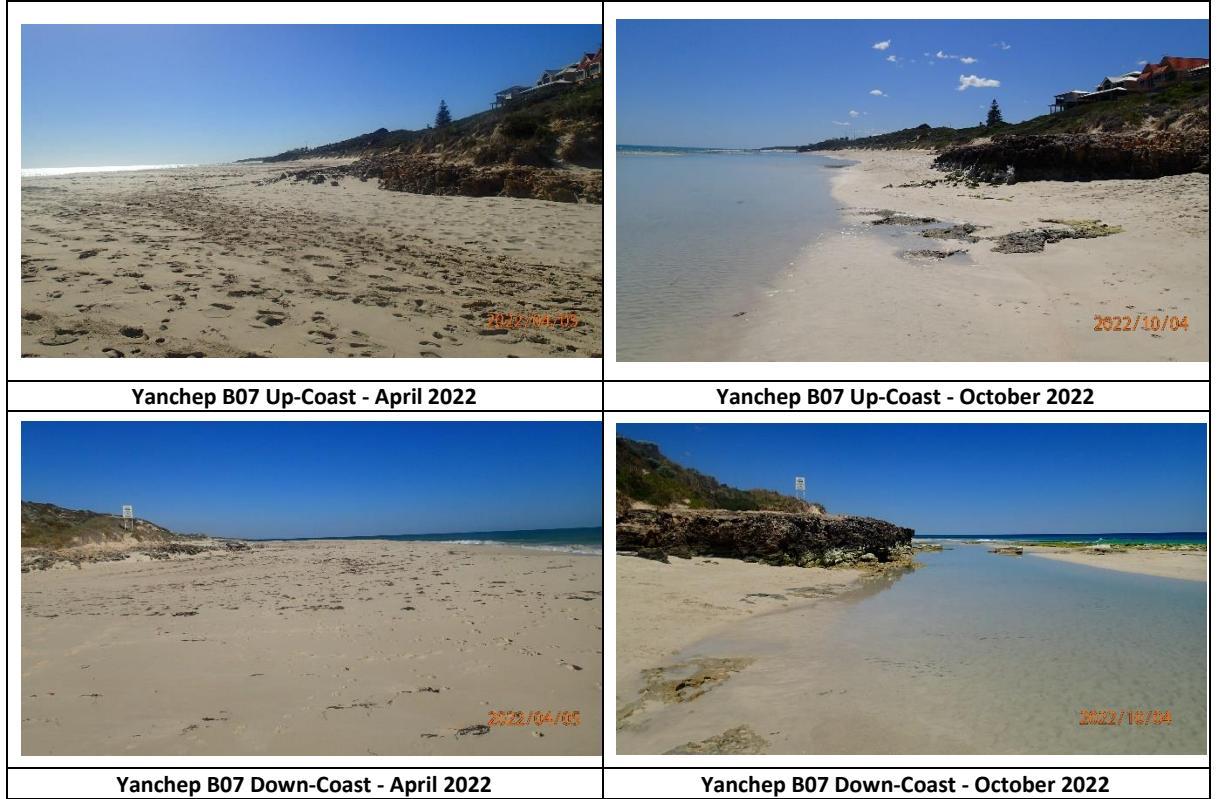
Figure 4-10 Major erosion over winter 2021 at Yanchep B07 Up-Coast and Down-Coast.

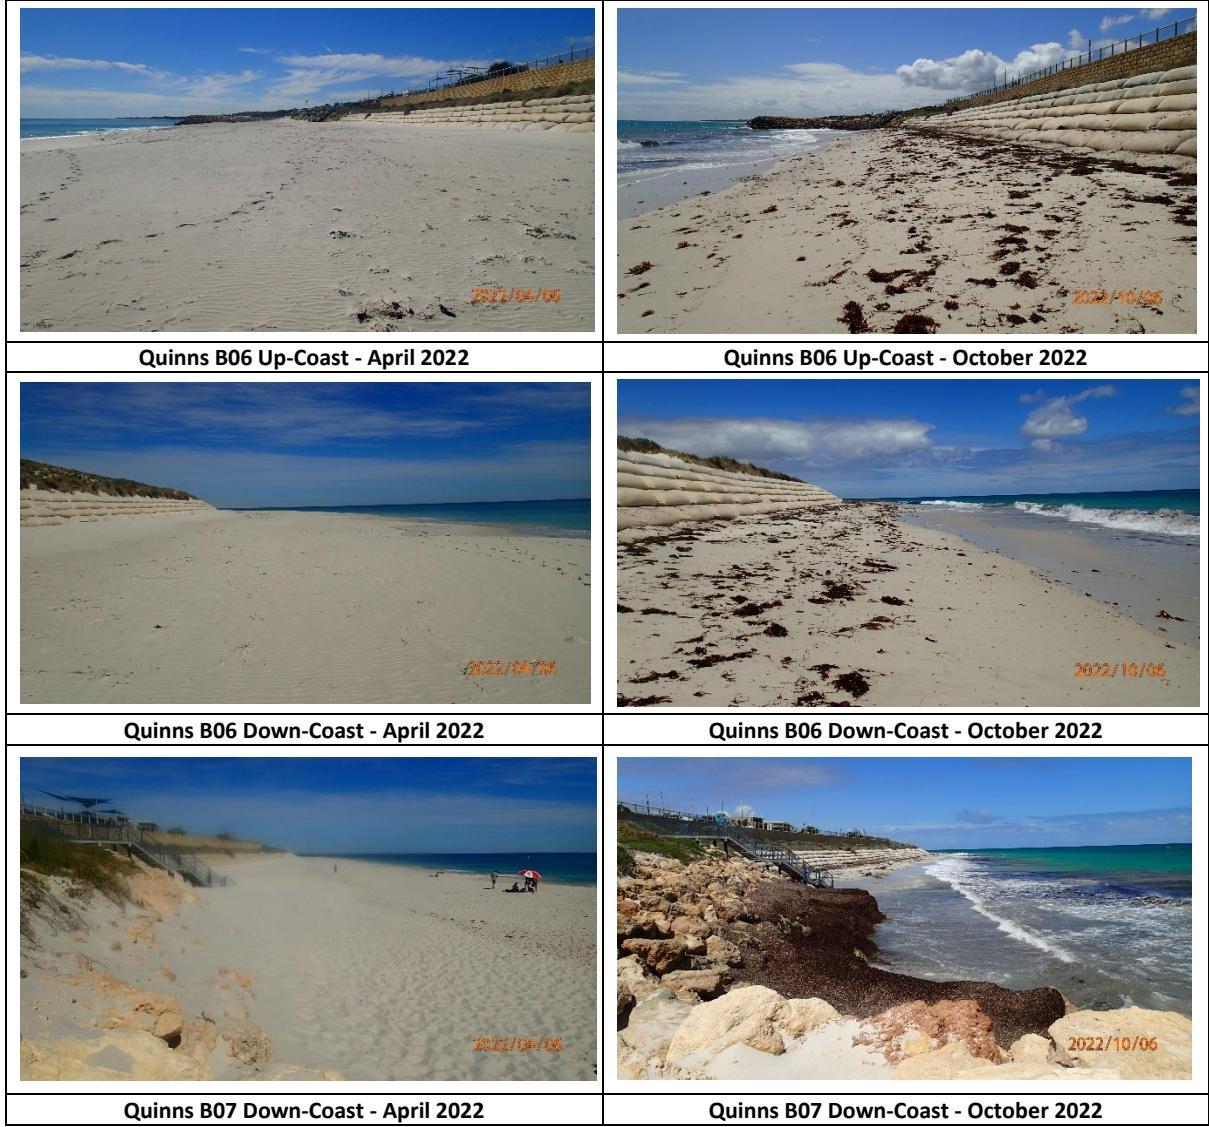
Figure 4-11 Major erosion over winter 2021 at Quinns B06 Up-Coast, Down-Coast and Quinns B07 Down-Coast.

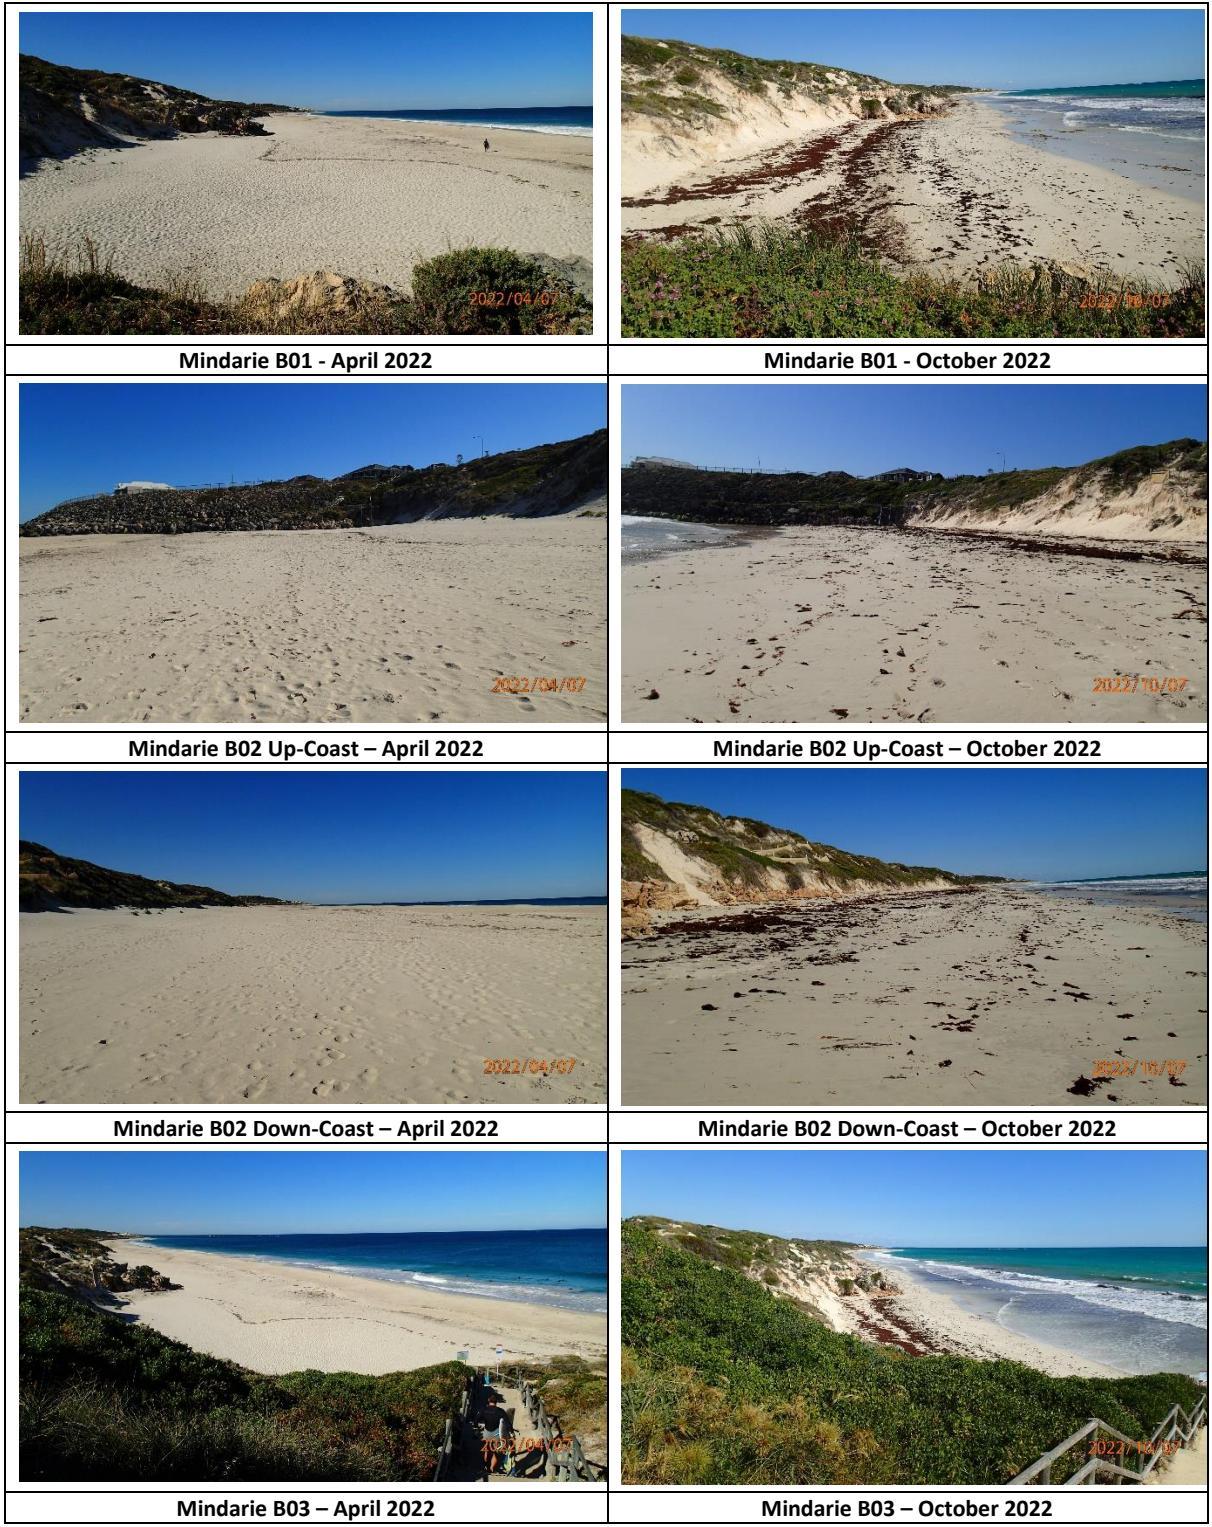
Figure 4-12 Major erosion over winter 2021 at Mindarie B01, B02 and B03.

Significant erosion was observed at Clayton's Beach in Mindarie over the 2022 winter period. While the images show some beach remaining in October 2022, images taken at site B01 and B02 show

significant impact to the base of the dunes at Clayton's Beach. Clayton's Beach experiences significant seasonal erosion and accretion each year however, there was significant dune erosion in 2021 which left the area vulnerable to further erosion in 2022. While there is little infrastructure landward of Claytons Beach it is recommended that the area be closely monitored in future coastal monitoring reports and if significant erosion continues coastal management measures should be investigated for the area.

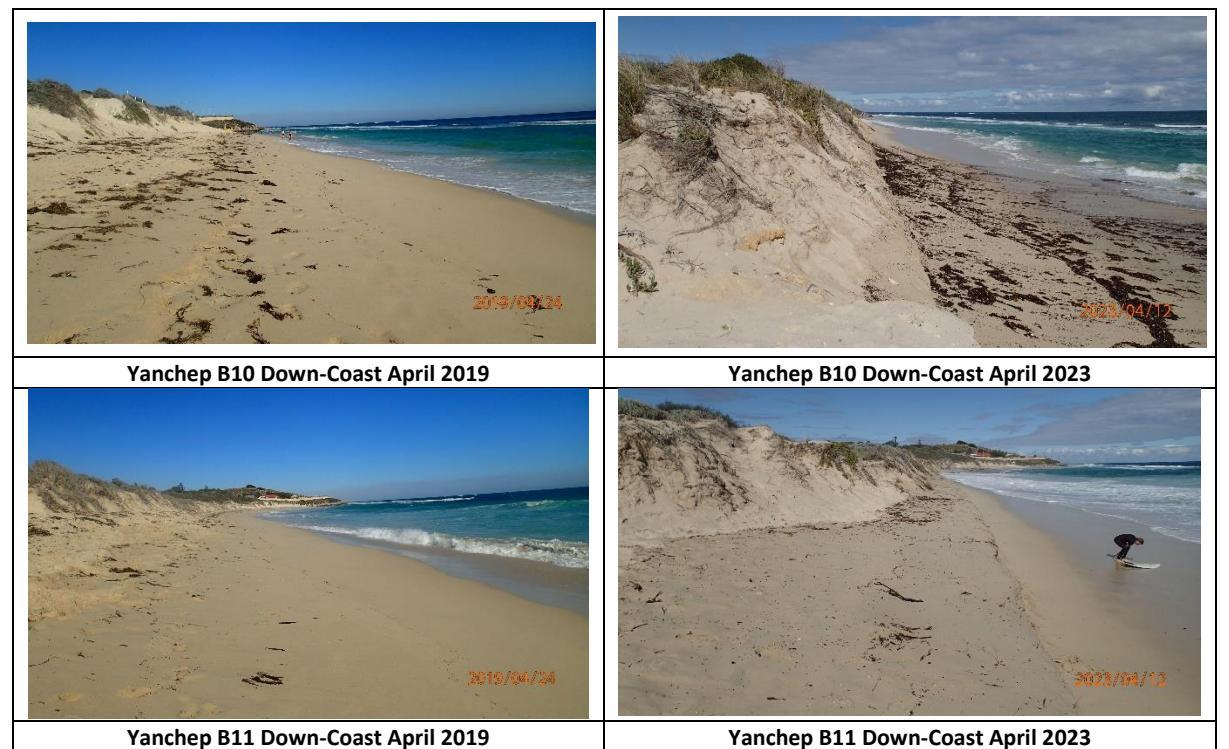
Figure 4-13 Significant long-term erosion at Yanchep Beach, north of Yanchep Lagoon.

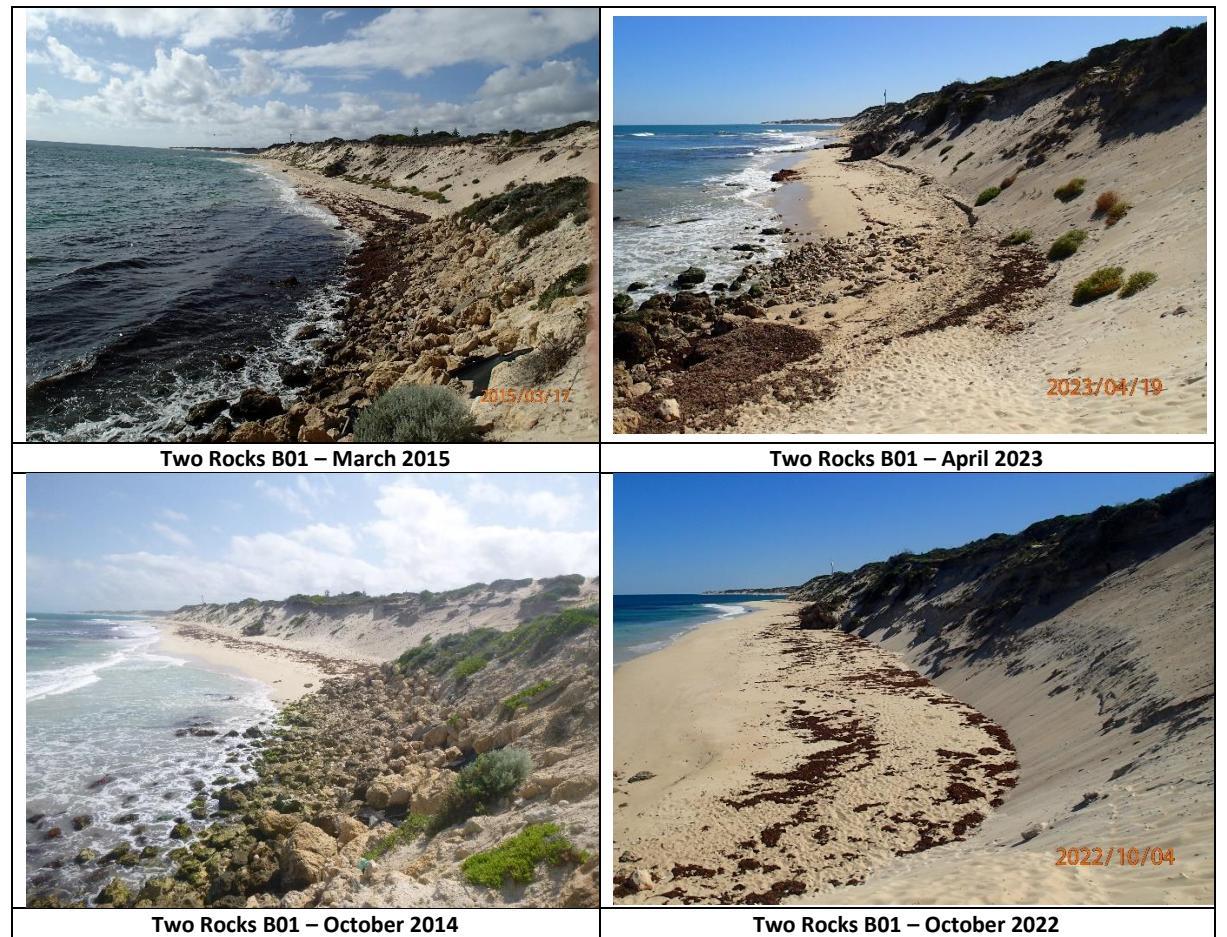
Figure 4-14 Significant long-term erosion at Two Rocks, north of the Two Rocks Marina.

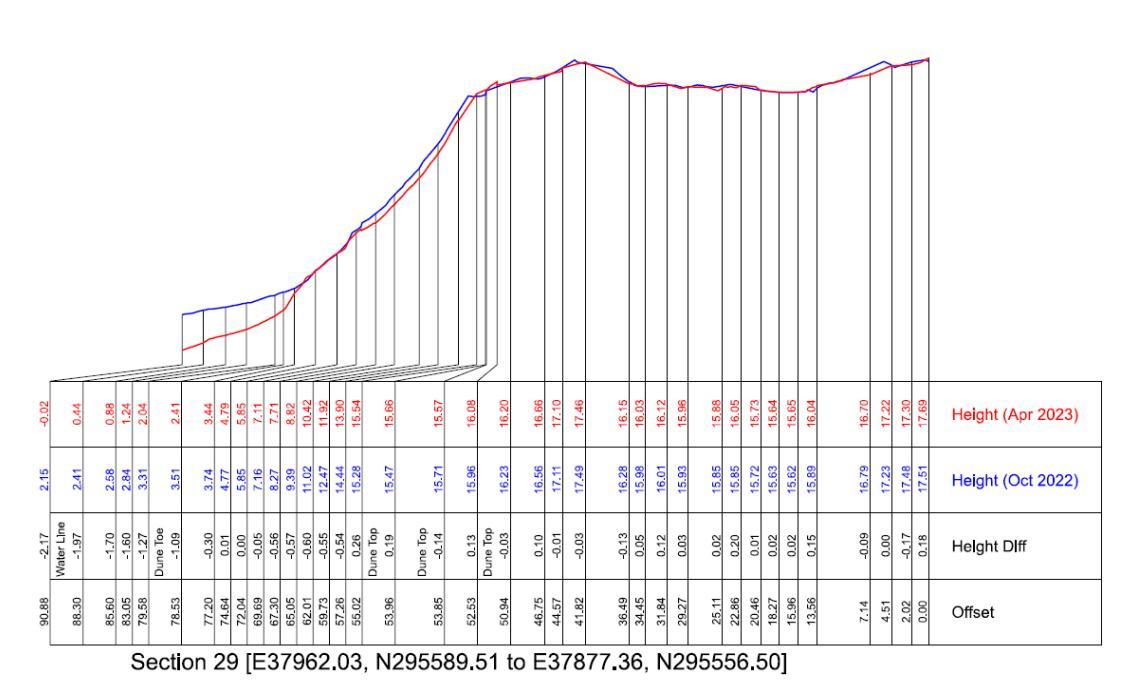
Quinns beach cross-section 29 is situated within the field of view of manual imagery point 'Quinns Rocks B13 Up-Coast'. Figure 5-4 shows a significant reduction in elevation (2.17m) between the October 2022 and April 2023 surveys which is consistent with the major seasonal summer erosion that was identified at the site through manual imagery analysis (**Section 4.2.1**). Significant seasonal summer erosion is common at this site as strong sea breeze conditions promote the northward transport of sediment, away from Quinns Groyne 3.

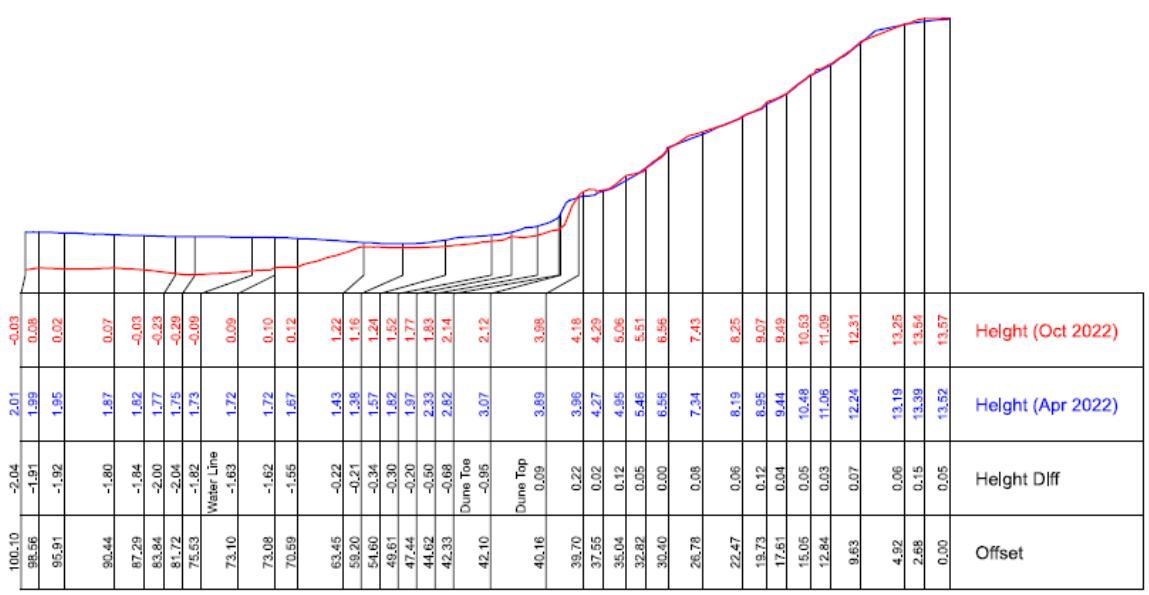
Section 21 [E32020.00, N307577.30 to E31928.96, N307535.69]

Yanchep Beach cross section 21 is situated within the field of view of manual imagery point 'Yanchep B07 Up-Coast' where significant erosion was observed between April and October 2022 in manual imagery. While levels above the water line show only a minor drop in elevation, levels below the water line show quite a significant reduction in elevation, with the maximum height difference between the April and October 2022 survey was 2.04m. These results outline the benefits of undertaking additional ground based nearshore survey transects as the results from these surveys can capture areas of significant erosion that is otherwise not captured through LiDAR Aerial Surveys. The results from this cross section are consistent with manual imagery observations.

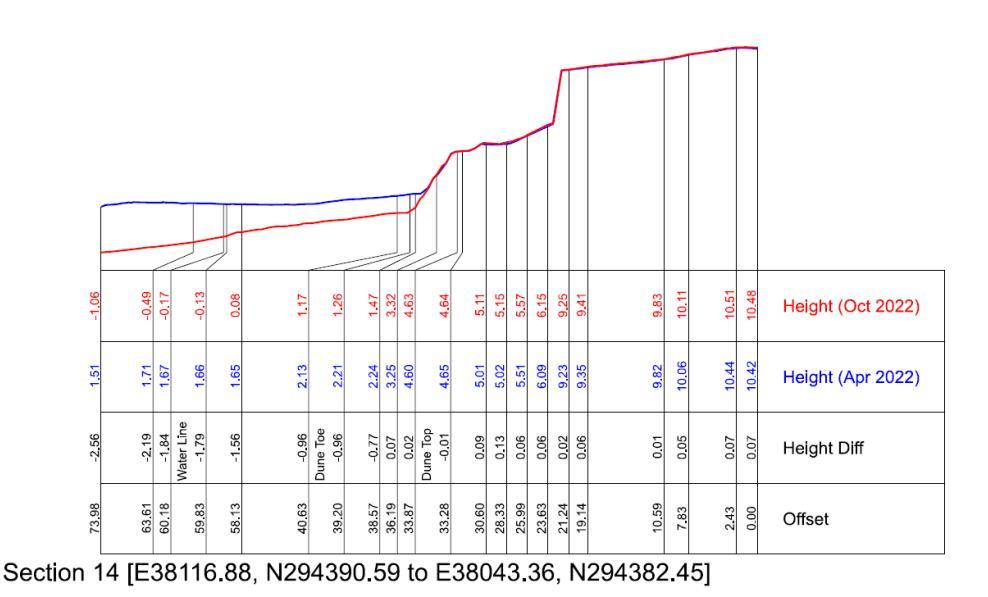
Figure 5-7 Quinns Beach cross section 14 elevation comparison between April 2022 and October 2022 surveys.

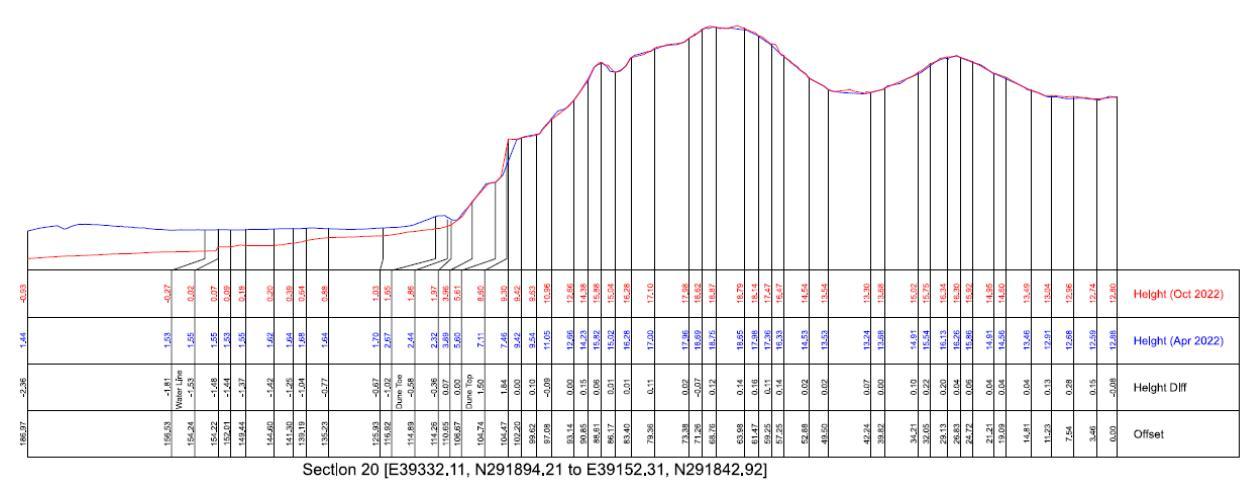
Figure 5-8 Mindarie cross section 20 elevation comparison between April 2022 and October 2022 surveys.

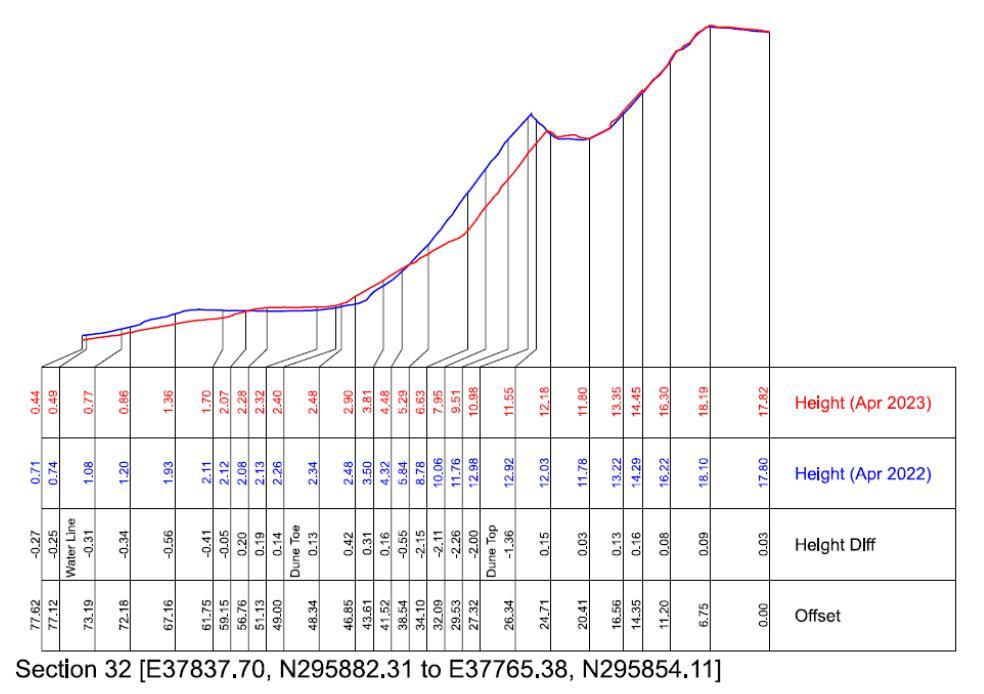
#### Cross Section 32 – Manual Imagery Site B14 Down-Coast

The cross section presented in Figure 5-9 indicates a significant recession of the dune face between the April 2022 survey and the April 2023 survey. This was not identified in manual imagery (Figure 5-10) as the dune face is not a main focus of the manual imagery field of view and recession in the dune face is difficult to interpret using manual imagery alone. Beach scraping was undertaken at this location in February 2023 to build-up the base of the dune system and protect the site from the impacts of winter storms. Despite this, there was still a significant recession of the upper dune face over the past 12 months.

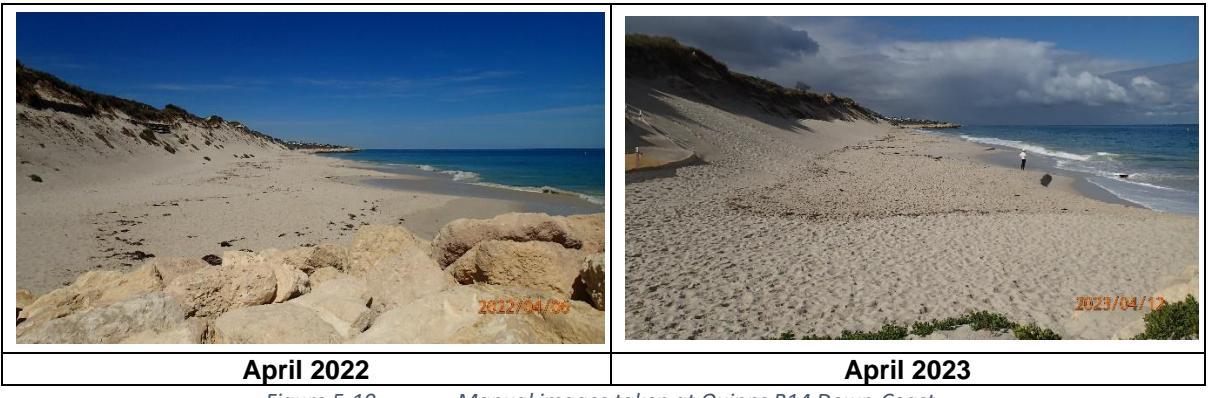
Figure 5-10 Manual images taken at Quinns B14 Down-Coast.

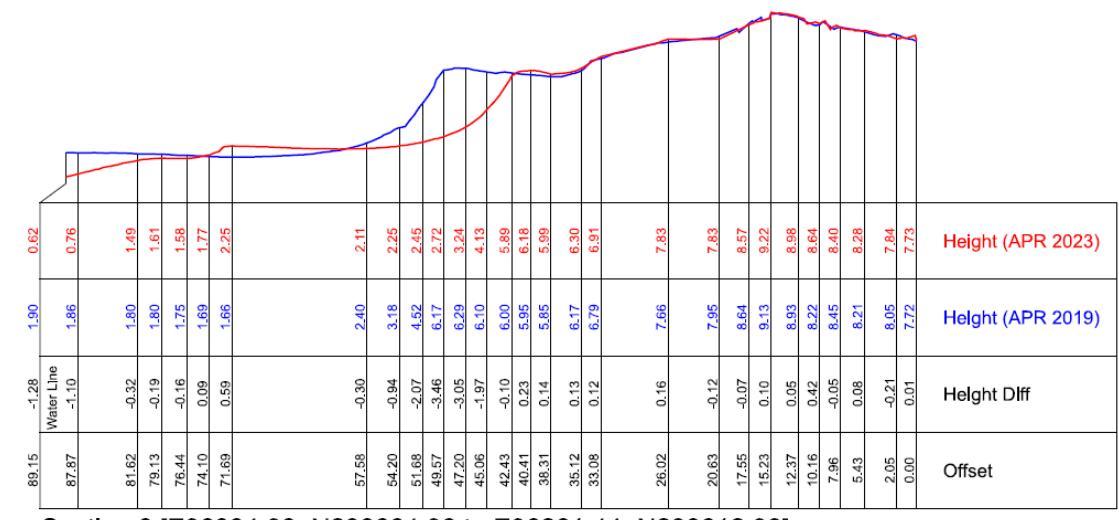
Section 6 [E36334.08, N298664.06 to E36261.44, N298612.39]

Figure 5-12 Cross section 6 at Eden Beach which shows dune recession of approximately 8m between April 2019 and April 2023.

Eden Beach cross section 6 is situated to the north of Eden Beach, just south of Eden Beach Access Way 3 and Eden Beach cross section 8 is located adjacent to Eden Beach Access Way 4. The crosssections show a significant reduction in elevation (maximum 6.08m) and a dune recession of almost 8m between the April 2019 and April 2023 surveys. There is no manual imagery site at this location. This foreshore area is still managed by a private land developer and this information has been passed on to the current land manager. Significant erosion was noted at this site by Land Development following a Practical Completion Meeting in early 2023.

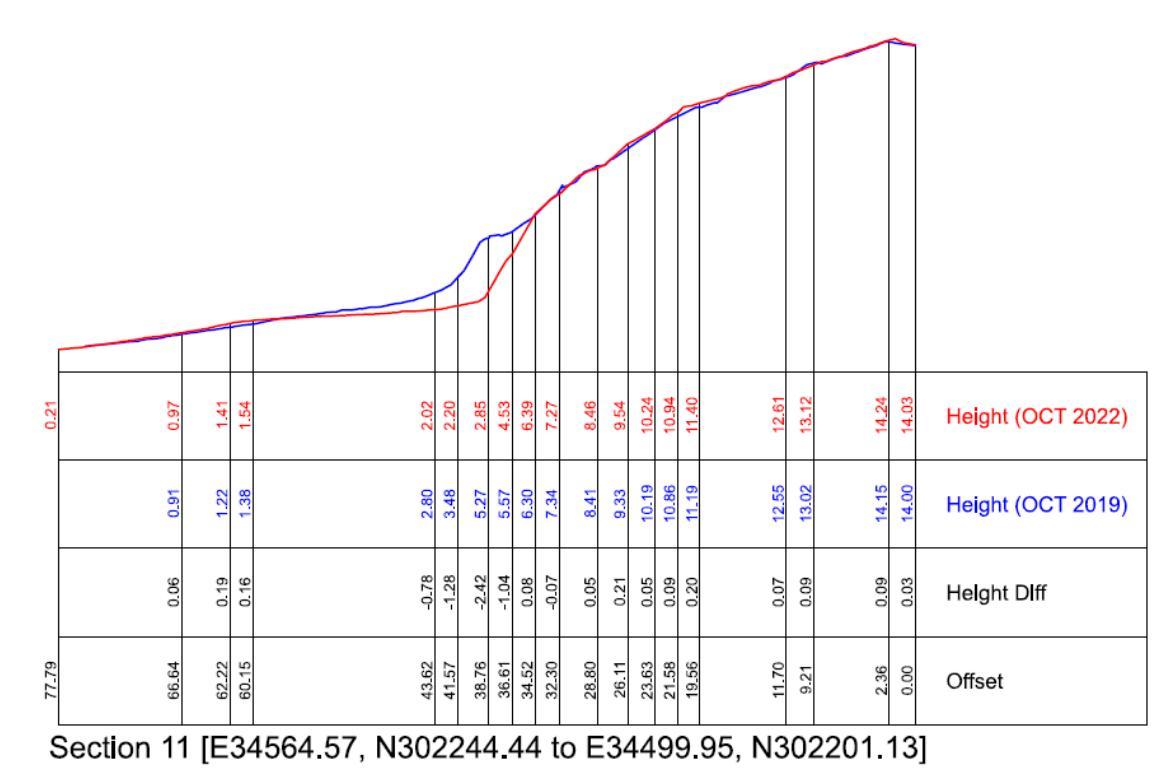
Figure 5-14 Cross section 11 at Amberton Beach which shows dune recession of 3m between October 2019 and April 2023.
