# City of Wanneroo Coastal Monitoring Report April 2023

# **1** Introduction

A long-term coastal monitoring program has been undertaken by the City of Wanneroo (CoW) since 2014. The purpose of the program is to evaluate the seasonal, annual and long-term trends in erosion and accretion along the City's coastline. This helps to better inform coastal management decisions, identify key areas with future management requirements and to provide data for future coastal hazard studies.

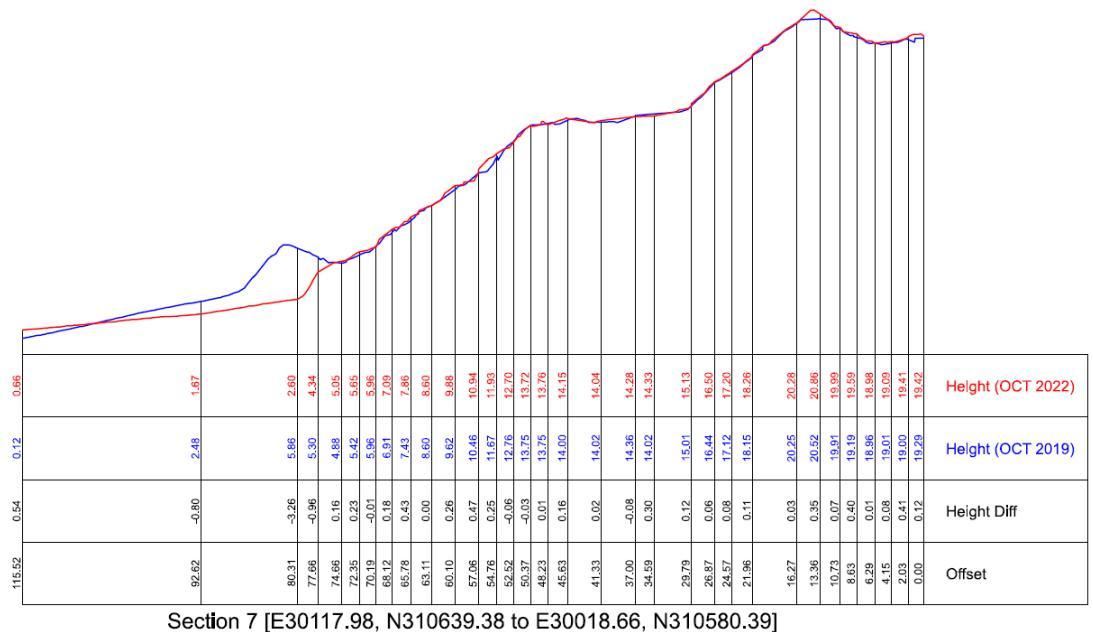
Figure 5-16 The Spot beach cross-section 7 October 2019 to October 2022 elevation difference.
