# Koondoola Regional Bushland Management Plan

July 2008

Originally prepared by Ecoscape (Australia Pty Ltd) & adapted by the City of Wanneroo

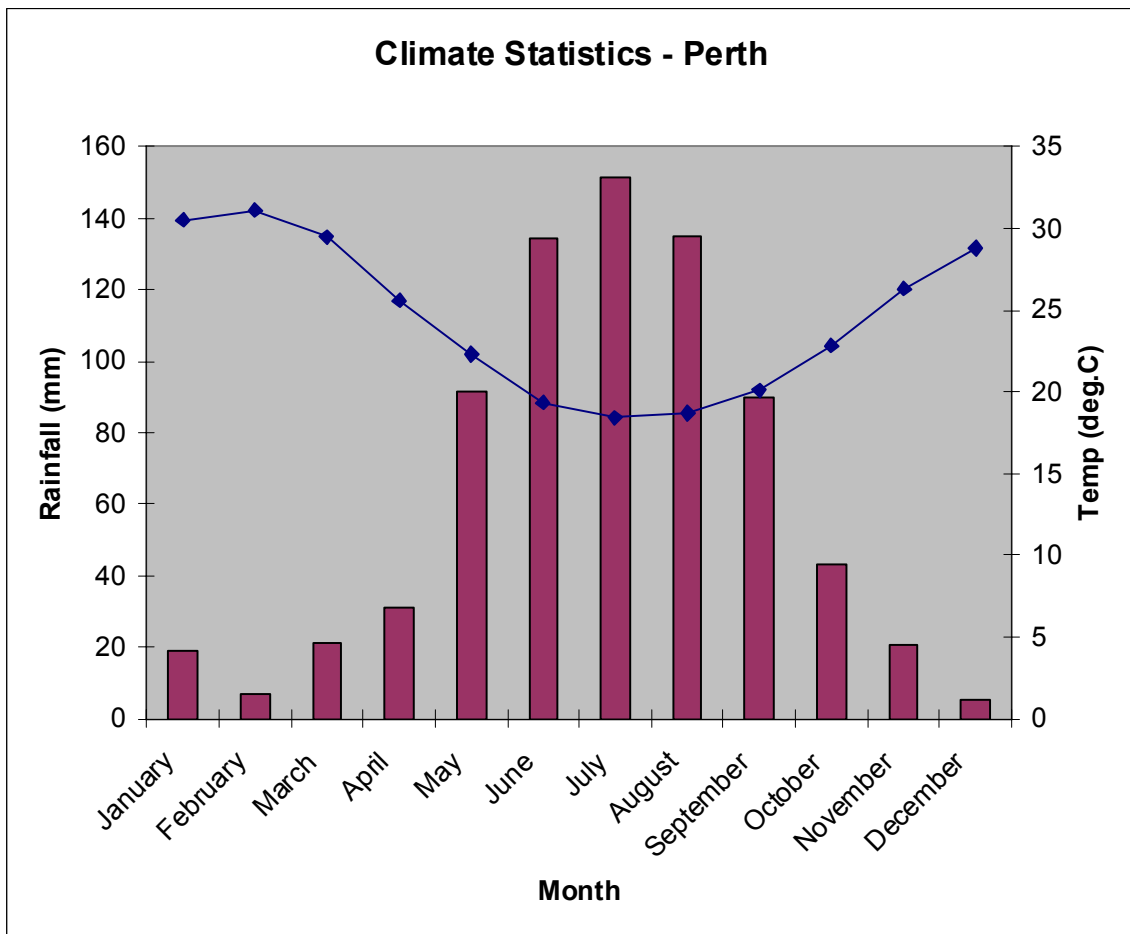
**Figure 2.1 Temperatures and Rainfall for Perth (Bureau of Meteorology 2005)**

The Perth region exhibits a Mediterranean climate with wet mild winters and dry hot summers. The average rainfall is 760mm each year, this generally occurs in the winter months when little is lost through evaporation (Bureau of Meteorology, 2007). The average rainfall and temperatures for Perth are shown in Figure 2.1 below.

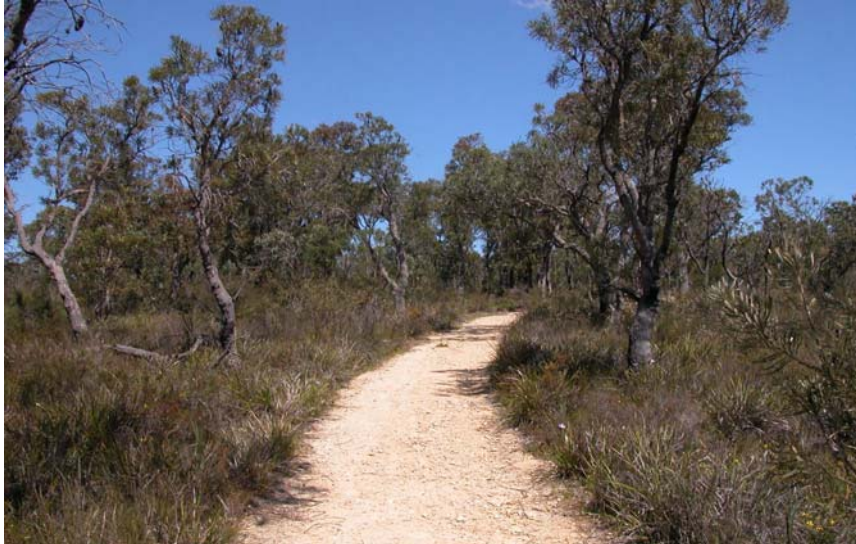
***Plate 4.1 Limestone track in excellent condition***

A walk trail that provides universal access is currently provided between gates 1 and 2. This path could be upgraded to provide interpretation or extended to provide a complete loop that is more appealing to visitors. Any material brought into the site to construct sites needs to be appropriately sourced in order to ensure diseases are not introduced into the site.

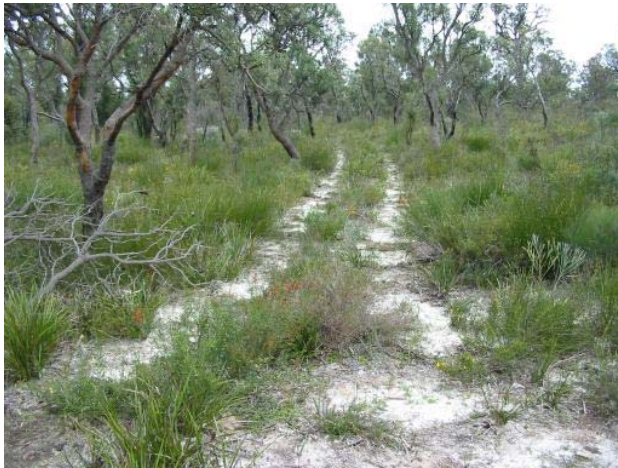
*Plate 4.2: Disused track revegetating*

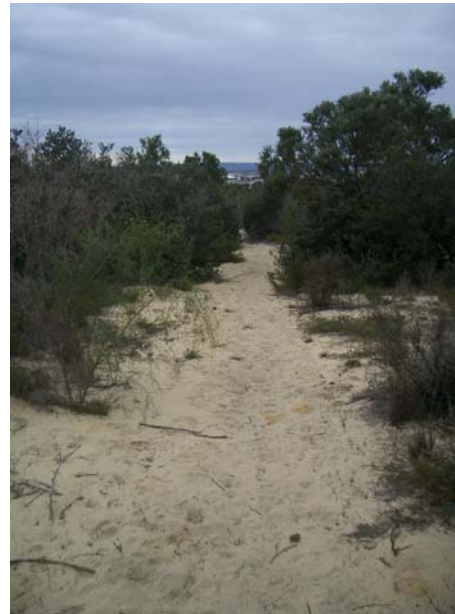
*Plate 4.3: Informal track in need of revegetation*

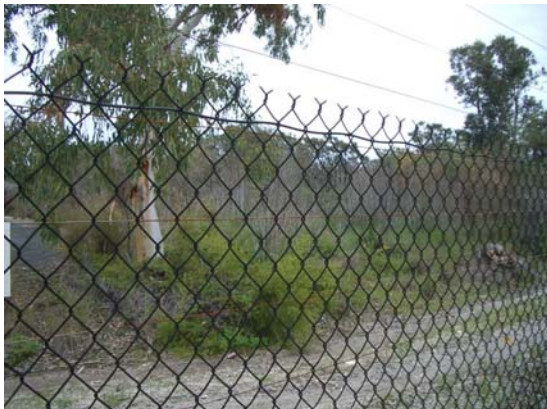
**Plate 4.4 Cyclone fencing**

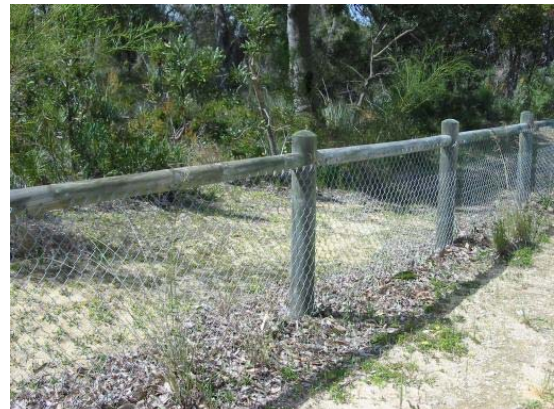
**Plate 4.6 Conservation fencing**

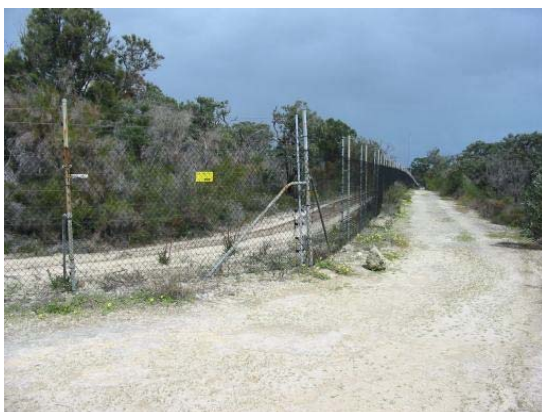
**Plate 4.5 Electric fencing**

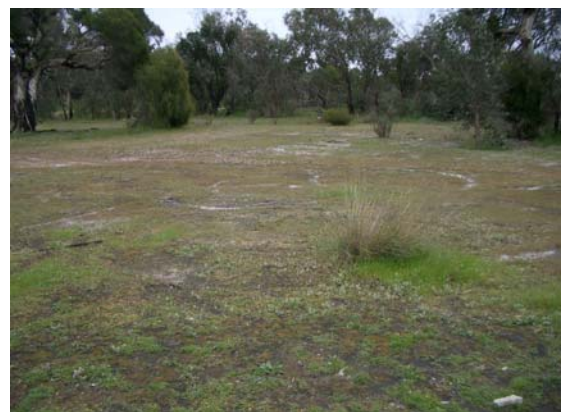
**Plate 4.7: Anti-social behaviour (Bike damage)**

These gates do limit access; however, unauthorised vehicles are still entering the bushland (eg. motorbikes) and causing damage to the bushland.

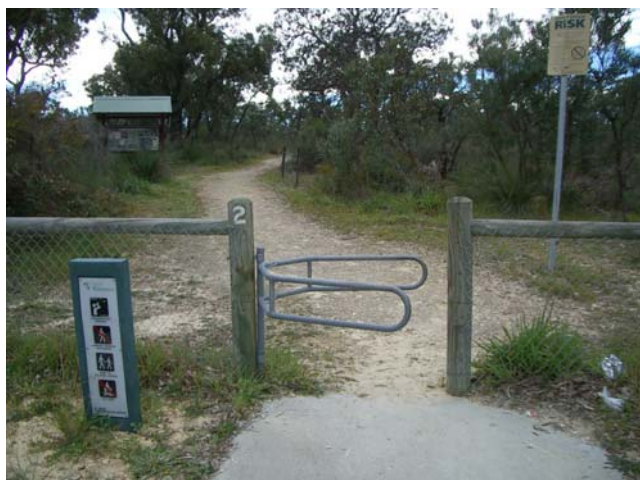
**Plate 4.8 Pedestrian Gate**

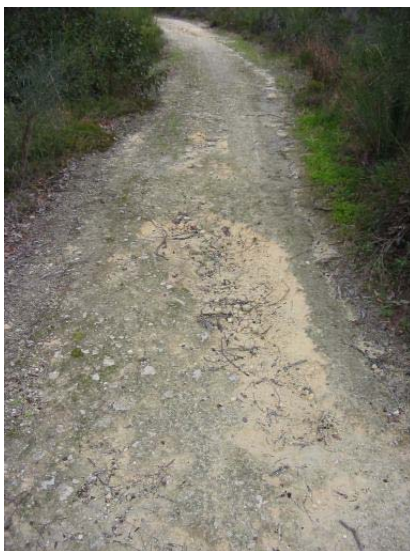
*Plate 5.1 Minor erosion of limestone path*

There also needs to be allocated paths that are wheelchair accessible. The Australian Standard for Walking Tracks (AS2156.1-2001) establishes that tracks should have a minimum width of 90 cm for minor paths and a minimum of 120 cm for major paths or paths with wheelchair access.

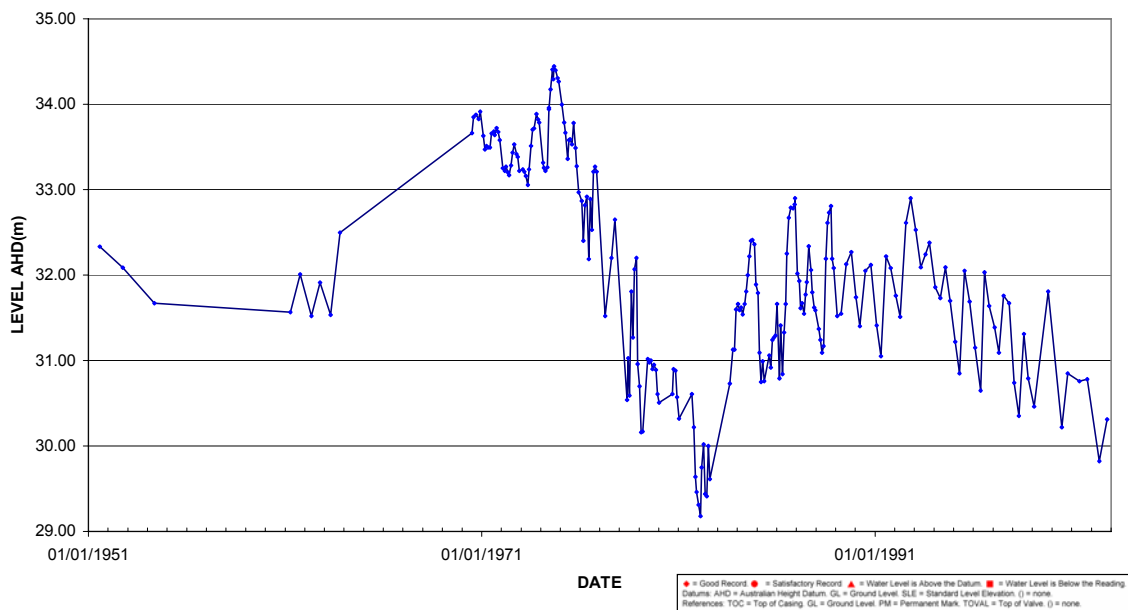
### 61610208 LAKES AND WETLANDS - BORE 469

Easting = 393624.00 Northing = 6476099.00 Zone = 50 TOC = 35.79mAHD WIN SITE ID = 4549

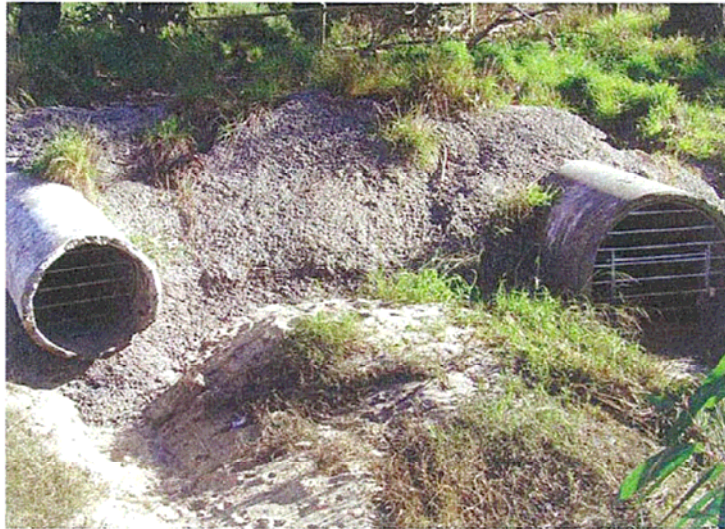
Photo 1 Catchment 1 675mm Outfall and Catchment 2 1050mm Outfall

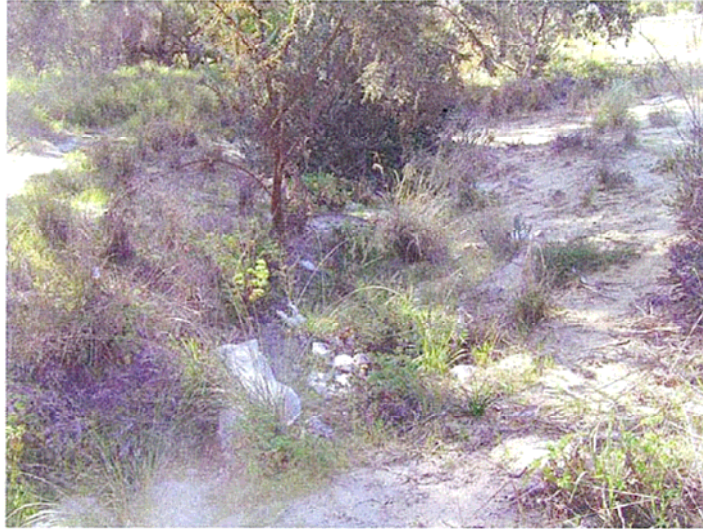
Photo 2 Gross Litter around Catchment 3 Outlet Pipe

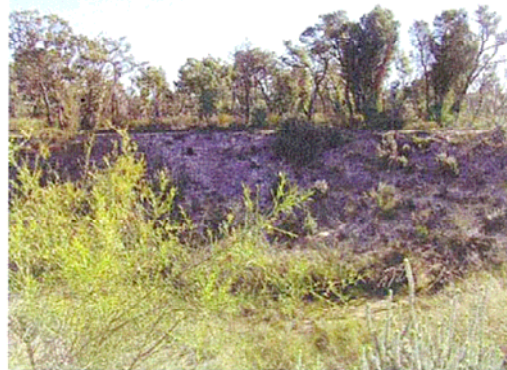
**Photo 3 Catchment 5 Drainage Sump**
