R361 Rev 1

April 2014

City of Wanneroo

**Two Rocks
Coastal Management**

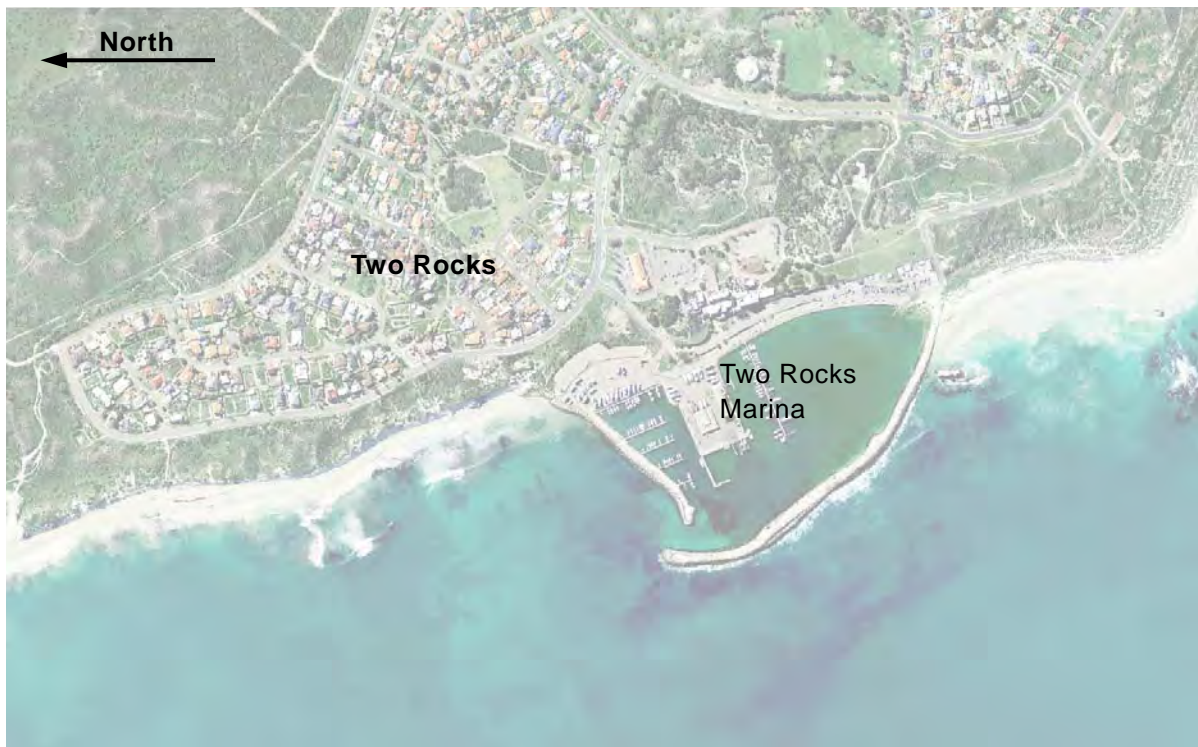
Figure 1.1 - Two Rocks Marina & Key Features (2011 Aerial)

Two Rocks is located on the Western Australian coastline, approximately 60 km north of Perth. Following construction of the Two Rocks Marina (Marina) in 1973, the sections of shoreline adjacent to the Marina have undergone significant changes. In particular, sections of the coastline immediately north of the Marina have experienced substantial and long term erosion while the coastline to the south of the Marina has undergone substantial accretion. Figure 1.1 shows the Marina and adjacent features.

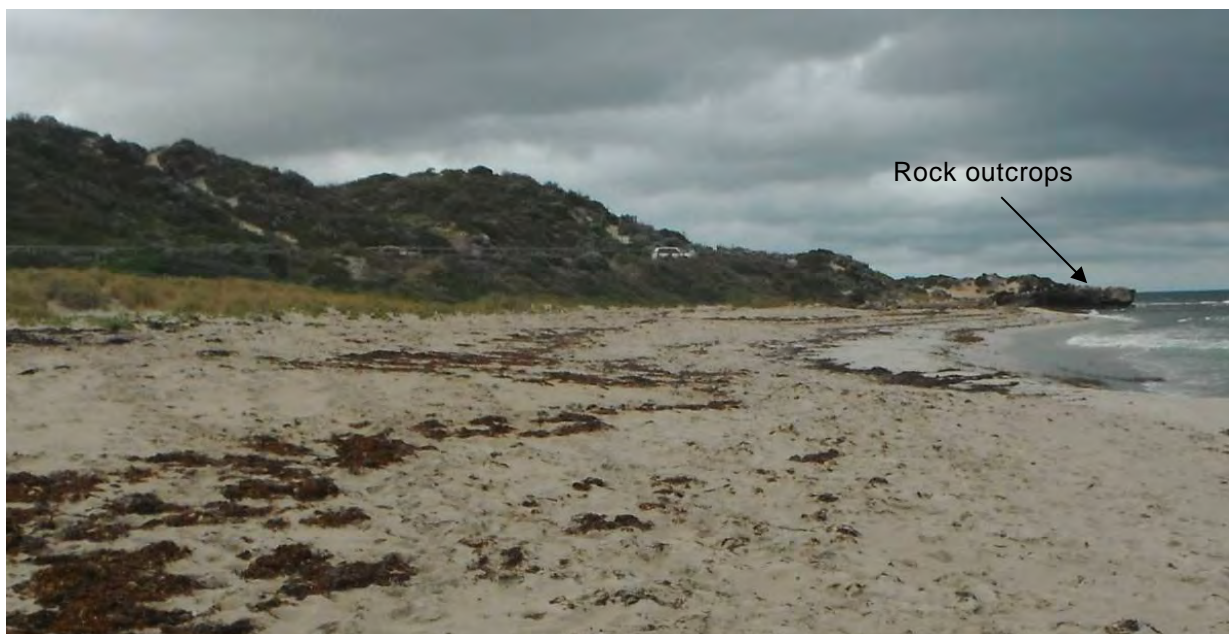
Figure 2.3 - Southern Study Area Coastline (6/12/12)

As stated previously, the coastline within the study area is predominately a sandy coastline, with isolated areas of limestone rock outcrops and nearshore reefs and rock platforms. An area of the shoreline near the southern end of the study area, known locally as 'The Spot', is shown in Figure 2.3.

Figure 2.3 shows that the coastline about The Spot consists of a series of limestone rock outcrops, backed by high dunes, with limited beach presence in front of the rock outcrops. Heading north from The Spot, the coastline becomes an increasingly wide sandy beach with low dunes. This trend of a wide beach with low dunes continues north towards Two Rocks as shown in Figure 2.4.

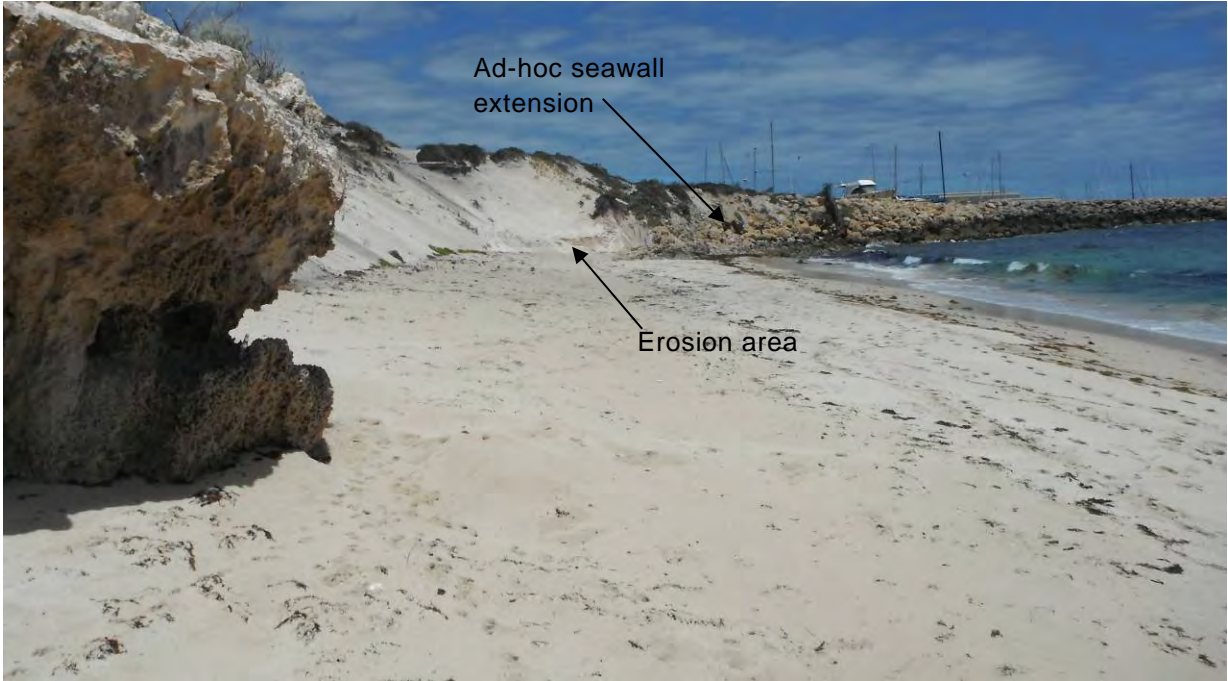
Figure 2.5 - Erosion at the Northern End of the Marina (6/12/12)

North of the Marina, the coastline is a narrower sandy beach backed by high dunes with steep erosion scarps. Immediately north of the Marina, the shoreline is receding past the current extents of the northern seawall. This has resulted in ad-hoc extensions to the seawall to protect the Marina from erosion as shown in Figure 2.5.

As shown in Figure 2.5, this area also includes a limestone rock outcrop located in the dune face that is currently exposed. The extent of this rock outcrop into the dunes is unknown.

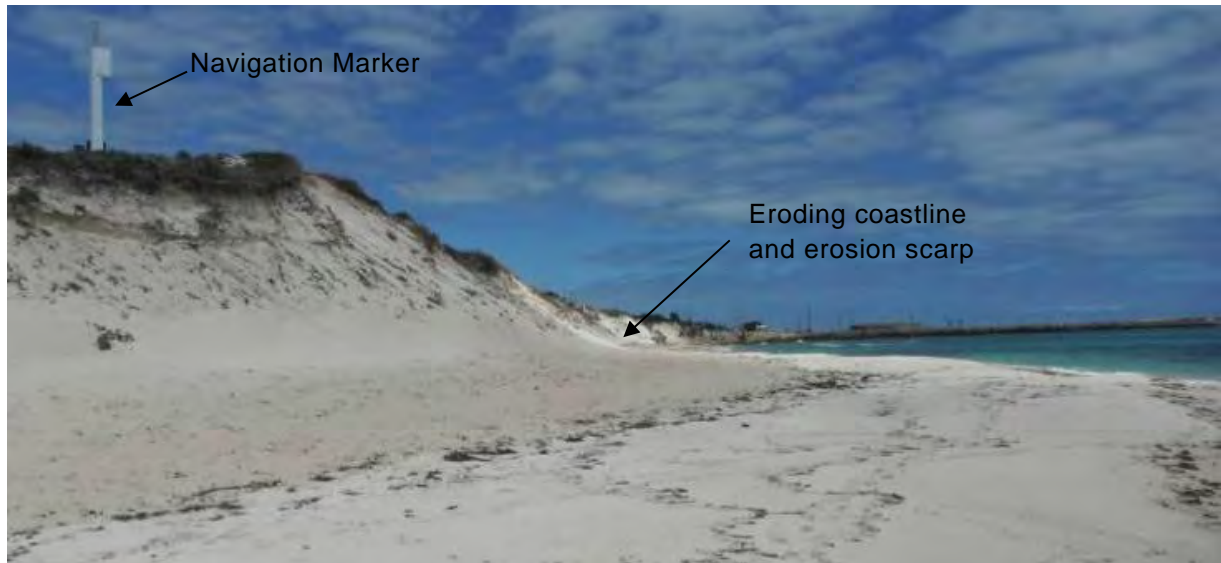
Figure 2.6 - Erosion North of the Marina (6/12/12)

Further north of the Marina the coastline continues as a narrow beach with high dunes and a steep erosion scarp. At the small headland approximately 400 m to the north of the Marina, a series of rock platforms in the nearshore area have resulted in a wider beach forming. As shown in Figure 2.6, the dunes behind the nearshore rock platforms are still eroding.

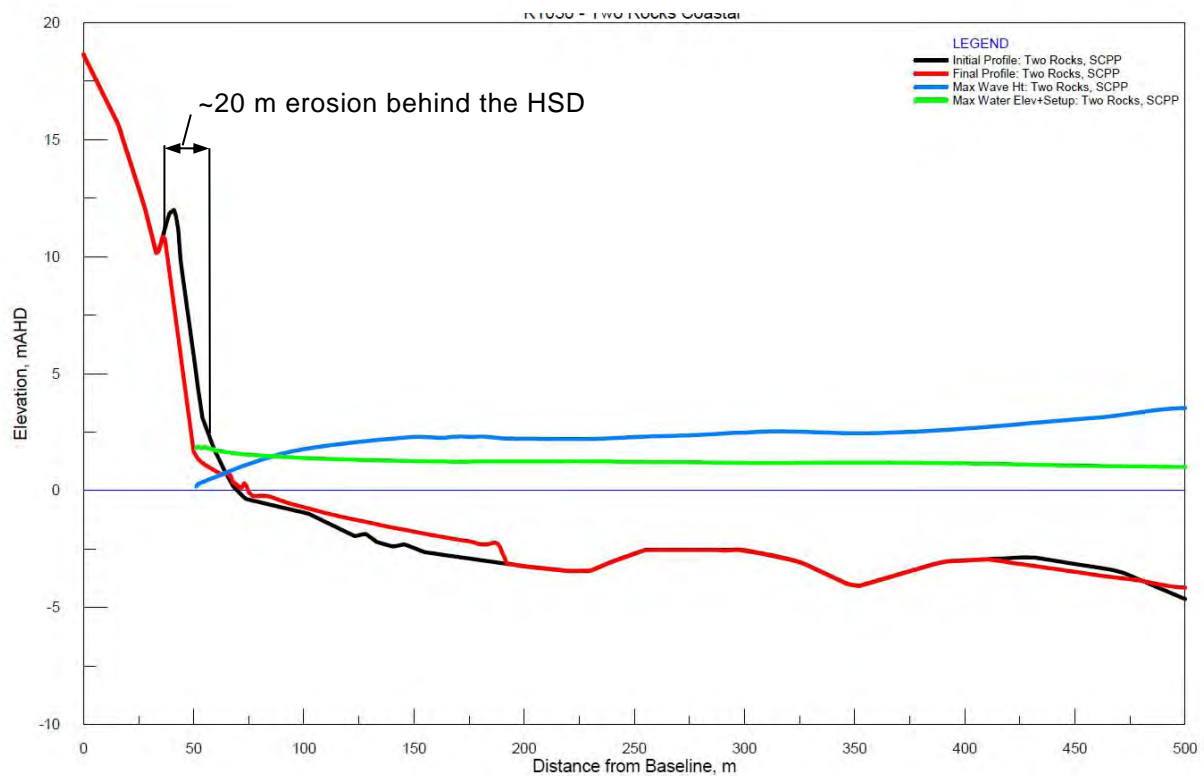
Figure 3.2 - Severe Storm Erosion North of Marina

Figure 3.2 shows the results of the SBEACH storm erosion modelling for the study area. The initial and final beach profiles, peak water levels and peak wave heights are also shown.

From on-site observations, it was determined that the HSD for the coastline to the north of the Marina was the toe of the erosion scarp at +2.5 mAHD. As shown in Figure 3.2, the extent of erosion behind the HSD is approximately 20 m.

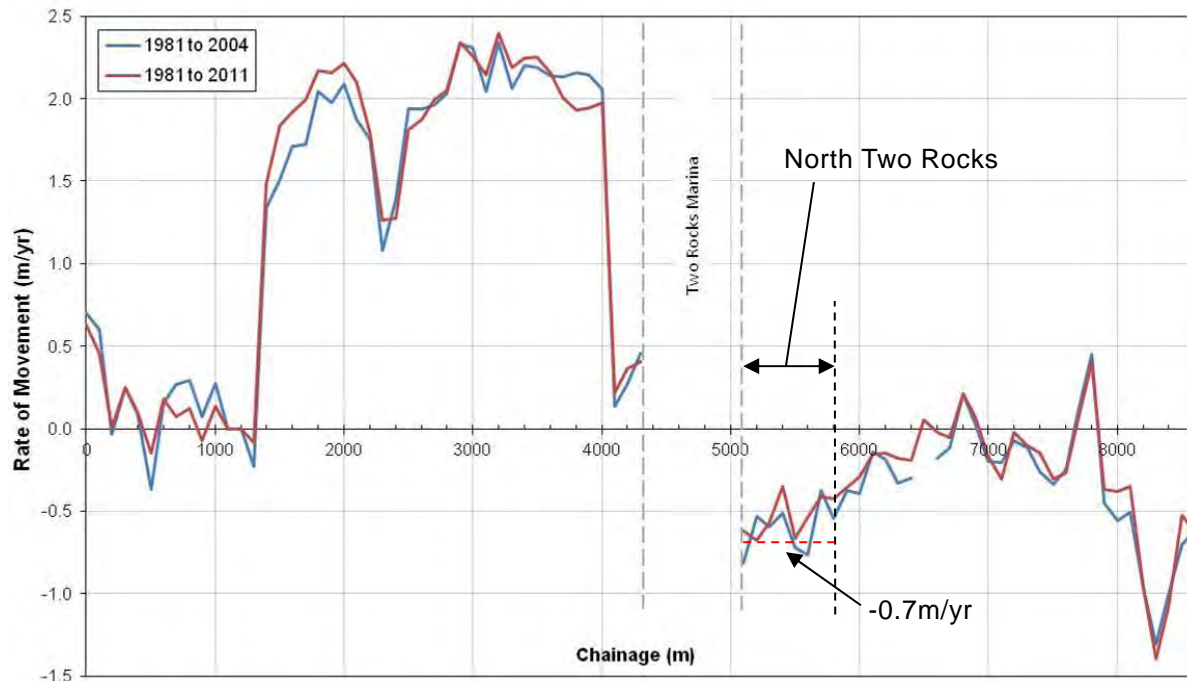
Figure 3.7 - Shoreline Movement Rates Relative to 1981 Baseline

In order to estimate the potential future shoreline movement of the coastline north of the Marina, the shoreline movement rates were determined. Average shoreline movement rates for the periods spanning 1981 to 2004 and 1981 to 2011 were obtained for each chainage within the study area and are shown in Figure 3.7.

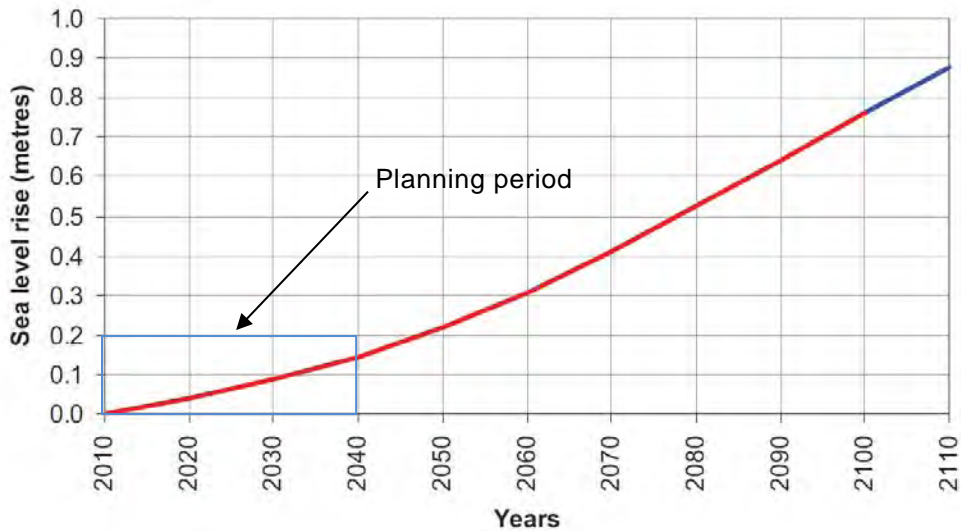
Figure 3.11 - DoT Recommended Allowance for SLR (DoT 2010)

It is assumed that for timeframes less than 100 years, the SLR values proposed by DoT (2010) would be appropriate for calculating the shoreline recession allowance due to SLR. Figure 3.11 shows the planning period considered for this investigation and the DoT recommended allowance for SLR.

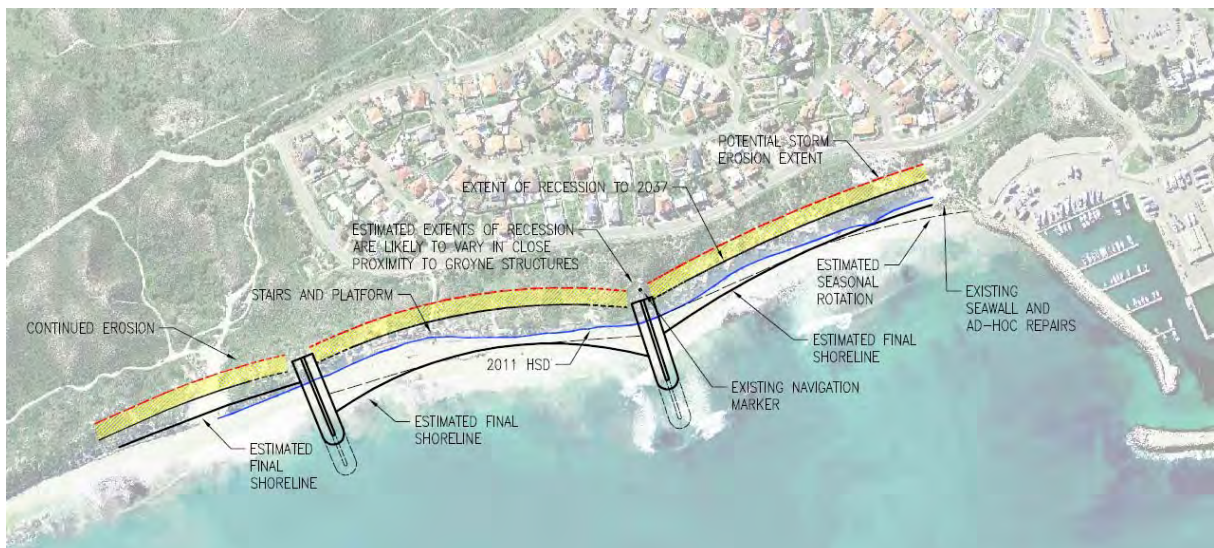
Figure 6.7 - Shoreline Recession & Potential Severe Storm Erosion to 2037

Based on the extent of shoreline recession rates previously estimated in Section 3, the extent of shoreline recession expected under the Staged Groyne option to 2037 is shown in Figure 6.7. The extent of severe storm erosion that may occur is also highlighted.
