Foreshore Management Plan

Catalina Estate Coastal Access Infrastructure

Revision 6, February 2019

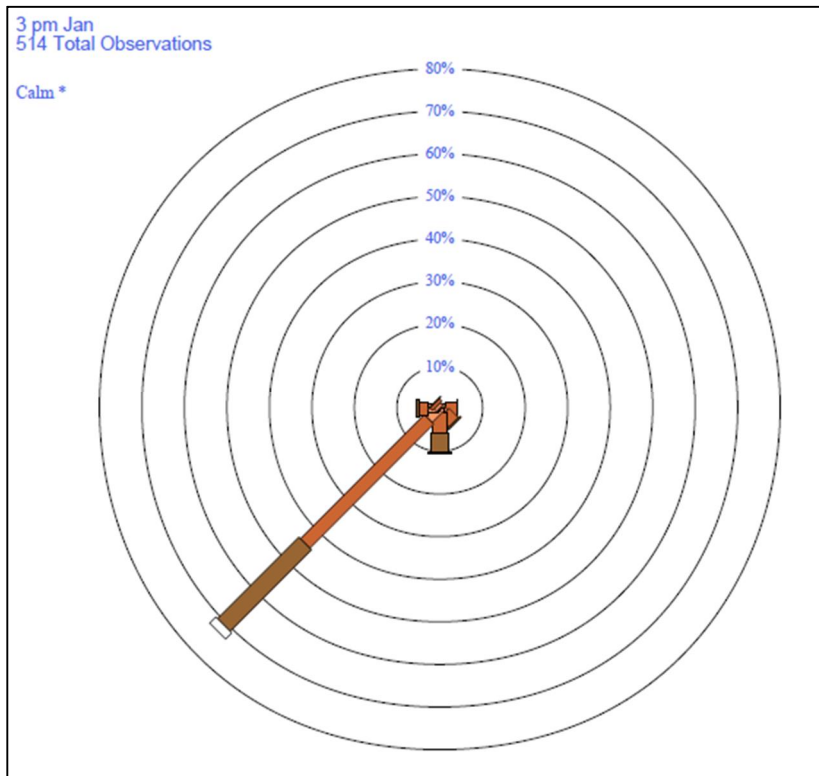
Plate 2: Wind rose (Swanbourne) - 3 pm January Observations (BOM, 2016)

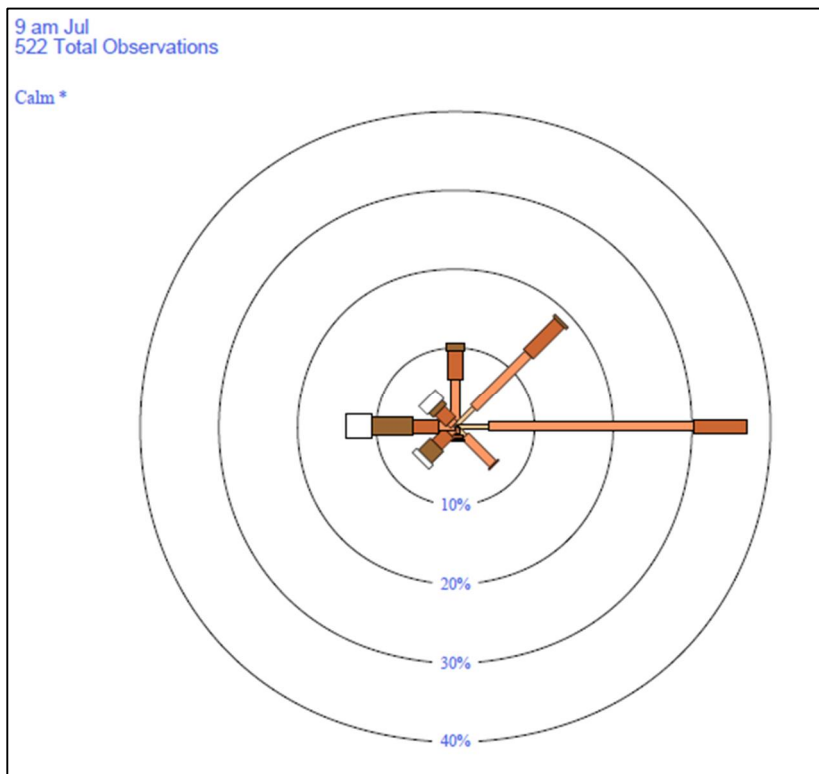
Plate 3: Wind rose (Swanbourne) - 9 am July Observations (BOM, 2016)

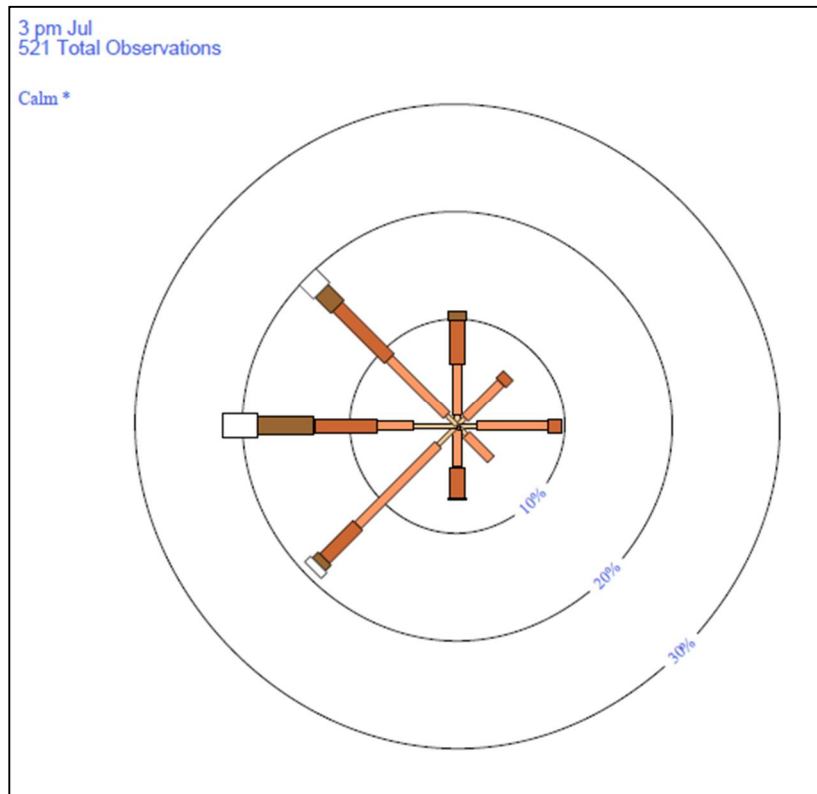
Plate 4: Wind rose (Swanbourne) – 3 pm July Observations (BOM, 2016)

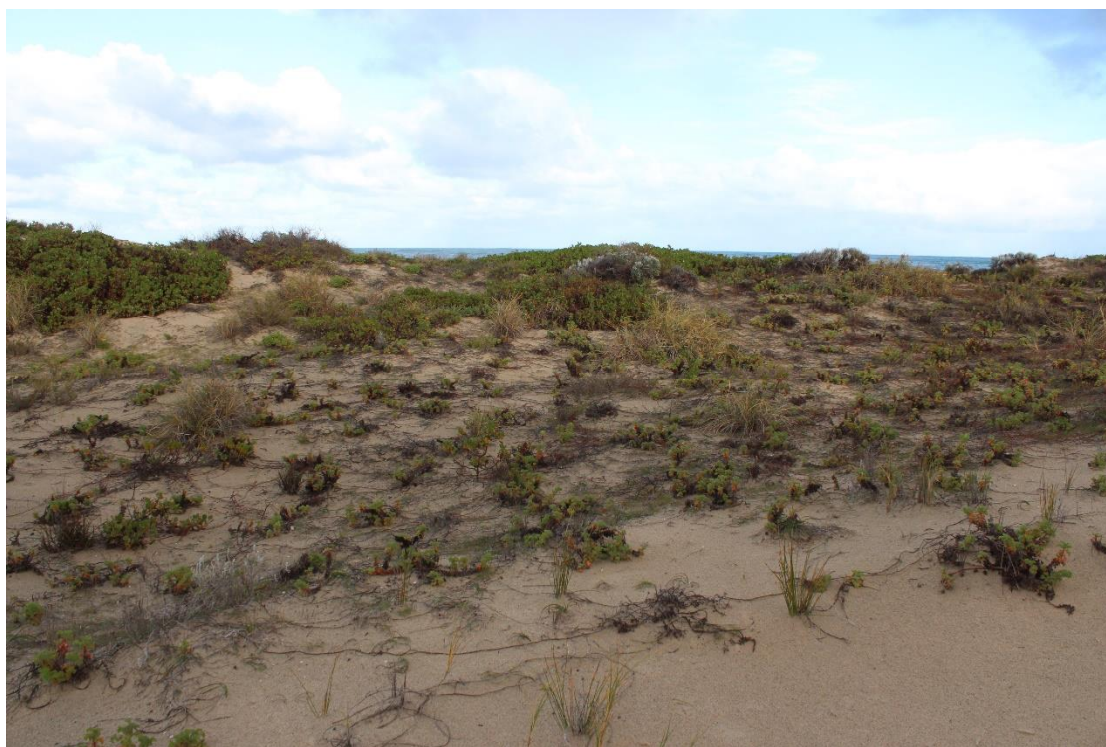
Plate 6: Foredune over which an access track will be constructed to provide pedestrian and maintenance vehicle accessway to the beachfront (photo taken facing west)

Beach accessway fencing will be installed along the path edges to prevent uncontrolled pedestrian access outside of this area, which could result in damage to the dune and coastal vegetation in this area. The beach accessway fencing will be compliant with the CoW's fencing specifications shown in drawing TS 01-4-2 (Appendix E). Lockable bollards will be installed at the carpark end of the beach accessway to prevent uncontrolled vehicular access to the beachfront.

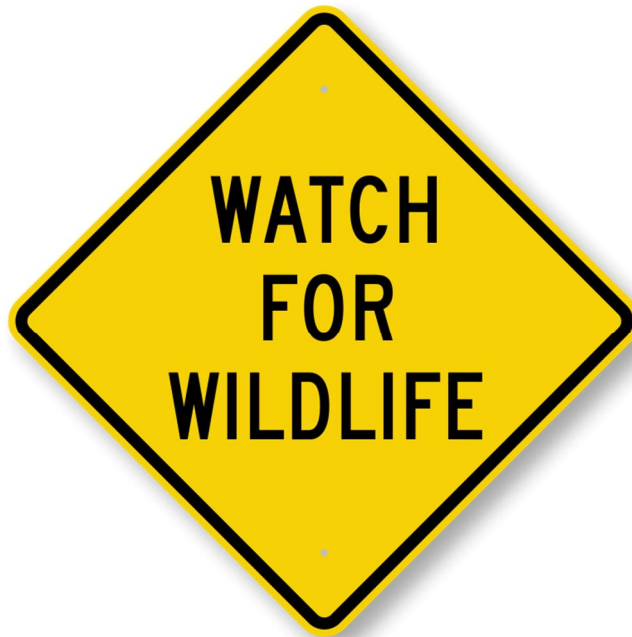
Plate 7: Example wildlife road awareness sign

To improve awareness of facility users, wildlife crossing signage shall be installed at both entrance points to the access road. Examples of signage are provided in Plate 7.

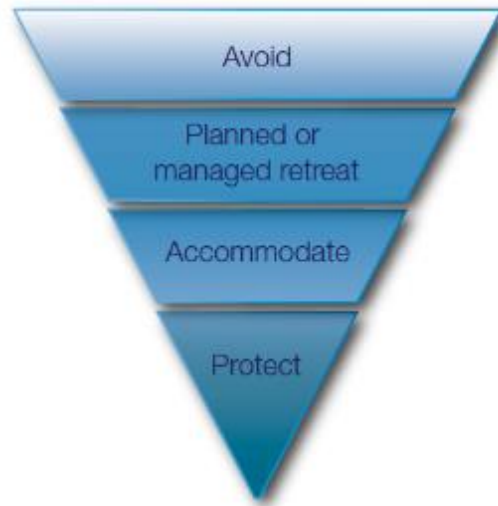
Figure 7.1 Risk Management & Adaptation Hierarchy

SPP2.6 outlines a hierarchy of risk adaptation and mitigation options, where options that allow for a wide range of future strategies are considered more favourably. This hierarchy of options is reproduced in Figure 7.1.
