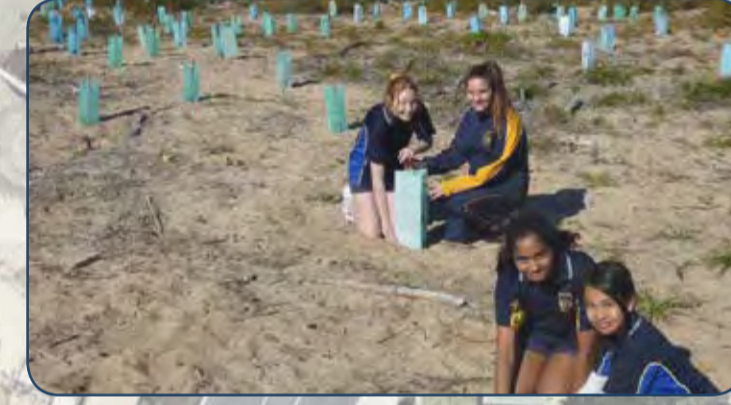
Dune rehabilitation: local community educational planting program.

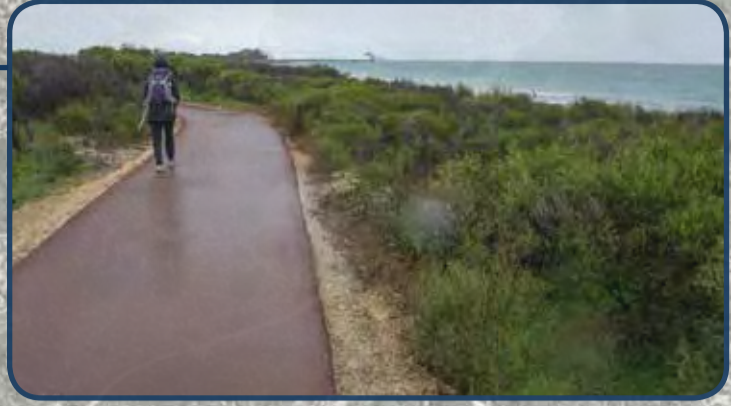
Sealed path: access path network constructed from asphalt on limestone base. Dark colours are recessive in landscapes.

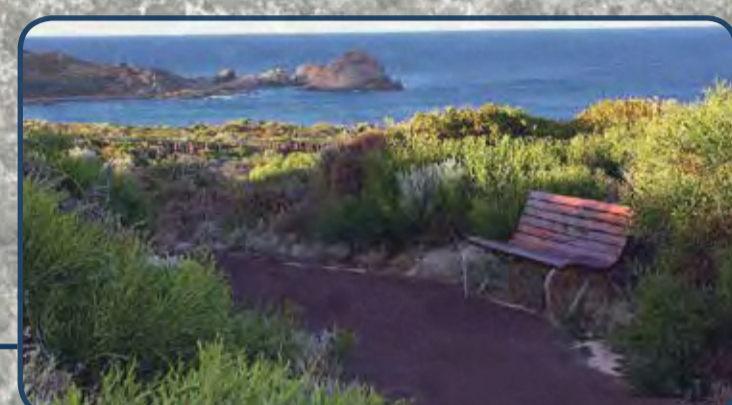
Seating lay-by: small seating lay-by nestled amongst existing tree canopy. Seating offers a break within the walk and an opportunity

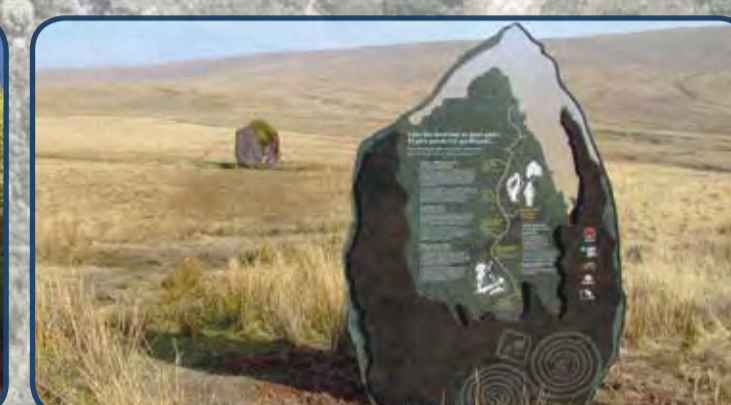
Interpretation signage: signage will document cultural history and identify local landmarks, flora and fauna.

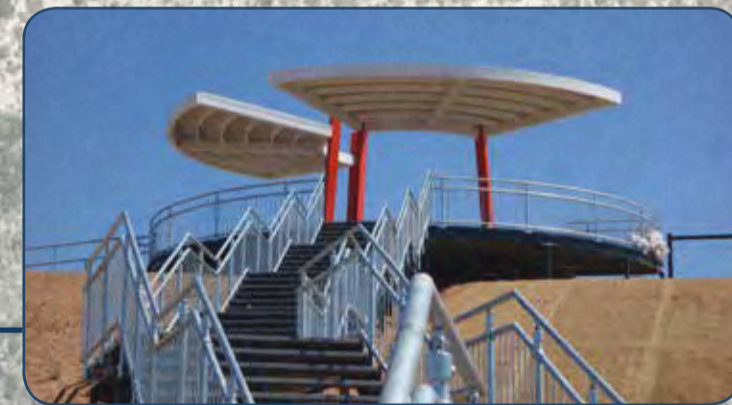
Lookout: vantage point shelter with interpretation signage.

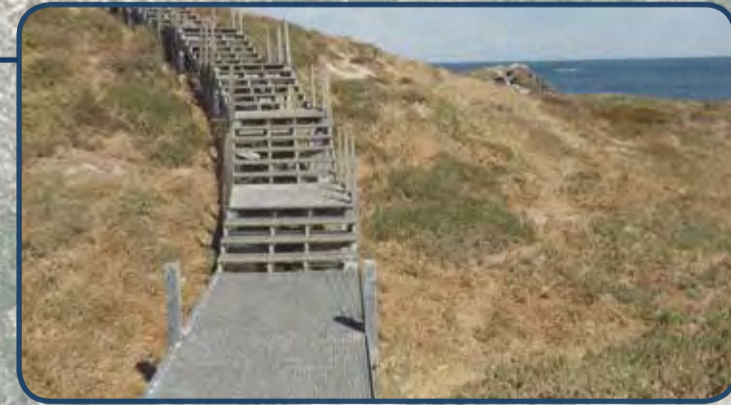
Boardwalk: access boardwalk constructed from composite materials. Recessive colour selections aligned with existing infrastructure.

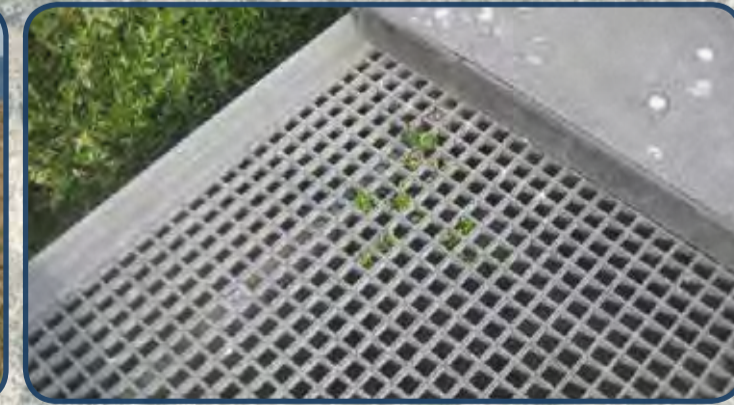
Fibre Reinforced Plastic (FRP): low maintenance materials allow sand to permeate and shrubs to grow through.

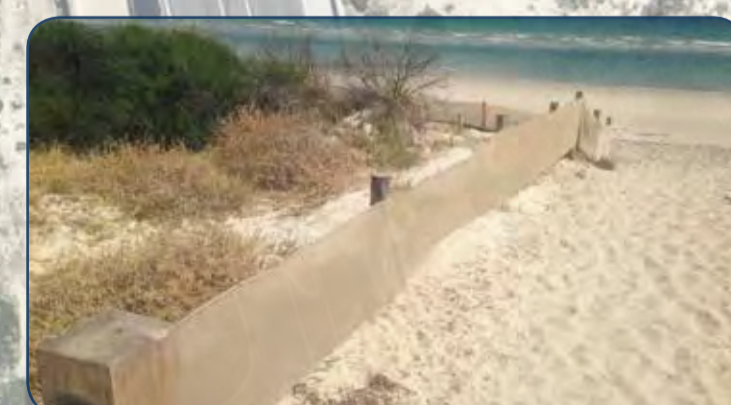
Protection fencing: sand drift dune fencing to restrict access, protect rehabilitation areas and mitigate sand drift.
