LOT 901 (NO. 150) FLYNN ROAD, NEERABUP
ADDENDUM TO EXCAVATION PLAN

EXCAVATION PLAN

LOT 901 (150) FLYNN DRIVE, NEERABUP

April 2014

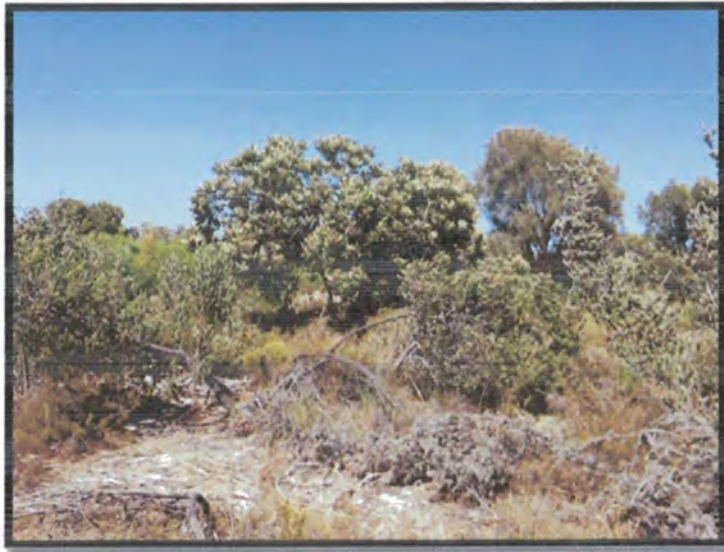
Plate 1 Vegetation in the south-west corner

A small amount of intact native vegetation occurs in the south-west corner of the lot. The vegetation consists of a Jarrah/Sheoak (*Allocasuarina fraseriana*)/*Nuytsia floribunda* Low

Woodland with some *Banksia menziesii* and Woolly Bush trees over *Hibbertia hypericoides/Desmocladius flexuosus* Heathland (Plate 1). The condition of this area was rated as Very Good.

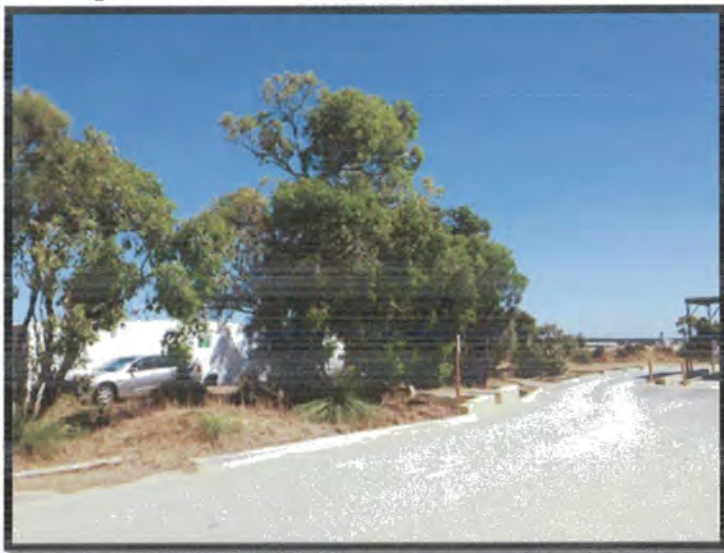
Plate 2. Clumps of Jarrah near around the entry road and site office

Some clumps of stunted Jarrah trees have been retained around the carpark and site office near Flynn Drive (Plate 2) as well as around the mulching facility in the north-west corner.

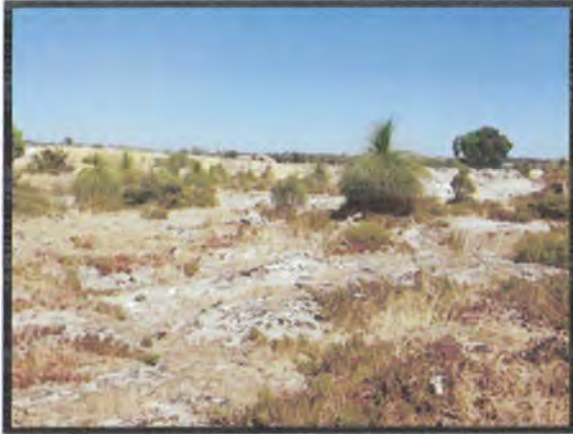
Plate 3 Cleared area with some native shrubs

The north-east quarter of the site contains a mix of cleared land, areas with native shrubs and no trees, previously cleared areas with some regeneration of native shrubs, and small clumps of remnant trees and understorey (Plate 3).

The few mature trees remaining in this area are mostly *Banksia attenuata* and some *B. menziesii*. No *Banksia* seedlings were observed in the area. Some Jarrah saplings are regrowing from the cleared stumps (Plate 4). The areas containing understorey species only contains common species *Xanthorrhoea preissii*, *Stirlingia latifolia*, *Alexgeorgea nitens*,
